SMCCCD - Cañada College

Appendix H: Facilities

Access Compliance Survey Report

Building 2 - Bookstore

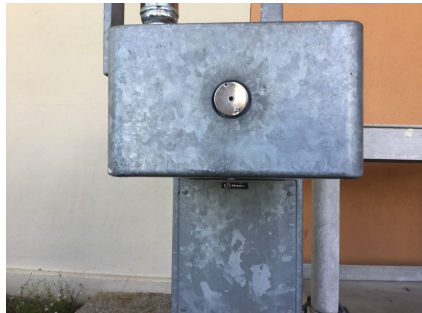
Item no., Rm no. and Name	Existing Architectural Barrier and Proposed Solution	Codes / Mitigation Info	Qty	Unit	Cost	Total
Drinking Fountain						
10993	<ul style="list-style-type: none"> As-Built Description: Wall- and post-mounted cantilevered units: Knee space not provided at drinking fountain (27" high, 8" deep, 30" wide from front of drinking fountain). As-Built: 26.75" high Proposed Solution: Provide new, accessible fountain. 	PCODE IA02 ADAAG 91 4.15.5(1) ADA 2010 602.2 CBC 2007 1115B.4.6.2 CBC 2016 11B-602.2 Mitigated: <input type="radio"/> YES <input checked="" type="radio"/> NO	1	JOB	\$9,600	\$9,600

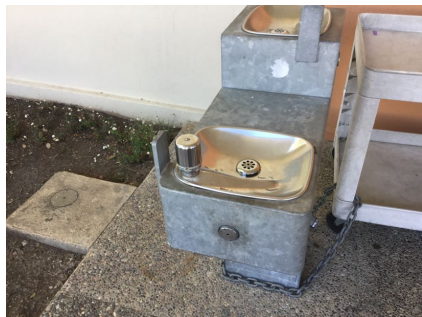
<input type="checkbox"/> Staff Only Priority 3 Severity 2			
10994	<ul style="list-style-type: none"> As-Built Description: Drinking fountain water flow less than 4" high; unit in good condition. As-Built: 1.5" high Proposed Solution: Adjust water flow. 	PCODE IA03D ADAAG 91 4.15.3 ADA 2010 602.6 CBC 2007 1115B.4.6.5 CBC 2016 11B-602.6 Mitigated: <input type="radio"/> YES <input checked="" type="radio"/> NO	1	JOB	\$225	\$225

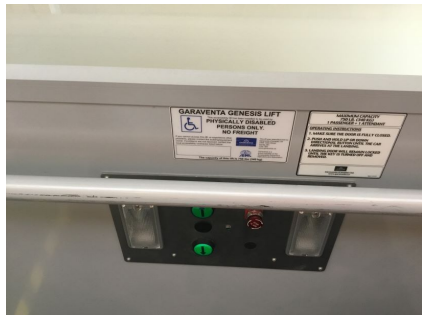
Item no., Rm no. and Name	Existing Architectural Barrier and Proposed Solution	Codes / Mitigation Info	Qty	Unit	Cost	Total
General Note						
10818	<ul style="list-style-type: none"> As-Built Description: Refer to notes for observation and recommendation. Proposed Solution: Notes: Incorrect/insensitive terminology at lift notes. 	PCODE GN01 CBC 2016 11B-404.2.5 Mitigated: <input type="radio"/> YES <input checked="" type="radio"/> NO				
			REF

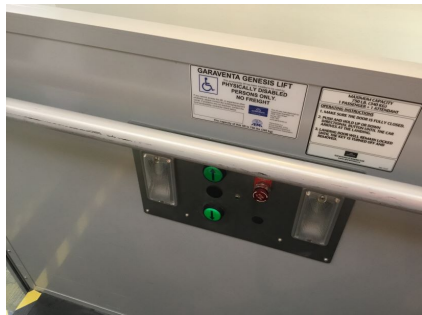
<input type="checkbox"/> Staff Only			
			Priority 1 Severity 3			
10819	<ul style="list-style-type: none"> As-Built Description: Refer to notes for observation and recommendation. Proposed Solution: Notes: Ensure the lift is provided with standby power for egress. 	PCODE GN01 CBC 2016 11B-404.2.5 Mitigated: <input type="radio"/> YES <input checked="" type="radio"/> NO				
			REF

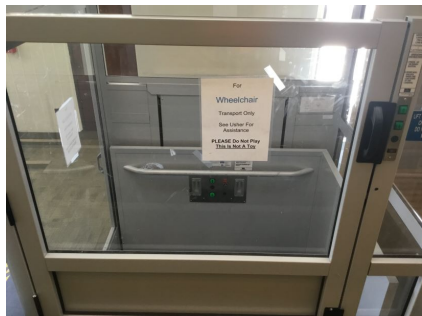
10837	<ul style="list-style-type: none"> As-Built Description: Refer to notes for observation and recommendation. Proposed Solution: Notes: The surveyor was able to use the lift without assistance per requirements. However the sign indicates that assistance is needed. Inform staff that unassisted use is a requirement. 	PCODE GN01 CBC 2016 11B-703.7.2.4 Mitigated: <input type="radio"/> YES <input checked="" type="radio"/> NO				
			REF

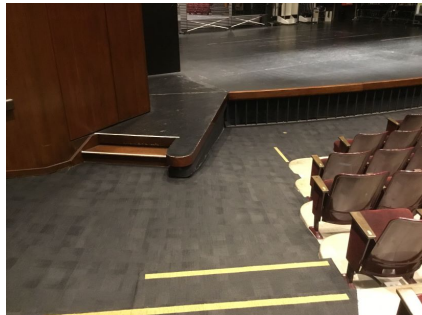
10839	<ul style="list-style-type: none"> As-Built Description: Walk: Slope greater than 1:20 (5.0%), and walk does not comply with requirements for ramps. As-Built: 22.2% Proposed Solution: Modify walk/sidewalk slope to 1:20 or less. Notes: <i>There are coinciding cross slopes of 11%. This condition occurs at the exit/entrance is nearest the stage. These routes appear to serve the wheelchair seating areas nearest the stage.</i> 	PCODE EF01 ADAAG 91 4.3.7 ADA 2010 403.3 CBC 2007 1133B.7.3 CBC 2016 11B-403.3 Mitigated: <input type="radio"/> YES <input checked="" type="radio"/> NO	150	SF	\$75	\$11,250

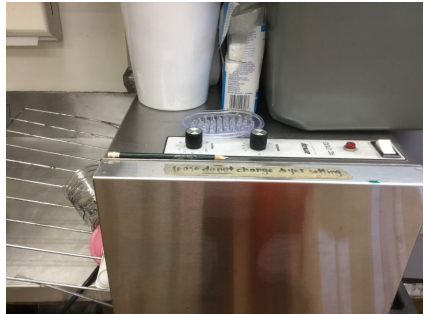
Item no., Rm no. and Name	Existing Architectural Barrier and Proposed Solution	Codes / Mitigation Info	Qty	Unit	Cost	Total
10807	<ul style="list-style-type: none"> • <i>As-Built Description:</i> Operable part(s) require tight grasping, pinching, or twisting of the wrist with one hand. • <i>Proposed Solution:</i> Modify or replace the operable part(s) to not require tight grasping, pinching, or twisting of the wrist with one hand. 	PCODE IC02 ADAAG 91 4.27.4 ADA 2010 309.4 CBC 2007 1117B.6.4 CBC 2016 11B-309.4 Mitigated: <input type="radio"/> YES <input checked="" type="radio"/> NO	1	JOB	\$900	\$900

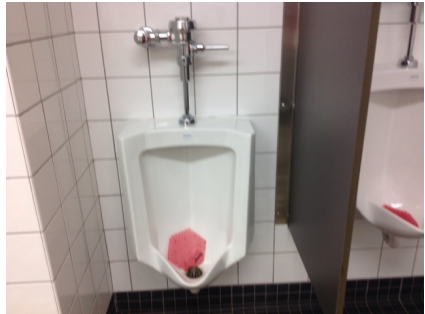
Item no., Rm no. and Name	Existing Architectural Barrier and Proposed Solution	Codes / Mitigation Info	Qty	Unit	Cost	Total
702	<ul style="list-style-type: none"> • <i>As-Built Description:</i> Flush Control: Operating handle mounted more than 44" above floor. • <i>As-Built:</i> 46" • <i>Proposed Solution:</i> Replace flush control with properly mounted accessible type, or install sensor flush. 	PCODE WB10A ADAAG 91 4.16.5 ADA 2010 604.6 CBC 2007 1115B.4.1.5 CBC 2016 11B-604.6 Mitigated: <input type="radio"/> YES <input checked="" type="radio"/> NO	1	JOB	\$1,500	\$1,500

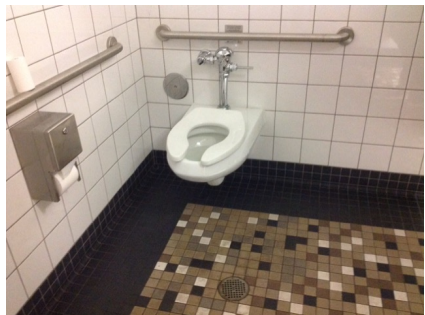
Item no., Rm no. and Name	Existing Architectural Barrier and Proposed Solution	Codes / Mitigation Info	Qty	Unit	Cost	Total
Water Closet						
686	<ul style="list-style-type: none"> As-Built Description: Water closet not 16"-18" (CA: 17"-18") from near side wall to center line of water closet (2010 ADAAG: 16"-18"). As-Built: 19" o.c. Proposed Solution: Relocate existing water closet and plumbing, remount with offset closet flange to provide 18" max. from side wall. 	PCODE WB02C ADAAG 91 Fig. 28 ADA 2010 604.2 CBC 2007 1115B.4.1.1 CBC 2016 11B-604.2 Mitigated: <input type="radio"/> YES <input checked="" type="radio"/> NO	1	JOB	\$1,500	\$1,500

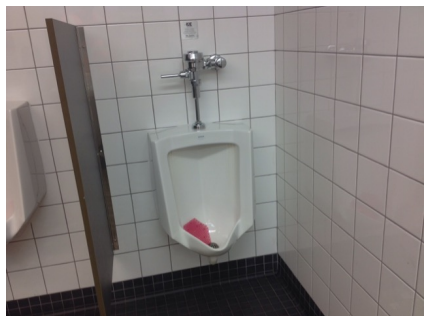
<input type="checkbox"/> Staff Only			
			Priority		Severity	
			3		4	
685	<ul style="list-style-type: none"> As-Built Description: Flush Control: Operating handle mounted more than 44" above floor. As-Built: 45" high Proposed Solution: Replace flush control with properly mounted accessible type, or install sensor flush. 	PCODE WB10A ADAAG 91 4.16.5 ADA 2010 604.6 CBC 2007 1115B.4.1.5 CBC 2016 11B-604.6 Mitigated: <input type="radio"/> YES <input checked="" type="radio"/> NO	1	JOB	\$1,500	\$1,500

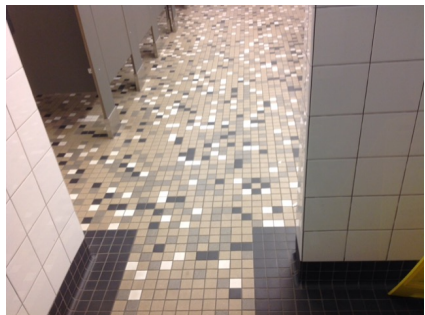
812	<ul style="list-style-type: none"> As-Built Description: Clear passage width (except doorways) from rest room entry to accessible water closet compartment less than 36" (CA only: 44" wide). As-Built: 36" wide Proposed Solution: Modify facility passage to be min. 44" wide. Demolish existing partition and replace. 	PCODE WC02A ADAAG 91 4.3.3 ADA 2010 403.5.1 CBC 2007 1115B.3.2.4 CBC 2016 11B-403.5.1 Mitigated: <input type="radio"/> YES <input checked="" type="radio"/> NO	2	LF	\$510	\$1,020

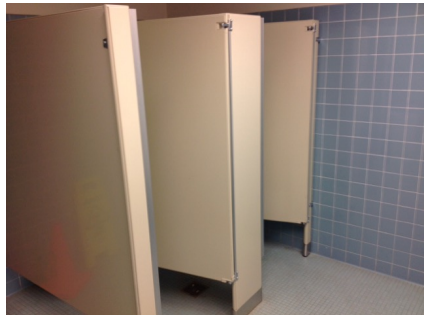
12	<ul style="list-style-type: none"> As-Built Description: Multiple accommodation restroom not accessible; multiple compliance violations. Proposed Solution: Remodel area to provide accessible restroom with one accessible stall, lavatory (and one urinal at Mens). 	PCODE WA01A ADAAG 91 4.22 ADA 2010 603.1 CBC 2007 1115B.3.1 CBC 2016 11B-603.1 Mitigated: <input type="radio"/> YES <input checked="" type="radio"/> NO	1	JOB	\$105,000	\$105,000
<div>

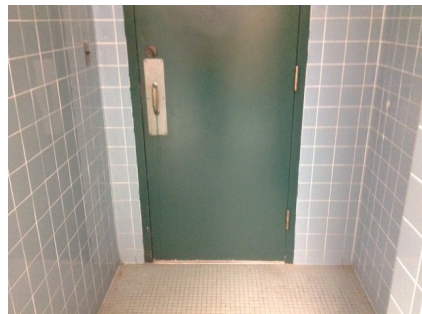
Item no., Rm no. and Name	Existing Architectural Barrier and Proposed Solution	Codes / Mitigation Info	Qty	Unit	Cost	Total
<u>Door Swing</u>						
39	<ul style="list-style-type: none">As-Built Description: Front approach: At pull side, door does not have clear and level maneuvering space measuring door width plus 18" x 60". (24" x 60" at exterior doors).As-Built: 6"Proposed Solution: Provide power door operator.	PCODE ID23C ADAAG 91 Fig. 25(a) ADA 2010 404.2.4 CBC 2007 11B-26A(a) CBC 2016 11B-404.2.4 Mitigated: <input type="radio"/> YES <input checked="" type="radio"/> NO	1	JOB	\$15,000	\$15,000

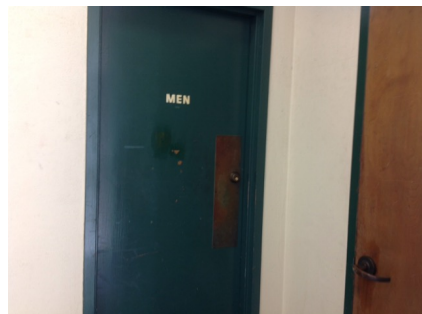
<input type="checkbox"/> Staff Only			
			Priority	Severity		
			3	3		
<u>Signage</u>						
36	<ul style="list-style-type: none">As-Built Description: Entrance to toilet or bathing facility not identified with ADAAG compliant signage.Proposed Solution: Provide ADA compliant sign mounted at 48" min. above to baseline of the lowest Braille cells and 60" max. to baseline of the highest line of raised characters on nearest adjacent wall, on latch side of a single door (located not to cause a Braille reader to stand within the door swing).	PCODE SA11A ADAAG 91 4.1.3(16)(a) ADA 2010 216.8 CBC 2016 11B-216.8 Mitigated: <input type="radio"/> YES <input checked="" type="radio"/> NO	1	JOB	\$270	\$270

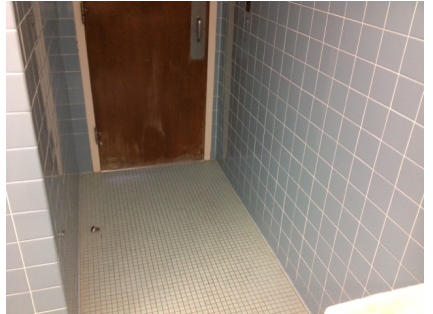
Item no., Rm no. and Name	Existing Architectural Barrier and Proposed Solution	Codes / Mitigation Info	Qty	Unit	Cost	Total
Wheelchair Clearance						
157	<ul style="list-style-type: none"> • <i>As-Built Description:</i> Clear passage width (except doorways) from rest room entry to accessible water closet compartment less than 36" (CA only: 44" wide). • <i>As-Built:</i> 41" wide • <i>Proposed Solution:</i> Modify facility passage to be min. 44" wide. Demolish existing partition and replace. 	PCODE WC02AREF ADAAG 91 4.3.3 ADA 2010 403.5.1 CBC 2007 1115B.3.2.4 CBC 2016 11B-403.5.1 Mitigated: <input type="radio"/> YES <input checked="" type="radio"/> NO				
			REF

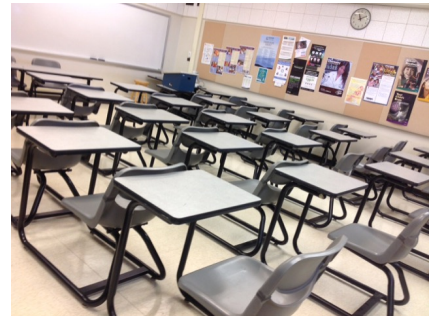
Item no., Rm no. and Name	Existing Architectural Barrier and Proposed Solution	Codes / Mitigation Info	Qty	Unit	Cost	Total
<u>Non-Fixed Desk</u>						
175	<ul style="list-style-type: none"> • <i>As-Built Description:</i> Recommended only: Accessible non-fixed table or desk (top 28" to 34" high; knee space at least 27" high x 19" deep x 30" wide) not provided. • <i>Proposed Solution:</i> Provide table or desk with accessible dimensions when purchasing new furniture. • <i>Notes:</i> 41 seats 3 accessible - OK 	PCODE IN02AREF ADAAG 91 4.32.3 & .4 ADA 2010 306.1 CBC 2007 1122B.3 & 4 CBC 2016 11B-306.1 & 11B-902.3 Mitigated: <input type="radio"/> YES <input checked="" type="radio"/> NO				
			REF

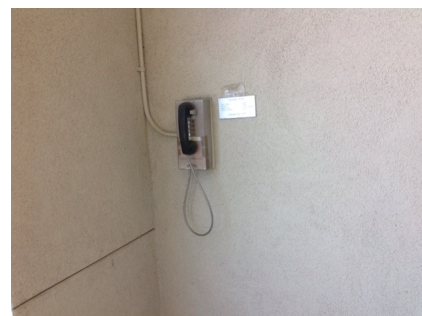
The telephone is not TTY capable. We recommend as best practice to provide TTY on each floor of the building.

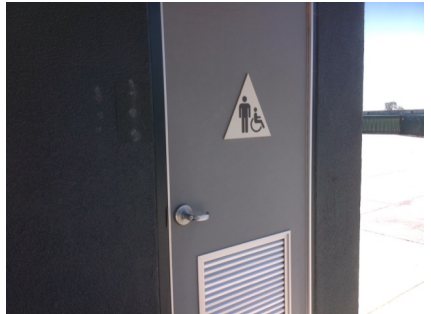
Item no., Rm no. and Name	Existing Architectural Barrier and Proposed Solution	Codes / Mitigation Info	Qty	Unit	Cost	Total
81	<ul style="list-style-type: none"> As-Built Description: Entrance to toilet or bathing facility not identified with ADAAG compliant signage. Proposed Solution: Provide ADA compliant sign mounted at 48" min. above to baseline of the lowest Braille cells and 60" max. to baseline of the highest line of raised characters on nearest adjacent wall, on latch side of a single door (located not to cause a Braille reader to stand within the door swing). 	PCODE SA11A ADAAG 91 4.1.3(16)(a) ADA 2010 216.8 CBC 2016 11B-216.8 Mitigated: <input type="radio"/> YES <input checked="" type="radio"/> NO	1	JOB	\$270	\$270

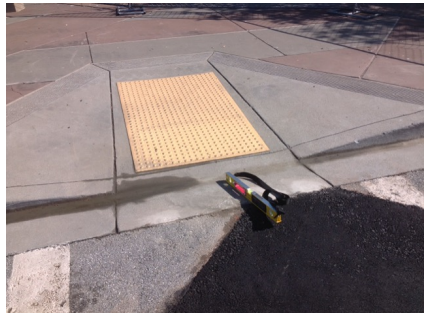
Item no., Rm no. and Name	Existing Architectural Barrier and Proposed Solution	Codes / Mitigation Info	Qty	Unit	Cost	Total
Curb Ramp						
754	<ul style="list-style-type: none"> • <i>As-Built Description:</i> Maximum slope of adjoining gutters, street surface at bottom of ramp exceeds 5% (1:20). • <i>As-Built:</i> 13.5% • <i>Proposed Solution:</i> Modify road/gutter slopes. Demolish existing and provide new curb ramp. 	PCODE EH02E ADAAG 91 4.7.2 ADA 2010 406.2 CBC 2007 1127B.5.3 CBC 2016 11B-406.5.8 Mitigated: <input type="radio"/> YES <input checked="" type="radio"/> NO	1	JOB	\$3,750	\$3,750

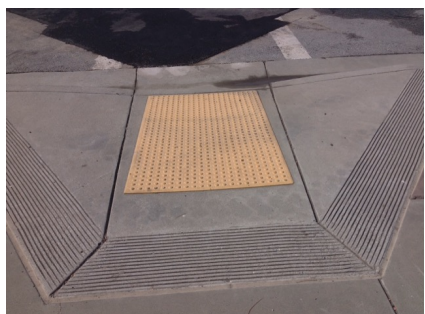
<input type="checkbox"/> Staff Only Priority 1 Severity 4			
757	<ul style="list-style-type: none"> • <i>As-Built Description:</i> Less than 48" level space at top and 1:12 flared sides not provided. • <i>As-Built:</i> 42" wide • <i>Proposed Solution:</i> Demolish existing and provide new curb ramp. 	PCODE EH05B ADAAG 91 4.7.5; Fig.12(a) ADA 2010 406.4 CBC 2007 1127B.5.4 CBC 2016 11B-406.5.3 Mitigated: <input type="radio"/> YES <input checked="" type="radio"/> NO	1	JOB	\$7,500	\$7,500

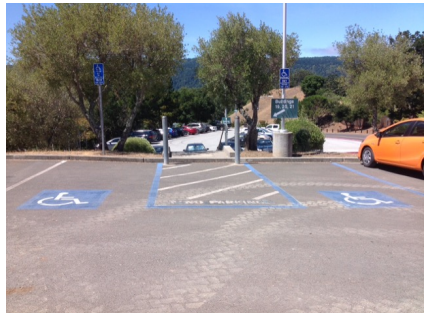
Item no., Rm no. and Name	Existing Architectural Barrier and Proposed Solution	Codes / Mitigation Info	Qty	Unit	Cost	Total
Parking						
329	<ul style="list-style-type: none"> As-Built Description: Accessible parking space smaller than 8' wide (CA only: 9' x 18'). As-Built: Left space 8'7" right space 8'10" Proposed Solution: Modify parking space(s) to create accessible space. 	PCODE EA02A ADAAG 91 4.6.3 ADA 2010 502.2 CBC 2007 1129B.3.1 CBC 2016 11B-502.2 Mitigated: <input type="radio"/> YES <input checked="" type="radio"/> NO	2	JOB	\$600	\$1,200

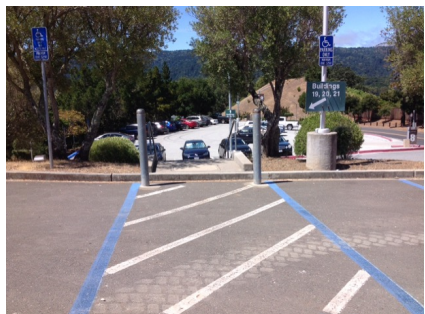
<input type="checkbox"/> Staff Only Priority 1 Severity 3			
330	<ul style="list-style-type: none"> As-Built Description: Disabled persons must wheel or walk behind parked car(s) other than their own. Proposed Solution: Relocate parking and provide curb ramp to accessible route. Notes: Accessible parking serves only stairs and patrons must travel behind cars other than their own. We recommend relocating parking near an accessible route. 	PCODE EA03 ADAAG 91 Fig.9 ADA 2010 502.3 CBC 2007 1129B.3.1 CBC 2016 11B-502.7.1 Mitigated: <input type="radio"/> YES <input checked="" type="radio"/> NO	1	JOB	\$2,190	\$2,190
