SMCCCD - College of San Mateo

Appendix L: Facilities

Access Compliance Survey Report

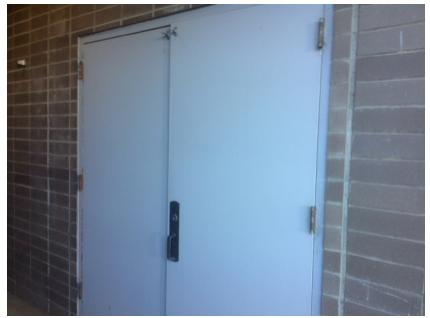
Item no., Rm no. and Name	Existing Architectural Barrier and Proposed Solution	Codes / Mitigation Info	Qty	Unit	Cost	Total
559	<ul style="list-style-type: none"> As-Built Description: Entrance to toilet or bathing facility not identified with ADAAG compliant signage. Proposed Solution: Provide ADA compliant sign mounted at 48" min. above to baseline of the lowest Braille cells and 60" max. to baseline of the highest line of raised characters on nearest adjacent wall, on latch side of a single door (located not to cause a Braille reader to stand within the door swing). Notes: Exterior entrance 	PCODE SA11A ADAAG 91 4.1.3(16)(a) ADA 2010 216.8 CBC 2016 11B-216.8 Mitigated: <input type="radio"/> YES <input checked="" type="radio"/> NO	1	JOB	\$270	\$270

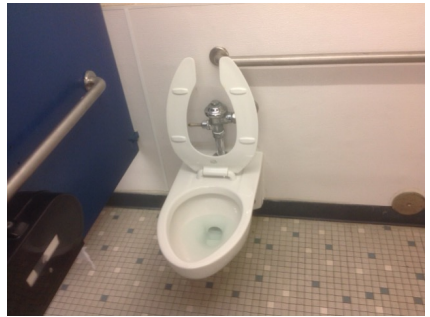
551	<ul style="list-style-type: none"> As-Built Description: Flush Control: Operating handle not mounted toward wide side of stall. Proposed Solution: Replace flush control with properly mounted accessible type, or install sensor flush. 	PCODE WB10 ADAAG 91 4.16.5 ADA 2010 604.6 CBC 2007 1115B.4.1.5 CBC 2016 11B-604.6 Mitigated: <input type="radio"/> YES <input checked="" type="radio"/> NO	1	JOB	\$1,500	\$1,500

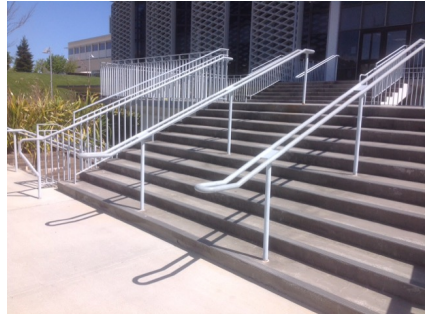
130	<ul style="list-style-type: none"> As-Built Description: Bottom extension of handrail does not return creating a hazard for blind individuals. Proposed Solution: Remodel handrail return. 	PCODE ED12 ADAAG 91 4.9.4(6) ADA 2010 505.10.3 CBC 2007 1133B.4.2.3 CBC 2016 11B-505.10.1; 11B-505.10.3 Mitigated: <input type="radio"/> YES <input checked="" type="radio"/> NO	1	JOB	\$690	\$690

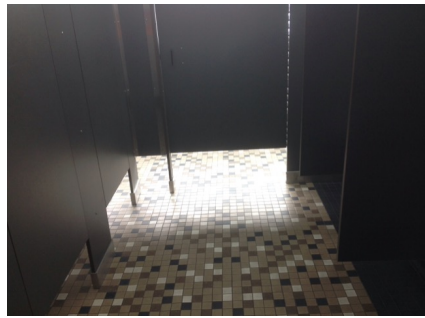
Item no., Rm no. and Name	Existing Architectural Barrier and Proposed Solution	Codes / Mitigation Info	Qty	Unit	Cost	Total
516	<ul style="list-style-type: none"> As-Built Description: Clear passage width (except doorways) from rest room entry to accessible water closet compartment less than 36" (CA only: 44" wide). As-Built: 44.5" wide Proposed Solution: Modify facility passage to be min. 44" wide. Demolish existing partition and replace. Notes: We recommend making urinal partitions shorter. 	PCODE WC02A ADAAG 91 4.3.3 ADA 2010 403.5.1 CBC 2007 1115B.3.2.4 CBC 2016 11B-403.5.1 Mitigated: <input type="radio"/> YES <input checked="" type="radio"/> NO	?10	LF	\$510	\$5,100

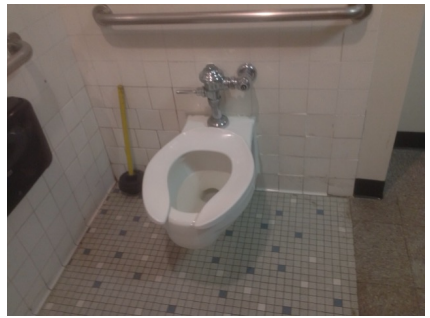
Item no., Rm no. and Name	Existing Architectural Barrier and Proposed Solution	Codes / Mitigation Info	Qty	Unit	Cost	Total
407	<ul style="list-style-type: none"> As-Built Description: Flush Control: Operating handle not mounted toward wide side of stall. Proposed Solution: Replace flush control with properly mounted accessible type, or install sensor flush. 	PCODE WB10 ADAAG 91 4.16.5 ADA 2010 604.6 CBC 2007 1115B.4.1.5 CBC 2016 11B-604.6	1	JOB	\$1,500	\$1,500

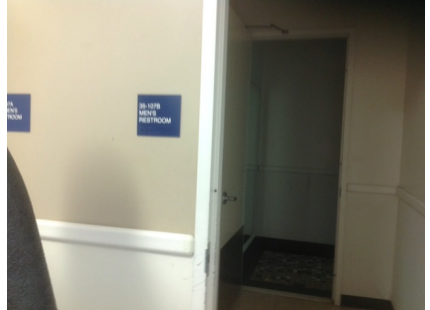
Item no., Rm no. and Name	Existing Architectural Barrier and Proposed Solution	Codes / Mitigation Info	Qty	Unit	Cost	Total
Signage						
41	<ul style="list-style-type: none"> As-Built Description: Signs containing tactile characters is not located so that a clear floor space of 18" min x 18" min., centered on the tactile characters, is provided beyond the arc of any door swing between the closed position and 45 degree open position. As-Built: 62" to bottom of highest tactile Proposed Solution: Relocate compliant signage on latch side of door located at compliant height with a clear floor space. 	PCODE SA07B ADA 2010 703.4.2 CBC 2016 11B-703.4.2 Mitigated: <input type="radio"/> YES <input checked="" type="radio"/> NO	1	JOB	\$150	\$150

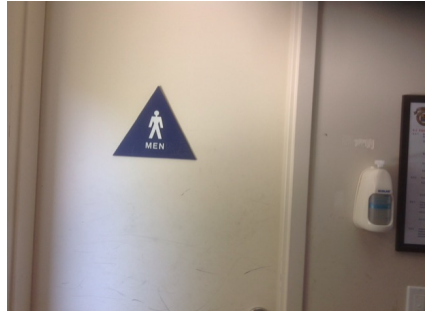
<input type="checkbox"/> Staff Only Priority 3 Severity 4			
49	<ul style="list-style-type: none"> As-Built Description: Entrance to toilet or bathing facility not identified with ADAAG compliant signage. Proposed Solution: Provide ADA compliant sign mounted at 48" min. above to baseline of the lowest Braille cells and 60" max. to baseline of the highest line of raised characters on nearest adjacent wall, on latch side of a single door (located not to cause a Braille reader to stand within the door swing). Notes: From class room 	PCODE SA11A ADAAG 91 4.1.3(16)(a) ADA 2010 216.8 CBC 2016 11B-216.8 Mitigated: <input type="radio"/> YES <input checked="" type="radio"/> NO	1	JOB	\$270	\$270

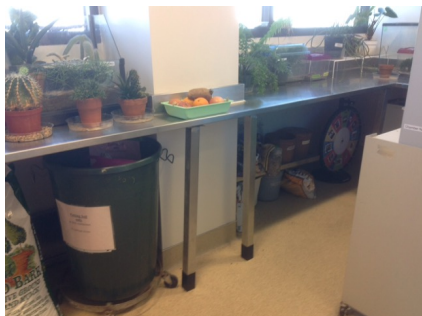
<input type="checkbox"/> Staff Only			
			Priority	Severity		
			2	2		
675	<ul style="list-style-type: none">• <i>As-Built Description:</i> Accessible non-fixed table or desk (top 28" to 34" high; knee space at least 27" high x 19" deep x 30" wide) not provided.• <i>As-Built:</i> 37" high• <i>Proposed Solution:</i> Provide table or desk with accessible dimensions when purchasing new furniture.• <i>Notes:</i> If used by students	<p>PCODE IN02A</p> <p>ADAAG 91 4.32.3 & .4</p> <p>ADA 2010 306.1</p> <p>CBC 2007 1122B.3 & 4</p> <p>CBC 2016 11B-306.1 & 11B-902.3</p> <p>Mitigated:</p> <p><input type="radio"/> YES</p> <p><input checked="" type="radio"/> NO</p>	1	JOB	\$4,800	\$4,800

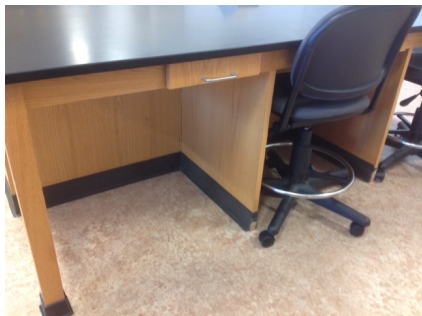
<input type="checkbox"/> Staff Only			
			Priority	Severity		
			2	2		
673	<ul style="list-style-type: none">• <i>As-Built Description:</i> Recommended only: Accessible non-fixed table or desk (top 28" to 34" high; knee space at least 27" high x 19" deep x 30" wide) not provided.• <i>As-Built:</i> 26.5" knee space• <i>Proposed Solution:</i> Provide table or desk with accessible dimensions when purchasing new furniture.	<p>PCODE IN02AREF</p> <p>ADAAG 91 4.32.3 & .4</p> <p>ADA 2010 306.1</p> <p>CBC 2007 1122B.3 & 4</p> <p>CBC 2016 11B-306.1 & 11B-902.3</p> <p>Mitigated:</p> <p><input type="radio"/> YES</p> <p><input checked="" type="radio"/> NO</p>	REF

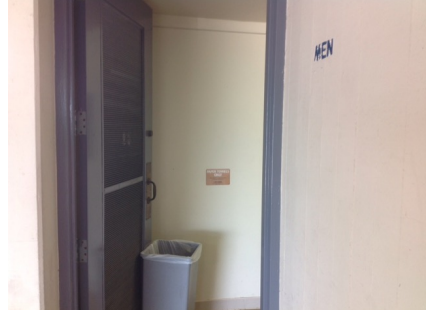
Item no., Rm no. and Name	Existing Architectural Barrier and Proposed Solution	Codes / Mitigation Info	Qty	Unit	Cost	Total
Signage						
285	<ul style="list-style-type: none"> As-Built Description: Entrance to toilet or bathing facility not identified with ADAAG compliant signage. Proposed Solution: Provide ADA compliant sign mounted at 48" min. above to baseline of the lowest Braille cells and 60" max. to baseline of the highest line of raised characters on nearest adjacent wall, on latch side of a single door (located not to cause a Braille reader to stand within the door swing). 	PCODE SA11A ADAAG 91 4.1.3(16)(a) ADA 2010 216.8 CBC 2016 11B-216.8 Mitigated: <input type="radio"/> YES <input checked="" type="radio"/> NO	1	JOB	\$270	\$270

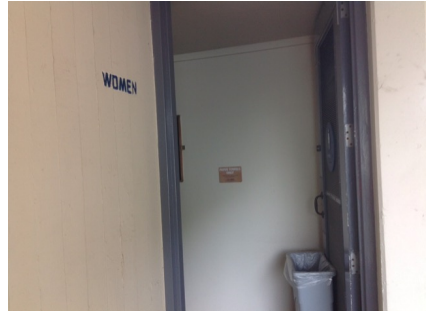
<input type="checkbox"/> Staff Only Priority 3 Severity 3			
290	<ul style="list-style-type: none"> As-Built Description: Entrance to toilet or bathing facility not identified with ADAAG compliant signage. Proposed Solution: Provide ADA compliant sign mounted at 48" min. above to baseline of the lowest Braille cells and 60" max. to baseline of the highest line of raised characters on nearest adjacent wall, on latch side of a single door (located not to cause a Braille reader to stand within the door swing). 	PCODE SA11A ADAAG 91 4.1.3(16)(a) ADA 2010 216.8 CBC 2016 11B-216.8 Mitigated: <input type="radio"/> YES <input checked="" type="radio"/> NO	1	JOB	\$270	\$270

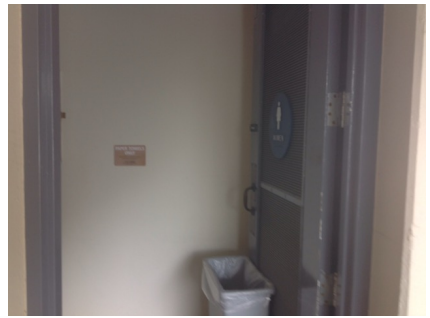
Item no., Rm no. and Name	Existing Architectural Barrier and Proposed Solution	Codes / Mitigation Info	Qty	Unit	Cost	Total
289	<ul style="list-style-type: none"> As-Built Description: Required in CA only: identification symbol centered 58" to 60" high on sanitary facility door that contrasts with the door not provided (women: 12" ø circle, men: 12" triangle, unisex: combined symbol). As-Built: No contrast Proposed Solution: Provide properly mounted sanitary facility symbol when altering area. If wheelchair accessible, include International Symbol of Accessibility on sign. 	PCODE SA15 CBC 2007 1115B.6 CBC 2016 11B-703.7.2.6 Mitigated: <input type="radio"/> YES <input checked="" type="radio"/> NO	1	JOB	\$270	\$270

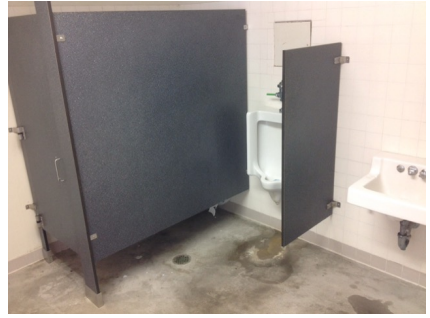
<input type="checkbox"/> Staff Only Priority 3 Severity 3						
Restroom						
287	<ul style="list-style-type: none"> As-Built Description: Multiple accommodation restroom not accessible; multiple compliance violations. Proposed Solution: Remodel area to provide accessible restroom with one accessible stall, lavatory (and one urinal at Mens). 	PCODE WA01A ADAAG 91 4.22 ADA 2010 603.1 CBC 2007 1115B.3.1 CBC 2016 11B-603.1 Mitigated: <input type="radio"/> YES <input checked="" type="radio"/> NO	1	JOB	? \$105,000

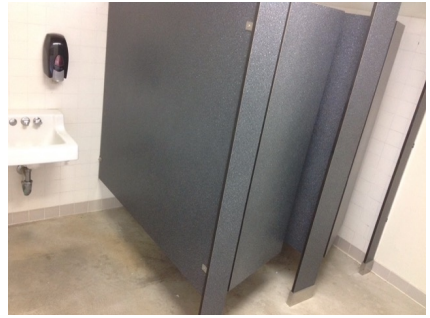
<input type="checkbox"/> Staff Only Priority 3 Severity 1						
291	<ul style="list-style-type: none"> As-Built Description: Multiple accommodation restroom not accessible; multiple compliance violations. Proposed Solution: Remodel area to provide accessible restroom with one accessible stall, lavatory (and one urinal at Mens). 	PCODE WA01A ADAAG 91 4.22 ADA 2010 603.1 CBC 2007 1115B.3.1 CBC 2016 11B-603.1 Mitigated: <input type="radio"/> YES <input checked="" type="radio"/> NO	1	JOB	? \$105,000

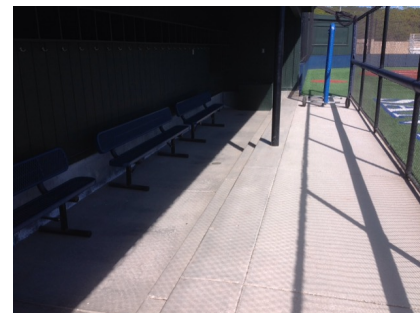
Two steps down to dugout. No accessible route.**Mitigated:**☐ YES☒ NO

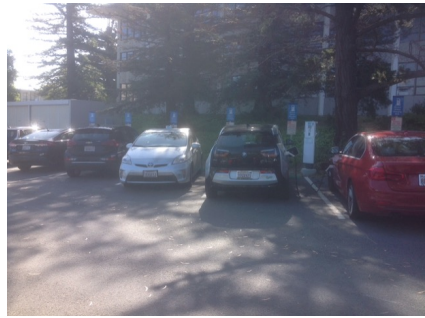
241	<ul style="list-style-type: none"> As-Built Description: Refer to notes for observation and recommendation. Proposed Solution: Notes: 8 total EV charging stations with no accessible station provided. 1 standard accessible and 1 van accessible space are required. Existing EV spaces have slopes of 5% in the direction of travel. 	PCODE GN01 CBC 2016 11B-208.2 Tbl. 11B-208.2 Mitigated: <input type="radio"/> YES <input checked="" type="radio"/> NO	REF
