SMCCCD - Cañada College

Appendix H: Facilities

Access Compliance Survey Report

Building 2 - Bookstore

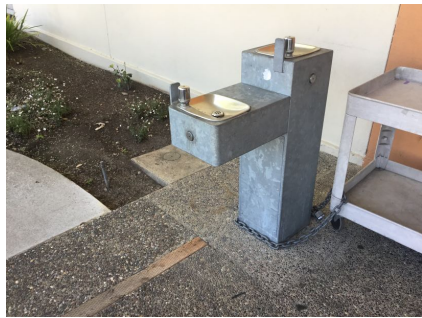
<input type="checkbox"/> Staff Only Priority 3 Severity 3			
10995	<ul style="list-style-type: none"> As-Built Description: Drinking fountain lacks protection for visually impaired persons. Proposed Solution: Provide cane-detectable rails. 	PCODE IA05C ADAAG 91 4.4.1 ADA 2010 307.2 CBC 2007 1115B.4.6.3 CBC 2016 11B-307.2 Mitigated: <input type="radio"/> YES <input checked="" type="radio"/> NO	1	JOB	\$1,500	\$1,500

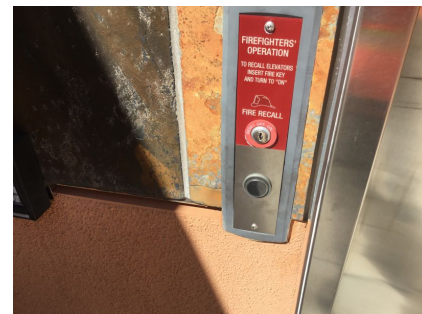
Landing call button does not illuminate.PCODE **IK07B**ADAAG 91 **4.10.12 (2)**ADA 2010 **407.4.5**CBC 2007 **1116B.1.9**CBC 2016 **11B-407.4.6.2.3****Mitigated:**☐ YES☒ NO2 JOB \$2,940 **\$5,880**

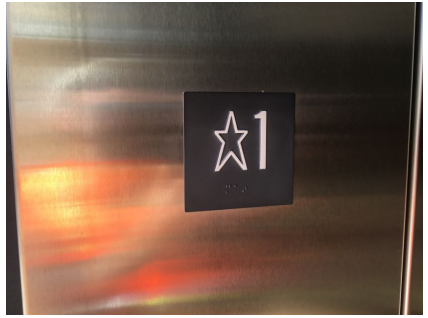
Item no., Rm no. and Name	Existing Architectural Barrier and Proposed Solution	Codes / Mitigation Info	Qty	Unit	Cost	Total
11009	<ul style="list-style-type: none"> • <i>As-Built Description:</i> Braille and raised floor numbers on entrance incorrect. • <i>Proposed Solution:</i> Relocate Braille and raised floor numbers on entrance jambs to 5' above floor. • <i>Notes:</i> Star 1.25" wide. 2" minimum required. 	PCODE IK11C ADAAG 91 4.10.5 ADA 2010 703.4.1 CBC 2007 1116B.1.14 CBC 2016 11B-703.4.1 Mitigated: <input type="radio"/> YES <input checked="" type="radio"/> NO	2	JOB	\$360	\$720

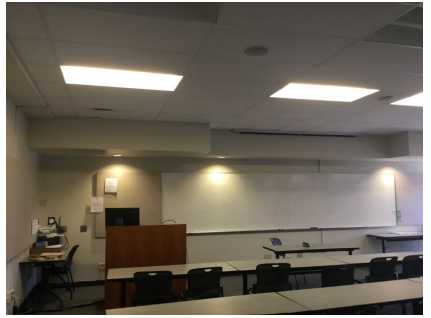
Item no., Rm no. and Name	Existing Architectural Barrier and Proposed Solution	Codes / Mitigation Info	Qty	Unit	Cost	Total
11013	<ul style="list-style-type: none"> • <i>As-Built Description:</i> No signs at the building or assembly area entrance to notify patrons that an assistive listening system is available. • <i>Proposed Solution:</i> Provide assistive listening signage. 	PCODE GI02 ADAAG 91 4.1.3(19)(b) ADA 2010 703.7.2.4 CBC 2007 1104B.2.4 CBC 2016 11B-703.7.2.4 Mitigated: <input type="radio"/> YES <input checked="" type="radio"/> NO	1	JOB	\$300	\$300

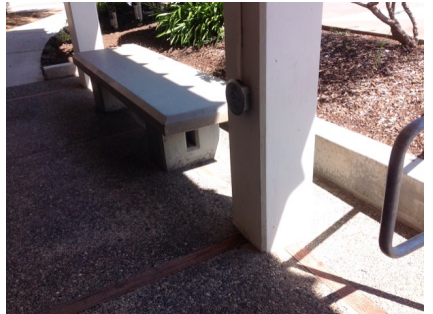
Item no., Rm no. and Name	Existing Architectural Barrier and Proposed Solution	Codes / Mitigation Info	Qty	Unit	Cost	Total
217	<ul style="list-style-type: none"> • <i>As-Built Description:</i> High push plate located at 30" minimum and 44" maximum above the floor or ground surface not provided. • <i>As-Built:</i> 29" o.c. • <i>Proposed Solution:</i> Provide higher push plate. 	PCODE ID13E CBC 2007 1133B.2.3.2 CBC 2016 11B-404.2.9 2.C Mitigated: <input type="radio"/> YES <input checked="" type="radio"/> NO	1	JOB	\$1,500	\$1,500

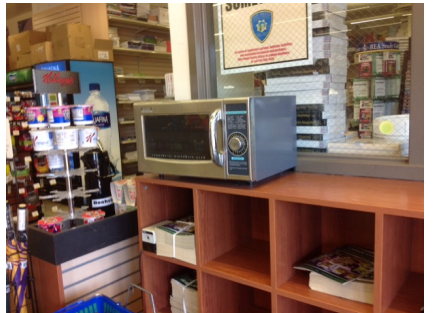
220	<ul style="list-style-type: none"> • <i>As-Built Description:</i> Microwave door does not have accessible operating hardware. • <i>Proposed Solution:</i> Provide accessible microwave with lever handle or other accessible hardware. 	PCODE ID07NT ADAAG 91 4.13.9 ADA 2010 404.2.7 CBC 2007 1133B.2.5.2 CBC 2016 11B-404.2.7 Mitigated: <input type="radio"/> YES <input checked="" type="radio"/> NO	1	JOB	\$750	\$750

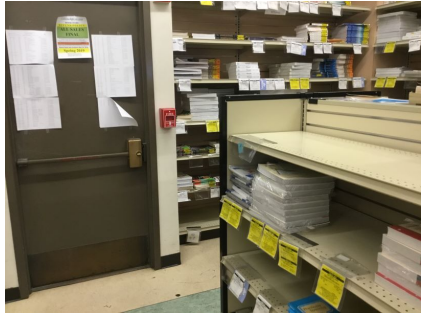
Item no., Rm no. and Name	Existing Architectural Barrier and Proposed Solution	Codes / Mitigation Info	Qty	Unit	Cost	Total
<u>Door Swing</u>						
11005	<ul style="list-style-type: none">As-Built Description: Front approach: At push side, door does not have clear and level maneuvering space measuring door width x 48" (door width plus 12" if door has both, latch and closer).As-Built: Display shelf 38" from door. 5" from the strike side.Proposed Solution: Remove or relocate furniture or storage items.	<p>PCODE ID24A</p> <p>ADAAG 91 Fig. 25(a)</p> <p>ADA 2010 404.2.4</p> <p>CBC 2007 11B-26A(a)</p> <p>CBC 2016 11B-404.2.4</p> <p>Mitigated:</p> <p><input type="radio"/> YES</p> <p><input checked="" type="radio"/> NO</p>	1	JOB	\$150	\$150

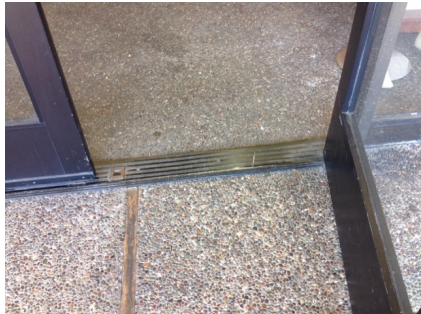
<input type="checkbox"/> Staff Only			
			Priority	Severity		
			2	2		
<u>Door Threshold</u>						
215	<ul style="list-style-type: none">As-Built Description: Door inaccessible due to threshold or step at door exceeding 1/2".As-Built: 0.75"Proposed Solution: Modify threshold to be no more than 1/2" by removing existing paving at door and providing landing with edge ramping (slope 1:20 max).	<p>PCODE ID02A</p> <p>ADAAG 91 4.13.8</p> <p>ADA 2010 404.2.5</p> <p>CBC 2007 1133B.2.4.1</p> <p>CBC 2016 11B-404.2.5</p> <p>Mitigated:</p> <p><input type="radio"/> YES</p> <p><input checked="" type="radio"/> NO</p>	1	JOB	\$1,200	\$1,200

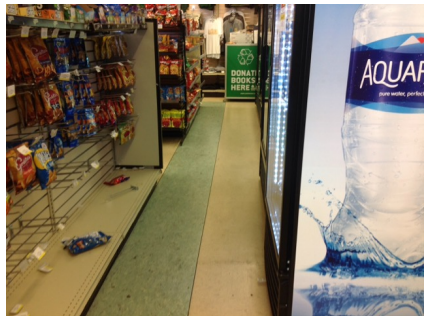
Item no., Rm no. and Name	Existing Architectural Barrier and Proposed Solution	Codes / Mitigation Info	Qty	Unit	Cost	Total
222	<ul style="list-style-type: none"> As-Built Description: Corridor less than 44" wide. As-Built: 36" wide serving both sides Proposed Solution: Enlarge corridor to 44" wide; relocate stud wall. Notes: Several rows 	PCODE IH03 ADAAG 91 4.3.3 ADA 2010 403.5.1 CBC 2007 1133B.3.1 CBC 2016 11B-403.5.1 Mitigated: <input type="radio"/> YES <input checked="" type="radio"/> NO		LF	\$420

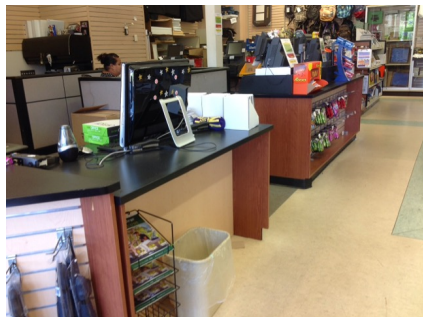
223	<ul style="list-style-type: none"> As-Built Description: Service counter (stand-up): Accessible section min. 36" length and 36" max. height (in CA: 28" to 34" high) not provided. Proposed Solution: Retrofit existing counter to provide accessible section. Interim solution: Provide auxiliary counter, table, or clipboard. Notes: Ensure both registers provide same services. The lowered counter must be operational at all times. 	PCODE IN03 ADAAG 91 7.2(2) ADA 2010 904.4 CBC 2007 1122B.4 CBC 2016 11B-904.4 Mitigated: <input type="radio"/> YES <input checked="" type="radio"/> NO	1	JOB	\$6,000	\$6,000

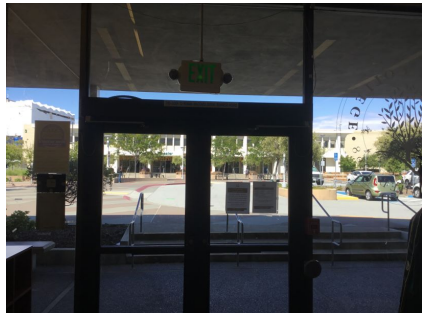
Item no., Rm no. and Name	Existing Architectural Barrier and Proposed Solution	Codes / Mitigation Info	Qty	Unit	Cost	Total
Signage						
11002	<ul style="list-style-type: none"> As-Built Description: At final exit door to exterior: Where required exit signs are installed, signs to provide exiting information for people with vision impairment are not provided. Proposed Solution: Provide raised letter/Braille "EXIT" sign at door. 	PCODE SA10A ADAAG 91 4.1.3(16) ADA 2010 216.4.1 CBC 2007 1011.3 CBC 2016 11B-216.4.1 Mitigated: <input type="radio"/> YES <input checked="" type="radio"/> NO	2	JOB	\$270	\$540

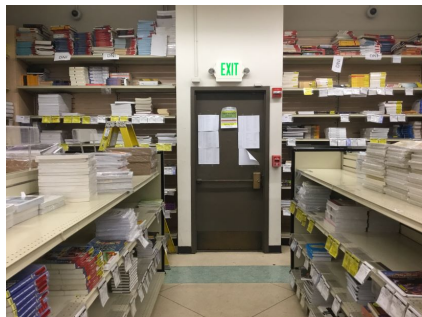
<input type="checkbox"/> Staff Only Priority 2 Severity 3			
11004	<ul style="list-style-type: none"> As-Built Description: At final exit door to exterior: Where required exit signs are installed, signs to provide exiting information for people with vision impairment are not provided. Proposed Solution: Provide raised letter/Braille "EXIT" sign at door. 	PCODE SA10A ADAAG 91 4.1.3(16) ADA 2010 216.4.1 CBC 2007 1011.3 CBC 2016 11B-216.4.1 Mitigated: <input type="radio"/> YES <input checked="" type="radio"/> NO	1	JOB	\$270	\$270

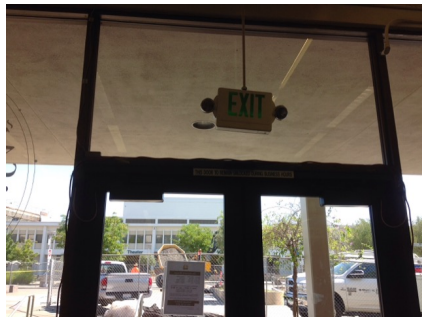
<input type="checkbox"/> Staff Only Priority 2 Severity 3			
216	<ul style="list-style-type: none"> As-Built Description: At final exit door to exterior: Where required exit signs are installed, signs to provide exiting information for people with vision impairment are not provided. Proposed Solution: Provide raised letter/Braille "EXIT" sign at door. 	PCODE SA10A ADAAG 91 4.1.3(16) ADA 2010 216.4.1 CBC 2007 1011.3 CBC 2016 11B-216.4.1 Mitigated: <input type="radio"/> YES <input checked="" type="radio"/> NO	2	JOB	\$270	\$540

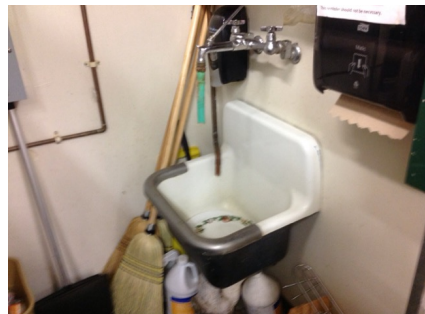
Item no., Rm no. and Name	Existing Architectural Barrier and Proposed Solution	Codes / Mitigation Info	Qty	Unit	Cost	Total
Sink						
229	<ul style="list-style-type: none">• <i>As-Built Description:</i> Sink does not have knee space min. 27" high x 19" deep x 30" wide.• <i>Proposed Solution:</i> Provide compliant sink.	<p>PCODE IN06A</p> <p>ADAAG 91 4.24.3</p> <p>ADA 2010 606.2</p> <p>CBC 2007 1115B.4.7.1</p> <p>CBC 2016 11B-606.2</p> <p>Mitigated:</p> <p><input type="radio"/> YES</p> <p><input checked="" type="radio"/> NO</p>	1	JOB	\$5,250	\$5,250

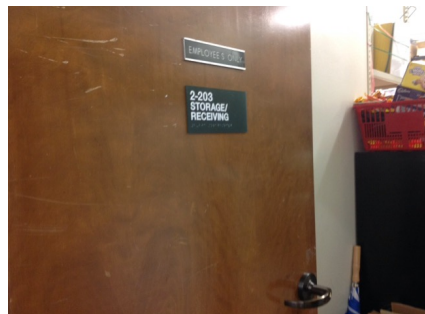
Signage						
225	<ul style="list-style-type: none">• <i>As-Built Description:</i> Sign not located on latch side of door and/or not located at 48" min. above to baseline of the lowest Braille cells and 60" max. to baseline of the highest line of raised characters.• <i>Proposed Solution:</i> Provide compliant signage including tactile characters and Grade II Braille on latch side of door located at compliant height.	<p>PCODE SA07</p> <p>ADAAG 91 4.30.6</p> <p>ADA 2010 703.4.1</p> <p>CBC 2007 1117B.5.7</p> <p>CBC 2016 11B-703.4.1</p> <p>Mitigated:</p> <p><input type="radio"/> YES</p> <p><input checked="" type="radio"/> NO</p>	1	JOB	\$150	\$150

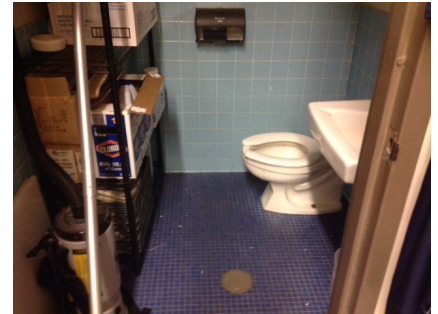
Single accommodation restroom not accessible;
multiple compliance violations.

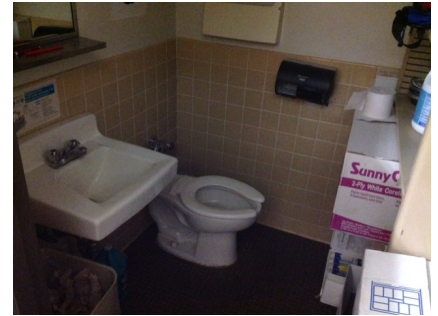
Single accommodation restroom not accessible;
multiple compliance violations.

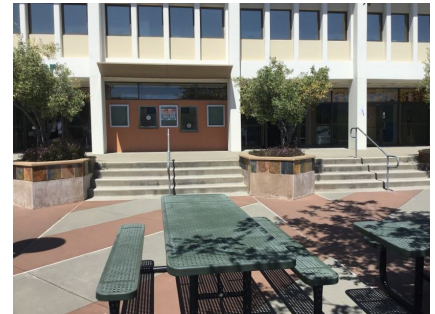
Exterior signage at inaccessible entrances to provide direction to accessible entrances is missing or noncompliant.

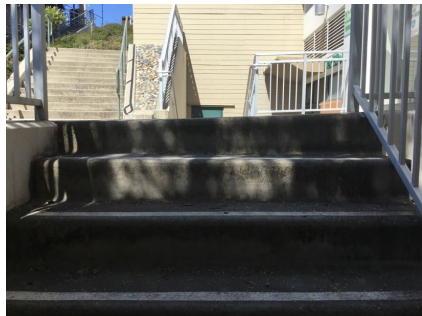
Item no., Rm no. and Name	Existing Architectural Barrier and Proposed Solution	Codes / Mitigation Info	Qty	Unit	Cost	Total
10983	<ul style="list-style-type: none"> As-Built Description: Steps do not have uniform riser height. As-Built: 6" - 8" high Proposed Solution: Remodel stairs as needed. 	PCODE EC07A ADA 2010 504.2 CBC 2007 1133B.4.5.3 CBC 2016 11B-504.2 Mitigated: <input type="radio"/> YES <input checked="" type="radio"/> NO	10	LF	\$225	\$2,250

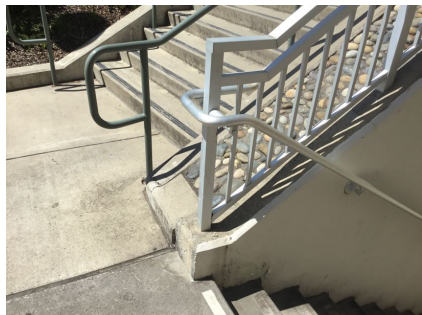
Top & Bottom Extension at Stairs

10979	<ul style="list-style-type: none"> As-Built Description: Stair handrail does not extend horizontally 12" minimum beyond top nosing, and one tread width sloped, plus 12" minimum horizontally beyond the bottom nosing. As-Built: 6" - 9" long Proposed Solution: Extend stair handrail at top and bottom (cost for each extension piece). 	PCODE ED06 ADAAG 91 4.9.4(2) ADA 2010 505.10.2; CBC 2007 1133B.4.2.2 CBC 2016 11B-505.10.2; 11B-505.10.3 Mitigated: <input type="radio"/> YES <input checked="" type="radio"/> NO	6	JOB	\$510	\$3,060

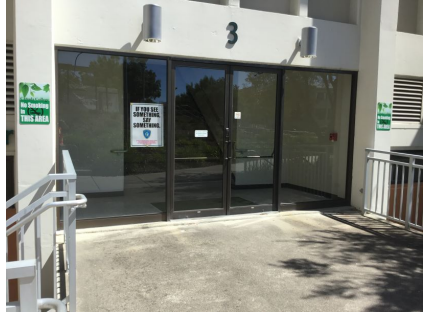
Item no., Rm no. and Name	Existing Architectural Barrier and Proposed Solution	Codes / Mitigation Info	Qty	Unit	Cost	Total
Route Sign						
10984	<ul style="list-style-type: none"> • <i>As-Built Description:</i> No sign by inaccessible route directing persons to an accessible route. • <i>Proposed Solution:</i> Provide directional sign. • <i>Notes:</i> Only accessed by stairs. Provide directional signage at the bottom of the stairs. 	PCODE SA20 ADAAG 91 35.163(b) ADA 2010 216.3 CBC 2007 1127B.3 CBC 2016 11B-216.3 Mitigated: <input type="radio"/> YES <input checked="" type="radio"/> NO	1	JOB	\$510	\$510

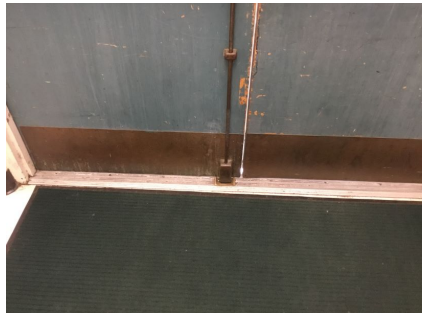
Item no., Rm no. and Name	Existing Architectural Barrier and Proposed Solution	Codes / Mitigation Info	Qty	Unit	Cost	Total
Door						
10939	<ul style="list-style-type: none"> As-Built Description: At push side of door on accessible route, bottom 10" does not have a smooth, uninterrupted surface. Proposed Solution: Provide 10" min. "kick plate" covering width of door when altering area. 	PCODE ID06 ADA 2010 404.2.10 CBC 2007 1133B.2.6 CBC 2016 11B-404.2.10 Mitigated: <input type="radio"/> YES <input checked="" type="radio"/> NO	1	JOB	\$300	\$300

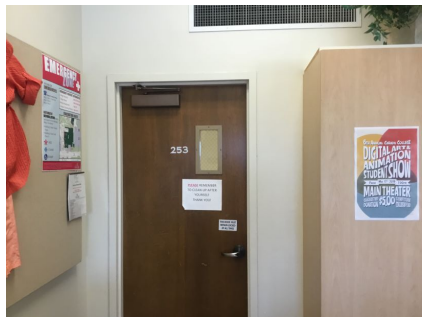
<input type="checkbox"/> Staff Only Priority 2 Severity 3			
10813	<ul style="list-style-type: none"> As-Built Description: Vision Light at door that permits viewing, does not have bottom of at least one glazed panel located 43 inches maximum above the finish floor. (Exception: More than 66" above finished floor.) As-Built: 60" AFF Proposed Solution: Provide new door with vision panel at 43" max. 	PCODE ID06C ADA 2010 404.2.11 CBC 2016 11B-404.2.11 Mitigated: <input type="radio"/> YES <input checked="" type="radio"/> NO	1	JOB	\$7,500	\$7,500

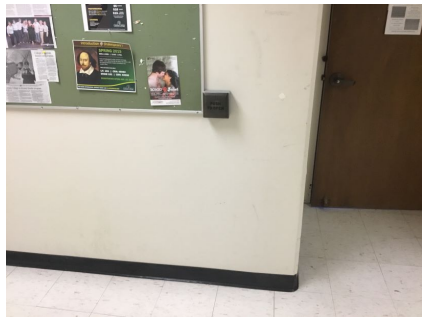
<input type="checkbox"/> Staff Only Priority 2 Severity 1			
10748	<ul style="list-style-type: none"> As-Built Description: Push plate to operate automatic door not a minimum 4" in diameter or a minimum of 4" x 4" square. Proposed Solution: Provide compliant push plate. Notes: No ISA is provided. 	PCODE ID13C CBC 2016 11B-404.2.9 2.C Mitigated: <input type="radio"/> YES <input checked="" type="radio"/> NO	20	JOB	\$1,500	\$30,000

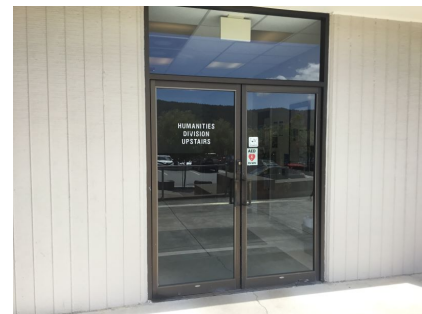
Exterior signage at inaccessible entrances to provide direction to accessible entrances is missing or noncompliant.

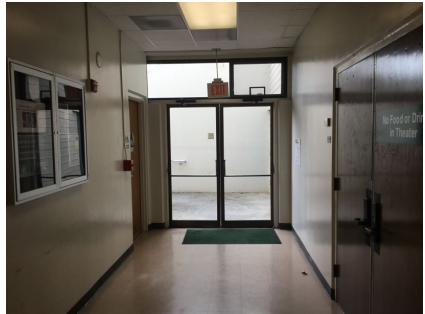
Item no., Rm no. and Name	Existing Architectural Barrier and Proposed Solution	Codes / Mitigation Info	Qty	Unit	Cost	Total
10869	<ul style="list-style-type: none"> As-Built Description: At final exit door to exterior: Where required exit signs are installed, signs to provide exiting information for people with vision impairment are not provided. Proposed Solution: Provide raised letter/Braille "EXIT" sign at door. 	PCODE SA10A ADAAG 91 4.1.3(16) ADA 2010 216.4.1 CBC 2007 1011.3 CBC 2016 11B-216.4.1 Mitigated: <input type="radio"/> YES <input checked="" type="radio"/> NO	10	JOB	\$270	\$2,700

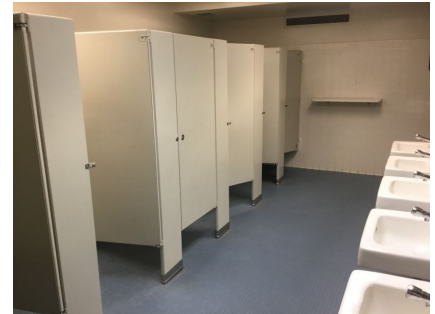
Multiple accommodation restroom not accessible;
multiple compliance violations.

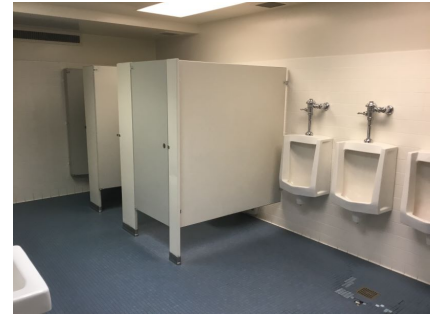
Multiple accommodation restroom not accessible;
multiple compliance violations.

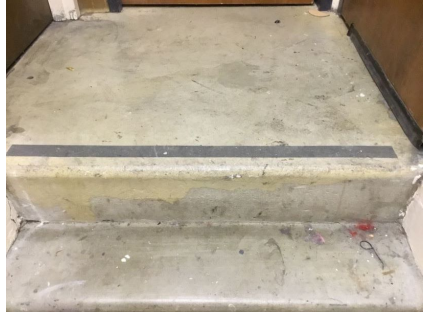
Item no., Rm no. and Name	Existing Architectural Barrier and Proposed Solution	Codes / Mitigation Info	Qty	Unit	Cost	Total
<u>Stairway</u>						
10963	<ul style="list-style-type: none"> • <i>As-Built Description:</i> The leading 2" of the tread does not have visual contrast of dark-on-light or light-on-dark from the remainder of the tread. • <i>As-Built:</i> 2" from nosing • <i>Proposed Solution:</i> Provide 2" min., 4" max. wide contrasting color strip 1" max. from nosing on top & bottom treads when altering area. 	PCODE II02B ADA 2010 504.4 CBC 2007 1133B.4.4 CBC 2016 11B-504.4.1 Mitigated: <input type="radio"/> YES <input checked="" type="radio"/> NO	8	LF	\$42	\$336

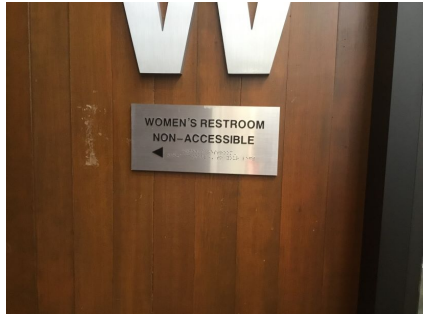
Item no., Rm no. and Name	Existing Architectural Barrier and Proposed Solution	Codes / Mitigation Info	Qty	Unit	Cost	Total
10834	<ul style="list-style-type: none"> As-Built Description: No sign by inaccessible route directing persons to an accessible route. Proposed Solution: Provide directional sign. Notes: <i>Provide directional sign to accessible restroom.</i> 	PCODE SA20 ADAAG 91 35.163(b) ADA 2010 216.3 CBC 2007 1127B.3 CBC 2016 11B-216.3 Mitigated: <input type="radio"/> YES <input checked="" type="radio"/> NO	1	JOB	\$510	\$510

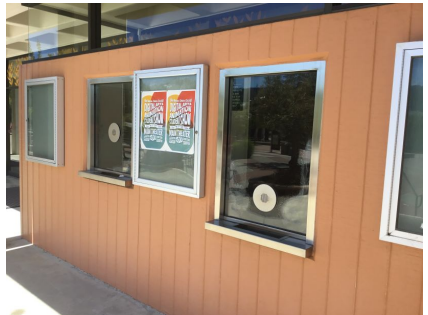
10836	<ul style="list-style-type: none"> As-Built Description: No signs at the building or assembly area entrance to notify patrons that an assistive listening system is available. Proposed Solution: Provide assistive listening signage. 	PCODE GI02 ADAAG 91 4.1.3(19)(b) ADA 2010 703.7.2.4 CBC 2007 1104B.2.4 CBC 2016 11B-703.7.2.4 Mitigated: <input type="radio"/> YES <input checked="" type="radio"/> NO	1	JOB	\$300	\$300

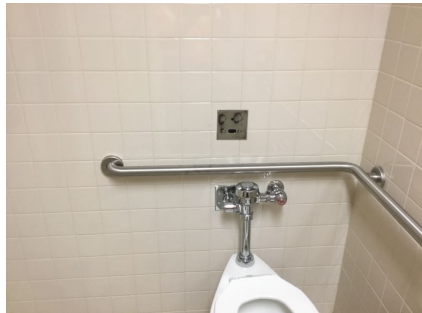
Item no., Rm no. and Name	Existing Architectural Barrier and Proposed Solution	Codes / Mitigation Info	Qty	Unit	Cost	Total
Grab Bars						
10824	<ul style="list-style-type: none"> As-Built Description: The rear wall grab is less than 36" min. or does not extend from the centerline of the water closet 12" min. on one side and 24" min. on the other side. As-Built: 20" on the wide side Proposed Solution: Provide or relocate accessible rear grab bar. 	PCODE WB07B ADAAG 91 4.17.6 ADA 2010 604.5.2 CBC 2007 1115B.4.1.3.2 CBC 2016 11B-604.5.2 Mitigated: <input type="radio"/> YES <input checked="" type="radio"/> NO	1	JOB	\$1,020	\$1,020

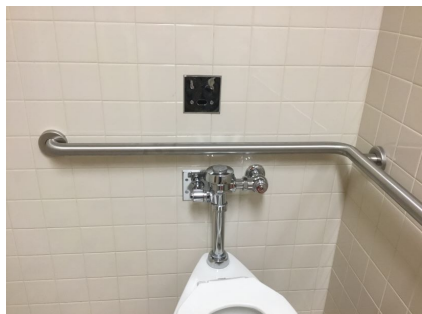
<input type="checkbox"/> Staff Only			
			Priority	Severity		
			3	3		
10823	<ul style="list-style-type: none"> As-Built Description: Accessories/dispensers in accessible stall located closer than 1-1/2" below or 12" above grab bar impedes its use. As-Built: 1.25" between grab bar and flush valve Proposed Solution: Relocate accessories/dispensers to be no closer than 1-1/2" below and 12" above grab bars (except if accessories are recessed, flush with wall, and have no sharp edges). 	PCODE WB071 ADAAG 91 4.26.2 ADA 2010 609.3 CBC 2007 1133B.4.2.5 CBC 2016 11B-609.3 Mitigated: <input type="radio"/> YES <input checked="" type="radio"/> NO	1	JOB	\$225	\$225

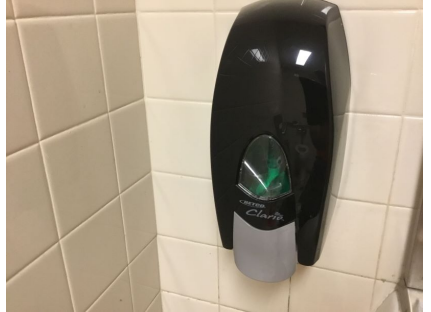
Item no., Rm no. and Name	Existing Architectural Barrier and Proposed Solution	Codes / Mitigation Info	Qty	Unit	Cost	Total
<u>Accessories</u>						
10825	<ul style="list-style-type: none"> • <i>As-Built Description:</i> Dispensers in sanitary facilities, such as for towels, soap, sanitary napkins, seat covers, etc., and waste receptacles more than 48" (CA only: 40") from floor to highest operating slot or control. • <i>As-Built:</i> 41" AFF • <i>Proposed Solution:</i> Relocate existing restroom accessories. 	PCODE WG01A ADAAG 91 4.23.7 ADA 2010 308.2.1 CBC 2007 1115B.8.3 CBC 2016 11B-603.5 Mitigated: <input type="radio"/> YES <input checked="" type="radio"/> NO	1	JOB	\$300	\$300

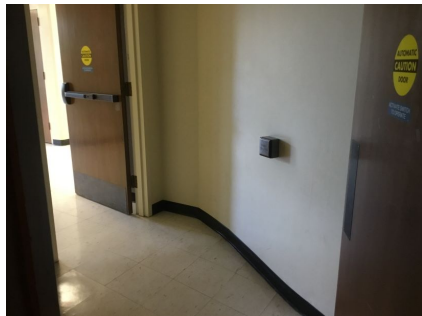
Item no., Rm no. and Name	Existing Architectural Barrier and Proposed Solution	Codes / Mitigation Info	Qty	Unit	Cost	Total
10853	<ul style="list-style-type: none"> As-Built Description: Cross slope more than 1":48" (2.083%). As-Built: 13% Proposed Solution: Modify cross slope. Notes: <i>Clear floor space slopes 13% at automatic door openers.</i> 	PCODE EF07 ADAAG 91 4.3.7 ADA 2010 403.3 CBC 2007 1133B.7.1.3 CBC 2016 11B-403.3 Mitigated: <input type="radio"/> YES <input checked="" type="radio"/> NO	24	SF	\$75	\$1,800

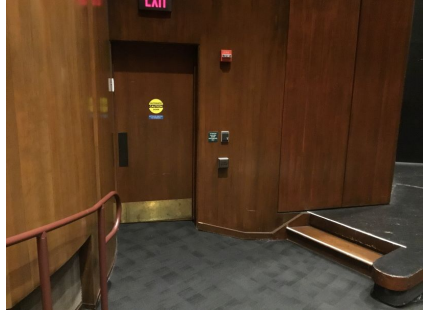
10842	<ul style="list-style-type: none"> • <i>As-Built Description:</i> Surface of required maneuvering clearance at door slopes more than 1/4":12" (2.0%). • <i>As-Built:</i> 13% • <i>Proposed Solution:</i> Modify surface slope at door. 	PCODE ID11 ADAAG 91 4.13.6 ADA 2010 404.2.4.4 CBC 2007 1133B.2.4 CBC 2016 11B-404.2.4 Mitigated: <input type="radio"/> YES <input checked="" type="radio"/> NO	50	SF	\$120	\$6,000

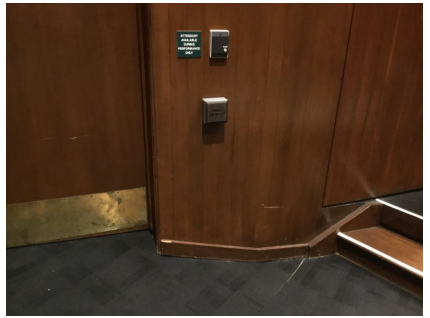
<input type="checkbox"/> Staff Only						
Priority 2 Severity 1						
10841	<ul style="list-style-type: none"> • <i>As-Built Description:</i> Push plate to operate automatic door not a minimum 4" in diameter or a minimum of 4" x 4" square. • <i>Proposed Solution:</i> Provide compliant push plate. 	PCODE ID13C CBC 2016 11B-404.2.9 2.C Mitigated: <input type="radio"/> YES <input checked="" type="radio"/> NO	4	JOB	\$1,500	\$6,000

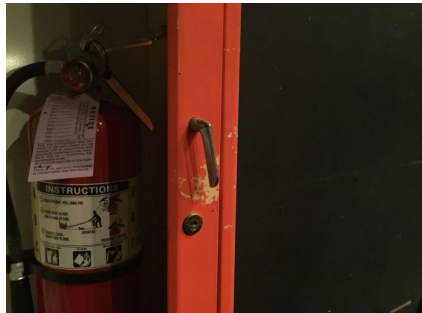
Item no., Rm no. and Name	Existing Architectural Barrier and Proposed Solution	Codes / Mitigation Info	Qty	Unit	Cost	Total
Reach Range						
10851	<ul style="list-style-type: none"> As-Built Description: Reach height to control or access point, where side approach is available, exceeds 48" or is less than 15" in height, or exceeds 10" in depth. As-Built: 52" AFF Proposed Solution: Modify equipment or mounting. 	PCODE IE02 ADAAG 91 4.2.6 ADA 2010 308.3.1 CBC 2007 1118B.6 CBC 2016 11B-308.3 Mitigated: <input type="radio"/> YES <input checked="" type="radio"/> NO	1	JOB	\$300	\$300

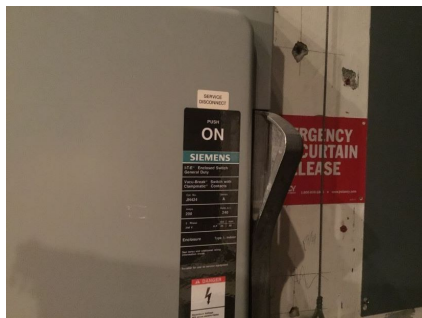
<input type="checkbox"/> Staff Only			
			Priority 2 Severity 4			
10852	<ul style="list-style-type: none"> As-Built Description: Reach height to control or access point, where side approach is available, exceeds 48" or is less than 15" in height, or exceeds 10" in depth. As-Built: 57" AFF Proposed Solution: Modify equipment or mounting. 	PCODE IE02 ADAAG 91 4.2.6 ADA 2010 308.3.1 CBC 2007 1118B.6 CBC 2016 11B-308.3 Mitigated: <input type="radio"/> YES <input checked="" type="radio"/> NO	1	JOB	\$300	\$300

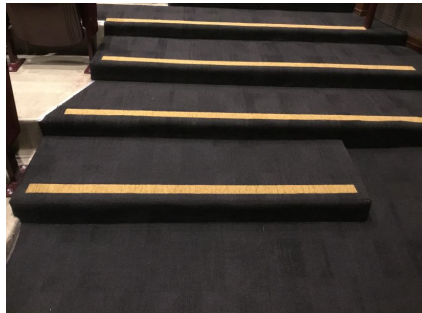
Item no., Rm no. and Name	Existing Architectural Barrier and Proposed Solution	Codes / Mitigation Info	Qty	Unit	Cost	Total
Stairway						
10844	<ul style="list-style-type: none"> • <i>As-Built Description:</i> The leading 2" of the tread does not have visual contrast of dark-on-light or light-on-dark from the remainder of the tread. • <i>As-Built:</i> 2" from nosing • <i>Proposed Solution:</i> Provide 2" min., 4" max. wide contrasting color strip 1" max. from nosing on top & bottom treads when altering area. 	PCODE II02B ADA 2010 504.4 CBC 2007 1133B.4.4 CBC 2016 11B-504.4.1 Mitigated: <input type="radio"/> YES <input checked="" type="radio"/> NO	30	LF	\$42	\$1,260

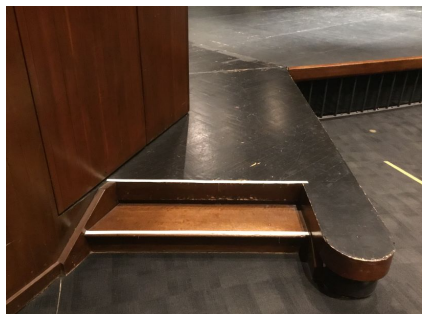
<input type="checkbox"/> Staff Only Priority 2 Severity 3			
10845	<ul style="list-style-type: none"> • <i>As-Built Description:</i> The leading 2" of the tread does not have visual contrast of dark-on-light or light-on-dark from the remainder of the tread. • <i>As-Built:</i> 1" wide • <i>Proposed Solution:</i> Provide 2" min., 4" max. wide contrasting color strip 1" max. from nosing on top & bottom treads when altering area. 	PCODE II02B ADA 2010 504.4 CBC 2007 1133B.4.4 CBC 2016 11B-504.4.1 Mitigated: <input type="radio"/> YES <input checked="" type="radio"/> NO	20	LF	\$42	\$840

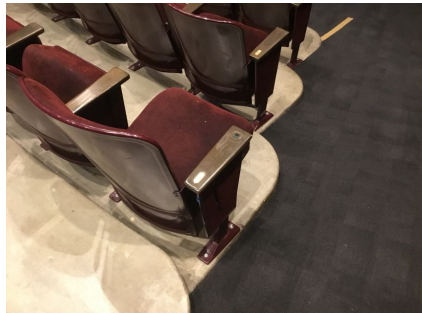
Item no., Rm no. and Name	Existing Architectural Barrier and Proposed Solution	Codes / Mitigation Info	Qty	Unit	Cost	Total
Fixed Seating						
10838	<ul style="list-style-type: none"> As-Built Description: Less than five percent of the total number of aisle seats are accessible. Proposed Solution: Provide aisle seats with no or removable armrest and post availability at ticket office. Notes: 509 seats, 4 designated aisle seats provided. There are no ISA's on the aisle seats. 	PCODE GE01ANT ADAAG 91 4.1.2(19)a ADA 2010 221.4 CBC 2007 1104B.3.4 CBC 2016 11B-221.4 Mitigated: <input type="radio"/> YES <input checked="" type="radio"/> NO	1	EA	\$1,050	\$1,050

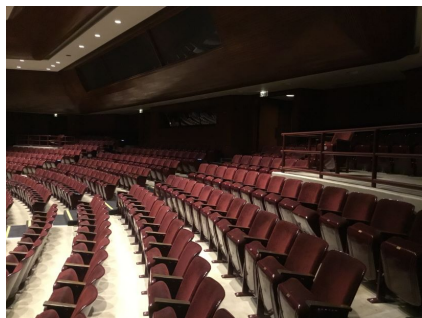
<input type="checkbox"/> Staff Only			
			Priority 2 Severity 3			
10843	<ul style="list-style-type: none"> As-Built Description: Wheelchair locations not dispersed throughout seating area (n/a if floor slope greater than 1:20 or 5%). Proposed Solution: Disperse accessible wheelchair space(s). Notes: There does not appear to be horizontal or vertical dispersion at the wheelchair seating spaces. The wheelchair spaces are at the outside edges of the theater. 	PCODE GE01C ADAAG 91 4.33.3 ADA 2010 221.2.3 CBC 2007 1104B.3.3 CBC 2016 11B-221.2.3 Mitigated: <input type="radio"/> YES <input checked="" type="radio"/> NO	1	EA	\$1,800	\$1,800

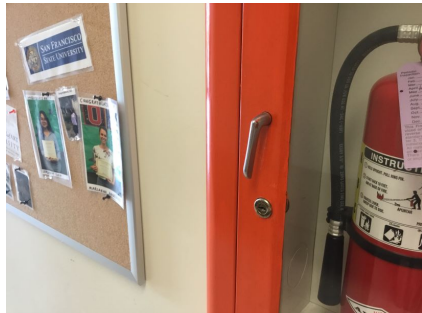
Item no., Rm no. and Name	Existing Architectural Barrier and Proposed Solution	Codes / Mitigation Info	Qty	Unit	Cost	Total
Reach Range						
10859	<ul style="list-style-type: none"> As-Built Description: Reach height to control or access point, where side approach is available, exceeds 48" or is less than 15" in height, or exceeds 10" in depth. As-Built: 51" above finished floor Proposed Solution: Modify equipment or mounting. 	PCODE IE02 ADAAG 91 4.2.6 ADA 2010 308.3.1 CBC 2007 1118B.6 CBC 2016 11B-308.3 Mitigated: <input type="radio"/> YES <input checked="" type="radio"/> NO	1	JOB	\$300	\$300

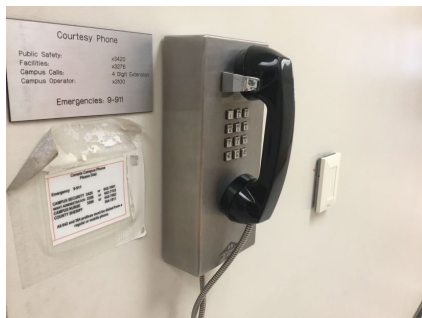
<input type="checkbox"/> Staff Only			
			Priority		Severity	
			2		4	
10866	<ul style="list-style-type: none"> As-Built Description: Reach height to control or access point, where side approach is available, exceeds 48" or is less than 15" in height, or exceeds 10" in depth. As-Built: 55.25" above finished floor Proposed Solution: Modify equipment or mounting. 	PCODE IE02 ADAAG 91 4.2.6 ADA 2010 308.3.1 CBC 2007 1118B.6 CBC 2016 11B-308.3 Mitigated: <input type="radio"/> YES <input checked="" type="radio"/> NO	1	JOB	\$300	\$300

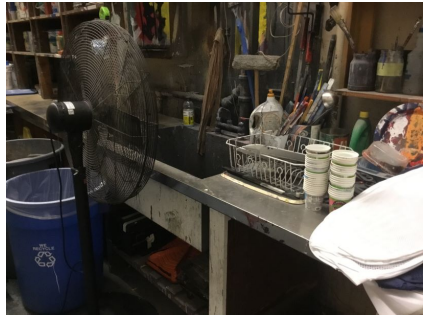
Item no., Rm no. and Name	Existing Architectural Barrier and Proposed Solution	Codes / Mitigation Info	Qty	Unit	Cost	Total
2	<ul style="list-style-type: none"> As-Built Description: Sink does not have knee space min. 27" high x 19" deep x 30" wide. As-Built: No knee clearance provided Proposed Solution: Remodel sink cabinet. 	PCODE IN06A ADAAG 91 4.24.3 ADA 2010 606.2 CBC 2007 1115B.4.7.1 CBC 2016 11B-606.2 Mitigated: <input type="radio"/> YES <input checked="" type="radio"/> NO	1	JOB	\$5,250	\$5,250

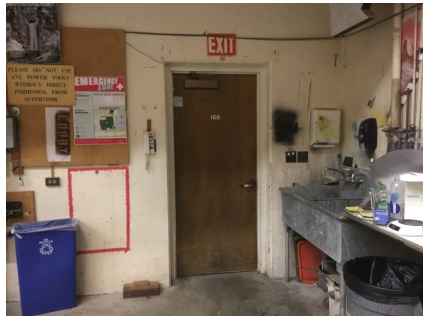
10877	<ul style="list-style-type: none"> As-Built Description: At door leading into exit corridor: Where required exit signs are installed, signs to provide exiting information for people with vision impairment are not provided. Proposed Solution: Provide raised letter/Braille "EXIT ROUTE" sign at door. 	PCODE SA10D ADAAG 91 4.1.3(16) ADA 2010 216.4.1 CBC 2007 1011.3 CBC 2016 11B-216.4.1 Mitigated: <input type="radio"/> YES <input checked="" type="radio"/> NO	1	JOB	\$270	\$270

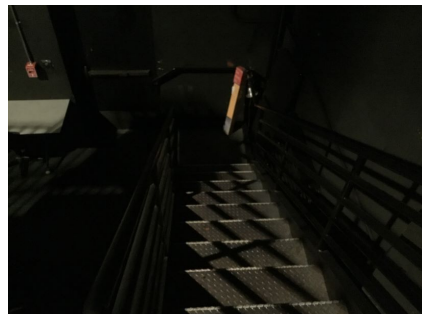
Item no., Rm no. and Name	Existing Architectural Barrier and Proposed Solution	Codes / Mitigation Info	Qty	Unit	Cost	Total
<u>Stairway</u>						
3	<ul style="list-style-type: none">• <i>As-Built Description:</i> The leading 2" of the tread does not have visual contrast of dark-on-light or light-on-dark from the remainder of the tread.• <i>Proposed Solution:</i> Provide 2" min., 4" max. wide contrasting color strip 1" max. from nosing on top & bottom treads when altering area.	<p>PCODE II02B</p> <p>ADA 2010 504.4</p> <p>CBC 2007 1133B.4.4</p> <p>CBC 2016 11B-504.4.1</p> <p>Mitigated:</p> <p><input type="radio"/> YES</p> <p><input checked="" type="radio"/> NO</p>	12	LF	\$42	\$504

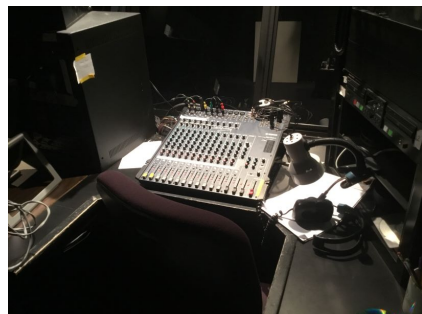
<input type="checkbox"/> Staff Only			
			Priority		Severity	
			2		3	
<u>Non-Fixed Desk</u>						
10885	<ul style="list-style-type: none">• <i>As-Built Description:</i> Accessible non-fixed table or desk (top 28" to 34" high; knee space at least 27" high x 19" deep x 30" wide) not provided.• <i>As-Built:</i> Sound board desk 25" wide• <i>Proposed Solution:</i> Provide table or desk with accessible dimensions when purchasing new furniture.	<p>PCODE IN02A</p> <p>ADAAG 91 4.32.3 & .4</p> <p>ADA 2010 306.1</p> <p>CBC 2007 1122B.3 & 4</p> <p>CBC 2016 11B-306.1 & 11B-902.3</p> <p>Mitigated:</p> <p><input type="radio"/> YES</p> <p><input checked="" type="radio"/> NO</p>	1	JOB	\$4,800	\$4,800

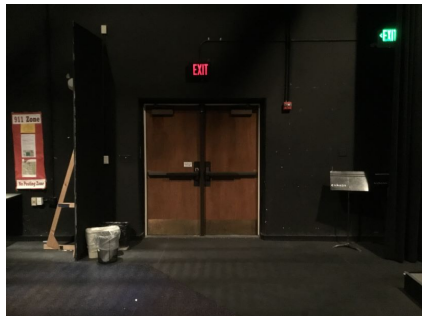
Item no., Rm no. and Name	Existing Architectural Barrier and Proposed Solution	Codes / Mitigation Info	Qty	Unit	Cost	Total
10881	<ul style="list-style-type: none"> As-Built Description: At door leading into exit corridor: Where required exit signs are installed, signs to provide exiting information for people with vision impairment are not provided. Proposed Solution: Provide raised letter/Braille "EXIT ROUTE" sign at door. 	PCODE SA10D ADAAG 91 4.1.3(16) ADA 2010 216.4.1 CBC 2007 1011.3 CBC 2016 11B-216.4.1 Mitigated: <input type="radio"/> YES <input checked="" type="radio"/> NO	2	JOB	\$270	\$540

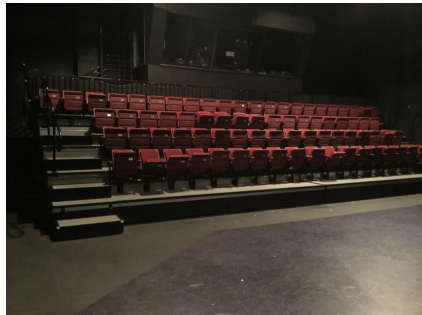
10878	<ul style="list-style-type: none"> As-Built Description: At room with 51-150 fixed seats, fewer than required number of wheelchair seating spaces provided; 4 spaces required. Proposed Solution: Provide 33" x 60" wheelchair spaces and work surfaces. Notes: No wheelchair seating. The available space for wheelchairs is on the raised area. 76 seats are provided. 	PCODE CB02C ADAAG 91 4.1.3(19)a ADA 2010 221.2.1.1 CBC 2007 1104B.3.4 CBC 2016 11B-221.2.1.1 Mitigated: <input type="radio"/> YES <input checked="" type="radio"/> NO	1	JOB	\$2,280	\$2,280

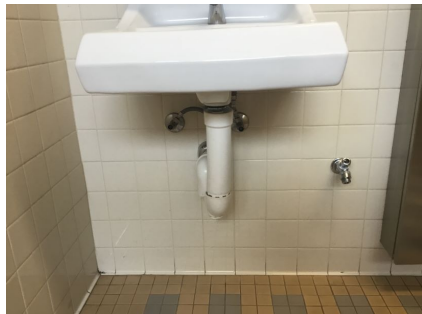
Item no., Rm no. and Name	Existing Architectural Barrier and Proposed Solution	Codes / Mitigation Info	Qty	Unit	Cost	Total
10889	<ul style="list-style-type: none"> As-Built Description: Hot or sharp-surfaced water/drain pipe not insulated or covered. Proposed Solution: Insulate or cover water/drain pipe. 	PCODE WD05REF ADAAG 91 4.19.4 ADA 2010 606.5 CBC 2007 1115B.4.3.4 CBC 2016 11B-606.5 Mitigated: <input type="radio"/> YES <input checked="" type="radio"/> NO	REF

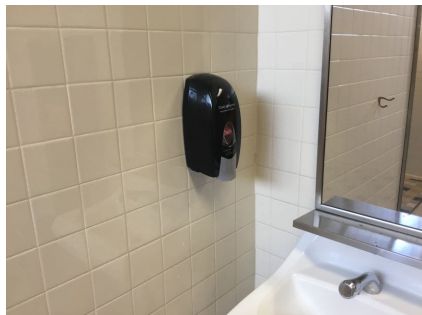
<input type="checkbox"/> Staff Only Priority 3 Severity 3						
Accessories						
10891	<ul style="list-style-type: none"> As-Built Description: Dispensers in sanitary facilities, such as for towels, soap, sanitary napkins, seat covers, etc., and waste receptacles more than 48" (CA only: 40") from floor to highest operating slot or control. As-Built: 43" above finished floor Proposed Solution: Relocate existing restroom accessories. 	PCODE WG01A ADAAG 91 4.23.7 ADA 2010 308.2.1 CBC 2007 1115B.8.3 CBC 2016 11B-603.5 Mitigated: <input type="radio"/> YES <input checked="" type="radio"/> NO	1	JOB	\$300	\$300

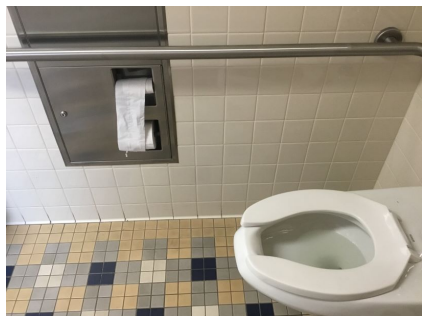
<input type="checkbox"/> Staff Only Priority 3 Severity 4						
10893	<ul style="list-style-type: none"> As-Built Description: Toilet paper dispenser less than 15" (CA: 19") or more than 48" above floor or not within 7" to 9" from front of water closet (Note: CA pre-2010 is allowed within 12" from front of water closet). As-Built: 12" from the front of the water closet Proposed Solution: Relocate or provide new toilet paper dispenser. 	PCODE WG02 ADAAG 91 4.16.6 ADA 2010 604.7 CBC 2007 1115B.8.4 CBC 2016 11B-604.7 Mitigated: <input type="radio"/> YES <input checked="" type="radio"/> NO	1	JOB	\$225	\$225

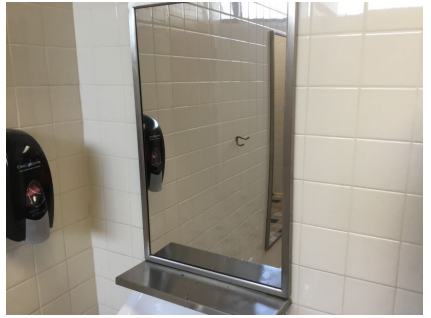
Item no., Rm no. and Name	Existing Architectural Barrier and Proposed Solution	Codes / Mitigation Info	Qty	Unit	Cost	Total
10892	<ul style="list-style-type: none"> As-Built Description: Bottom of mirror located above lavatories or countertops more than 40" above floor. As-Built: 40.25" above finished floor Proposed Solution: Relocate or provide new accessible mirror. 	PCODE WG03 ADAAG 91 4.19.6 ADA 2010 603.3 CBC 2007 1115B.8.1 CBC 2016 11B-603.3 Mitigated: <input type="radio"/> YES <input checked="" type="radio"/> NO	1	JOB	\$450	\$450

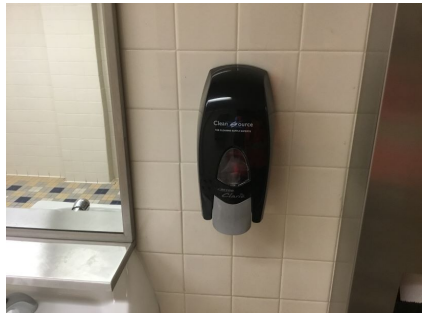
Item no., Rm no. and Name	Existing Architectural Barrier and Proposed Solution	Codes / Mitigation Info	Qty	Unit	Cost	Total
Accessories						
10900	<ul style="list-style-type: none"> As-Built Description: Dispensers in sanitary facilities, such as for towels, soap, sanitary napkins, seat covers, etc., and waste receptacles more than 48" (CA only: 40") from floor to highest operating slot or control. As-Built: 43" above finished floor Proposed Solution: Relocate existing restroom accessories. 	PCODE WG01A ADAAG 91 4.23.7 ADA 2010 308.2.1 CBC 2007 1115B.8.3 CBC 2016 11B-603.5 Mitigated: <input type="radio"/> YES <input checked="" type="radio"/> NO	1	JOB	\$300	\$300

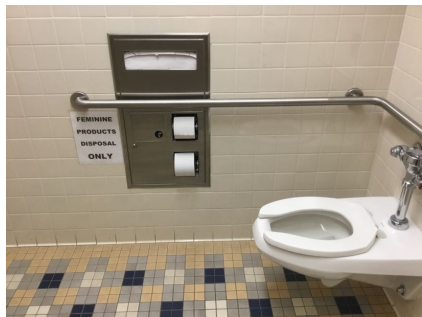
<input type="checkbox"/> Staff Only Priority 3 Severity 4			
10901	<ul style="list-style-type: none"> As-Built Description: Toilet paper dispenser less than 15" (CA: 19") or more than 48" above floor or not within 7" to 9" from front of water closet (Note: CA pre-2010 is allowed within 12" from front of water closet). As-Built: 12" from the front of the water closet Proposed Solution: Relocate or provide new toilet paper dispenser. 	PCODE WG02 ADAAG 91 4.16.6 ADA 2010 604.7 CBC 2007 1115B.8.4 CBC 2016 11B-604.7 Mitigated: <input type="radio"/> YES <input checked="" type="radio"/> NO	1	JOB	\$225	\$225

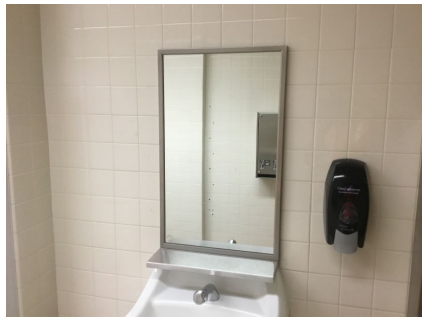
<input type="checkbox"/> Staff Only Priority 3 Severity 3			
10897	<ul style="list-style-type: none"> As-Built Description: Bottom of mirror located above lavatories or countertops more than 40" above floor. As-Built: 40.25" to bottom of reflective surface Proposed Solution: Relocate or provide new accessible mirror. 	PCODE WG03 ADAAG 91 4.19.6 ADA 2010 603.3 CBC 2007 1115B.8.1 CBC 2016 11B-603.3 Mitigated: <input type="radio"/> YES <input checked="" type="radio"/> NO	1	JOB	\$450	\$450

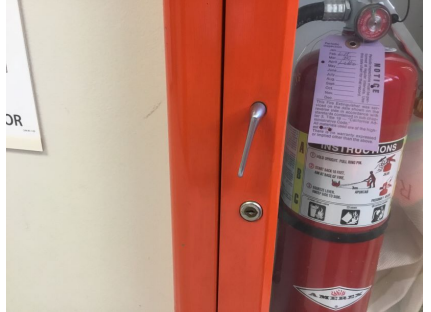
Item no., Rm no. and Name	Existing Architectural Barrier and Proposed Solution	Codes / Mitigation Info	Qty	Unit	Cost	Total
Reach Range						
10907	<ul style="list-style-type: none"> As-Built Description: Reach height to control or access point, where side approach is available, exceeds 48" or is less than 15" in height, or exceeds 10" in depth. As-Built: 51" above finished floor Proposed Solution: Modify equipment or mounting. 	PCODE IE02 ADAAG 91 4.2.6 ADA 2010 308.3.1 CBC 2007 1118B.6 CBC 2016 11B-308.3 Mitigated: <input type="radio"/> YES <input checked="" type="radio"/> NO	1	JOB	\$300	\$300

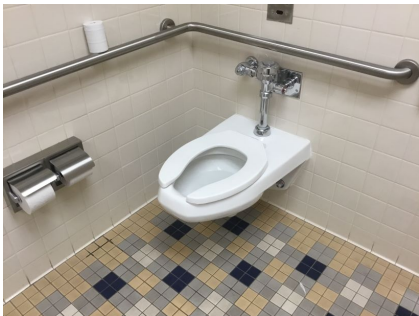
Item no., Rm no. and Name	Existing Architectural Barrier and Proposed Solution	Codes / Mitigation Info	Qty	Unit	Cost	Total
10938	<ul style="list-style-type: none">As-Built Description: Height of water closet seat less than 17" or more than 19" from floor.As-Built: 19.25" above finished floorProposed Solution: Provide new accessible water closet.	PCODE WB08 ADAAG 91 4.16.3 ADA 2010 604.4 CBC 2007 1115B.4.1.4 CBC 2016 11B-604.4 Mitigated: <div><input type="radio"/> YES</div> <div><input checked="" type="radio"/> NO</div>	1	JOB	\$4,200	\$4,200

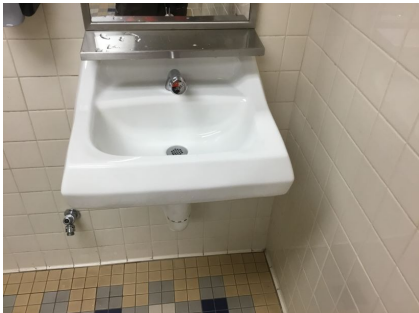
<div><input type="checkbox"/> Staff Only</div> <div><div>Priority</div><div>3</div><div>Severity</div><div>4</div></div>			
<hr/>						
Lavatory						
10917	<ul style="list-style-type: none">As-Built Description: Clear floor space, 30" x 48" in front of fixture, extending 19" max. under the lavatory, not provided (CA only: Less than 18" from side wall to centerline of lavatory).As-Built: 16.5" o.c.Proposed Solution: Provide new accessible lavatory. Remodel restroom as needed.	PCODE WD01 ADAAG 91 4.19.3 ADA 2010 606.2 CBC 2007 1115B.4.3 CBC 2016 11B-606.2, 11B-606.6 Mitigated: <div><input type="radio"/> YES</div> <div><input checked="" type="radio"/> NO</div>	1	JOB	\$10,200	\$10,200

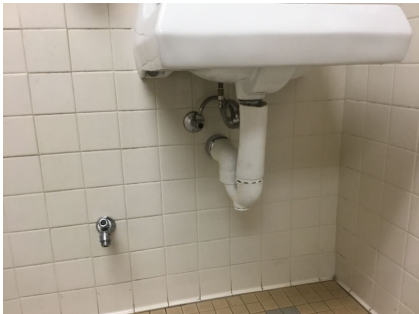
<div><input type="checkbox"/> Staff Only</div> <div><div>Priority</div><div>3</div><div>Severity</div><div>2</div></div>			
<hr/>						
10919	<ul style="list-style-type: none">As-Built Description: Hot or sharp-surfaced water/drain pipe not insulated or covered.Proposed Solution: Insulate or cover water/drain pipe.	PCODE WD05REF ADAAG 91 4.19.4 ADA 2010 606.5 CBC 2007 1115B.4.3.4 CBC 2016 11B-606.5 Mitigated: <div><input type="radio"/> YES</div> <div><input checked="" type="radio"/> NO</div>	REF

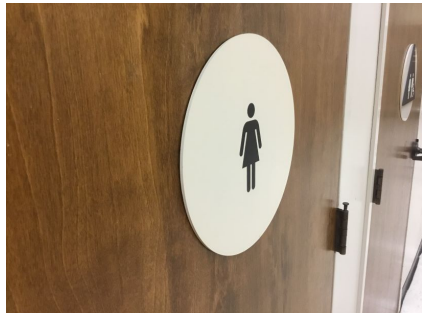
Item no., Rm no. and Name	Existing Architectural Barrier and Proposed Solution	Codes / Mitigation Info	Qty	Unit	Cost	Total
Signage						
10922	<ul style="list-style-type: none"> As-Built Description: Required in CA only: identification symbol centered 58" to 60" high on sanitary facility door that contrasts with the door not provided (women: 12" ø circle, men: 12" triangle, unisex: combined symbol). As-Built: Not eased Proposed Solution: Provide properly mounted sanitary facility symbol when altering area. If wheelchair accessible, include International Symbol of Accessibility on sign. 	PCODE SA15 CBC 2007 1115B.6 CBC 2016 11B-703.7.2.6 Mitigated: <input type="radio"/> YES <input checked="" type="radio"/> NO	1	JOB	\$270	\$270

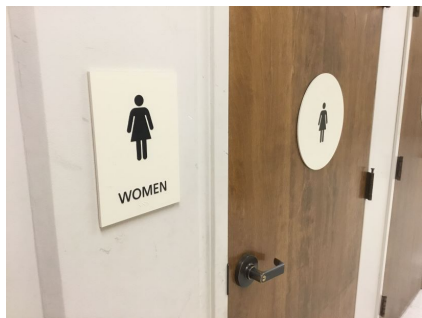
<input type="checkbox"/> Staff Only Priority 3 Severity 3			
10923	<ul style="list-style-type: none"> As-Built Description: Required in CA only: identification symbol centered 58" to 60" high on sanitary facility door that contrasts with the door not provided (women: 12" ø circle, men: 12" triangle, unisex: combined symbol). Proposed Solution: Provide properly mounted sanitary facility symbol when altering area. If wheelchair accessible, include International Symbol of Accessibility on sign. Notes: No ISA provided. Where there are non-accessible restrooms within the building, an ISA must identify the accessible restrooms. 	PCODE SA15 CBC 2007 1115B.6 CBC 2016 11B-703.7.2.6 Mitigated: <input type="radio"/> YES <input checked="" type="radio"/> NO	1	JOB	\$270	\$270

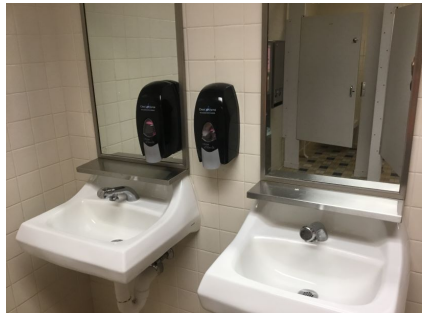
Item no., Rm no. and Name	Existing Architectural Barrier and Proposed Solution	Codes / Mitigation Info	Qty	Unit	Cost	Total
Accessories						
10926	<ul style="list-style-type: none"> • <i>As-Built Description:</i> Dispensers in sanitary facilities, such as for towels, soap, sanitary napkins, seat covers, etc., and waste receptacles more than 48" (CA only: 40") from floor to highest operating slot or control. • <i>As-Built:</i> 41.5" above finished floor • <i>Proposed Solution:</i> Relocate existing restroom accessories. 	PCODE WG01A ADAAG 91 4.23.7 ADA 2010 308.2.1 CBC 2007 1115B.8.3 CBC 2016 11B-603.5 Mitigated: <input type="radio"/> YES <input checked="" type="radio"/> NO	1	JOB	\$300	\$300

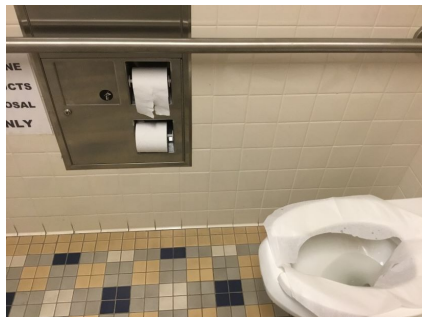
<input type="checkbox"/> Staff Only Priority 3 Severity 4			
10933	<ul style="list-style-type: none"> • <i>As-Built Description:</i> Toilet paper dispenser less than 15" (CA: 19") or more than 48" above floor or not within 7" to 9" from front of water closet (Note: CA pre-2010 is allowed within 12" from front of water closet). • <i>As-Built:</i> 11.5" in front of the water closet • <i>Proposed Solution:</i> Relocate or provide new toilet paper dispenser. 	PCODE WG02 ADAAG 91 4.16.6 ADA 2010 604.7 CBC 2007 1115B.8.4 CBC 2016 11B-604.7 Mitigated: <input type="radio"/> YES <input checked="" type="radio"/> NO	1	JOB	\$225	\$225

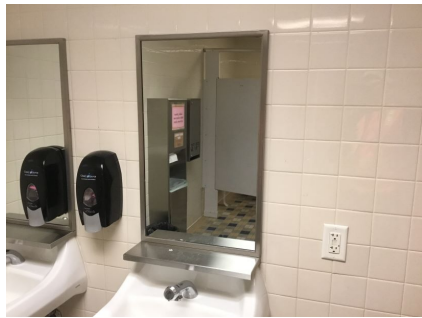
<input type="checkbox"/> Staff Only Priority 3 Severity 3			
10935	<ul style="list-style-type: none"> • <i>As-Built Description:</i> Bottom of mirror located above lavatories or countertops more than 40" above floor. • <i>As-Built:</i> 40.25" above finished floor • <i>Proposed Solution:</i> Relocate or provide new accessible mirror. 	PCODE WG03 ADAAG 91 4.19.6 ADA 2010 603.3 CBC 2007 1115B.8.1 CBC 2016 11B-603.3 Mitigated: <input type="radio"/> YES <input checked="" type="radio"/> NO	1	JOB	\$450	\$450

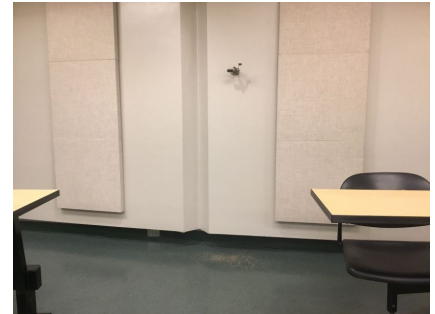
• *Proposed Solution:*CBC 2016 11B-306.1 & 11B
-902.3• **Notes:***Due to steps no accessible route to pencil sharpener provided. Provide pencil sharpener at accessible level.***Mitigated:**☐ YES☒ NO

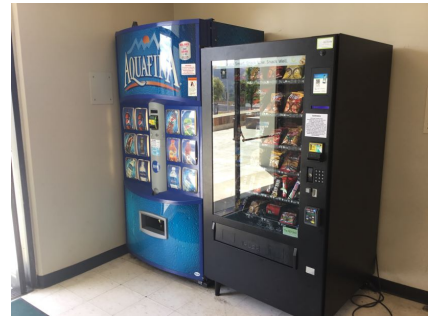
Item no., Rm no. and Name	Existing Architectural Barrier and Proposed Solution	Codes / Mitigation Info	Qty	Unit	Cost	Total
<u>Vending Machine</u>						
10947	<ul style="list-style-type: none"> • <i>As-Built Description:</i> Vending machine coin slot or dispensing outlet, more than 48" above or less than 15" above the floor. • <i>As-Built:</i> 8"-11" to the bottom of the dispensing trays. 53" to the top of the card reader. • <i>Proposed Solution:</i> Advise vendor/leasing company to provide accessible vending machine with operable parts between 15" min. and 48" max. 	PCODE IL02 ADAAG 91 4.2.5 ADA 2010 308.2.1 CBC 2007 1126B CBC 2016 11B-308.2.1 Mitigated: <input type="radio"/> YES <input checked="" type="radio"/> NO				
			REF

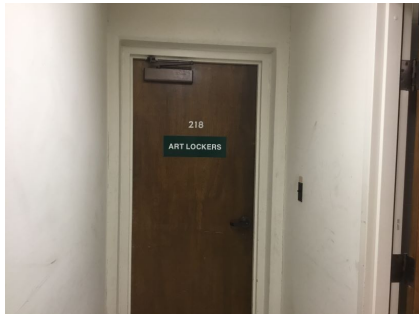
Item no., Rm no. and Name	Existing Architectural Barrier and Proposed Solution	Codes / Mitigation Info	Qty	Unit	Cost	Total
Door Swing						
10730	<ul style="list-style-type: none">As-Built Description: Front approach: At push side, door does not have clear and level maneuvering space measuring door width x 48" (door width plus 12" if door has both, latch and closer).As-Built: 3" strike side clearanceProposed Solution: <i>Remove the closer and or latch.</i>	<p>PCODE ID24A</p> <p>ADAAG 91 Fig. 25(a)</p> <p>ADA 2010 404.2.4</p> <p>CBC 2007 11B-26A(a)</p> <p>CBC 2016 11B-404.2.4</p> <p>Mitigated:</p> <p><input type="radio"/> YES</p> <p><input checked="" type="radio"/> NO</p>	2	JOB	\$150	\$300

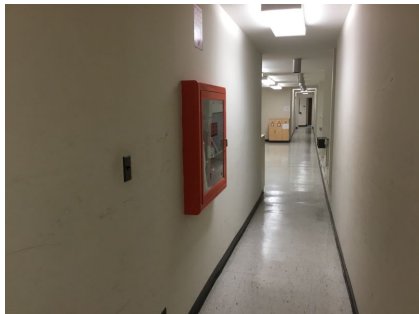
Corridor						
10729	<ul style="list-style-type: none">As-Built Description: Corridor less than 44" wide.As-Built: 40" wide at fire hose cabinetProposed Solution: <i>Install a lower profile fire extinguisher cabinet.</i>	<p>PCODE IH03</p> <p>ADAAG 91 4.3.3</p> <p>ADA 2010 403.5.1</p> <p>CBC 2007 1133B.3.1</p> <p>CBC 2016 11B-403.5.1</p> <p>Mitigated:</p> <p><input type="radio"/> YES</p> <p><input checked="" type="radio"/> NO</p>	3	LF	\$420	\$1,260

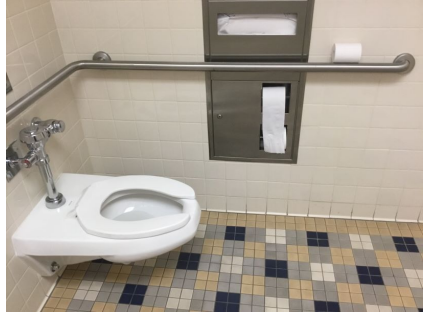
Item no., Rm no. and Name	Existing Architectural Barrier and Proposed Solution	Codes / Mitigation Info	Qty	Unit	Cost	Total
Accessories						
10745	<ul style="list-style-type: none"> As-Built Description: Toilet paper dispenser less than 15" (CA: 19") or more than 48" above floor or not within 7" to 9" from front of water closet (Note: CA pre-2010 is allowed within 12" from front of water closet). As-Built: 11" from the front of the water closet Proposed Solution: Relocate or provide new toilet paper dispenser. 	PCODE WG02 ADAAG 91 4.16.6 ADA 2010 604.7 CBC 2007 1115B.8.4 CBC 2016 11B-604.7 Mitigated: <input type="radio"/> YES <input checked="" type="radio"/> NO	1	JOB	\$225	\$225

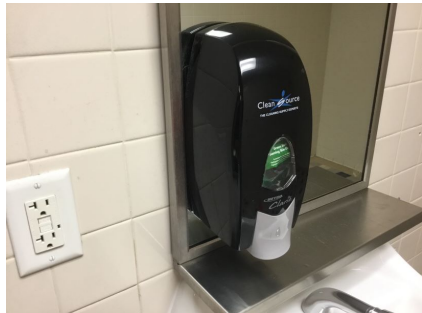
Item no., Rm no. and Name	Existing Architectural Barrier and Proposed Solution	Codes / Mitigation Info	Qty	Unit	Cost	Total
Accessories						
10758	<ul style="list-style-type: none"> As-Built Description: Dispensers in sanitary facilities, such as for towels, soap, sanitary napkins, seat covers, etc., and waste receptacles more than 48" (CA only: 40") from floor to highest operating slot or control. As-Built: 41.5" AFF Proposed Solution: Relocate existing restroom accessories. 	PCODE WG01A ADAAG 91 4.23.7 ADA 2010 308.2.1 CBC 2007 1115B.8.3 CBC 2016 11B-603.5 Mitigated: <input type="radio"/> YES <input checked="" type="radio"/> NO	1	JOB	\$300	\$300

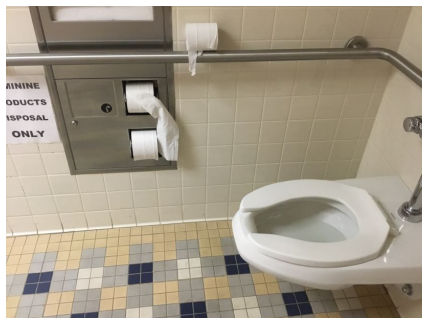
<input type="checkbox"/> Staff Only Priority 3 Severity 4			
10762	<ul style="list-style-type: none"> As-Built Description: Toilet paper dispenser less than 15" (CA: 19") or more than 48" above floor or not within 7" to 9" from front of water closet (Note: CA pre-2010 is allowed within 12" from front of water closet). As-Built: 11" from the front of the water closet Proposed Solution: Relocate or provide new toilet paper dispenser. 	PCODE WG02 ADAAG 91 4.16.6 ADA 2010 604.7 CBC 2007 1115B.8.4 CBC 2016 11B-604.7 Mitigated: <input type="radio"/> YES <input checked="" type="radio"/> NO	1	JOB	\$225	\$225

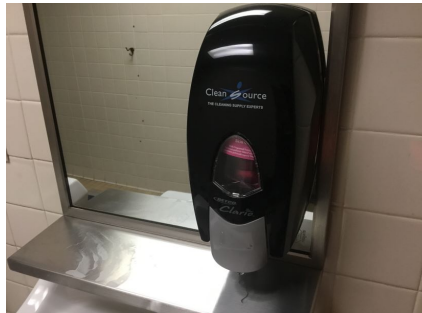
Item no., Rm no. and Name	Existing Architectural Barrier and Proposed Solution	Codes / Mitigation Info	Qty	Unit	Cost	Total
Accessories						
10765	<ul style="list-style-type: none"> As-Built Description: Dispensers in sanitary facilities, such as for towels, soap, sanitary napkins, seat covers, etc., and waste receptacles more than 48" (CA only: 40") from floor to highest operating slot or control. As-Built: 42" AFF Proposed Solution: Relocate existing restroom accessories. 	PCODE WG01A ADAAG 91 4.23.7 ADA 2010 308.2.1 CBC 2007 1115B.8.3 CBC 2016 11B-603.5 Mitigated: <input type="radio"/> YES <input checked="" type="radio"/> NO	1	JOB	\$300	\$300

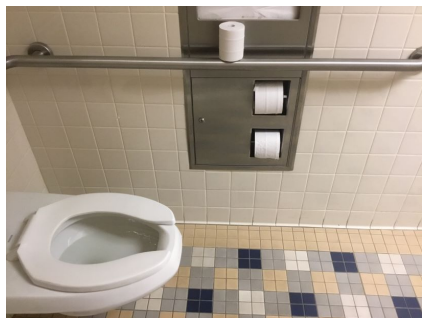
<input type="checkbox"/> Staff Only Priority 3 Severity 4			
10767	<ul style="list-style-type: none"> As-Built Description: Toilet paper dispenser less than 15" (CA: 19") or more than 48" above floor or not within 7" to 9" from front of water closet (Note: CA pre-2010 is allowed within 12" from front of water closet). As-Built: 12" in front of the water closet Proposed Solution: Relocate or provide new toilet paper dispenser. 	PCODE WG02 ADAAG 91 4.16.6 ADA 2010 604.7 CBC 2007 1115B.8.4 CBC 2016 11B-604.7 Mitigated: <input type="radio"/> YES <input checked="" type="radio"/> NO	1	JOB	\$225	\$225

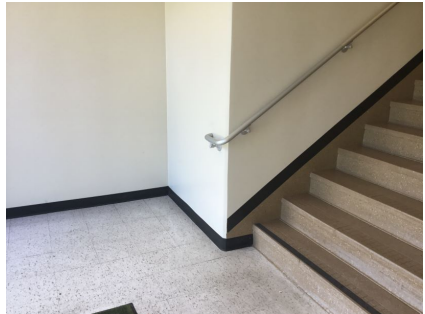
Item no., Rm no. and Name	Existing Architectural Barrier and Proposed Solution	Codes / Mitigation Info	Qty	Unit	Cost	Total
10783	<ul style="list-style-type: none"> As-Built Description: Stair handrail does not extend horizontally 12" minimum beyond top nosing, and one tread width sloped, plus 12" minimum horizontally beyond the bottom nosing. As-Built: 0"-10" Proposed Solution: Extend stair handrail at top and bottom (cost for each extension piece). Notes: Occurs at all open stairs. 	PCODE ED06 ADAAG 91 4.9.4(2) ADA 2010 505.10.2; CBC 2007 1133B.4.2.2 CBC 2016 11B-505.10.2; 11B-505.10.3 Mitigated: <input type="radio"/> YES <input checked="" type="radio"/> NO	4	JOB	\$510	\$2,040
