SMCCCD - Cañada College

Appendix H: Facilities

Access Compliance Survey Report

Building 2 - Bookstore

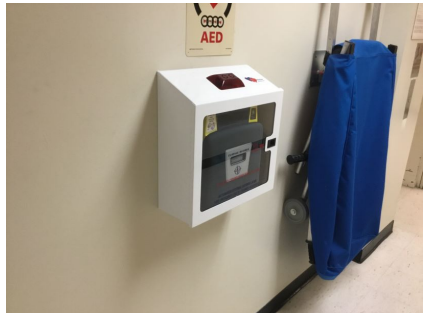
10788	<ul style="list-style-type: none"> As-Built Description: Protruding objects more than 4" from wall, when bottom of object more than 27" or less than 80" above finished floor. As-Built: AED protrudes 6.25" at 35" high Proposed Solution: Provide cane-detectable railing to mark area of low clearance. 	PCODE EG04A ADAAG 91 4.4.1 ADA 2010 307.2 CBC 2007 1133B.8.6.1 CBC 2016 11B-307.2 Mitigated: <input type="radio"/> YES <input checked="" type="radio"/> NO	4	LF	\$300	\$1,200

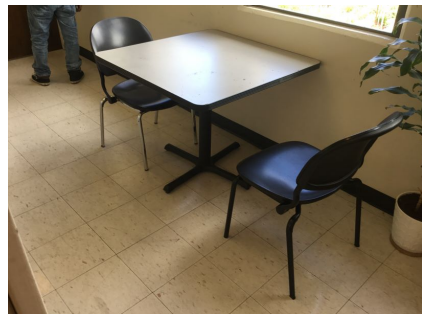
Item no., Rm no. and Name	Existing Architectural Barrier and Proposed Solution	Codes / Mitigation Info	Qty	Unit	Cost	Total
<u>Non-Fixed Desk</u>						
10777	<ul style="list-style-type: none">As-Built Description: Accessible non-fixed table or desk (top 28" to 34" high; knee space at least 27" high x 19" deep x 30" wide) not provided.As-Built: 2 seats, 0 accessibleProposed Solution: Provide table or desk with accessible dimensions when purchasing new furniture.	<p>PCODE IN02A</p> <p>ADAAG 91 4.32.3 & .4</p> <p>ADA 2010 306.1</p> <p>CBC 2007 1122B.3 & 4</p> <p>CBC 2016 11B-306.1 & 11B-902.3</p> <p>Mitigated:</p> <p><input type="radio"/> YES</p> <p><input checked="" type="radio"/> NO</p>	1	JOB	\$4,800	\$4,800

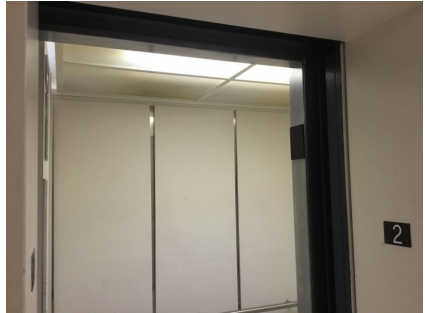
Item no., Rm no. and Name	Existing Architectural Barrier and Proposed Solution	Codes / Mitigation Info	Qty	Unit	Cost	Total
10796	<ul style="list-style-type: none"> As-Built Description: Visual hall lantern, minimum 2-1/2" x 2-1/2", not provided, or installed less than 72" above floor. Proposed Solution: Provide or raise proper visual hall lantern for elevator. 	PCODE IK10A ADAAG 91 4.10.4(1) ADA 2010 407.2.2.2 CBC 2007 1116B.1.13 CBC 2016 11B-407.2.2.2 Mitigated: <input type="radio"/> YES <input checked="" type="radio"/> NO	1	JOB	\$4,650	\$4,650

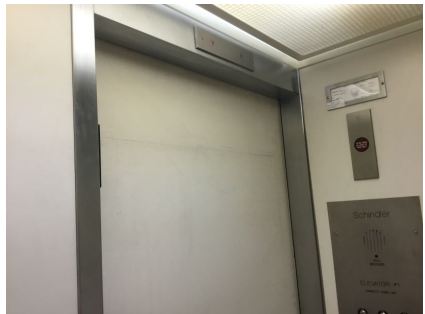
<input type="checkbox"/> Staff Only Priority 2 Severity 3						
10797	<ul style="list-style-type: none"> As-Built Description: Audible signal not provided (one for up, two for down). Proposed Solution: Provide proper audible hall signal for elevator. 	PCODE IK10B ADAAG 91 4.10.4 ADA 2010 407.2.2.3 CBC 2007 1116B.1.13 CBC 2016 11B-407.2.2.3 Mitigated: <input type="radio"/> YES <input checked="" type="radio"/> NO	1	JOB	\$4,650	\$4,650

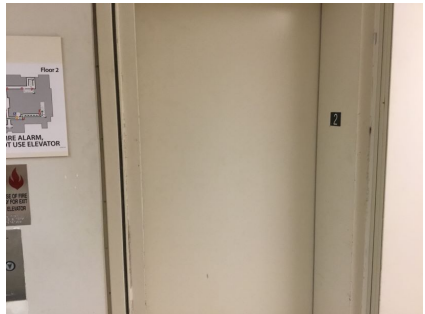
<input type="checkbox"/> Staff Only Priority 2 Severity 3						
10795	<ul style="list-style-type: none"> As-Built Description: Door reopening device does not remain effective for at least 20 seconds. As-Built: Door requires contact to re-open. Proposed Solution: Adjust timing. 	PCODE IK14 ADAAG 91 4.10.6 ADA 2010 407.3.3.3 CBC 2007 1116B.1.5 CBC 2016 11B-407.3.3.3 Mitigated: <input type="radio"/> YES <input checked="" type="radio"/> NO	1	JOB	\$150	\$150

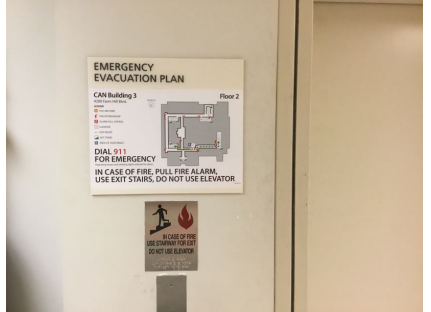
Item no., Rm no. and Name	Existing Architectural Barrier and Proposed Solution	Codes / Mitigation Info	Qty	Unit	Cost	Total
Signage						
10792	<ul style="list-style-type: none"> As-Built Description: At door leading to horizontal exit: Where required exit signs are installed, signs to provide exiting information for people with vision impairment are not provided. Proposed Solution: Provide raised letter/Braille "TO EXIT" sign at door. Notes: <i>There is no sign indicating which means of egress are accessible. The evacuation sign seems to indicate that the elevator is accessible during emergencies however there is a sign instructing people to use stairs in case of emergency.</i> 	PCODE SA10E ADAAG 91 4.1.3(16) ADA 2010 216.4.1 CBC 2007 1011.3 CBC 2016 11B-216.4.1 Mitigated: <input type="radio"/> YES <input checked="" type="radio"/> NO	1	JOB	\$270	\$270

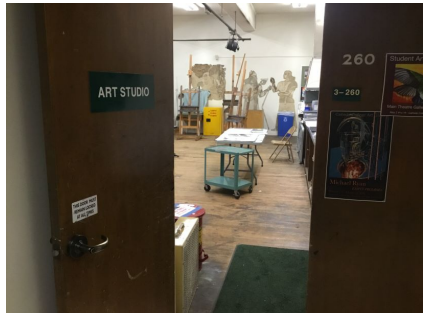
10800	<ul style="list-style-type: none"> • <i>As-Built Description:</i> Pair of doors on accessible route has less than 32" clear opening width with one leaf open 90°. • <i>As-Built:</i> 28" wide • <i>Proposed Solution:</i> Provide new door leaves, unequal in width, to existing frame for pair of doors. 	PCODE ID08A ADAAG 91 4.13.4 ADA 2010 404.2.2 CBC 2007 1133B.2.3.1 CBC 2016 11B-404.2.2 Mitigated: <input type="radio"/> YES <input checked="" type="radio"/> NO	1	JOB	\$4,500	\$4,500

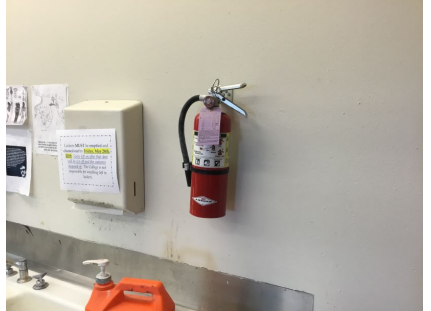
Item no., Rm no. and Name	Existing Architectural Barrier and Proposed Solution	Codes / Mitigation Info	Qty	Unit	Cost	Total
Reach Range						
10803	<ul style="list-style-type: none"> As-Built Description: Reach height to control or access point, where side approach is available, exceeds 48" or is less than 15" in height, or exceeds 10" in depth. As-Built: 65" AFF Proposed Solution: Modify equipment or mounting. 	PCODE IE02 ADAAG 91 4.2.6 ADA 2010 308.3.1 CBC 2007 1118B.6 CBC 2016 11B-308.3 Mitigated: <input type="radio"/> YES <input checked="" type="radio"/> NO	1	JOB	\$300	\$300

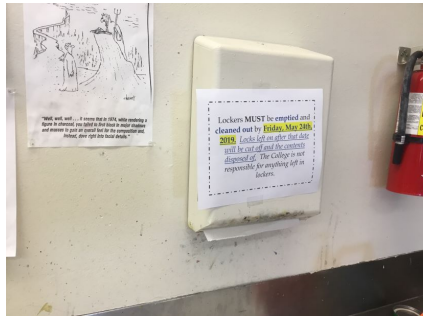
<input type="checkbox"/> Staff Only			
			Priority 2 Severity 2			
10805	<ul style="list-style-type: none"> As-Built Description: Reach height to control or access point, where side approach is available, exceeds 48" or is less than 15" in height, or exceeds 10" in depth. As-Built: 21" deep 50" AFF Proposed Solution: Modify equipment or mounting. 	PCODE IE02 ADAAG 91 4.2.6 ADA 2010 308.3.1 CBC 2007 1118B.6 CBC 2016 11B-308.3 Mitigated: <input type="radio"/> YES <input checked="" type="radio"/> NO	1	JOB	\$300	\$300

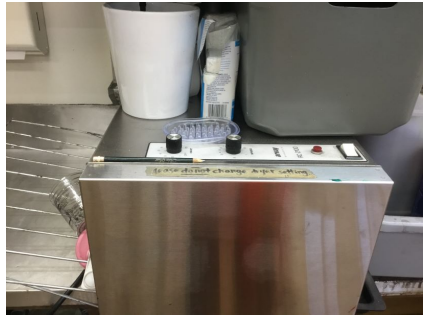
<input type="checkbox"/> Staff Only			
			Priority 2 Severity 4			
10806	<ul style="list-style-type: none"> As-Built Description: Reach height to control or access point, where side approach is available, exceeds 48" or is less than 15" in height, or exceeds 10" in depth. As-Built: 49" AFF Proposed Solution: Modify equipment or mounting. 	PCODE IE02 ADAAG 91 4.2.6 ADA 2010 308.3.1 CBC 2007 1118B.6 CBC 2016 11B-308.3 Mitigated: <input type="radio"/> YES <input checked="" type="radio"/> NO	1	JOB	\$300	\$300

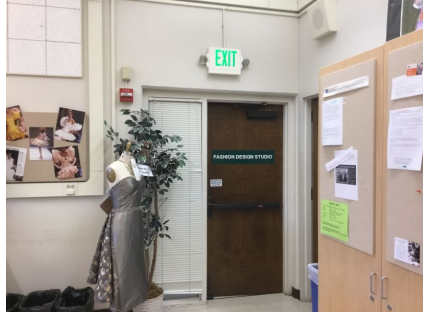
Item no., Rm no. and Name	Existing Architectural Barrier and Proposed Solution	Codes / Mitigation Info	Qty	Unit	Cost	Total
Signage						
10810	<ul style="list-style-type: none"> • <i>As-Built Description:</i> At door leading into exit corridor: Where required exit signs are installed, signs to provide exiting information for people with vision impairment are not provided. • <i>Proposed Solution:</i> Provide raised letter/Braille "EXIT ROUTE" sign at door. 	PCODE SA10D ADAAG 91 4.1.3(16) ADA 2010 216.4.1 CBC 2007 1011.3 CBC 2016 11B-216.4.1 Mitigated: <input type="radio"/> YES <input checked="" type="radio"/> NO	2	JOB	\$270	\$540

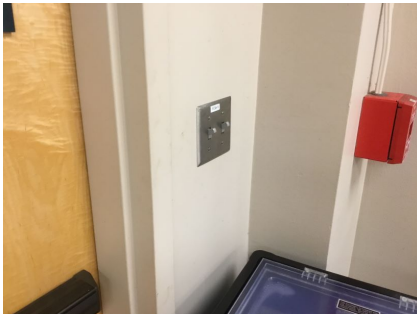
Item no., Rm no. and Name	Existing Architectural Barrier and Proposed Solution	Codes / Mitigation Info	Qty	Unit	Cost	Total
<u>Electrical</u>						
11037	<ul style="list-style-type: none">• <i>As-Built Description:</i> Electric switch or control mounted less than 15" measured to the bottom of the outlet box or greater than 48 inches measured to the top of the outlet box.• <i>As-Built:</i> 50" to the top of the switch 51.5" to the top of the box• <i>Proposed Solution:</i> Relocate light switches or control to between 15" and 48" height.	<p>PCODE IC01</p> <p>ADAAG 91 4.2.5 & 6</p> <p>ADA 2010 308.2.1 & 308.2.2</p> <p>CBC 2007 1117B.6.3</p> <p>CBC 2016 11B-308.2.1 & 11B-308.2.2</p> <p>Mitigated:</p> <p><input type="radio"/> YES</p> <p><input checked="" type="radio"/> NO</p>	30	JOB	\$900	\$27,000

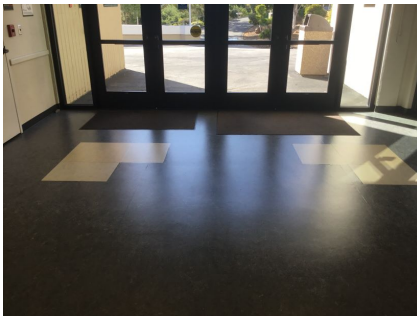
11113	<ul style="list-style-type: none">• <i>As-Built Description:</i> Doormat not securely attached to ground or floor structure.• <i>Proposed Solution:</i> Attach doormat to floor surface or remove doormat.	<p>PCODE ID05A</p> <p>ADAAG 91 4.5.3</p> <p>ADA 2010 302.2</p> <p>CBC 2007 1124B.3</p> <p>CBC 2016 11B-302.2</p> <p>Mitigated:</p> <p><input type="radio"/> YES</p> <p><input checked="" type="radio"/> NO</p>	11	JOB	\$225	\$2,475

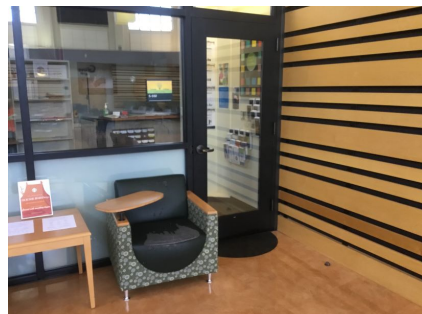
<input type="checkbox"/> Staff Only			
			Priority		Severity	
			2		2	
<u>Door Swing</u>						
11036	<ul style="list-style-type: none">• <i>As-Built Description:</i> Front approach: At pull side, door does not have clear and level maneuvering space measuring door width plus 18" x 60". (24" x 60" at exterior doors).• <i>Proposed Solution:</i> Remove or relocate furniture or storage items.	PCODE ID23A ADAAG 91 Fig. 25(a) ADA 2010 404.2.4 CBC 2007 11B-26A(a) CBC 2016 11B-404.2.4 Mitigated: <input type="radio"/> YES <input checked="" type="radio"/> NO	10	JOB	\$150	\$1,500

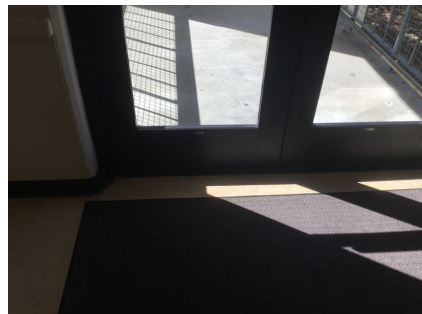
Item no., Rm no. and Name	Existing Architectural Barrier and Proposed Solution	Codes / Mitigation Info	Qty	Unit	Cost	Total
<u>Door Threshold</u>						
11056	<ul style="list-style-type: none">As-Built Description: Door inaccessible due to threshold or step at door exceeding 1/2".As-Built: 1" highProposed Solution: Modify threshold.	PCODE ID02A ADAAG 91 4.13.8 ADA 2010 404.2.5 CBC 2007 1133B.2.4.1 CBC 2016 11B-404.2.5 Mitigated: <input type="radio"/> YES <input checked="" type="radio"/> NO	4	JOB	\$1,200	\$4,800

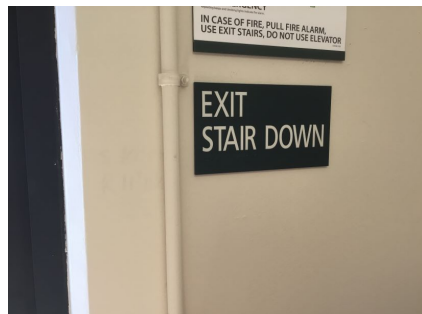
<input type="checkbox"/> Staff Only			
			Priority		Severity	
			2		4	
<u>Signage</u>						
11058	<ul style="list-style-type: none">As-Built Description: Signs containing tactile characters is not located so that a clear floor space of 18" min x 18" min., centered on the tactile characters, is provided beyond the arc of any door swing between the closed position and 45 degree open position.As-Built: 61" to the bottom of the highest tactile characterProposed Solution: Relocate compliant signage on latch side of door located at compliant height with a clear floor space.Notes: Tactile should be 60" high maximum to the bottom of the highest tactile character.	PCODE SA07B ADA 2010 703.4.2 CBC 2016 11B-703.4.2 Mitigated: <input type="radio"/> YES <input checked="" type="radio"/> NO	1	JOB	\$150	\$150

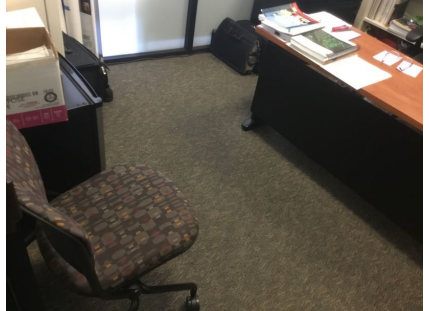
Item no., Rm no. and Name	Existing Architectural Barrier and Proposed Solution	Codes / Mitigation Info	Qty	Unit	Cost	Total
Disabled Seating						
11035	<ul style="list-style-type: none"> As-Built Description: Wheelchair space (33"x48") not provided at fixed seating with forward or rear approach. (NOTE: Space must be adjacent to regular seating; can provide easily removable fixed seat). Proposed Solution: Remove seating and provide wheelchair space plus necessary maneuvering clearance. 	PCODE GB01A ADAAG 91 4.1.3(19)(a) ADA 2010 221.2 CBC 2007 1104B.3.6 CBC 2016 11B-221.2 Mitigated: <input type="radio"/> YES <input checked="" type="radio"/> NO	1	JOB	\$1,350	\$1,350

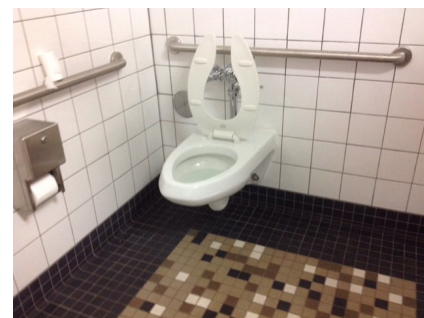
Item no., Rm no. and Name	Existing Architectural Barrier and Proposed Solution	Codes / Mitigation Info	Qty	Unit	Cost	Total
702	<ul style="list-style-type: none"> • <i>As-Built Description:</i> Flush Control: Operating handle mounted more than 44" above floor. • <i>As-Built:</i> 46" • <i>Proposed Solution:</i> Replace flush control with properly mounted accessible type, or install sensor flush. 	PCODE WB10A ADAAG 91 4.16.5 ADA 2010 604.6 CBC 2007 1115B.4.1.5 CBC 2016 11B-604.6 Mitigated: <input type="radio"/> YES <input checked="" type="radio"/> NO	1	JOB	\$1,500	\$1,500

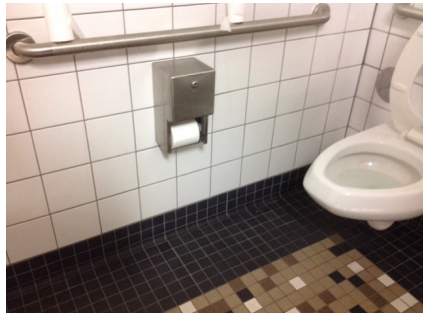
704	<ul style="list-style-type: none"> • <i>As-Built Description:</i> Toilet paper dispenser less than 15" (CA: 19") or more than 48" above floor or not within 7" to 9" from front of water closet (Note: CA pre-2010 is allowed within 12" from front of water closet). • <i>As-Built:</i> 12" o.c. • <i>Proposed Solution:</i> Relocate or provide new toilet paper dispenser. 	PCODE WG02 ADAAG 91 4.16.6 ADA 2010 604.7 CBC 2007 1115B.8.4 Mitigated: <input type="radio"/> YES <input checked="" type="radio"/> NO	1	JOB	\$225	\$225

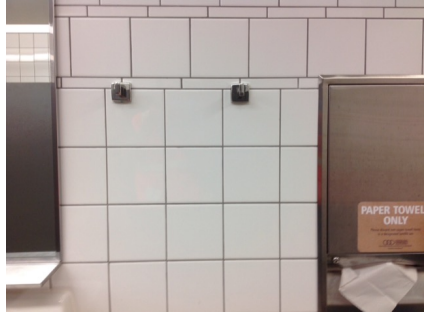
Item no., Rm no. and Name	Existing Architectural Barrier and Proposed Solution	Codes / Mitigation Info	Qty	Unit	Cost	Total
Coat Hook						
709	<ul style="list-style-type: none"> As-Built Description: Accessible coat hook not within reach range. As-Built: 60" high Proposed Solution: Adjust existing or provide new coat hook at maximum 48" height. 	PCODE WG03A ADAAG 91 4.2.5 ADA 2010 603.4 CBC 2007 1118B.5 CBC 2016 11B-603.4 Mitigated: <input type="radio"/> YES <input checked="" type="radio"/> NO	1	JOB	\$150	\$150

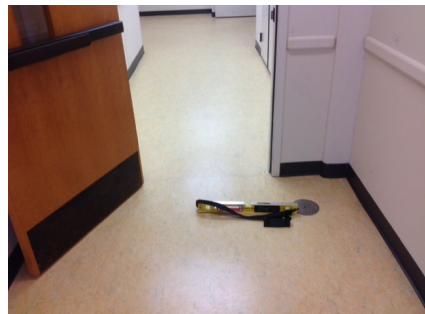
Item no., Rm no. and Name	Existing Architectural Barrier and Proposed Solution	Codes / Mitigation Info	Qty	Unit	Cost	Total
Door Swing						
659	<ul style="list-style-type: none">As-Built Description: Front approach: At pull side, door does not have clear and level maneuvering space measuring door width plus 18" x 60". (24" x 60" at exterior doors).As-Built: 3.8% cross slopeProposed Solution: Provide power door operator.	<p>PCODE ID23C</p> <p>ADAAG 91 Fig. 25(a)</p> <p>ADA 2010 404.2.4</p> <p>CBC 2007 11B-26A(a)</p> <p>CBC 2016 11B-404.2.4</p> <p>Mitigated:</p> <p><input type="radio"/> YES</p> <p><input checked="" type="radio"/> NO</p>	1	JOB	\$15,000	\$15,000

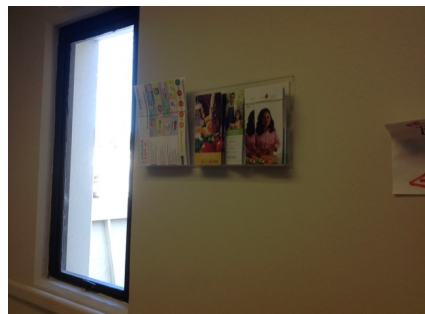
<input type="checkbox"/> Staff Only			
			Priority	Severity		
			1	4		
Brochure Bins						
660	<ul style="list-style-type: none">As-Built Description: Information brochure bins mounted above accessible height of 48".As-Built: 65" highProposed Solution: Relocate/remount bins at accessible height.	<p>PCODE IN08</p> <p>ADAAG 91 4.2.5 & 6</p> <p>ADA 2010 308.2.1</p> <p>CBC 2007 1118B.5</p> <p>CBC 2016 11B-308.2.1</p> <p>Mitigated:</p> <p><input type="radio"/> YES</p> <p><input checked="" type="radio"/> NO</p>	1	JOB	\$300	\$300

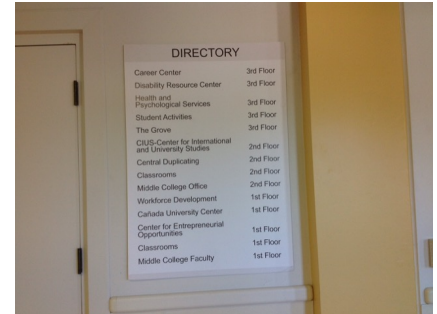
• **Notes:****No restroom on directory.****Mitigated:**☐ YES☒ NO

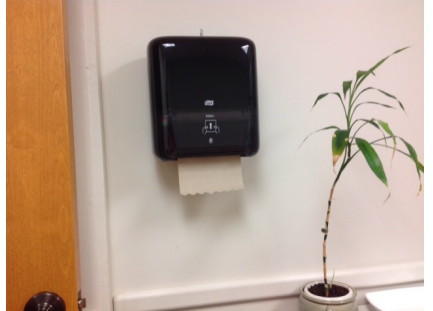
Item no., Rm no. and Name	Existing Architectural Barrier and Proposed Solution	Codes / Mitigation Info	Qty	Unit	Cost	Total
Reach Range						
664	<ul style="list-style-type: none"> As-Built Description: Reach height to control or access point, exceeds 48" or is less than 15". As-Built: 54" high Proposed Solution: Modify equipment or mounting. Notes: Break Room 	PCODE IE01 ADAAG 91 4.2.5 ADA 2010 308.2.1 CBC 2007 1118B.5 CBC 2016 11B-308.2.1 Mitigated: <input type="radio"/> YES <input checked="" type="radio"/> NO	1	JOB	\$300	\$300

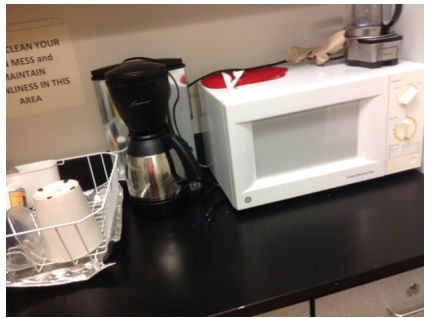
<input type="checkbox"/> Staff Only			
			Priority 2 Severity 3			
666	<ul style="list-style-type: none"> As-Built Description: Reach height to control or access point, exceeds 48" or is less than 15". As-Built: 26" deep to outlet Proposed Solution: Modify equipment or mounting. Notes: Break Room 	PCODE IE01 ADAAG 91 4.2.5 ADA 2010 308.2.1 CBC 2007 1118B.5 CBC 2016 11B-308.2.1 Mitigated: <input type="radio"/> YES <input checked="" type="radio"/> NO	1	JOB	\$300	\$300

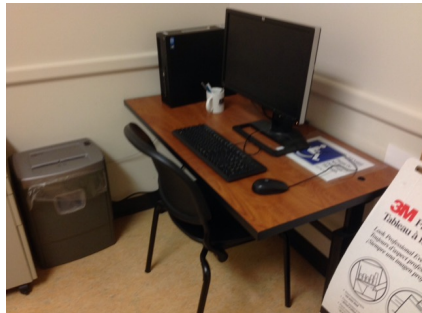
Item no., Rm no. and Name	Existing Architectural Barrier and Proposed Solution	Codes / Mitigation Info	Qty	Unit	Cost	Total
Non-Fixed Desk						
667	<ul style="list-style-type: none"> • <i>As-Built Description:</i> Accessible non-fixed table or desk (top 28" to 34" high; knee space at least 27" high x 19" deep x 30" wide) not provided. • <i>As-Built:</i> 25" knee height • <i>Proposed Solution:</i> Provide table or desk with accessible dimensions when purchasing new furniture. • <i>Notes:</i> Break Room 	PCODE IN02A ADAAG 91 4.32.3 & .4 ADA 2010 306.1 CBC 2007 1122B.3 & 4 CBC 2016 11B-306.1 & 11B-902.3 Mitigated: <input type="radio"/> YES <input checked="" type="radio"/> NO	1	JOB	\$4,800	\$4,800

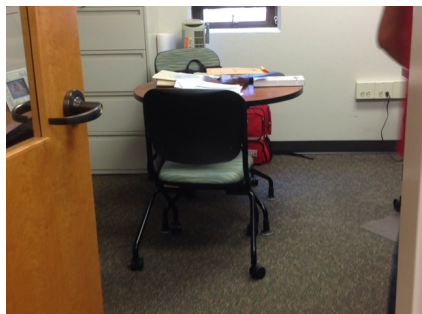
<input type="checkbox"/> Staff Only			
			Priority		Severity	
			2		2	
668	<ul style="list-style-type: none"> • <i>As-Built Description:</i> Accessible non-fixed table or desk (top 28" to 34" high; knee space at least 27" high x 19" deep x 30" wide) not provided. • <i>Proposed Solution:</i> Provide table or desk with accessible dimensions when purchasing new furniture. 	PCODE IN02A ADAAG 91 4.32.3 & .4 ADA 2010 306.1 CBC 2007 1122B.3 & 4 CBC 2016 11B-306.1 & 11B-902.3 Mitigated: <input type="radio"/> YES <input checked="" type="radio"/> NO	1	JOB	\$4,800	\$4,800

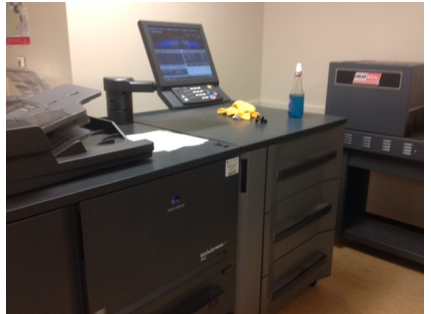
Item no., Rm no. and Name	Existing Architectural Barrier and Proposed Solution	Codes / Mitigation Info	Qty	Unit	Cost	Total
671	<ul style="list-style-type: none">• <i>As-Built Description:</i> Reach height to control or access point, exceeds 48" or is less than 15".• <i>As-Built:</i> 60" high to equipment• <i>Proposed Solution:</i> Modify equipment or mounting.• <i>Notes:</i> Faculty area	<i>PCODE</i> IE01 <i>ADAAG 91</i> 4.2.5 <i>ADA 2010</i> 308.2.1 <i>CBC 2007</i> 1118B.5 <i>CBC 2016</i> 11B-308.2.1 Mitigated: <input type="radio"/> YES <input checked="" type="radio"/> NO	1	JOB	\$300	\$300

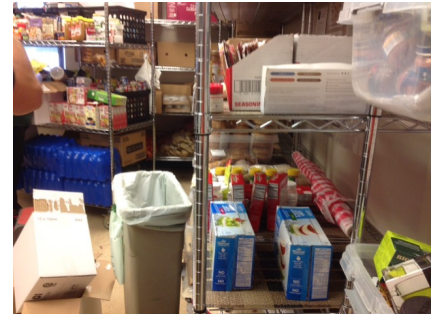
• **Notes:****Pantry is self service but employee on duty during open hours to assist.****Mitigated:**☐ YES☒ NO

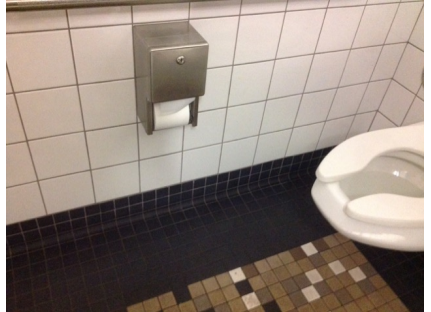
Item no., Rm no. and Name	Existing Architectural Barrier and Proposed Solution	Codes / Mitigation Info	Qty	Unit	Cost	Total
<u>Accessories</u>						
688	<ul style="list-style-type: none"> • <i>As-Built Description:</i> Toilet paper dispenser less than 15" (CA: 19") or more than 48" above floor or not within 7" to 9" from front of water closet (Note: CA pre-2010 is allowed within 12" from front of water closet). • <i>As-Built:</i> 12" o.c. • <i>Proposed Solution:</i> Relocate or provide new toilet paper dispenser. 	PCODE WG02 ADAAG 91 4.16.6 ADA 2010 604.7 CBC 2007 1115B.8.4 CBC 2016 11B-604.7 Mitigated: <input type="radio"/> YES <input checked="" type="radio"/> NO	1	JOB	\$225	\$225

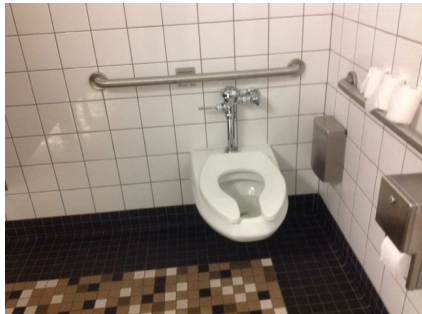
Item no., Rm no. and Name	Existing Architectural Barrier and Proposed Solution	Codes / Mitigation Info	Qty	Unit	Cost	Total
<u>Water Closet</u>						
692	<ul style="list-style-type: none">• <i>As-Built Description:</i> Water closet not 16"-18" (CA: 17"-18") from near side wall to center line of water closet (2010 ADAAG: 16"-18").• <i>As-Built:</i> 18.5" o.c.• <i>Proposed Solution:</i> Relocate existing water closet and plumbing, remount with offset closet flange to provide 18" max. from side wall.	<p>PCODE WB02C</p> <p>ADAAG 91 Fig. 28</p> <p>ADA 2010 604.2</p> <p>CBC 2007 1115B.4.1.1</p> <p>CBC 2016 11B-604.2</p> <p>Mitigated:</p> <p><input type="radio"/> YES</p> <p><input checked="" type="radio"/> NO</p>	1	JOB	\$1,500	\$1,500

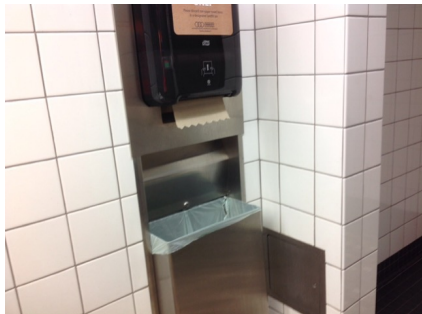
<input type="checkbox"/> Staff Only			
			Priority		Severity	
			3		4	
<u>Accessories</u>						
690	<ul style="list-style-type: none">• <i>As-Built Description:</i> Dispensers in sanitary facilities, such as for towels, soap, sanitary napkins, seat covers, etc., and waste receptacles more than 48" (CA only: 40") from floor to highest operating slot or control.• <i>As-Built:</i> 45" high• <i>Proposed Solution:</i> Relocate existing restroom accessories.	<p>PCODE WG01A</p> <p>ADAAG 91 4.23.7</p> <p>ADA 2010 308.2.1</p> <p>CBC 2007 1115B.8.3</p> <p>CBC 2016 11B-603.5</p> <p>Mitigated:</p> <p><input type="radio"/> YES</p> <p><input checked="" type="radio"/> NO</p>	1	JOB	\$300	\$300

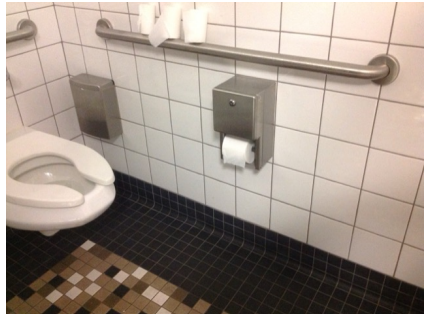
Item no., Rm no. and Name	Existing Architectural Barrier and Proposed Solution	Codes / Mitigation Info	Qty	Unit	Cost	Total
694	<ul style="list-style-type: none"> • <i>As-Built Description:</i> Toilet paper dispenser less than 15" (CA: 19") or more than 48" above floor or not within 7" to 9" from front of water closet (Note: CA pre-2010 is allowed within 12" from front of water closet). • <i>As-Built:</i> 12" o.c. • <i>Proposed Solution:</i> Relocate or provide new toilet paper dispenser. 	PCODE WG02 ADAAG 91 4.16.6 ADA 2010 604.7 CBC 2007 1115B.8.4 CBC 2016 11B-604.7 Mitigated: <input type="radio"/> YES <input checked="" type="radio"/> NO	1	JOB	\$225	\$225

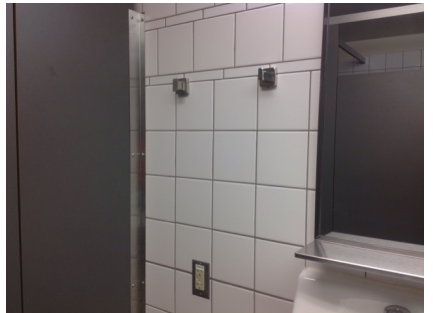
691	<ul style="list-style-type: none"> • <i>As-Built Description:</i> Accessible coat hook not within reach range. • <i>As-Built:</i> 65" • <i>Proposed Solution:</i> Adjust existing or provide new coat hook at maximum 48" height. 	PCODE WG03A ADAAG 91 4.2.5 ADA 2010 603.4 CBC 2007 1118B.5 CBC 2016 11B-603.4 Mitigated: <input type="radio"/> YES <input checked="" type="radio"/> NO	1	JOB	\$150	\$150

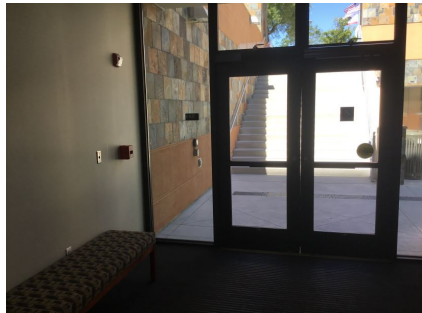
Item no., Rm no. and Name	Existing Architectural Barrier and Proposed Solution	Codes / Mitigation Info	Qty	Unit	Cost	Total
Signage						
11020	<ul style="list-style-type: none"> As-Built Description: Sign not located on latch side of door and/or not located at 48" min. above to baseline of the lowest Braille cells and 60" max. to baseline of the highest line of raised characters. Proposed Solution: Provide compliant signage including tactile characters and Grade II Braille on latch side of door located at compliant height. 	PCODE SA07 ADAAG 91 4.30.6 ADA 2010 703.4.1 CBC 2007 1117B.5.7 CBC 2016 11B-703.4.1 Mitigated: <input type="radio"/> YES <input checked="" type="radio"/> NO	1	JOB	\$150	\$150

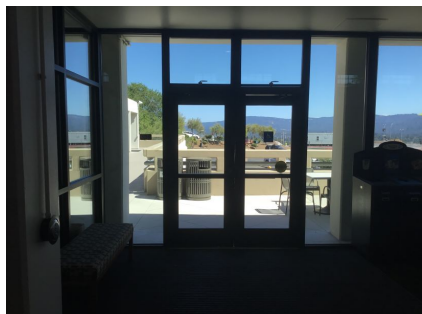
<input type="checkbox"/> Staff Only			
			Priority 2 Severity 3			
11025	<ul style="list-style-type: none"> As-Built Description: Sign not located on latch side of door and/or not located at 48" min. above to baseline of the lowest Braille cells and 60" max. to baseline of the highest line of raised characters. Proposed Solution: Provide compliant signage including tactile characters and Grade II Braille on latch side of door located at compliant height. 	PCODE SA07 ADAAG 91 4.30.6 ADA 2010 703.4.1 CBC 2007 1117B.5.7 CBC 2016 11B-703.4.1 Mitigated: <input type="radio"/> YES <input checked="" type="radio"/> NO	1	JOB	\$150	\$150

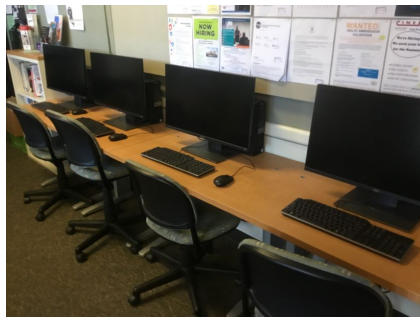
Item no., Rm no. and Name	Existing Architectural Barrier and Proposed Solution	Codes / Mitigation Info	Qty	Unit	Cost	Total
Non-Fixed Desk						
11031	<ul style="list-style-type: none"> • <i>As-Built Description:</i> Accessible non-fixed table or desk (top 28" to 34" high; knee space at least 27" high x 19" deep x 30" wide) not provided. • <i>As-Built:</i> 28" wide and 16.5" deep • <i>Proposed Solution:</i> Provide table or desk with accessible dimensions when purchasing new furniture. 	PCODE IN02A ADAAG 91 4.32.3 & .4 ADA 2010 306.1 CBC 2007 1122B.3 & 4 CBC 2016 11B-306.1 & 11B-902.3 Mitigated: <input type="radio"/> YES <input checked="" type="radio"/> NO	1	JOB	\$4,800	\$4,800

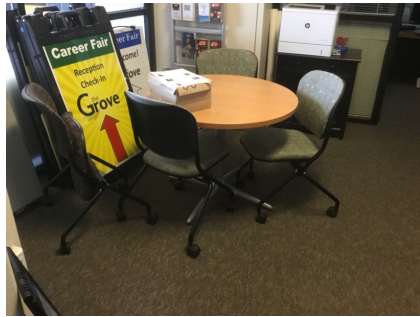
<input type="checkbox"/> Staff Only Priority 2 Severity 2			
11032	<ul style="list-style-type: none"> • <i>As-Built Description:</i> Accessible non-fixed table or desk (top 28" to 34" high; knee space at least 27" high x 19" deep x 30" wide) not provided. • <i>Proposed Solution:</i> Provide table or desk with accessible dimensions when purchasing new furniture. 	PCODE IN02A ADAAG 91 4.32.3 & .4 ADA 2010 306.1 CBC 2007 1122B.3 & 4 CBC 2016 11B-306.1 & 11B-902.3 Mitigated: <input type="radio"/> YES <input checked="" type="radio"/> NO	1	JOB	\$4,800	\$4,800

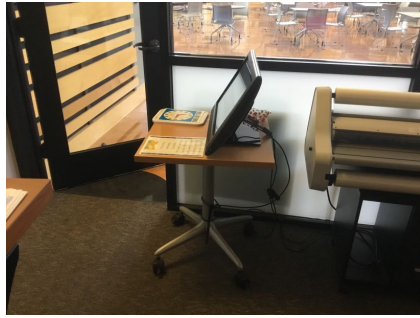
<input type="checkbox"/> Staff Only Priority 2 Severity 2			
11033	<ul style="list-style-type: none"> • <i>As-Built Description:</i> Accessible non-fixed table or desk (top 28" to 34" high; knee space at least 27" high x 19" deep x 30" wide) not provided. • <i>Proposed Solution:</i> Provide table or desk with accessible dimensions when purchasing new furniture. 	PCODE IN02A ADAAG 91 4.32.3 & .4 ADA 2010 306.1 CBC 2007 1122B.3 & 4 CBC 2016 11B-306.1 & 11B-902.3 Mitigated: <input type="radio"/> YES <input checked="" type="radio"/> NO	1	JOB	\$4,800	\$4,800

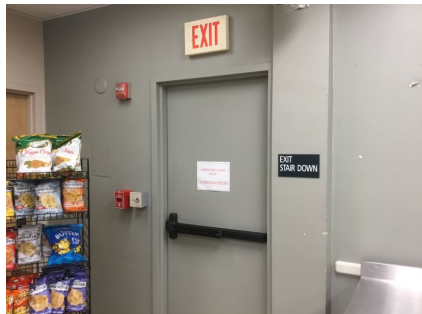
Signage						
11041	<ul style="list-style-type: none"> As-Built Description: Sign not located on latch side of door and/or not located at 48" min. above to baseline of the lowest Braille cells and 60" max. to baseline of the highest line of raised characters. As-Built: 60.5" to the bottom of the highest tactile character Proposed Solution: Provide compliant signage including tactile characters and Grade II Braille on latch side of door located at compliant height. 	PCODE SA07 ADAAG 91 4.30.6 ADA 2010 703.4.1 CBC 2007 1117B.5.7 CBC 2016 11B-703.4.1	1	JOB	\$150	\$150

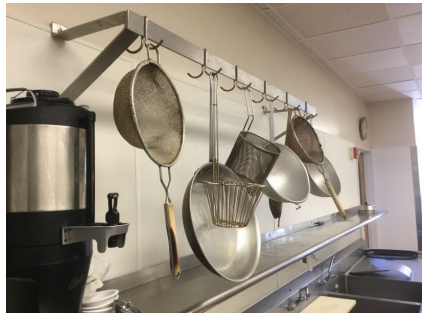
Item no., Rm no. and Name	Existing Architectural Barrier and Proposed Solution	Codes / Mitigation Info	Qty	Unit	Cost	Total
Reach Range						
11047	<ul style="list-style-type: none"> As-Built Description: Reach height to control or access point, where side approach is available, exceeds 48" or is less than 15" in height, or exceeds 10" in depth. As-Built: Pots and pans storage 84" AFF Proposed Solution: Modify equipment or mounting. Notes: Staff only 	PCODE IE02 ADAAG 91 4.2.6 ADA 2010 308.3.1 CBC 2007 1118B.6 CBC 2016 11B-308.3 Mitigated: <input type="radio"/> YES <input checked="" type="radio"/> NO	1	JOB	\$300	\$300

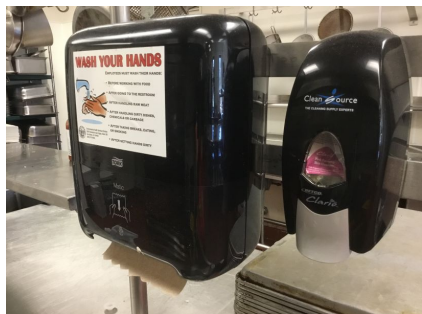
<input checked="" type="checkbox"/> Staff Only Priority Severity <input checked="" type="radio"/> 4 <input checked="" type="radio"/> 1			
11049	<ul style="list-style-type: none"> As-Built Description: Reach height to control or access point, where side approach is available, exceeds 48" or is less than 15" in height, or exceeds 10" in depth. As-Built: 22" deep 52" to 54" AFF Proposed Solution: Modify equipment or mounting. 	PCODE IE02 ADAAG 91 4.2.6 ADA 2010 308.3.1 CBC 2007 1118B.6 CBC 2016 11B-308.3 Mitigated: <input type="radio"/> YES <input checked="" type="radio"/> NO	1	JOB	\$300	\$300

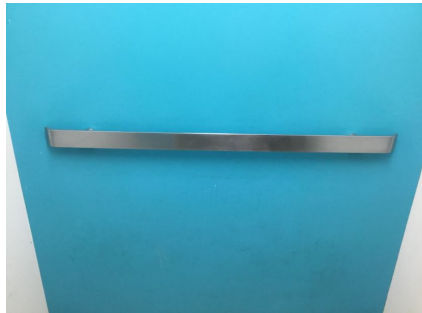
Item no., Rm no. and Name	Existing Architectural Barrier and Proposed Solution	Codes / Mitigation Info	Qty	Unit	Cost	Total
Elevator						
11054	<ul style="list-style-type: none"> • <i>As-Built Description:</i> Handrail not mounted with top 32", plus or minus one inch, above the floor of car. (CA Only) • <i>As-Built:</i> 39.3" high • <i>Proposed Solution:</i> Remount handrail at 32" above floor. 	PCODE IK08A CBC 2007 1116B.1.11 CBC 2016 11B-407.4.10 Mitigated: <input type="radio"/> YES <input checked="" type="radio"/> NO	1	JOB	\$1,080	\$1,080

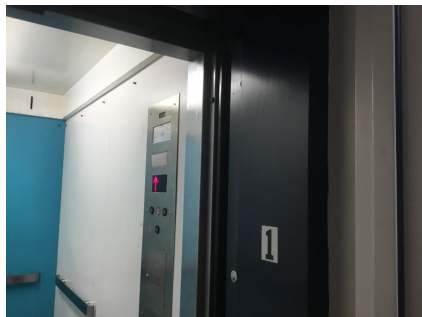
<input type="checkbox"/> Staff Only Priority 4 Severity 2			
11051	<ul style="list-style-type: none"> • <i>As-Built Description:</i> Visual hall lantern, minimum 2-1/2" x 2-1/2", not provided, or installed less than 72" above floor. • <i>Proposed Solution:</i> Provide or raise proper visual hall lantern for elevator. 	PCODE IK10A ADAAG 91 4.10.4(1) ADA 2010 407.2.2.2 CBC 2007 1116B.1.13 CBC 2016 11B-407.2.2.2 Mitigated: <input type="radio"/> YES <input checked="" type="radio"/> NO	1	JOB	\$4,650	\$4,650

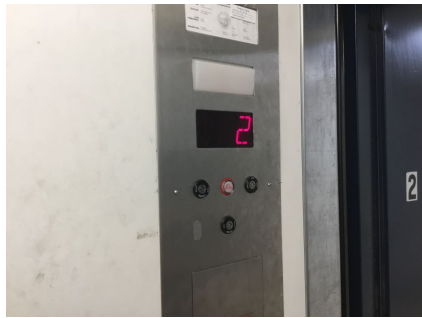
<input type="checkbox"/> Staff Only Priority 4 Severity 3			
11053	<ul style="list-style-type: none"> • <i>As-Built Description:</i> Audible signal not provided (one for up, two for down). • <i>Proposed Solution:</i> Provide proper audible hall signal for elevator. 	PCODE IK10B ADAAG 91 4.10.4 ADA 2010 407.2.2.3 CBC 2007 1116B.1.13 CBC 2016 11B-407.2.2.3 Mitigated: <input type="radio"/> YES <input checked="" type="radio"/> NO	1	JOB	\$4,650	\$4,650

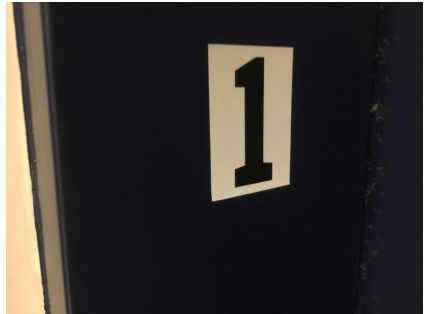
Item no., Rm no. and Name	Existing Architectural Barrier and Proposed Solution	Codes / Mitigation Info	Qty	Unit	Cost	Total
11052	<ul style="list-style-type: none"> As-Built Description: Braille and raised floor numbers on entrance jambs located more or less than 5' above floor. Proposed Solution: Relocate Braille and raised floor numbers on entrance jambs to 5' above floor. Notes: Not Braille and tactile 	PCODE IK11C ADAAG 91 4.10.5 ADA 2010 703.4.1 CBC 2007 1116B.1.14 CBC 2016 11B-703.4.1 Mitigated: <input type="radio"/> YES <input checked="" type="radio"/> NO	6	JOB	\$360	\$2,160

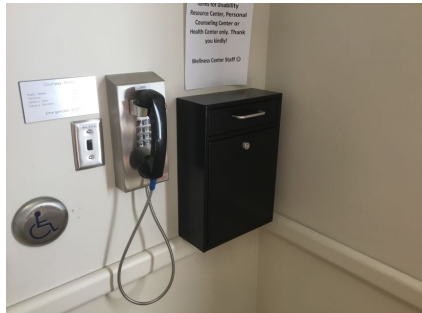
Item no., Rm no. and Name	Existing Architectural Barrier and Proposed Solution	Codes / Mitigation Info	Qty	Unit	Cost	Total
Reach Range						
11061	<ul style="list-style-type: none"> As-Built Description: Reach height to control or access point, where side approach is available, exceeds 48" or is less than 15" in height, or exceeds 10" in depth. As-Built: 50" high Proposed Solution: Modify equipment or mounting. 	PCODE IE02 ADAAG 91 4.2.6 ADA 2010 308.3.1 CBC 2007 1118B.6 CBC 2016 11B-308.3 Mitigated: <input type="radio"/> YES <input checked="" type="radio"/> NO	1	JOB	\$300	\$300

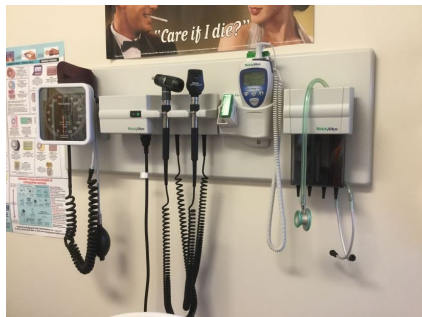
<input type="checkbox"/> Staff Only Priority 2 Severity 4			
11068	<ul style="list-style-type: none"> As-Built Description: Reach height to control or access point, where side approach is available, exceeds 48" or is less than 15" in height, or exceeds 10" in depth. As-Built: 62" AFF Proposed Solution: Modify equipment or mounting. Notes: Staff only 	PCODE IE02 ADAAG 91 4.2.6 ADA 2010 308.3.1 CBC 2007 1118B.6 CBC 2016 11B-308.3 Mitigated: <input type="radio"/> YES <input checked="" type="radio"/> NO	1	JOB	\$300	\$300

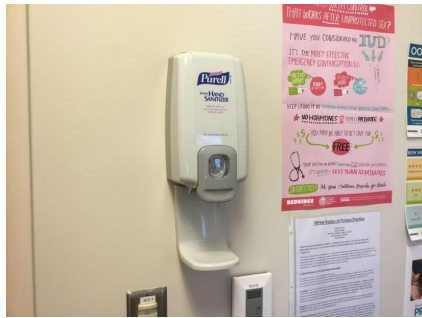
<input checked="" type="checkbox"/> Staff Only Priority 2 Severity 2			
11069	<ul style="list-style-type: none"> As-Built Description: Reach height to control or access point, where side approach is available, exceeds 48" or is less than 15" in height, or exceeds 10" in depth. As-Built: 57" high Proposed Solution: Modify equipment or mounting. 	PCODE IE02 ADAAG 91 4.2.6 ADA 2010 308.3.1 CBC 2007 1118B.6 CBC 2016 11B-308.3 Mitigated: <input type="radio"/> YES <input checked="" type="radio"/> NO	4	JOB	\$300	\$1,200

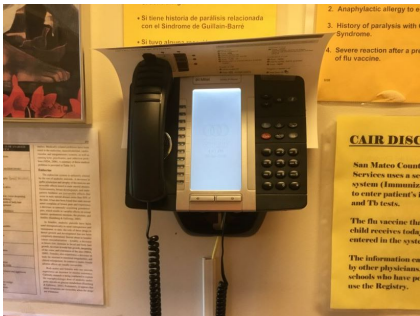
Item no., Rm no. and Name	Existing Architectural Barrier and Proposed Solution	Codes / Mitigation Info	Qty	Unit	Cost	Total
11071	<ul style="list-style-type: none">As-Built Description: Reach height to control or access point, where side approach is available, exceeds 48" or is less than 15" in height, or exceeds 10" in depth.As-Built: 58" highProposed Solution: Modify equipment or mounting.	PCODE IE02 ADAAG 91 4.2.6 ADA 2010 308.3.1 CBC 2007 1118B.6 CBC 2016 11B-308.3 Mitigated: <div><input type="radio"/> YES</div> <div><input checked="" type="radio"/> NO</div>	1	JOB	\$300	\$300

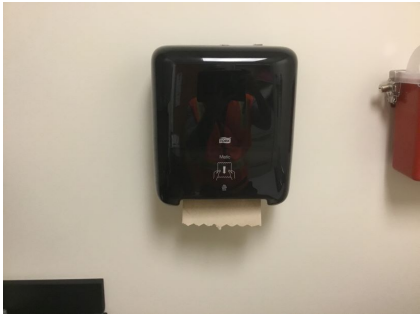
<input type="checkbox"/> Staff Only			
			Priority	Severity		
			<div>2</div>	<div>3</div>		
11076	<ul style="list-style-type: none">As-Built Description: Reach height to control or access point, where side approach is available, exceeds 48" or is less than 15" in height, or exceeds 10" in depth.As-Built: 50" AFFProposed Solution: Modify equipment or mounting.	PCODE IE02 ADAAG 91 4.2.6 ADA 2010 308.3.1 CBC 2007 1118B.6 CBC 2016 11B-308.3 Mitigated: <div><input type="radio"/> YES</div> <div><input checked="" type="radio"/> NO</div>	1	JOB	\$300	\$300

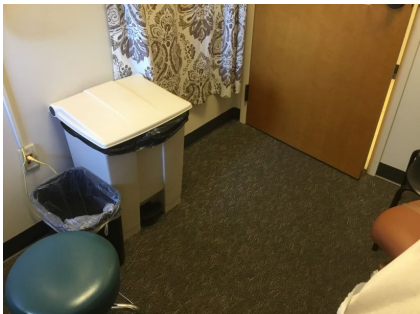
<input type="checkbox"/> Staff Only			
			Priority	Severity		
			<div>2</div>	<div>4</div>		
Turning Space						
11065	<ul style="list-style-type: none">As-Built Description: The area does not provide a minimum 60" diameter turning space within to allow maneuvering through the space.Proposed Solution: Modify area to provide sufficient maneuvering space.Notes: A trash can obstructs the turning space in exam room one.	PCODE IH05 ADA 2010 304.3 CBC 2016 11B-304.3 Mitigated: <div><input type="radio"/> YES</div> <div><input checked="" type="radio"/> NO</div>	1	JOB	\$1,500	\$1,500

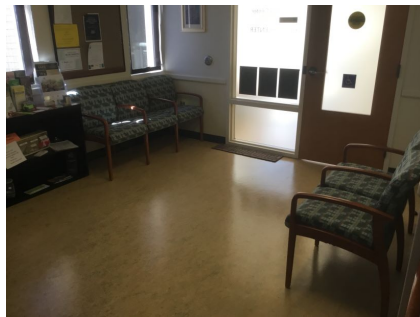
Item no., Rm no. and Name	Existing Architectural Barrier and Proposed Solution	Codes / Mitigation Info	Qty	Unit	Cost	Total
Disabled Seating						
11062	<ul style="list-style-type: none"> As-Built Description: Wheelchair space (33"x48") not provided at fixed seating with forward or rear approach. (NOTE: Space must be adjacent to regular seating; can provide easily removable fixed seat). Proposed Solution: Remove fixed seating and provide wheelchair space plus necessary maneuvering clearance. 	PCODE GB01A ADAAG 91 4.1.3(19)(a) ADA 2010 221.2 CBC 2007 1104B.3.6 CBC 2016 11B-221.2 Mitigated: <input type="radio"/> YES <input checked="" type="radio"/> NO	1	JOB	\$1,350	\$1,350

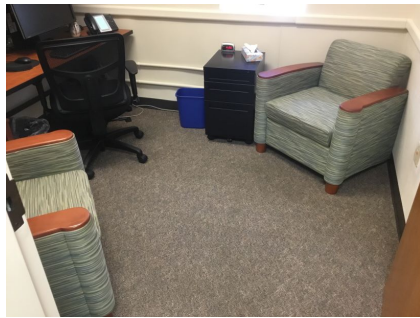
<input type="checkbox"/> Staff Only			
			Priority 2 Severity 3			
11063	<ul style="list-style-type: none"> As-Built Description: Wheelchair space (33"x48") not provided at fixed seating with forward or rear approach. (NOTE: Space must be adjacent to regular seating; can provide easily removable fixed seat). Proposed Solution: Remove fixed seating and provide wheelchair space plus necessary maneuvering clearance. Notes: <i>No wheelchair space in counseling offices. Consider using office is 306 and 307 for people in wheelchairs or people who need more space. The rooms are larger than others.</i> 	PCODE GB01A ADAAG 91 4.1.3(19)(a) ADA 2010 221.2 CBC 2007 1104B.3.6 CBC 2016 11B-221.2 Mitigated: <input type="radio"/> YES <input checked="" type="radio"/> NO	1	JOB	\$1,350	\$1,350

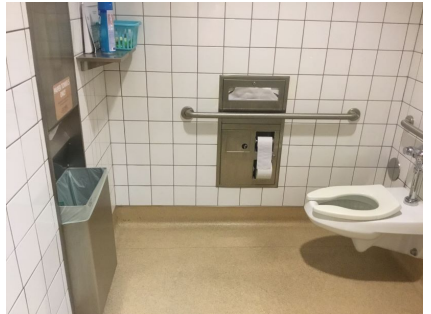
Item no., Rm no. and Name	Existing Architectural Barrier and Proposed Solution	Codes / Mitigation Info	Qty	Unit	Cost	Total
11092	<ul style="list-style-type: none"> As-Built Description: CA only: In single-accommodation restroom less than 48" in front of water closet provided. As-Built: 47" to the tile wall Proposed Solution: Install a shallow water closet. 	PCODE WB03A CBC 2007 1115B.3.2.1 CBC 2016 11B-604.3.1 Mitigated: <input type="radio"/> YES <input checked="" type="radio"/> NO	1	JOB	\$3,000	\$3,000

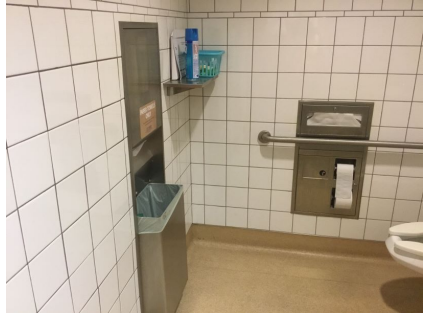
11093	<ul style="list-style-type: none"> As-Built Description: CA only: In single-accommodation restroom less than 48" in front of water closet provided. As-Built: 39" and 43" to the shelf and the wall-mounted trash can Proposed Solution: Remove the shelf and relocate the trash can. Notes: The shelf is a protruding object. 	PCODE WB03A CBC 2007 1115B.3.2.1 CBC 2016 11B-604.3.1 Mitigated: <input type="radio"/> YES <input checked="" type="radio"/> NO	1	JOB	\$15,000	\$15,000

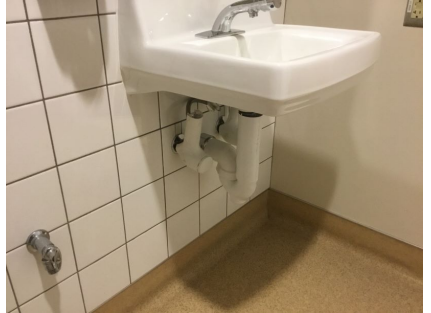
11086	<ul style="list-style-type: none"> As-Built Description: Knee clearance 27" min. high starting 8" back from the front edge of the lavatory towards the wall is not provided. As-Built: Drain pipes 9" from the front of the lavatory at 17" AFF Proposed Solution: Remount compliant fixture to accessible height. 	PCODE WD04A ADAAG 91 Fig. 31 ADA 2010 306.3.3 CBC 2007 1115B.4.3 CBC 2016 11B-306.3.3 Mitigated: <input type="radio"/> YES <input checked="" type="radio"/> NO	1	JOB	\$4,500	\$4,500

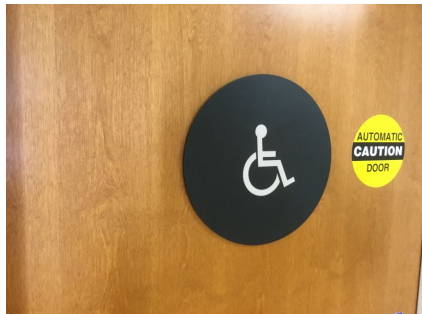
Item no., Rm no. and Name	Existing Architectural Barrier and Proposed Solution	Codes / Mitigation Info	Qty	Unit	Cost	Total
11099	<ul style="list-style-type: none"> As-Built Description: Required in CA only: identification symbol centered 58" to 60" high on sanitary facility door that contrasts with the door not provided (women: 12" ø circle, men: 12" triangle, unisex: combined symbol). As-Built: Edges not eased Proposed Solution: Provide properly mounted sanitary facility symbol when altering area. If wheelchair accessible, include International Symbol of Accessibility on sign. 	PCODE SA15 CBC 2007 1115B.6 CBC 2016 11B-703.7.2.6 Mitigated: <input type="radio"/> YES <input checked="" type="radio"/> NO	1	JOB	\$270	\$270

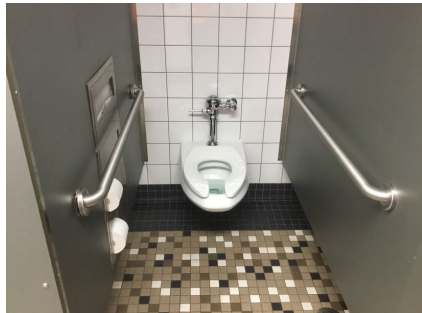
11102	<ul style="list-style-type: none"> As-Built Description: Side grab bar less than 42" long, or located more than 12 inches max. from the rear wall, or extending less than 54" from rear wall (CA only: front end min. 24" in front of water closet). As-Built: Side grab bars extend 52" from the rear wall. Proposed Solution: Provide or relocate accessible side grab bar. 	PCODE WB07A ADAAG 91 Fig. 29(b) ADA 2010 604.5.1 CBC 2007 1115B.4.1.3.1 CBC 2016 11B-604.5.1 Mitigated: <input type="radio"/> YES <input checked="" type="radio"/> NO	2	JOB	\$780	\$1,560

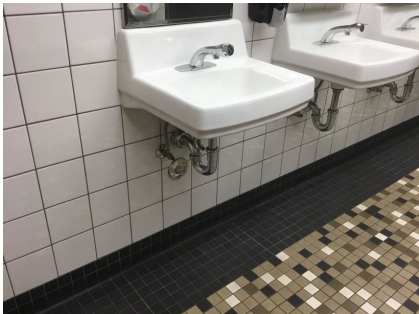
Item no., Rm no. and Name	Existing Architectural Barrier and Proposed Solution	Codes / Mitigation Info	Qty	Unit	Cost	Total
<u>Lavatory</u>						
11109	<ul style="list-style-type: none">• <i>As-Built Description:</i> Hot or sharp-surfaced water/drain pipe not insulated or covered.• <i>Proposed Solution:</i> Insulate or cover water/drain pipe.	PCODE WD05 ADAAG 91 4.19.4 ADA 2010 606.5 CBC 2007 1115B.4.3.4 CBC 2016 11B-606.5 Mitigated: <input type="radio"/> YES <input checked="" type="radio"/> NO	1	JOB	\$360	\$360

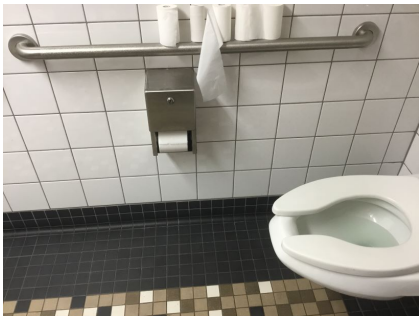
<input type="checkbox"/> Staff Only Priority 3 Severity 3			
<u>Accessories</u>						
11111	<ul style="list-style-type: none">• <i>As-Built Description:</i> Toilet paper dispenser less than 15" (CA: 19") or more than 48" above floor or not within 7" to 9" from front of water closet (Note: CA pre-2010 is allowed within 12" from front of water closet).• <i>As-Built:</i> 11" from the front of the water closet.• <i>Proposed Solution:</i> Relocate or provide new toilet paper dispenser.	PCODE WG02 ADAAG 91 4.16.6 ADA 2010 604.7 CBC 2007 1115B.8.4 CBC 2016 11B-604.7 Mitigated: <input type="radio"/> YES <input checked="" type="radio"/> NO	1	JOB	\$225	\$225

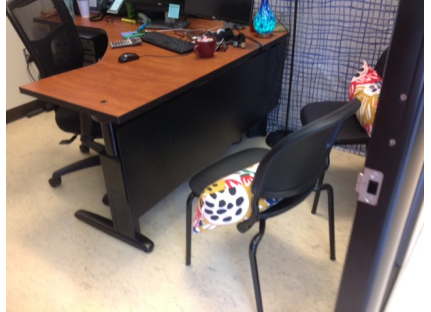
Item no., Rm no. and Name	Existing Architectural Barrier and Proposed Solution	Codes / Mitigation Info	Qty	Unit	Cost	Total
Non-Fixed Desk						
725	<ul style="list-style-type: none"> • <i>As-Built Description:</i> Accessible non-fixed table or desk (top 28" to 34" high; knee space at least 27" high x 19" deep x 30" wide) not provided. • <i>As-Built:</i> No knee clearance for student side if used as work surface. • <i>Proposed Solution:</i> Provide table or desk with accessible dimensions when purchasing new furniture. 	PCODE IN02A ADAAG 91 4.32.3 & .4 ADA 2010 306.1 CBC 2007 1122B.3 & 4 CBC 2016 11B-306.1 & 11B-902.3 Mitigated: <input type="radio"/> YES <input checked="" type="radio"/> NO	1	JOB	\$4,800	\$4,800

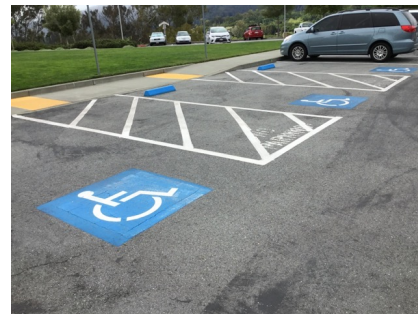
- 6
- *As-Built Description:*
Accessible parking space has slope greater than 1/4":12" (2%).
>2%
 - *Proposed Solution:*
Modify slope at accessible parking space.
- PCODE EA05
ADAAG 91 4.6.3
ADA 2010 502.4
CBC 2007 1129B.3.3
CBC 2016 11B-502.4
- Mitigated:
- ☐ YES
☒ NO

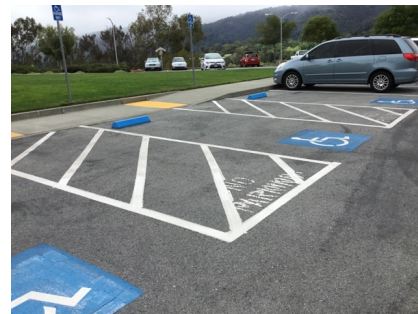
- 7
- *As-Built Description:*
Access aisle at accessible parking space has slope greater than 1/4":12" (2%).
>2%
 - *Proposed Solution:*
Modify slope at accessible parking space aisle.
- PCODE EA05B
ADAAG 91 4.6.3
ADA 2010 502.4
CBC 2007 1129B.3.3
CBC 2016 11B-502.4
- Mitigated:
- ☐ YES
☒ NO

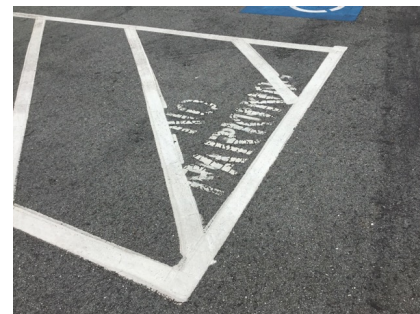
- 8
- **As-Built Description:**
The words "NO PARKING" not painted on the ground within loading and unloading access aisle (12" min high white letters), located so that it is visible to traffic enforcement officials (required in CA only).
 - **Proposed Solution:**
Provide the words "NO PARKING" in each access aisle, painted in 12" high letters, when altering area.
 - **Notes:**
Faded
- PCODE EA04D
CBC 2007 1129B.3.1
CBC 2016 11B-502.3.3

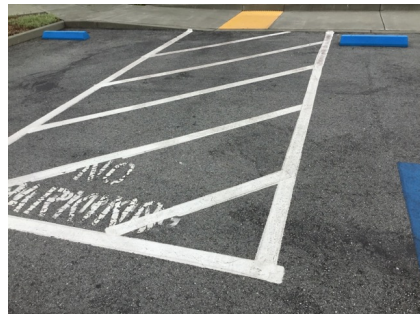
Item no., Rm no. and Name	Existing Architectural Barrier and Proposed Solution	Codes / Mitigation Info	Qty	Unit	Cost	Total
5	<ul style="list-style-type: none">• <i>As-Built Description:</i> CA only: The area within the blue borderlines not marked with hatched lines a maximum of 36" on center.• <i>Proposed Solution:</i> Restripe to provide hatched lines at 36" on center within access aisle.• <i>Notes:</i> No blue contrast	PCODE EA04I CBC 2007 1129B.3.1 CBC 2016 11B-502.3.3 Mitigated: <div><input type="radio"/> YES</div> <div><input checked="" type="radio"/> NO</div>	2	JOB	\$300	\$600

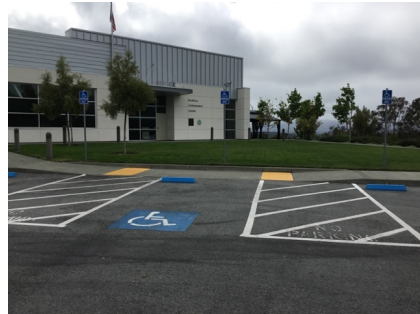
<div><input type="checkbox"/> Staff Only</div> <div>Priority <div>1</div>Severity <div>4</div></div>			
4	<ul style="list-style-type: none">• <i>As-Built Description:</i> No van parking provided (one in every 6 or fraction of 6 accessible spaces, but not less than one).• <i>Proposed Solution:</i> Provide van parking space(s) by restriping; provide van sign.• <i>Notes:</i> No signs	PCODE EA07 ADAAG 91 4.1.2(5)(b) ADA 2010 208.2; 502.1 CBC 2007 1129B.3.2 CBC 2016 11B-208.2.4 Mitigated: <div><input type="radio"/> YES</div> <div><input checked="" type="radio"/> NO</div>	1	JOB	\$1,050	\$1,050

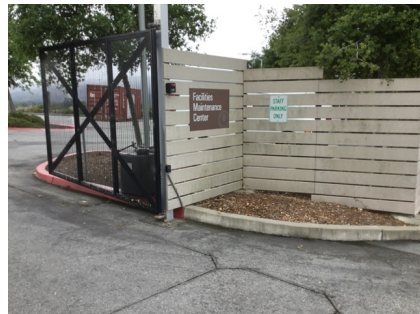
<div><input type="checkbox"/> Staff Only</div> <div>Priority <div>1</div>Severity <div>2</div></div>			
<u>Parking Signage</u>						
1	<ul style="list-style-type: none">• <i>As-Built Description:</i> No "Tow Away" sign at parking lot entrance (required in CA only).• <i>Proposed Solution:</i> Provide "Tow Away" sign at parking lot entrance when altering area.	PCODE EA04C CBC 2007 1129B.4 CBC 2016 11B-502.8.2 Mitigated: <div><input type="radio"/> YES</div> <div><input checked="" type="radio"/> NO</div>	1	JOB	\$975	\$975

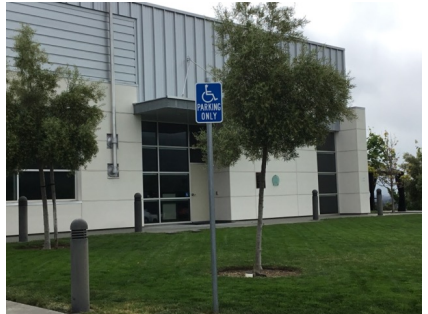
Item no., Rm no. and Name	Existing Architectural Barrier and Proposed Solution	Codes / Mitigation Info	Qty	Unit	Cost	Total
9	<ul style="list-style-type: none"> As-Built Description: CA only: Additional Sign or additional language below the symbol of accessibility stating "Minimum Fine \$250" not provided. Proposed Solution: Provide compliant parking signage that includes fine information. 	PCODE EA04G CBC 2007 1129B.4 CBC 2016 11B-502.6.2 Mitigated: <input type="radio"/> YES <input checked="" type="radio"/> NO	3	JOB	\$300	\$900

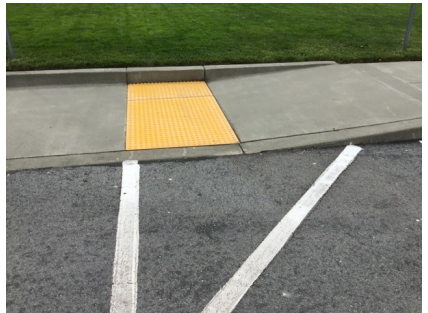
10	<ul style="list-style-type: none"> As-Built Description: Walk more than 36" but less than 48" wide (required in CA only). Proposed Solution: Enlarge width of walk to 48". Notes: 36" wide to access aisle - requires moving curb ramp. 	PCODE EF08 CBC 2007 1133B.7.1 CBC 2016 11B-403.5.1.3 Mitigated: <input type="radio"/> YES <input checked="" type="radio"/> NO	20	SF	\$135	\$2,700

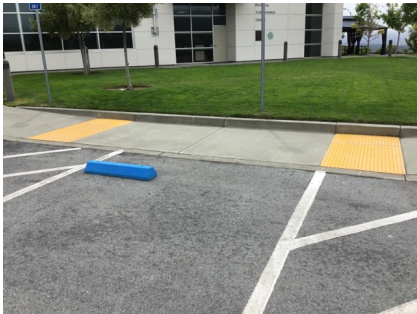
Item no., Rm no. and Name	Existing Architectural Barrier and Proposed Solution	Codes / Mitigation Info	Qty	Unit	Cost	Total
<u>Detectable Warning</u>						
11	<ul style="list-style-type: none">• <i>As-Built Description:</i> 36" wide band of truncated domes not provided at walkway or crossing adjoining a vehicular way, if surfaces are not separated by a curb, railing, or other element.• <i>Proposed Solution:</i> Provide 36" wide, contrasting color, band of truncated domes between pedestrian and vehicular area.	<p>PCODE EG09 ADAAG 91 4.29.5 CBC 2007 1133B.8.5 CBC 2016 11B-705.1.2.5</p> <p>Mitigated:</p> <p><input type="radio"/> YES <input checked="" type="radio"/> NO</p>	20	LF	\$81	\$1,620

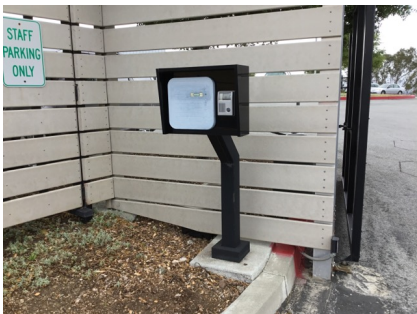
<input type="checkbox"/> Staff Only			
			Priority		Severity	
			1		3	
<u>Reach Range</u>						
2	<ul style="list-style-type: none">• <i>As-Built Description:</i> Reach height to control or access point, where side approach is available, exceeds 48" or is less than 15" in height, or exceeds 10" in depth.• <i>Proposed Solution:</i> Modify equipment or mounting.• <i>Notes:</i> Staff only, difficult to reach from car	<p>PCODE IE02REF ADAAG 91 4.2.6 ADA 2010 308.3.1 CBC 2007 1118B.6 CBC 2016 11B-308.3</p> <p>Mitigated:</p> <p><input type="radio"/> YES <input checked="" type="radio"/> NO</p>

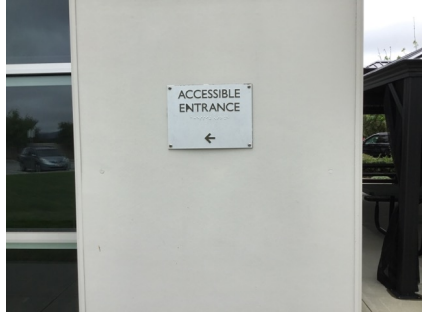
Item no., Rm no. and Name	Existing Architectural Barrier and Proposed Solution	Codes / Mitigation Info	Qty	Unit	Cost	Total
Route Sign						
15	<ul style="list-style-type: none"> • <i>As-Built Description:</i> No sign by inaccessible route directing persons to an accessible route. • <i>Proposed Solution:</i> Provide directional sign. • <i>Notes:</i> Provide directional sign with International Symbol of Accessibility. Braille cells are not required. 	PCODE SA20 ADAAG 91 35.163(b) ADA 2010 216.3 CBC 2007 1127B.3 CBC 2016 11B-216.3 Mitigated: <input type="radio"/> YES <input checked="" type="radio"/> NO	1	JOB	\$510	\$510

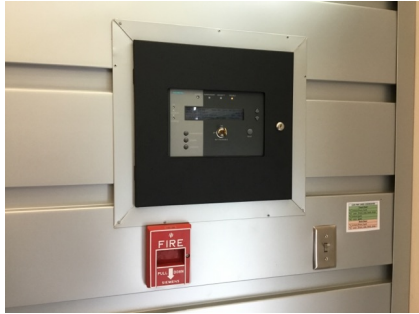
Item no., Rm no. and Name	Existing Architectural Barrier and Proposed Solution	Codes / Mitigation Info	Qty	Unit	Cost	Total
<u>Reach Range</u>						
22	<ul style="list-style-type: none">As-Built Description: Reach height to control or access point, exceeds 48" or is less than 15".As-Built: 60" highProposed Solution: Modify equipment or mounting.Notes: Staff only	<p>PCODE IE01</p> <p>ADAAG 91 4.2.5</p> <p>ADA 2010 308.2.1</p> <p>CBC 2007 1118B.5</p> <p>CBC 2016 11B-308.2.1</p> <p>Mitigated:</p> <p><input type="radio"/> YES</p> <p><input checked="" type="radio"/> NO</p>	1	JOB	\$300	\$300

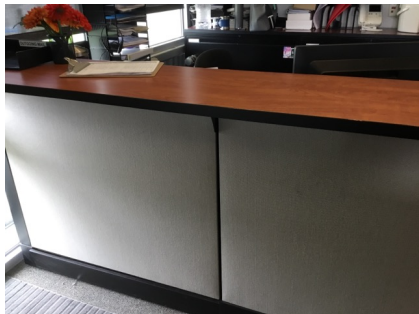
<u>Public Counter</u>						
21	<ul style="list-style-type: none">As-Built Description: Service counter (stand-up): Accessible section min. 36" length and 36" max. height (in CA: 28" to 34" high) not provided.As-Built: 45"Proposed Solution: Retrofit existing counter to provide accessible section. Interim solution: Provide auxiliary counter, table, or clipboard.	<p>PCODE IN03</p> <p>ADAAG 91 7.2(2)</p> <p>ADA 2010 904.4</p> <p>CBC 2007 1122B.4</p> <p>CBC 2016 11B-904.4</p> <p>Mitigated:</p> <p><input type="radio"/> YES</p> <p><input checked="" type="radio"/> NO</p>	1	JOB	\$6,000	\$6,000
