SMCCCD - Cañada College

Appendix H: Facilities

Access Compliance Survey Report

Building 2 - Bookstore

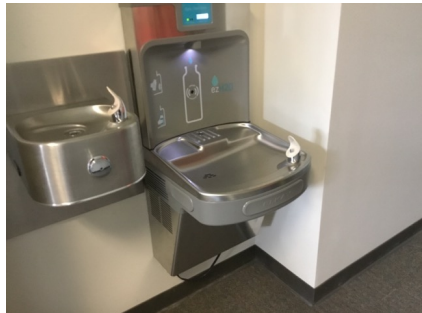
Item no., Rm no. and Name	Existing Architectural Barrier and Proposed Solution	Codes / Mitigation Info	Qty	Unit	Cost	Total
Drinking Fountain						
29	<ul style="list-style-type: none"> • <i>As-Built Description:</i> Wall- and post-mounted cantilevered units: Knee space not provided at drinking fountain (27" high, 8" deep, 30" wide from front of drinking fountain). • <i>As-Built:</i> 26.75" • <i>Proposed Solution:</i> Provide new, accessible fountain. 	PCODE IA02 ADAAG 91 4.15.5(1) ADA 2010 602.2 CBC 2007 1115B.4.6.2 CBC 2016 11B-602.2 Mitigated: <input type="radio"/> YES <input checked="" type="radio"/> NO	1	JOB	\$9,600	\$9,600

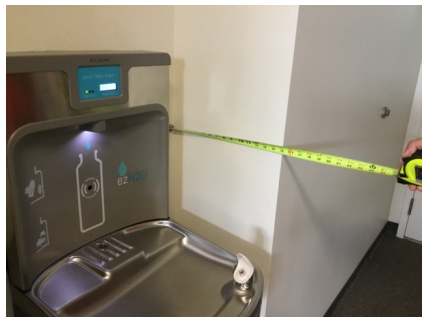
<input type="checkbox"/> Staff Only Priority 3 Severity 2			
30	<ul style="list-style-type: none"> • <i>As-Built Description:</i> CA only: Drinking fountain not located in an alcove (min. 32" wide x 18" deep) or otherwise encroaches into pedestrian way. • <i>As-Built:</i> 15" deep • <i>Proposed Solution:</i> Provide new alcove for drinking fountain, or, if unreasonable hardship is determined, provide wing walls or cane-detectable railings on each side of the drinking fountain. 	PCODE IA04 CBC 2007 1115B.4.6.3; Fig. 11B-3A(b) CBC 2016 11B-602.9 Mitigated: <input type="radio"/> YES <input checked="" type="radio"/> NO	1	JOB	\$9,000	\$9,000

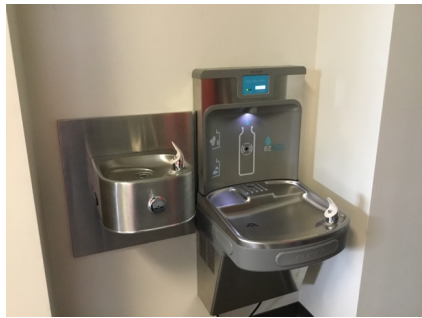
<input type="checkbox"/> Staff Only Priority 3 Severity 2			
31	<ul style="list-style-type: none"> • <i>As-Built Description:</i> 30" wide x 48" long clear floor space not provided at drinking fountain. • <i>As-Built:</i> 13.5" o.c. • <i>Proposed Solution:</i> Provide clear floor space at drinking fountain. 	PCODE IA06 ADAAG 91 4.15.5(1)* ADA 2010 602.2 CBC 2007 1115B.4.6.2 CBC 2016 11B-602.2 Mitigated: <input type="radio"/> YES <input checked="" type="radio"/> NO	1	JOB	\$6,660	\$6,660

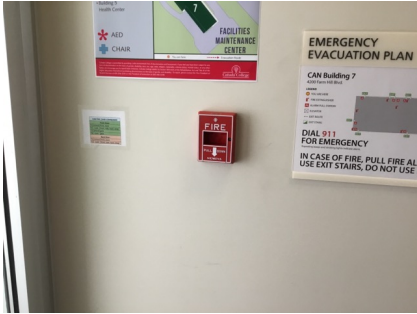
Item no., Rm no. and Name	Existing Architectural Barrier and Proposed Solution	Codes / Mitigation Info	Qty	Unit	Cost	Total
<u>Fire Alarm</u>						
27	<ul style="list-style-type: none">• <i>As-Built Description:</i> Fire alarm pull stations not 42"-48" from floor to center. Note: Required only at new construction, or where mounting location was or is to be remodeled.• <i>As-Built:</i> 48.25"• <i>Proposed Solution:</i> Remount fire alarm station to be 42" min., and 48" max. from floor to center.	<p>PCODE IC03</p> <p>ADAAG 91 4.2.5</p> <p>ADA 2010 308.2.1</p> <p>CBC 2007 907.4.2</p> <p>CBC 2016 907.4.2.2</p> <p>Mitigated:</p> <p><input type="radio"/> YES</p> <p><input checked="" type="radio"/> NO</p>	1	JOB	\$825	\$825

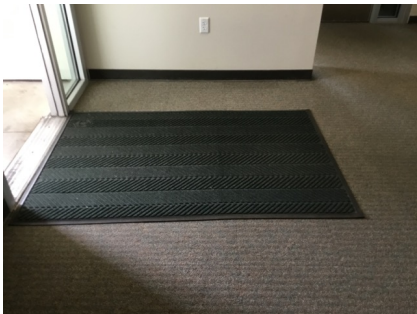
<input type="checkbox"/> Staff Only			
			Priority		Severity	
			2		4	
<u>Carpet/Doormat</u>						
26	<ul style="list-style-type: none">• <i>As-Built Description:</i> Doormat not securely attached to ground or floor structure.• <i>Proposed Solution:</i> Attach doormat to floor surface or remove doormat.	<p>PCODE ID05A</p> <p>ADAAG 91 4.5.3</p> <p>ADA 2010 302.2</p> <p>CBC 2007 1124B.3</p> <p>CBC 2016 11B-302.2</p> <p>Mitigated:</p> <p><input type="radio"/> YES</p> <p><input checked="" type="radio"/> NO</p>	2	JOB	\$225	\$450

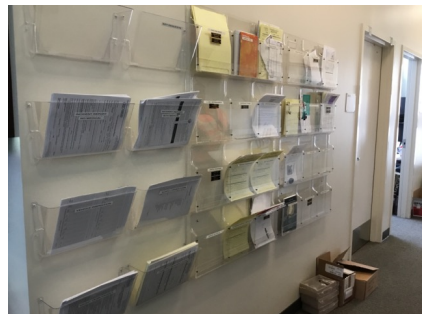
Item no., Rm no. and Name	Existing Architectural Barrier and Proposed Solution	Codes / Mitigation Info	Qty	Unit	Cost	Total
Brochure Bins						
24	<ul style="list-style-type: none">As-Built Description: Information brochure bins mounted above accessible height of 48".As-Built: 60"- 74" highProposed Solution: Relocate/remount bins at accessible height.	PCODE IN08 ADAAG 91 4.2.5 & 6 ADA 2010 308.2.1 CBC 2007 1118B.5 CBC 2016 11B-308.2.1 Mitigated: <input type="radio"/> YES <input checked="" type="radio"/> NO	1	JOB	\$300	\$300

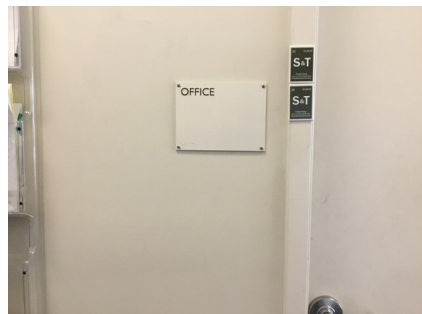
<input type="checkbox"/> Staff Only			
			Priority		Severity	
			2		1	
Signage						
25	<ul style="list-style-type: none">As-Built Description: Sign not located on latch side of door and/or not located at 48" min. above to baseline of the lowest Braille cells and 60" max. to baseline of the highest line of raised characters.As-Built: 61.5" highProposed Solution: Provide compliant signage including tactile characters and Grade II Braille on latch side of door located at compliant height.	PCODE SA07 ADAAG 91 4.30.6 ADA 2010 703.4.1 CBC 2007 1117B.5.7 CBC 2016 11B-703.4.1 Mitigated: <input type="radio"/> YES <input checked="" type="radio"/> NO	13	JOB	\$150	\$1,950

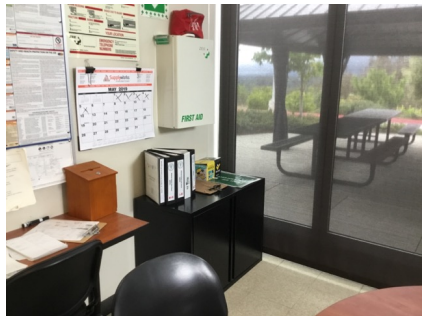
Item no., Rm no. and Name	Existing Architectural Barrier and Proposed Solution	Codes / Mitigation Info	Qty	Unit	Cost	Total
39	<ul style="list-style-type: none"> As-Built Description: Reach height to control or access point, exceeds 48" or is less than 15". As-Built: 63" high to First Aid Proposed Solution: Modify equipment or mounting. 	PCODE IE01 ADAAG 91 4.2.5 ADA 2010 308.2.1 CBC 2007 1118B.5 CBC 2016 11B-308.2.1 Mitigated: <input type="radio"/> YES <input checked="" type="radio"/> NO	1	JOB	\$300	\$300

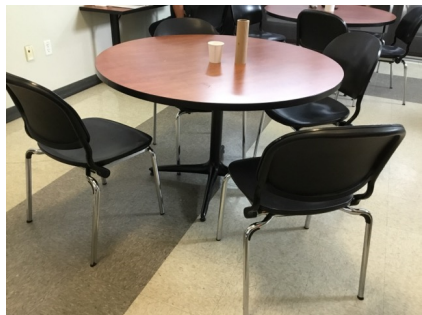
Non-Fixed Desk

42	<ul style="list-style-type: none"> As-Built Description: Accessible non-fixed table or desk (top 28" to 34" high; knee space at least 27" high x 19" deep x 30" wide) not provided. Proposed Solution: Provide table or desk with accessible dimensions when purchasing new furniture. Notes: 4 tables, 0 accessible 	PCODE IN02A ADAAG 91 4.32.3 & .4 ADA 2010 306.1 CBC 2007 1122B.3 & 4 CBC 2016 11B-306.1 & 11B-902.3 Mitigated: <input type="radio"/> YES <input checked="" type="radio"/> NO	1	JOB	\$4,800	\$4,800

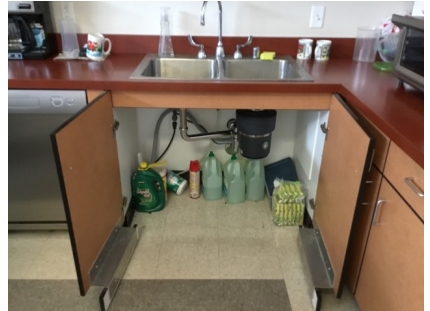
Item no., Rm no. and Name	Existing Architectural Barrier and Proposed Solution	Codes / Mitigation Info	Qty	Unit	Cost	Total
Sink						
41	<ul style="list-style-type: none">As-Built Description: Sink does not have knee space min. 27" high x 19" deep x 30" wide.Proposed Solution: Remodel sink cabinet.	PCODE IN06A ADAAG 91 4.24.3 ADA 2010 606.2 CBC 2007 1115B.4.7.1 CBC 2016 11B-606.2 Mitigated: <div><input type="radio"/> YES</div> <div><input checked="" type="radio"/> NO</div>	1	JOB	\$5,250	\$5,250

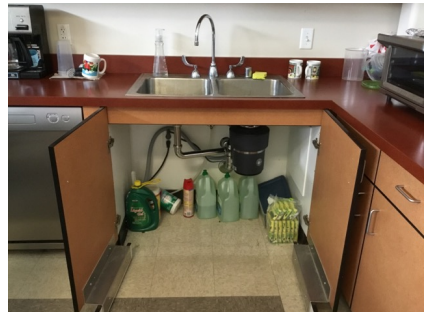
40	<ul style="list-style-type: none">As-Built Description: Sink rim higher than 34" above floor.As-Built: 34.25" highProposed Solution: Remodel sink cabinet to lower sink.	PCODE IN06REF ADAAG 91 4.24.2 ADA 2010 606.3 CBC 2007 1115B.4.7.1 CBC 2016 11B-606.3 Mitigated: <div><input type="radio"/> YES</div> <div><input checked="" type="radio"/> NO</div>	REF

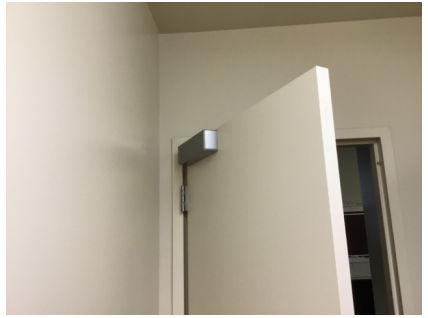
Item no., Rm no. and Name	Existing Architectural Barrier and Proposed Solution	Codes / Mitigation Info	Qty	Unit	Cost	Total
51	<ul style="list-style-type: none"> As-Built Description: Excessive force required to open door. As-Built: 11 lbs. Proposed Solution: Adjust regular door closer to accessible standards (5 lbs. max). 	PCODE ID03 ADAAG 91 4.13.11 ADA 2010 404.2.9 CBC 2007 113B.2.5 CBC 2016 11B-404.2.9 Mitigated: <input type="radio"/> YES <input checked="" type="radio"/> NO	1	JOB	\$75	\$75

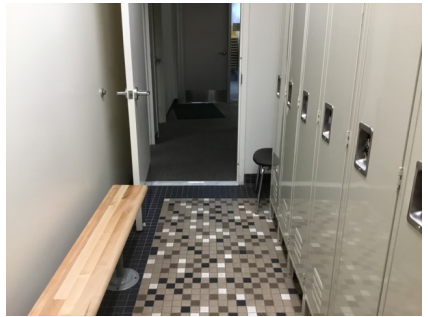
Door Swing

50	<ul style="list-style-type: none"> As-Built Description: Front approach: At pull side, door does not have clear and level maneuvering space measuring door width plus 18" x 60". (24" x 60" at exterior doors). As-Built: 42" to bench and 27" to locker Proposed Solution: Remove or relocate furniture or storage items. 	PCODE ID23A ADAAG 91 Fig. 25(a) ADA 2010 404.2.4 CBC 2007 11B-26A(a) CBC 2016 11B-404.2.4 Mitigated: <input type="radio"/> YES <input checked="" type="radio"/> NO	1	JOB	\$150	\$150

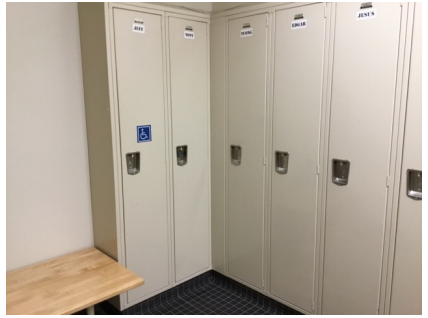
Item no., Rm no. and Name	Existing Architectural Barrier and Proposed Solution	Codes / Mitigation Info	Qty	Unit	Cost	Total
47	<ul style="list-style-type: none"> As-Built Description: Accessible locker(s) in dressing room not provided (5% of lockers; not less than one). Proposed Solution: Provide new locker(s) with accessible locking hardware that is operable with one hand and does not require grasping, pinching or twisting. Notes: 29 lockers, 1 accessible, need to provide 1 more accessible locker 	PCODE GG04 ADAAG 91 4.1.3(12)(a) ADA 2010 222.1 CBC 2007 1115B.8.5 CBC 2016 11B-222.1 Mitigated: <input type="radio"/> YES <input checked="" type="radio"/> NO	1	JOB	\$2,250	\$2,250

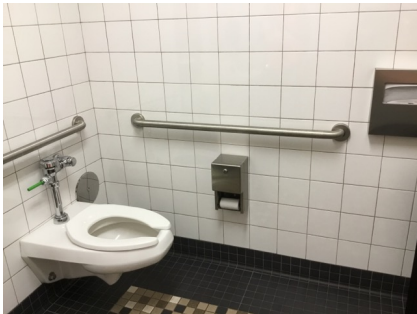
Item no., Rm no. and Name	Existing Architectural Barrier and Proposed Solution	Codes / Mitigation Info	Qty	Unit	Cost	Total
Grab Bars						
57	<ul style="list-style-type: none">As-Built Description: Side grab bar less than 42" long, or located more than 12 inches max. from the rear wall, or extending less than 54" from rear wall (CA only: front end min. 24" in front of water closet).As-Built: Extends 53" from rear wallProposed Solution: Provide or relocate accessible side grab bar.	PCODE WB07A ADAAG 91 Fig. 29(b) ADA 2010 604.5.1 CBC 2007 1115B.4.1.3.1 CBC 2016 11B-604.5.1 Mitigated: <div><input type="radio"/> YES</div> <div><input checked="" type="radio"/> NO</div>	1	JOB	\$780	\$780

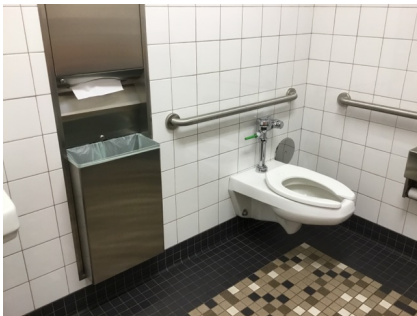
Toilet Stall						
58	<ul style="list-style-type: none">As-Built Description: 60" min. clearance around a water closet measured perpendicular from the side wall not provided (Fixtures are not allowed to overlap this clearance).As-Built: 48" to trash binProposed Solution: Remove adjacent fixture and provide new enclosure at accessible water closet.	PCODE WB01A ADA 2010 604.3.1; 604.3.2 CBC 2007 1115B.7.1.3 CBC 2016 11B-604.3.1; 11B-604.3.2 Mitigated: <div><input type="radio"/> YES</div> <div><input checked="" type="radio"/> NO</div>	1	JOB	\$6,000	\$6,000

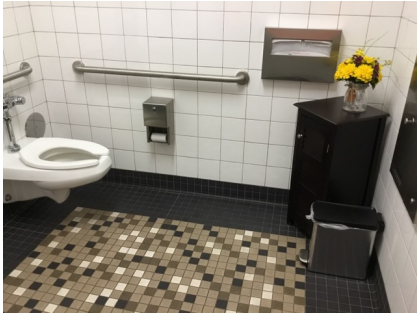
Item no., Rm no. and Name	Existing Architectural Barrier and Proposed Solution	Codes / Mitigation Info	Qty	Unit	Cost	Total
Water Closet						
56	<ul style="list-style-type: none">As-Built Description: CA only: In single-accommodation restroom less than 48" in front of water closet provided.As-Built: 39" to furnitureProposed Solution: Remodel restroom to provide at least 48" in front of water closet.Notes: Relocate furniture	<p>PCODE WB03A</p> <p>CBC 2007 1115B.3.2.1</p> <p>CBC 2016 11B-604.3.1</p> <p>Mitigated:</p> <p><input type="radio"/> YES</p> <p><input checked="" type="radio"/> NO</p>	1	JOB	\$15,000	\$15,000

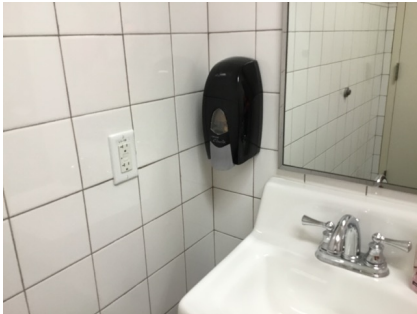
<input type="checkbox"/> Staff Only			
			Priority		Severity	
			<input checked="" type="radio"/> 3		<input checked="" type="radio"/> 3	
Accessories						
55	<ul style="list-style-type: none">As-Built Description: Dispensers in sanitary facilities, such as for towels, soap, sanitary napkins, seat covers, etc., and waste receptacles more than 48" (CA only: 40") from floor to highest operating slot or control.As-Built: 41" AFFProposed Solution: Relocate existing restroom accessories.	<p>PCODE WG01A</p> <p>ADAAG 91 4.23.7</p> <p>ADA 2010 308.2.1</p> <p>CBC 2007 1115B.8.3</p> <p>CBC 2016 11B-603.5</p> <p>Mitigated:</p> <p><input type="radio"/> YES</p> <p><input checked="" type="radio"/> NO</p>	1	JOB	\$300	\$300

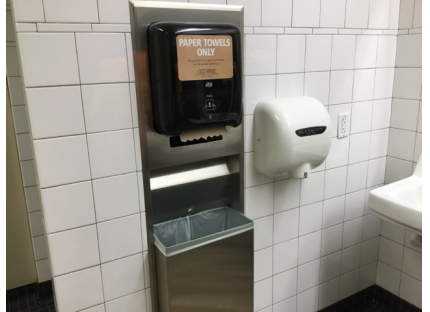
Item no., Rm no. and Name	Existing Architectural Barrier and Proposed Solution	Codes / Mitigation Info	Qty	Unit	Cost	Total
<u>Accessories</u>						
61	<ul style="list-style-type: none"> • <i>As-Built Description:</i> Dispensers in sanitary facilities, such as for towels, soap, sanitary napkins, seat covers, etc., and waste receptacles more than 48" (CA only: 40") from floor to highest operating slot or control. • <i>As-Built:</i> 46" ptd • <i>Proposed Solution:</i> Relocate existing restroom accessories. 	PCODE WG01A ADAAG 91 4.23.7 ADA 2010 308.2.1 CBC 2007 1115B.8.3 CBC 2016 11B-603.5 Mitigated: <input type="radio"/> YES <input checked="" type="radio"/> NO	1	JOB	\$300	\$300

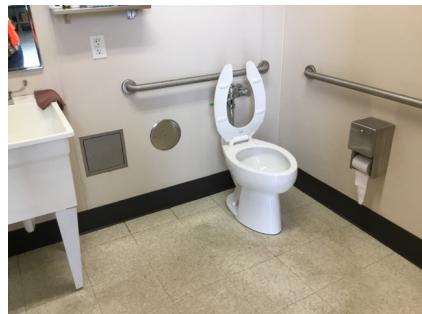
Item no., Rm no. and Name	Existing Architectural Barrier and Proposed Solution	Codes / Mitigation Info	Qty	Unit	Cost	Total
<u>Toilet Stall</u>						
75	<ul style="list-style-type: none">• <i>As-Built Description:</i> 60" min. clearance around a water closet measured perpendicular from the side wall not provided (Fixtures are not allowed to overlap this clearance).• <i>As-Built:</i> 58"• <i>Proposed Solution:</i> Remove adjacent fixture and provide new enclosure at accessible water closet.	<p>PCODE WB01A</p> <p>ADA 2010 604.3.1; 604.3.2</p> <p>CBC 2007 1115B.7.1.3</p> <p>CBC 2016 11B-604.3.1; 11B-604.3.2</p> <p>Mitigated:</p> <p><input type="radio"/> YES</p> <p><input checked="" type="radio"/> NO</p>	1	JOB	\$6,000	\$6,000

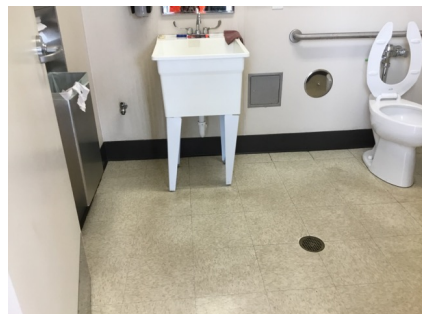
<input type="checkbox"/> Staff Only			
			<div><div>Priority</div><div>4</div></div> <div><div>Severity</div><div>4</div></div>			
<u>Lavatory</u>						
72	<ul style="list-style-type: none">• <i>As-Built Description:</i> Knee clearance 27" min. high starting 8" back from the front edge of the lavatory towards the wall is not provided.• <i>Proposed Solution:</i> Provide new accessible lavatory. Remodel restroom as needed.	<p>PCODE WD04</p> <p>ADAAG 91 Fig. 31</p> <p>ADA 2010 306.3.3</p> <p>CBC 2007 1115B.4.3</p> <p>CBC 2016 11B-306.3.3</p> <p>Mitigated:</p> <p><input type="radio"/> YES</p> <p><input checked="" type="radio"/> NO</p>	1	JOB	\$10,200	\$10,200

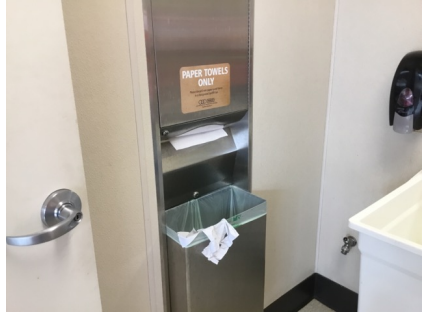
Item no., Rm no. and Name	Existing Architectural Barrier and Proposed Solution	Codes / Mitigation Info	Qty	Unit	Cost	Total
Accessories						
73	<ul style="list-style-type: none"> • <i>As-Built Description:</i> Dispensers in sanitary facilities, such as for towels, soap, sanitary napkins, seat covers, etc., and waste receptacles more than 48" (CA only: 40") from floor to highest operating slot or control. • <i>As-Built:</i> 41" ptd • <i>Proposed Solution:</i> Relocate existing restroom accessories. 	PCODE WG01A ADAAG 91 4.23.7 ADA 2010 308.2.1 CBC 2007 1115B.8.3 CBC 2016 11B-603.5 Mitigated: <input type="radio"/> YES <input checked="" type="radio"/> NO	1	JOB	\$300	\$300

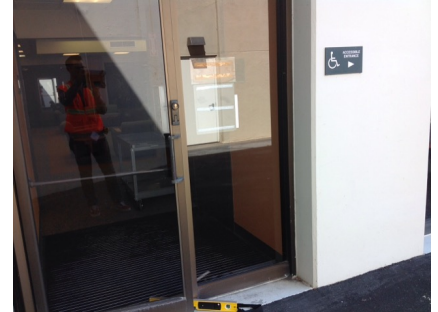
• *Proposed Solution:*CBC 2016 11B-306.1 & 11B
-902.3• *Notes:***Non accessible entrance provides signage to accessible entry. No additional action required.****Mitigated:**☐ YES☒ NO

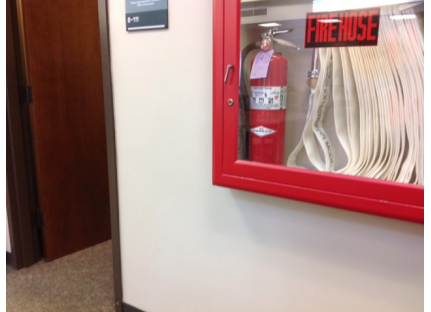
Item no., Rm no. and Name	Existing Architectural Barrier and Proposed Solution	Codes / Mitigation Info	Qty	Unit	Cost	Total
Reach Range						
257	<ul style="list-style-type: none"> As-Built Description: Reach height to control or access point, exceeds 48" or is less than 15". As-Built: 49" high Proposed Solution: Modify equipment or mounting. 	PCODE IE01 ADAAG 91 4.2.5 ADA 2010 308.2.1 CBC 2007 1118B.5 CBC 2016 11B-308.2.1 Mitigated: <input type="radio"/> YES <input checked="" type="radio"/> NO	1	JOB	\$300	\$300

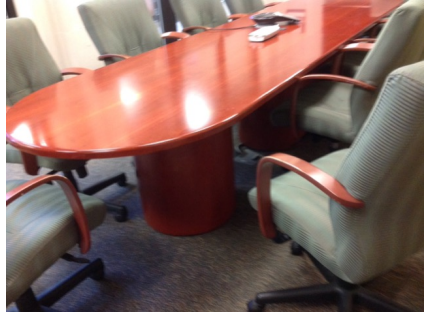
Item no., Rm no. and Name	Existing Architectural Barrier and Proposed Solution	Codes / Mitigation Info	Qty	Unit	Cost	Total
Non-Fixed Desk						
260	<ul style="list-style-type: none"> As-Built Description: Accessible non-fixed table or desk (top 28" to 34" high; knee space at least 27" high x 19" deep x 30" wide) not provided. As-Built: 17" deep Proposed Solution: Provide table or desk with accessible dimensions when purchasing new furniture. 	PCODE IN02A ADAAG 91 4.32.3 & .4 ADA 2010 306.1 CBC 2007 1122B.3 & 4 CBC 2016 11B-306.1 & 11B-902.3 Mitigated: <input type="radio"/> YES <input checked="" type="radio"/> NO	2	JOB	\$4,800	\$9,600

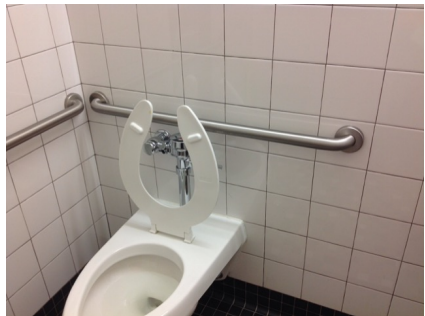
Item no., Rm no. and Name	Existing Architectural Barrier and Proposed Solution	Codes / Mitigation Info	Qty	Unit	Cost	Total
243	<ul style="list-style-type: none"> As-Built Description: The rear wall grab is less than 36" min. or does not extend from the centerline of the water closet 12" min. on one side and 24" min. on the other side. As-Built: 21" Proposed Solution: Provide or relocate accessible rear grab bar. 	PCODE WB07B ADAAG 91 4.17.6 ADA 2010 604.5.2 CBC 2007 1115B.4.1.3.2 CBC 2016 11B-604.5.2 Mitigated: <input type="radio"/> YES <input checked="" type="radio"/> NO	1	JOB	\$1,020	\$1,020

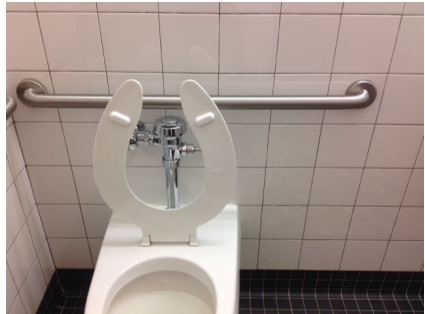
<div> <input type="checkbox"/> Staff Only </div> <div> Priority 3 Severity 3 </div>						
244	<ul style="list-style-type: none"> As-Built Description: Accessories/dispensers in accessible stall located closer than 1-1/2" below or 12" above grab bar impedes its use. As-Built: 1" below Proposed Solution: Relocate accessories/dispensers to be no closer than 1-1/2" below and 12" above grab bars (except if accessories are recessed, flush with wall, and have no sharp edges). 	PCODE WB071 ADAAG 91 4.26.2 ADA 2010 609.3 CBC 2007 1133B.4.2.5 CBC 2016 11B-609.3 Mitigated: <input type="radio"/> YES <input checked="" type="radio"/> NO	1	JOB	\$225	\$225

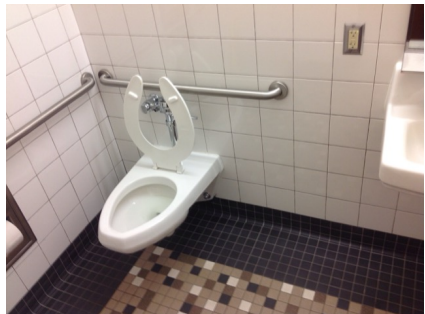
<div> <input type="checkbox"/> Staff Only </div> <div> Priority 3 Severity 4 </div>						
<u>Toilet Stall</u>						
241	<ul style="list-style-type: none"> As-Built Description: Toilet stall less than 60" wide. As-Built: 56" Proposed Solution: Provide new accessible stall. Notes: 28" between WC and lavatory 	PCODE WB06 ADAAG 91 4.17.3 ADA 2010 604.8.1.1 CBC 2007 1115B.3.1.4.1 CBC 2016 11B-604.8.1.1 Mitigated: <input type="radio"/> YES <input checked="" type="radio"/> NO	1	JOB	\$4,500	\$4,500

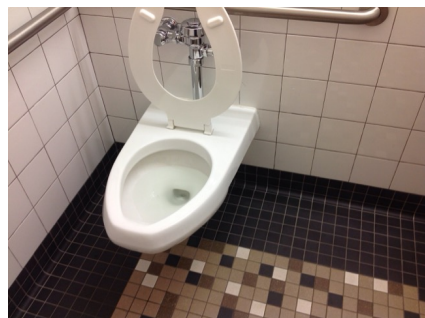
Item no., Rm no. and Name	Existing Architectural Barrier and Proposed Solution	Codes / Mitigation Info	Qty	Unit	Cost	Total
Water Closet						
242	<ul style="list-style-type: none">As-Built Description: Water closet not 16"-18" (CA: 17"-18") from near side wall to center line of water closet (2010 ADAAG: 16"-18").As-Built: 18.5" o.c.Proposed Solution: Relocate existing water closet and plumbing, remount with offset closet flange to provide 18" max. from side wall.	PCODE WB02C ADAAG 91 Fig. 28 ADA 2010 604.2 CBC 2007 1115B.4.1.1 CBC 2016 11B-604.2 Mitigated: <input type="radio"/> YES <input checked="" type="radio"/> NO	1	JOB	\$1,500	\$1,500

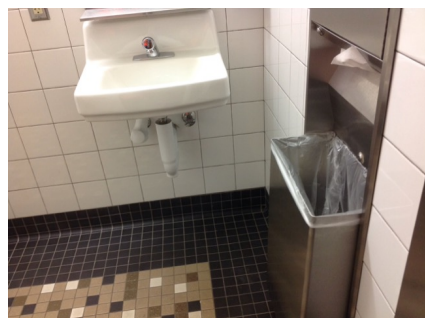
<input type="checkbox"/> Staff Only			
			Priority		Severity	
			3		4	
Lavatory						
238	<ul style="list-style-type: none">As-Built Description: Clear floor space, 30" x 48" in front of fixture, extending 19" max. under the lavatory, not provided (CA only: Less than 18" from side wall to centerline of lavatory).As-Built: 17.5" o.c.Proposed Solution: Provide new accessible lavatory. Remodel restroom as needed.Notes: Trash can obstructs clear approach.	PCODE WD01 ADAAG 91 4.19.3 ADA 2010 606.2 CBC 2007 1115B.4.3 CBC 2016 11B-606.2, 11B-606.6 Mitigated: <input type="radio"/> YES <input checked="" type="radio"/> NO	1	JOB	\$10,200	\$10,200

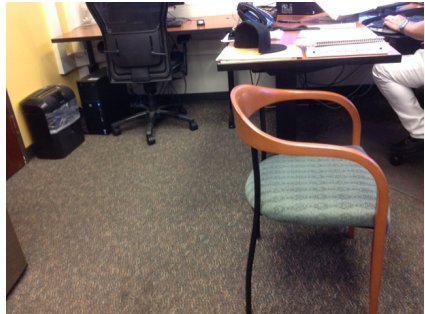
Item no., Rm no. and Name	Existing Architectural Barrier and Proposed Solution	Codes / Mitigation Info	Qty	Unit	Cost	Total
248	<ul style="list-style-type: none"> As-Built Description: Accessible non-fixed table or desk (top 28" to 34" high; knee space at least 27" high x 19" deep x 30" wide) not provided. As-Built: Knee space required if used as work surface for public. Proposed Solution: Provide table or desk with accessible dimensions when purchasing new furniture. 	PCODE IN02A ADAAG 91 4.32.3 & .4 ADA 2010 306.1 CBC 2007 1122B.3 & 4 CBC 2016 11B-306.1 & 11B-902.3 Mitigated: <input type="radio"/> YES <input checked="" type="radio"/> NO	1	JOB	\$4,800	\$4,800

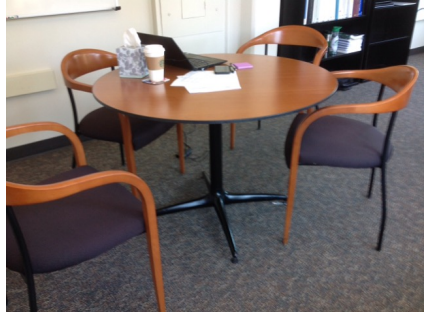
Item no., Rm no. and Name	Existing Architectural Barrier and Proposed Solution	Codes / Mitigation Info	Qty	Unit	Cost	Total
Non-Fixed Desk						
252	<ul style="list-style-type: none"> • <i>As-Built Description:</i> Accessible non-fixed table or desk (top 28" to 34" high; knee space at least 27" high x 19" deep x 30" wide) not provided. • <i>Proposed Solution:</i> Provide table or desk with accessible dimensions when purchasing new furniture. 	PCODE IN02A ADAAG 91 4.32.3 & .4 ADA 2010 306.1 CBC 2007 1122B.3 & 4 CBC 2016 11B-306.1 & 11B-902.3 Mitigated: <input type="radio"/> YES <input checked="" type="radio"/> NO	1	JOB	\$4,800	\$4,800

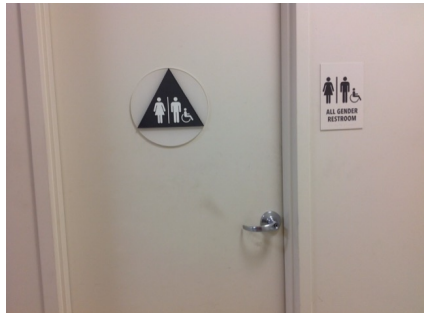
Item no., Rm no. and Name	Existing Architectural Barrier and Proposed Solution	Codes / Mitigation Info	Qty	Unit	Cost	Total
Signage						
762	<ul style="list-style-type: none"> As-Built Description: Required in CA only: identification symbol centered 58" to 60" high on sanitary facility door that contrasts with the door not provided (women: 12" ø circle, men: 12" triangle, unisex: combined symbol). Proposed Solution: Provide properly mounted sanitary facility symbol when altering area. If wheelchair accessible, include International Symbol of Accessibility on sign. Notes: No contrast between circle sign surface and door surface 	PCODE SA15 CBC 2007 1115B.6 CBC 2016 11B-703.7.2.6 Mitigated: <input type="radio"/> YES <input checked="" type="radio"/> NO	1	JOB	\$270	\$270

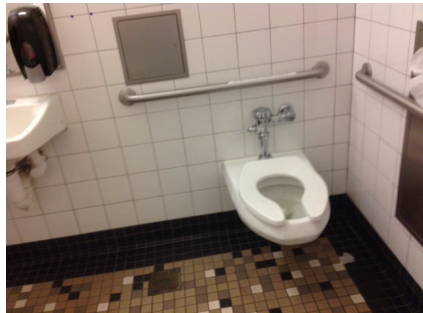
Toilet Stall

767	<ul style="list-style-type: none"> As-Built Description: Toilet stall less than 60" wide. As-Built: 54" wide Proposed Solution: Provide new accessible stall. Notes: 28" between toilet and lavatory 	PCODE WB06 ADAAG 91 4.17.3 ADA 2010 604.8.1.1 CBC 2007 1115B.3.1.4.1 CBC 2016 11B-604.8.1.1 Mitigated: <input type="radio"/> YES <input checked="" type="radio"/> NO	1	JOB	\$4,500	\$4,500

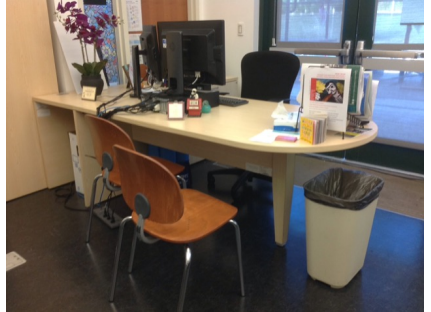
Item no., Rm no. and Name	Existing Architectural Barrier and Proposed Solution	Codes / Mitigation Info	Qty	Unit	Cost	Total
Non-Fixed Desk						
772	<ul style="list-style-type: none"> • <i>As-Built Description:</i> Accessible non-fixed table or desk (top 28" to 34" high; knee space at least 27" high x 19" deep x 30" wide) not provided. • <i>As-Built:</i> 18" deep knee • <i>Proposed Solution:</i> Provide table or desk with accessible dimensions when purchasing new furniture. • <i>Notes:</i> If used as work surface for students 	PCODE IN02A ADAAG 91 4.32.3 & .4 ADA 2010 306.1 CBC 2007 1122B.3 & 4 CBC 2016 11B-306.1 & 11B-902.3 Mitigated: <input type="radio"/> YES <input checked="" type="radio"/> NO	1	JOB	\$4,800	\$4,800

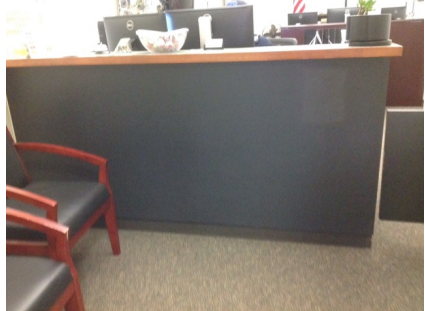
Item no., Rm no. and Name	Existing Architectural Barrier and Proposed Solution	Codes / Mitigation Info	Qty	Unit	Cost	Total
Public Counter						
773	<ul style="list-style-type: none"> As-Built Description: Service counter (stand-up): Accessible section min. 36" length and 36" max. height (in CA: 28" to 34" high) not provided. As-Built: 41" high Proposed Solution: Retrofit existing counter to provide accessible section. Interim solution: Provide auxiliary counter, table, or clipboard. 	PCODE IN03 ADAAG 91 7.2(2) ADA 2010 904.4 CBC 2007 1122B.4 CBC 2016 11B-904.4 Mitigated: <input type="radio"/> YES <input checked="" type="radio"/> NO	1	JOB	\$6,000	\$6,000

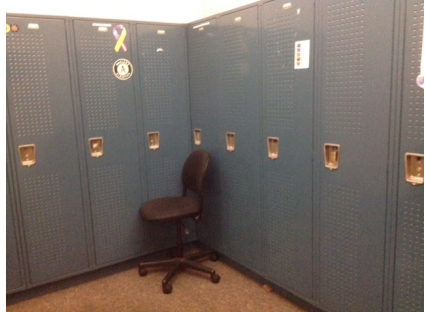
Locker Facilities						
776	<ul style="list-style-type: none"> As-Built Description: No section of bench provided adjacent to designated accessible locker, measuring minimum 20-24" deep, 48" wide, and 17-19" high, and fixed to a wall along the longer dimension. Proposed Solution: Provide a new bench, fixed to a wall along the longer dimension, close to the accessible locker. Notes: Locker room no permanent bench provided. Staff only. 	PCODE GG03 ADAAG 91 4.35.4 ADA 2010 803.4 CBC 2007 1117B.8 CBC 2016 11B-803.4 Mitigated: <input type="radio"/> YES <input checked="" type="radio"/> NO	1	JOB	\$2,250	\$2,250

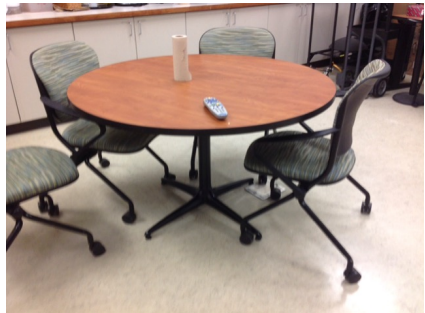
Item no., Rm no. and Name	Existing Architectural Barrier and Proposed Solution	Codes / Mitigation Info	Qty	Unit	Cost	Total
Non-Fixed Desk						
783	<ul style="list-style-type: none"> • <i>As-Built Description:</i> Accessible non-fixed table or desk (top 28" to 34" high; knee space at least 27" high x 19" deep x 30" wide) not provided. • <i>Proposed Solution:</i> Provide table or desk with accessible dimensions when purchasing new furniture. 	PCODE IN02A ADAAG 91 4.32.3 & .4 ADA 2010 306.1 CBC 2007 1122B.3 & 4 CBC 2016 11B-306.1 & 11B-902.3 Mitigated: <input type="radio"/> YES <input checked="" type="radio"/> NO	1	JOB	\$4,800	\$4,800

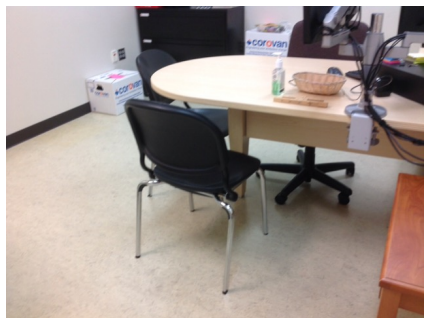
<input type="checkbox"/> Staff Only Priority 4 Severity 2			
784	<ul style="list-style-type: none"> • <i>As-Built Description:</i> Accessible non-fixed table or desk (top 28" to 34" high; knee space at least 27" high x 19" deep x 30" wide) not provided. • <i>As-Built:</i> 18" deep knee clearance if used as writing surface. • <i>Proposed Solution:</i> Provide table or desk with accessible dimensions when purchasing new furniture. 	PCODE IN02A ADAAG 91 4.32.3 & .4 ADA 2010 306.1 CBC 2007 1122B.3 & 4 CBC 2016 11B-306.1 & 11B-902.3 Mitigated: <input type="radio"/> YES <input checked="" type="radio"/> NO	1	JOB	\$4,800	\$4,800

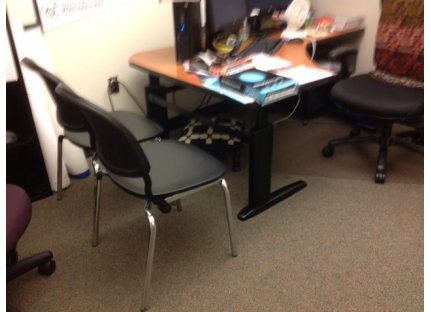
Item no., Rm no. and Name	Existing Architectural Barrier and Proposed Solution	Codes / Mitigation Info	Qty	Unit	Cost	Total
<u>Non-Fixed Desk</u>						
785	<ul style="list-style-type: none"> • <i>As-Built Description:</i> Accessible non-fixed table or desk (top 28" to 34" high; knee space at least 27" high x 19" deep x 30" wide) not provided. • <i>As-Built:</i> No knee clearance on the student side if used as writing surface. • <i>Proposed Solution:</i> Provide table or desk with accessible dimensions when purchasing new furniture. 	PCODE IN02A ADAAG 91 4.32.3 & .4 ADA 2010 306.1 CBC 2007 1122B.3 & 4 CBC 2016 11B-306.1 & 11B-902.3 Mitigated: <input type="radio"/> YES <input checked="" type="radio"/> NO	1	JOB	\$4,800	\$4,800

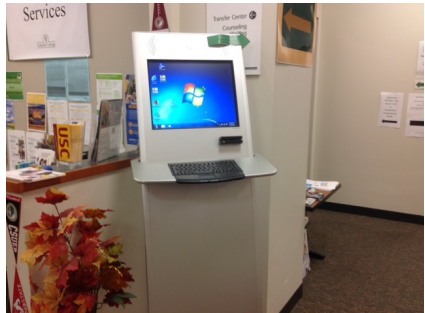
Item no., Rm no. and Name	Existing Architectural Barrier and Proposed Solution	Codes / Mitigation Info	Qty	Unit	Cost	Total
Non-Fixed Desk						
790	<ul style="list-style-type: none"> As-Built Description: Accessible non-fixed table or desk (top 28" to 34" high; knee space at least 27" high x 19" deep x 30" wide) not provided. As-Built: No knee space for check in computer Proposed Solution: Provide table or desk with accessible dimensions when purchasing new furniture. 	PCODE IN02A ADAAG 91 4.32.3 & .4 ADA 2010 306.1 CBC 2007 1122B.3 & 4 CBC 2016 11B-306.1 & 11B-902.3 Mitigated: <input type="radio"/> YES <input checked="" type="radio"/> NO	1	JOB	\$4,800	\$4,800

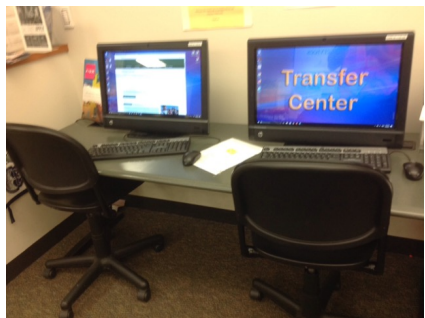
<input type="checkbox"/> Staff Only			
			Priority 2 Severity 2			
791	<ul style="list-style-type: none"> As-Built Description: Accessible non-fixed table or desk (top 28" to 34" high; knee space at least 27" high x 19" deep x 30" wide) not provided. As-Built: 17" deep knee clearance Proposed Solution: Provide table or desk with accessible dimensions when purchasing new furniture. Notes: Transfer Center Room 118 	PCODE IN02A ADAAG 91 4.32.3 & .4 ADA 2010 306.1 CBC 2007 1122B.3 & 4 CBC 2016 11B-306.1 & 11B-902.3 Mitigated: <input type="radio"/> YES <input checked="" type="radio"/> NO	1	JOB	\$4,800	\$4,800

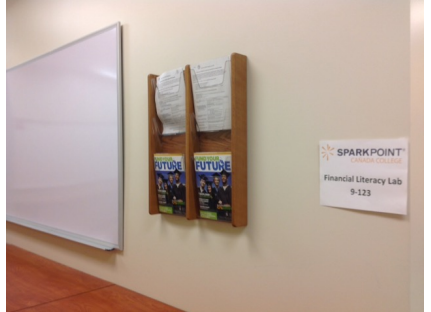
Item no., Rm no. and Name	Existing Architectural Barrier and Proposed Solution	Codes / Mitigation Info	Qty	Unit	Cost	Total
Brochure Bins						
794	<ul style="list-style-type: none"> • <i>As-Built Description:</i> Information brochure bins mounted above accessible height of 48". • <i>As-Built:</i> 60" high • <i>Proposed Solution:</i> Relocate/remount bins at accessible height. 	PCODE IN08 ADAAG 91 4.2.5 & 6 ADA 2010 308.2.1 CBC 2007 1118B.5 CBC 2016 11B-308.2.1 Mitigated: <input type="radio"/> YES <input checked="" type="radio"/> NO	1	JOB	\$300	\$300

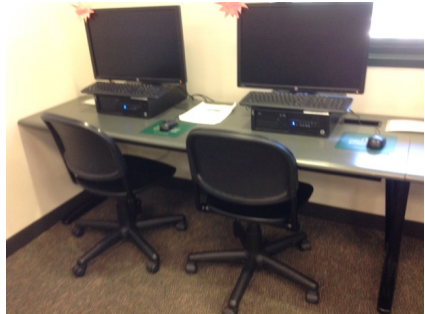
Item no., Rm no. and Name	Existing Architectural Barrier and Proposed Solution	Codes / Mitigation Info	Qty	Unit	Cost	Total
799	<ul style="list-style-type: none"> As-Built Description: Accessible non-fixed table or desk (top 28" to 34" high; knee space at least 27" high x 19" deep x 30" wide) not provided. As-Built: 26" high knee clearance Proposed Solution: Provide table or desk with accessible dimensions when purchasing new furniture. 	PCODE IN02A ADAAG 91 4.32.3 & .4 ADA 2010 306.1 CBC 2007 1122B.3 & 4 CBC 2016 11B-306.1 & 11B-902.3 Mitigated: <input type="radio"/> YES <input checked="" type="radio"/> NO	1	JOB	\$4,800	\$4,800

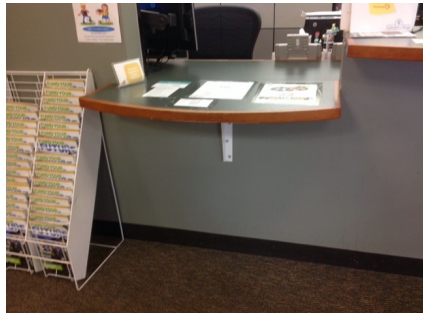
Public Counter

798	<ul style="list-style-type: none"> As-Built Description: Service counter (stand-up): Accessible section min. 36" length and 36" max. height (in CA: 28" to 34" high) not provided. As-Built: 34.5" high Proposed Solution: Retrofit existing counter to provide accessible section. Interim solution: Provide auxiliary counter, table, or clipboard. 	PCODE IN03 ADAAG 91 7.2(2) ADA 2010 904.4 CBC 2007 1122B.4 CBC 2016 11B-904.4 Mitigated: <input type="radio"/> YES <input checked="" type="radio"/> NO	1	JOB	\$6,000	\$6,000

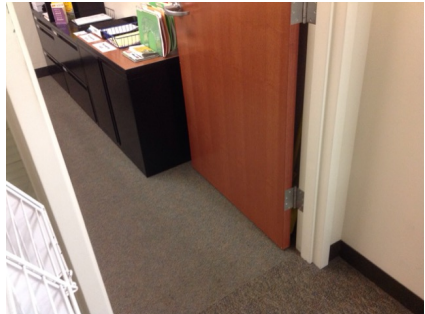
Item no., Rm no. and Name	Existing Architectural Barrier and Proposed Solution	Codes / Mitigation Info	Qty	Unit	Cost	Total
805	<ul style="list-style-type: none"> As-Built Description: Front approach: At pull side, door does not have clear and level maneuvering space measuring door width plus 18" x 60". (24" x 60" at exterior doors). Proposed Solution: Remove or relocate furniture or storage items. 	PCODE ID23A ADAAG 91 Fig. 25(a) ADA 2010 404.2.4 CBC 2007 11B-26A(a) CBC 2016 11B-404.2.4 Mitigated: <input type="radio"/> YES <input checked="" type="radio"/> NO	1	JOB	\$150	\$150

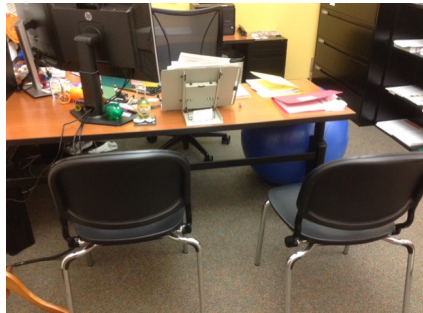
Non-Fixed Desk

803	<ul style="list-style-type: none"> As-Built Description: Accessible non-fixed table or desk (top 28" to 34" high; knee space at least 27" high x 19" deep x 30" wide) not provided. As-Built: No knee clearance if used as writing surface for public. Proposed Solution: Provide table or desk with accessible dimensions when purchasing new furniture. 	PCODE IN02A ADAAG 91 4.32.3 & .4 ADA 2010 306.1 CBC 2007 1122B.3 & 4 CBC 2016 11B-306.1 & 11B-902.3 Mitigated: <input type="radio"/> YES <input checked="" type="radio"/> NO	4	JOB	\$4,800	\$19,200

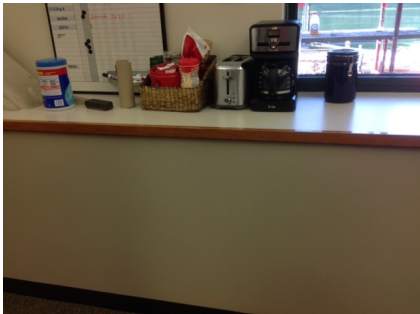
Item no., Rm no. and Name	Existing Architectural Barrier and Proposed Solution	Codes / Mitigation Info	Qty	Unit	Cost	Total
Public Counter						
807	<ul style="list-style-type: none">As-Built Description: Service counter (stand-up): Accessible section min. 36" length and 36" max. height (in CA: 28" to 34" high) not provided.As-Built: 37" high counterProposed Solution: Retrofit existing counter to provide accessible section. Interim solution: Provide auxiliary counter, table, or clipboard.	PCODE IN03 ADAAG 91 7.2(2) ADA 2010 904.4 CBC 2007 1122B.4 CBC 2016 11B-904.4 Mitigated: <input type="radio"/> YES <input checked="" type="radio"/> NO	1	JOB	\$6,000	\$6,000

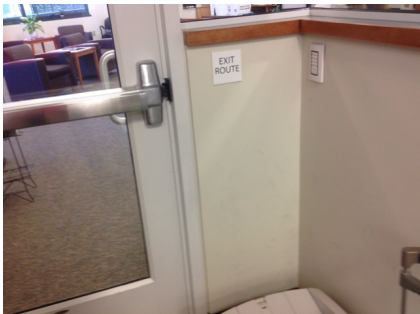
<input type="checkbox"/> Staff Only			
			Priority Severity <input checked="" type="radio"/> 4 <input checked="" type="radio"/> 4			
Signage						
806	<ul style="list-style-type: none">As-Built Description: Signs containing tactile characters is not located so that a clear floor space of 18" min x 18" min., centered on the tactile characters, is provided beyond the arc of any door swing between the closed position and 45 degree open position.As-Built: 42" highProposed Solution: Relocate compliant signage on latch side of door located at compliant height with a clear floor space.	PCODE SA07B ADA 2010 703.4.2 CBC 2016 11B-703.4.2 Mitigated: <input type="radio"/> YES <input checked="" type="radio"/> NO	1	JOB	\$150	\$150

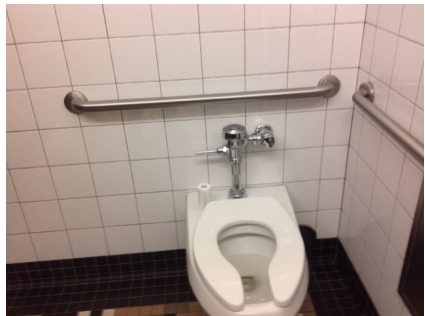
Item no., Rm no. and Name	Existing Architectural Barrier and Proposed Solution	Codes / Mitigation Info	Qty	Unit	Cost	Total
815	<ul style="list-style-type: none"> As-Built Description: The rear wall grab is less than 36" min. or does not extend from the centerline of the water closet 12" min. on one side and 24" min. on the other side. As-Built: 23" from the centerline of the toilet Proposed Solution: Provide or relocate accessible rear grab bar. 	PCODE WB07B ADAAG 91 4.17.6 ADA 2010 604.5.2 CBC 2007 1115B.4.1.3.2 CBC 2016 11B-604.5.2 Mitigated: <input type="radio"/> YES <input checked="" type="radio"/> NO	1	JOB	\$1,020	\$1,020

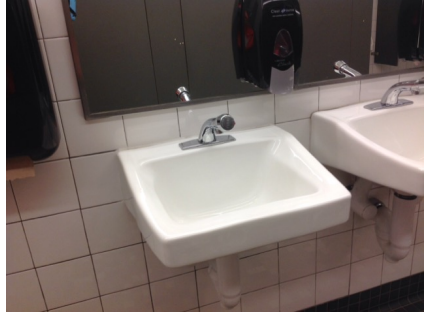
Item no., Rm no. and Name	Existing Architectural Barrier and Proposed Solution	Codes / Mitigation Info	Qty	Unit	Cost	Total
<u>Accessories</u>						
813	<ul style="list-style-type: none"> • <i>As-Built Description:</i> Dispensers in sanitary facilities, such as for towels, soap, sanitary napkins, seat covers, etc., and waste receptacles more than 48" (CA only: 40") from floor to highest operating slot or control. • <i>As-Built:</i> Soap dispenser 40.5" high • <i>Proposed Solution:</i> Relocate existing restroom accessories. 	PCODE WG01A ADAAG 91 4.23.7 ADA 2010 308.2.1 CBC 2007 1115B.8.3 CBC 2016 11B-603.5 Mitigated: <input type="radio"/> YES <input checked="" type="radio"/> NO	1	JOB	\$300	\$300

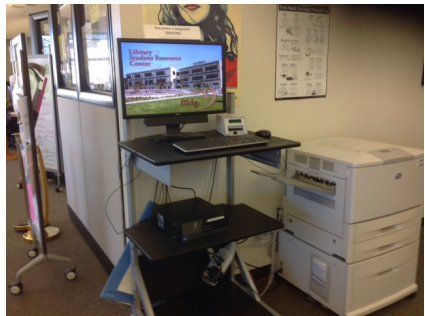
Item no., Rm no. and Name	Existing Architectural Barrier and Proposed Solution	Codes / Mitigation Info	Qty	Unit	Cost	Total
5	<ul style="list-style-type: none"> As-Built Description: Accessible non-fixed table or desk (top 28" to 34" high; knee space at least 27" high x 19" deep x 30" wide) not provided. Proposed Solution: Provide table or desk with accessible dimensions when purchasing new furniture. Notes: Printer computer not accessible 	PCODE IN02A ADAAG 91 4.32.3 & .4 ADA 2010 306.1 CBC 2007 1122B.3 & 4 CBC 2016 11B-306.1 & 11B-902.3 Mitigated: <input type="radio"/> YES <input checked="" type="radio"/> NO	1	JOB	\$4,800	\$4,800

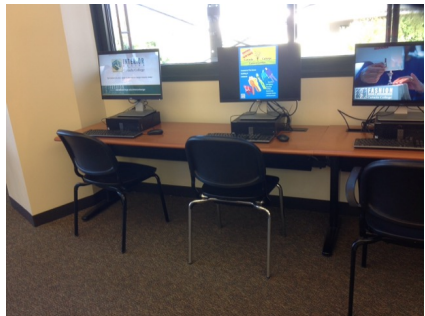
<input type="checkbox"/> Staff Only						
Priority 2 Severity 2						
831	<ul style="list-style-type: none"> As-Built Description: Accessible non-fixed table or desk (top 28" to 34" high; knee space at least 27" high x 19" deep x 30" wide) not provided. As-Built: 26" high, 15" deep Proposed Solution: Provide table or desk with accessible dimensions when purchasing new furniture. Notes: Approximately 56 computer stations, no accessible stations 	PCODE IN02A ADAAG 91 4.32.3 & .4 ADA 2010 306.1 CBC 2007 1122B.3 & 4 CBC 2016 11B-306.1 & 11B-902.3 Mitigated: <input type="radio"/> YES <input checked="" type="radio"/> NO	1	JOB	\$4,800	\$4,800

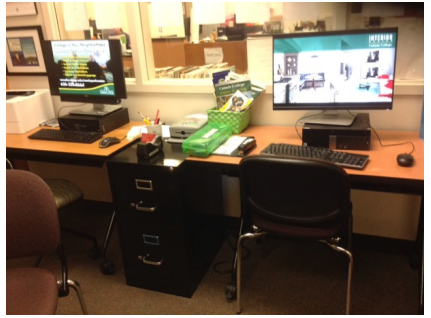
Item no., Rm no. and Name	Existing Architectural Barrier and Proposed Solution	Codes / Mitigation Info	Qty	Unit	Cost	Total
8	<ul style="list-style-type: none"> As-Built Description: Accessible non-fixed table or desk (top 28" to 34" high; knee space at least 27" high x 19" deep x 30" wide) not provided. As-Built: 24" knee space Proposed Solution: Provide table or desk with accessible dimensions when purchasing new furniture. 	PCODE IN02A ADAAG 91 4.32.3 & .4 ADA 2010 306.1 CBC 2007 1122B.3 & 4 CBC 2016 11B-306.1 & 11B-902.3 Mitigated: <input type="radio"/> YES <input checked="" type="radio"/> NO	1	JOB	\$4,800	\$4,800

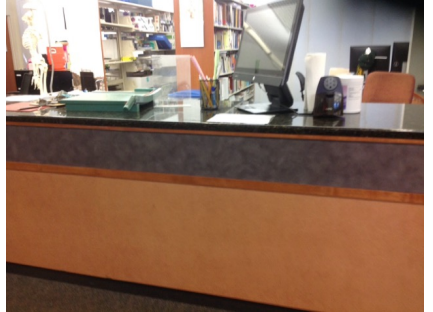
Item no., Rm no. and Name	Existing Architectural Barrier and Proposed Solution	Codes / Mitigation Info	Qty	Unit	Cost	Total
Public Counter						
9	<ul style="list-style-type: none"> • <i>As-Built Description:</i> Service counter (stand-up): Accessible section min. 36" length and 36" max. height (in CA: 28" to 34" high) not provided. • <i>As-Built:</i> 41" high • <i>Proposed Solution:</i> Retrofit existing counter to provide accessible section. Interim solution: Provide auxiliary counter, table, or clipboard. • <i>Notes:</i> Relocate computer to lowered counter 	PCODE IN03 ADAAG 91 7.2(2) ADA 2010 904.4 CBC 2007 1122B.4 CBC 2016 11B-904.4 Mitigated: <input type="radio"/> YES <input checked="" type="radio"/> NO	1	JOB	\$6,000	\$6,000

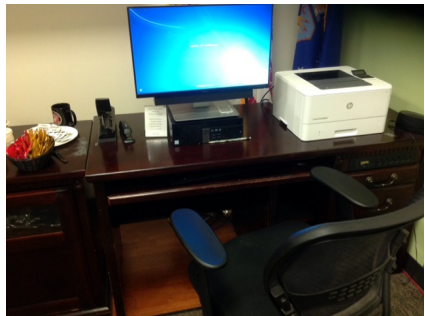
Item no., Rm no. and Name	Existing Architectural Barrier and Proposed Solution	Codes / Mitigation Info	Qty	Unit	Cost	Total
15	<ul style="list-style-type: none"> As-Built Description: Accessible non-fixed table or desk (top 28" to 34" high; knee space at least 27" high x 19" deep x 30" wide) not provided. As-Built: 25" knee height Proposed Solution: Provide table or desk with accessible dimensions when purchasing new furniture. 	PCODE IN02A ADAAG 91 4.32.3 & .4 ADA 2010 306.1 CBC 2007 1122B.3 & 4 CBC 2016 11B-306.1 & 11B-902.3 Mitigated: <input type="radio"/> YES <input checked="" type="radio"/> NO	1	JOB	\$4,800	\$4,800

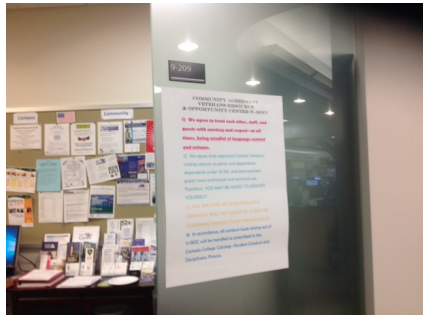
Signage

12	<ul style="list-style-type: none"> As-Built Description: Signs containing tactile characters is not located so that a clear floor space of 18" min x 18" min., centered on the tactile characters, is provided beyond the arc of any door swing between the closed position and 45 degree open position. As-Built: 72" high Proposed Solution: Relocate compliant signage on latch side of door located at compliant height with a clear floor space. 	PCODE SA07B ADA 2010 703.4.2 CBC 2016 11B-703.4.2 Mitigated: <input type="radio"/> YES <input checked="" type="radio"/> NO	1	JOB	\$150	\$150

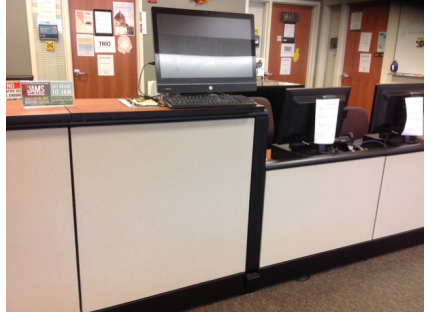
Item no., Rm no. and Name	Existing Architectural Barrier and Proposed Solution	Codes / Mitigation Info	Qty	Unit	Cost	Total
Public Counter						
16	<ul style="list-style-type: none"> • <i>As-Built Description:</i> Service counter (stand-up): Accessible section min. 36" length and 36" max. height (in CA: 28" to 34" high) not provided. • <i>As-Built:</i> 42" high • <i>Proposed Solution:</i> Retrofit existing counter to provide accessible section. Interim solution: Provide auxiliary counter, table, or clipboard. 	PCODE IN03 ADAAG 91 7.2(2) ADA 2010 904.4 CBC 2007 1122B.4 CBC 2016 11B-904.4 Mitigated: <input type="radio"/> YES <input checked="" type="radio"/> NO	1	JOB	\$6,000	\$6,000

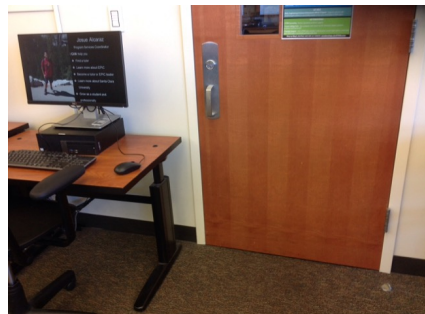
Item no., Rm no. and Name	Existing Architectural Barrier and Proposed Solution	Codes / Mitigation Info	Qty	Unit	Cost	Total
<u>Door Swing</u>						
23	<ul style="list-style-type: none">• <i>As-Built Description:</i> Front approach: At pull side, door does not have clear and level maneuvering space measuring door width plus 18" x 60". (24" x 60" at exterior doors).• <i>Proposed Solution:</i> Remove or relocate furniture or storage items.	<p>PCODE ID23A</p> <p>ADAAG 91 Fig. 25(a)</p> <p>ADA 2010 404.2.4</p> <p>CBC 2007 11B-26A(a)</p> <p>CBC 2016 11B-404.2.4</p> <p>Mitigated:</p> <p><input type="radio"/> YES</p> <p><input checked="" type="radio"/> NO</p>	1	JOB	\$150	\$150

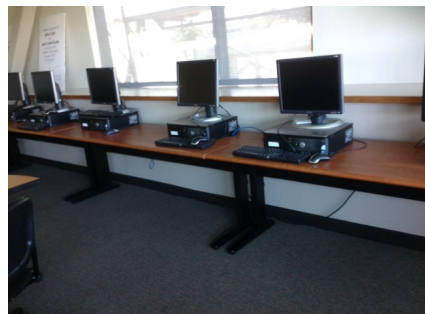
<u>Non-Fixed Desk</u>						
24	<ul style="list-style-type: none">• <i>As-Built Description:</i> Accessible non-fixed table or desk (top 28" to 34" high; knee space at least 27" high x 19" deep x 30" wide) not provided.• <i>As-Built:</i> 26" knee space• <i>Proposed Solution:</i> Provide table or desk with accessible dimensions when purchasing new furniture.	<p>PCODE IN02A</p> <p>ADAAG 91 4.32.3 & .4</p> <p>ADA 2010 306.1</p> <p>CBC 2007 1122B.3 & 4</p> <p>CBC 2016 11B-306.1 & 11B-902.3</p> <p>Mitigated:</p> <p><input type="radio"/> YES</p> <p><input checked="" type="radio"/> NO</p>	1	JOB	\$4,800	\$4,800

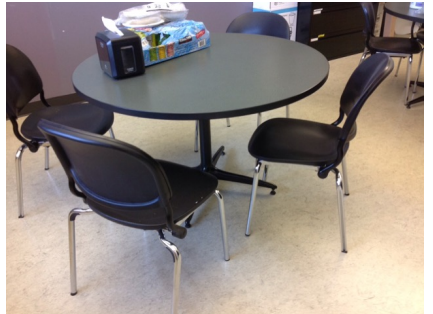
Item no., Rm no. and Name	Existing Architectural Barrier and Proposed Solution	Codes / Mitigation Info	Qty	Unit	Cost	Total
26	<ul style="list-style-type: none"> • <i>As-Built Description:</i> Accessible non-fixed table or desk (top 28" to 34" high; knee space at least 27" high x 19" deep x 30" wide) not provided. • <i>Proposed Solution:</i> Provide table or desk with accessible dimensions when purchasing new furniture. 	PCODE IN02A ADAAG 91 4.32.3 & .4 ADA 2010 306.1 CBC 2007 1122B.3 & 4 CBC 2016 11B-306.1 & 11B-902.3 Mitigated: <input type="radio"/> YES <input checked="" type="radio"/> NO	1	JOB	\$4,800	\$4,800

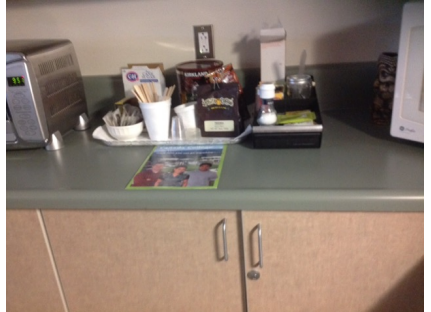
Item no., Rm no. and Name	Existing Architectural Barrier and Proposed Solution	Codes / Mitigation Info	Qty	Unit	Cost	Total
Reach Range						
30	<ul style="list-style-type: none"> As-Built Description: Reach height to control or access point, exceeds 48" or is less than 15". As-Built: 26" deep Proposed Solution: Modify equipment or mounting. 	PCODE IE01 ADAAG 91 4.2.5 ADA 2010 308.2.1 CBC 2007 1118B.5 CBC 2016 11B-308.2.1 Mitigated: <input type="radio"/> YES <input checked="" type="radio"/> NO	1	JOB	\$300	\$300

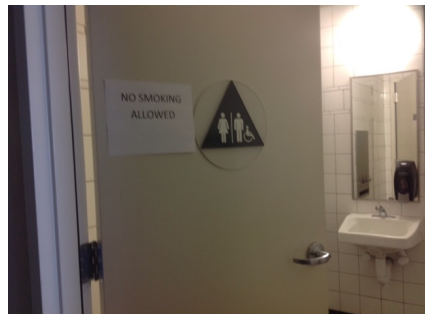
Item no., Rm no. and Name	Existing Architectural Barrier and Proposed Solution	Codes / Mitigation Info	Qty	Unit	Cost	Total
Signage						
31	<ul style="list-style-type: none">As-Built Description: Required in CA only: identification symbol centered 58" to 60" high on sanitary facility door that contrasts with the door not provided (women: 12" ø circle, men: 12" triangle, unisex: combined symbol).As-Built: No contrastProposed Solution: Provide properly mounted sanitary facility symbol when altering area. If wheelchair accessible, include International Symbol of Accessibility on sign.	<p>PCODE SA15</p> <p>CBC 2007 1115B.6</p> <p>CBC 2016 11B-703.7.2.6</p> <p>Mitigated:</p> <p><input type="radio"/> YES</p> <p><input checked="" type="radio"/> NO</p>	1	JOB	\$270	\$270

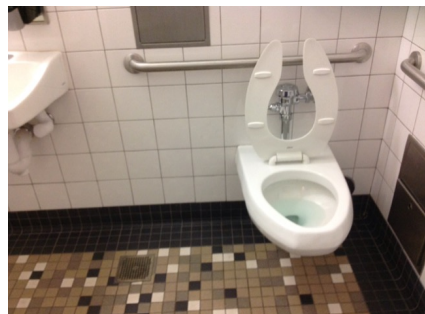
<input type="checkbox"/> Staff Only			
			Priority 3 Severity 3			
Toilet Stall						
34	<ul style="list-style-type: none">As-Built Description: Toilet stall less than 60" wide.As-Built: 55" wideProposed Solution: Provide new accessible stall.Notes: 28" between WC and lavatory	<p>PCODE WB06</p> <p>ADAAG 91 4.17.3</p> <p>ADA 2010 604.8.1.1</p> <p>CBC 2007 1115B.3.1.4.1</p> <p>CBC 2016 11B-604.8.1.1</p> <p>Mitigated:</p> <p><input type="radio"/> YES</p> <p><input checked="" type="radio"/> NO</p>	1	JOB	\$4,500	\$4,500

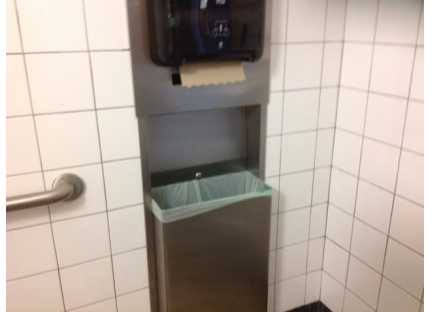
Item no., Rm no. and Name	Existing Architectural Barrier and Proposed Solution	Codes / Mitigation Info	Qty	Unit	Cost	Total
<u>Accessories</u>						
33	<ul style="list-style-type: none"> • <i>As-Built Description:</i> Dispensers in sanitary facilities, such as for towels, soap, sanitary napkins, seat covers, etc., and waste receptacles more than 48" (CA only: 40") from floor to highest operating slot or control. • <i>As-Built:</i> 45" high • <i>Proposed Solution:</i> Relocate existing restroom accessories. 	PCODE WG01A ADAAG 91 4.23.7 ADA 2010 308.2.1 CBC 2007 1115B.8.3 CBC 2016 11B-603.5 Mitigated: <input type="radio"/> YES <input checked="" type="radio"/> NO	1	JOB	\$300	\$300

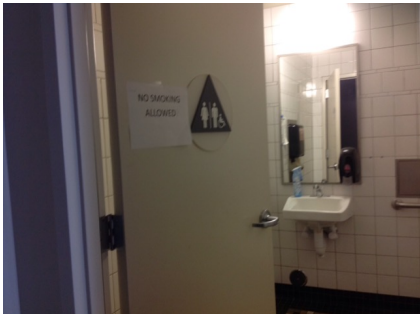
Item no., Rm no. and Name	Existing Architectural Barrier and Proposed Solution	Codes / Mitigation Info	Qty	Unit	Cost	Total
Signage						
36	<ul style="list-style-type: none">As-Built Description: Required in CA only: identification symbol centered 58" to 60" high on sanitary facility door that contrasts with the door not provided (women: 12" ø circle, men: 12" triangle, unisex: combined symbol).As-Built: No contrastProposed Solution: Provide properly mounted sanitary facility symbol when altering area. If wheelchair accessible, include International Symbol of Accessibility on sign.	PCODE SA15 CBC 2007 1115B.6 CBC 2016 11B-703.7.2.6 Mitigated: <div><input type="radio"/> YES</div> <div><input checked="" type="radio"/> NO</div>	1	JOB	\$270	\$270

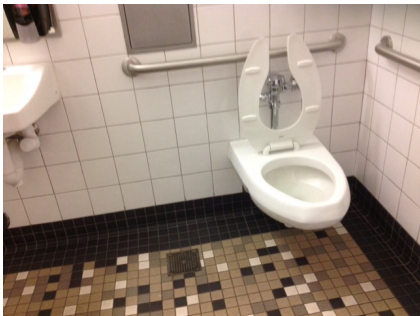
40	<ul style="list-style-type: none">As-Built Description: Toilet stall less than 60" wide.As-Built: 55" wideProposed Solution: Provide new accessible stall.Notes: 28" between WC and lavatory	PCODE WB06 ADAAG 91 4.17.3 ADA 2010 604.8.1.1 CBC 2007 1115B.3.1.4.1 CBC 2016 11B-604.8.1.1 Mitigated: <div><input type="radio"/> YES</div> <div><input checked="" type="radio"/> NO</div>	1	JOB	\$4,500	\$4,500

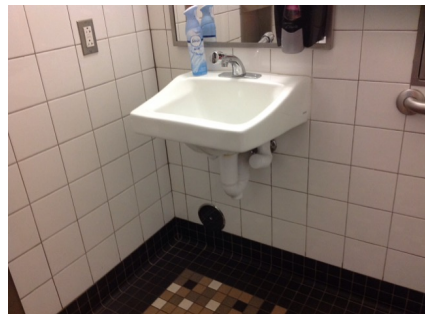
Item no., Rm no. and Name	Existing Architectural Barrier and Proposed Solution	Codes / Mitigation Info	Qty	Unit	Cost	Total
Lavatory						
38	<ul style="list-style-type: none">• <i>As-Built Description:</i> Clear floor space, 30" x 48" in front of fixture, extending 19" max. under the lavatory, not provided (CA only: Less than 18" from side wall to centerline of lavatory).• <i>As-Built:</i> 17.5" o.c.• <i>Proposed Solution:</i> Provide new accessible lavatory. Remodel restroom as needed.	<p>PCODE WD01</p> <p>ADAAG 91 4.19.3</p> <p>ADA 2010 606.2</p> <p>CBC 2007 1115B.4.3</p> <p>CBC 2016 11B-606.2, 11B-606.6</p> <p>Mitigated:</p> <p><input type="radio"/> YES</p> <p><input checked="" type="radio"/> NO</p>	1	JOB	\$10,200	\$10,200

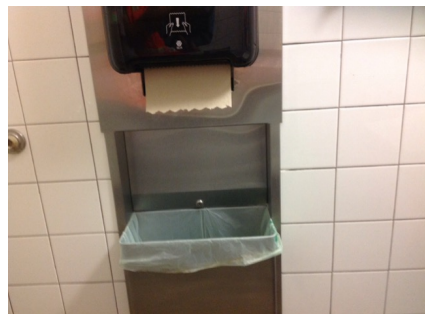
<input type="checkbox"/> Staff Only			
			<div><div>Priority</div><div>3</div></div> <div><div>Severity</div><div>2</div></div>			
Accessories						
39	<ul style="list-style-type: none">• <i>As-Built Description:</i> Dispensers in sanitary facilities, such as for towels, soap, sanitary napkins, seat covers, etc., and waste receptacles more than 48" (CA only: 40") from floor to highest operating slot or control.• <i>As-Built:</i> 45" high• <i>Proposed Solution:</i> Relocate existing restroom accessories.	<p>PCODE WG01A</p> <p>ADAAG 91 4.23.7</p> <p>ADA 2010 308.2.1</p> <p>CBC 2007 1115B.8.3</p> <p>CBC 2016 11B-603.5</p> <p>Mitigated:</p> <p><input type="radio"/> YES</p> <p><input checked="" type="radio"/> NO</p>	1	JOB	\$300	\$300

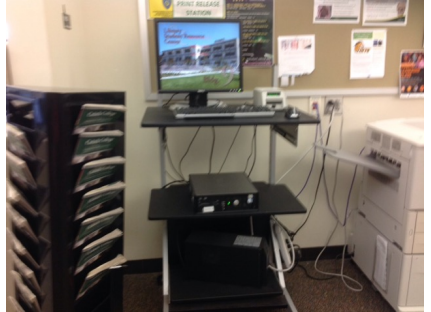
Item no., Rm no. and Name	Existing Architectural Barrier and Proposed Solution	Codes / Mitigation Info	Qty	Unit	Cost	Total
<u>Non-Fixed Desk</u>						
47	<ul style="list-style-type: none"> • <i>As-Built Description:</i> Accessible non-fixed table or desk (top 28" to 34" high; knee space at least 27" high x 19" deep x 30" wide) not provided. • <i>Proposed Solution:</i> Provide table or desk with accessible dimensions when purchasing new furniture. 	PCODE IN02A ADAAG 91 4.32.3 & .4 ADA 2010 306.1 CBC 2007 1122B.3 & 4 CBC 2016 11B-306.1 & 11B-902.3	1	JOB	\$4,800	\$4,800
Mitigated: <input type="radio"/> YES <input checked="" type="radio"/> NO

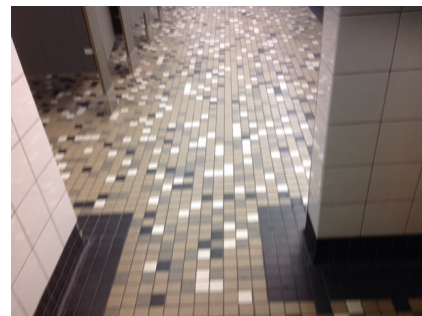
• *As-Built Description:*Clear passage width (except doorways) from rest
room entry to accessible water closet compartment
less than 36" (CA only: 44" wide).• *As-Built:* **36" wide**• *Proposed Solution:*Modify facility passage to be min. 44" wide.
Demolish existing partition and replace.

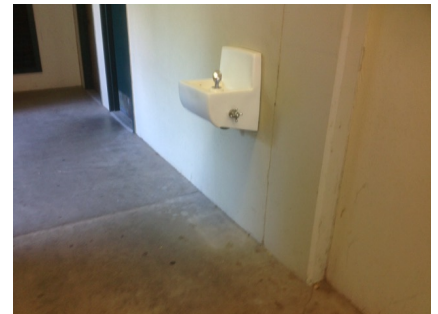
- 6
- *As-Built Description:*
Where only one drinking fountain is provided per floor: Fountain is not accessible to individuals who use wheelchairs, or to those who have difficulty bending or stooping.
 - *Proposed Solution:*
Provide additional fountain or hi-lo combination fountain.
