SMCCCD - Cañada College

Appendix H: Facilities

Access Compliance Survey Report

Building 2 - Bookstore

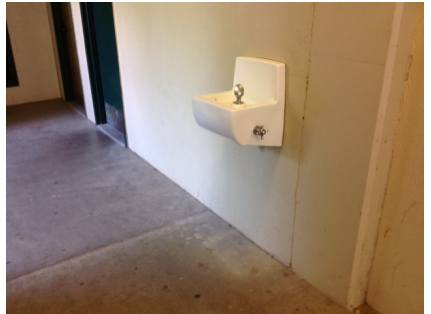
Item no., Rm no. and Name	Existing Architectural Barrier and Proposed Solution	Codes / Mitigation Info	Qty	Unit	Cost	Total
7	<ul style="list-style-type: none"> • <i>As-Built Description:</i> Drinking fountain lacks protection for visually impaired persons. • <i>Proposed Solution:</i> Provide cane-detectable rails. 	PCODE IA05C ADAAG 91 4.4.1 ADA 2010 307.2 CBC 2007 1115B.4.6.3 CBC 2016 11B-307.2 Mitigated: <input type="radio"/> YES <input checked="" type="radio"/> NO	1	JOB	\$1,500	\$1,500

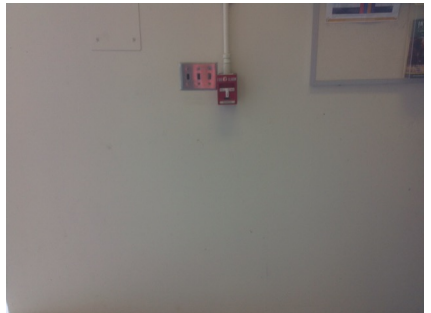
4	<ul style="list-style-type: none"> • <i>As-Built Description:</i> Reach height to control or access point, exceeds 48" or is less than 15". • <i>As-Built:</i> 48.5" AFF • <i>Proposed Solution:</i> Modify equipment or mounting. • <i>Notes:</i> Fire alarm pull 	PCODE IE01 ADAAG 91 4.2.5 ADA 2010 308.2.1 CBC 2007 1118B.5 CBC 2016 11B-308.2.1 Mitigated: <input type="radio"/> YES <input checked="" type="radio"/> NO	2	JOB	\$300	\$600

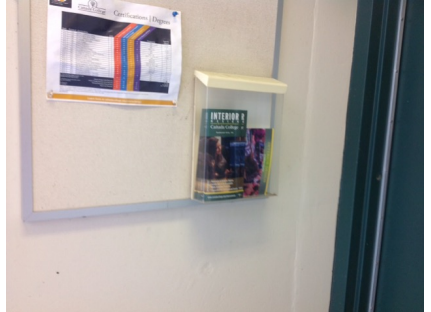
Item no., Rm no. and Name	Existing Architectural Barrier and Proposed Solution	Codes / Mitigation Info	Qty	Unit	Cost	Total
Brochure Bins						
8	<ul style="list-style-type: none"> • <i>As-Built Description:</i> Information brochure bins mounted above accessible height of 48". • <i>As-Built:</i> 60" AFF • <i>Proposed Solution:</i> Relocate/remount bins at accessible height. 	PCODE IN08 ADAAG 91 4.2.5 & 6 ADA 2010 308.2.1 CBC 2007 1118B.5 CBC 2016 11B-308.2.1 Mitigated: <input type="radio"/> YES <input checked="" type="radio"/> NO	1	JOB	\$300	\$300

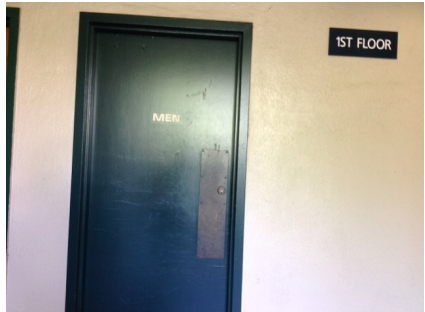
Item no., Rm no. and Name	Existing Architectural Barrier and Proposed Solution	Codes / Mitigation Info	Qty	Unit	Cost	Total
10	<ul style="list-style-type: none"> As-Built Description: Required in CA only: identification symbol centered 58" to 60" high on sanitary facility door that contrasts with the door not provided (women: 12" ø circle, men: 12" triangle, unisex: combined symbol). Proposed Solution: Provide properly mounted sanitary facility symbol when altering area. If wheelchair accessible, include International Symbol of Accessibility on sign. 	PCODE SA15REF CBC 2007 1115B.6 CBC 2016 11B-703.7.2.6 Mitigated: <input type="radio"/> YES <input checked="" type="radio"/> NO				
<div>REF</div> <div>

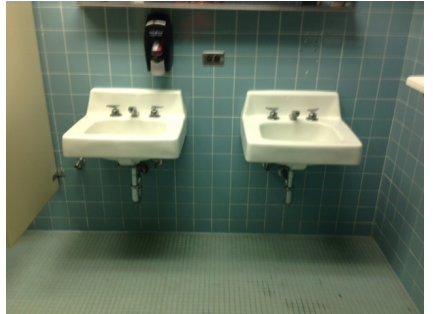
Item no., Rm no. and Name	Existing Architectural Barrier and Proposed Solution	Codes / Mitigation Info	Qty	Unit	Cost	Total
<u>Lavatory</u>						
13	<ul style="list-style-type: none"> • <i>As-Built Description:</i> Wheelchair clearance under lavatory apron or lavatory counter front edge less than 29" high. • <i>As-Built:</i> 27" knee height • <i>Proposed Solution:</i> Provide new accessible lavatory. Remodel restroom as needed. 	PCODE WD03REF ADAAG 91 4.19.2 ADA 2010 606.3 CBC 2007 1115B.4.3.3 CBC 2016 11B-306.3.1				
		Mitigated: <input type="radio"/> YES <input checked="" type="radio"/> NO				
					REF

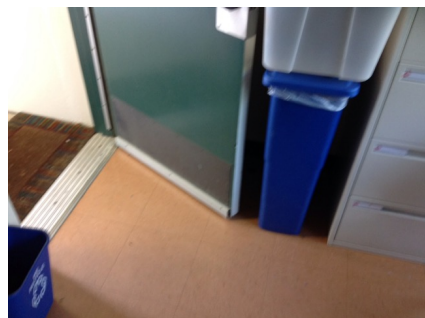
Item no., Rm no. and Name	Existing Architectural Barrier and Proposed Solution	Codes / Mitigation Info	Qty	Unit	Cost	Total
Door Swing						
16	<ul style="list-style-type: none">• <i>As-Built Description:</i> Front approach: At pull side, door does not have clear and level maneuvering space measuring door width plus 18" x 60". (24" x 60" at exterior doors).• <i>Proposed Solution:</i> Remove or relocate furniture or storage items.	<p>PCODE ID23A</p> <p>ADAAG 91 Fig. 25(a)</p> <p>ADA 2010 404.2.4</p> <p>CBC 2007 11B-26A(a)</p> <p>CBC 2016 11B-404.2.4</p> <p>Mitigated:</p> <p><input type="radio"/> YES</p> <p><input checked="" type="radio"/> NO</p>	2	JOB	\$150	\$300

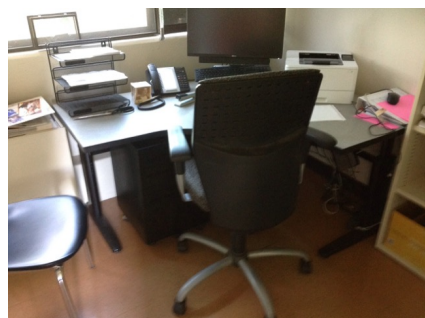
<input type="checkbox"/> Staff Only			
			Priority		Severity	
			2		2	
Non-Fixed Desk						
17	<ul style="list-style-type: none">• <i>As-Built Description:</i> Accessible non-fixed table or desk (top 28" to 34" high; knee space at least 27" high x 19" deep x 30" wide) not provided.• <i>As-Built:</i> 25"• <i>Proposed Solution:</i> Provide table or desk with accessible dimensions when purchasing new furniture.• <i>Notes:</i> Adjustable desk used by staff.	<p>PCODE IN02A</p> <p>ADAAG 91 4.32.3 & .4</p> <p>ADA 2010 306.1</p> <p>CBC 2007 1122B.3 & 4</p> <p>CBC 2016 11B-306.1 & 11B-902.3</p> <p>Mitigated:</p> <p><input type="radio"/> YES</p> <p><input checked="" type="radio"/> NO</p>	3	JOB	\$4,800	\$14,400

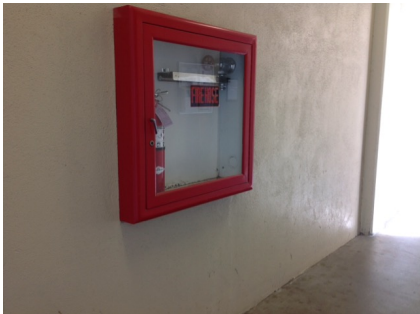
Item no., Rm no. and Name	Existing Architectural Barrier and Proposed Solution	Codes / Mitigation Info	Qty	Unit	Cost	Total
Protrusion Limits						
22	<ul style="list-style-type: none">As-Built Description: Protruding objects more than 4" from wall, when bottom of object more than 27" or less than 80" above finished floor.As-Built: Fire hose compartment 5" protrusion at 40" high.Proposed Solution: Provide cane-detectable railing to mark area of low clearance.	<p>PCODE EG04A</p> <p>ADAAG 91 4.4.1</p> <p>ADA 2010 307.2</p> <p>CBC 2007 1133B.8.6.1</p> <p>CBC 2016 11B-307.2</p> <p>Mitigated:</p> <p><input type="radio"/> YES</p> <p><input checked="" type="radio"/> NO</p>	6	LF	\$300	\$1,800

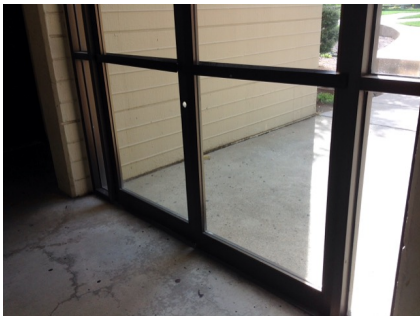
Door						
25	<ul style="list-style-type: none">As-Built Description: At push side of door on accessible route, bottom 10" does not have a smooth, uninterrupted surface.As-Built: 3" high kick plateProposed Solution: Provide 10" min. "kick plate" covering width of door when altering area.	<p>PCODE ID06</p> <p>ADA 2010 404.2.10</p> <p>CBC 2007 1133B.2.6</p> <p>CBC 2016 11B-404.2.10</p> <p>Mitigated:</p> <p><input type="radio"/> YES</p> <p><input checked="" type="radio"/> NO</p>	1	JOB	\$300	\$300

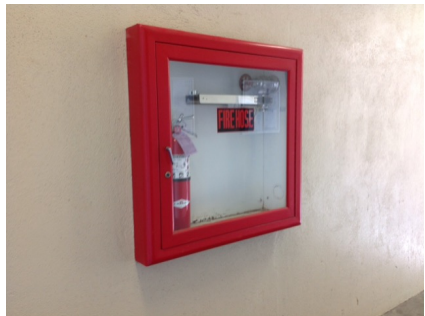
Item no., Rm no. and Name	Existing Architectural Barrier and Proposed Solution	Codes / Mitigation Info	Qty	Unit	Cost	Total
23	<ul style="list-style-type: none"> As-Built Description: Reach height to control or access point, exceeds 48" or is less than 15". As-Built: 50" AFF Proposed Solution: Modify equipment or mounting. Notes: Latch to open fire extinguisher cabinet 	PCODE IE01 ADAAG 91 4.2.5 ADA 2010 308.2.1 CBC 2007 1118B.5 CBC 2016 11B-308.2.1 Mitigated: <input type="radio"/> YES <input checked="" type="radio"/> NO	1	JOB	\$300	\$300

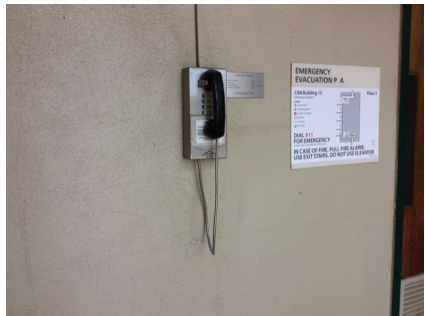
<input type="checkbox"/> Staff Only Priority 2 Severity 4						
24	<ul style="list-style-type: none"> As-Built Description: Reach height to control or access point, exceeds 48" or is less than 15". As-Built: 60" AFF Proposed Solution: Modify equipment or mounting. 	PCODE IE01 ADAAG 91 4.2.5 ADA 2010 308.2.1 CBC 2007 1118B.5 CBC 2016 11B-308.2.1 Mitigated: <input type="radio"/> YES <input checked="" type="radio"/> NO	1	JOB	\$300	\$300

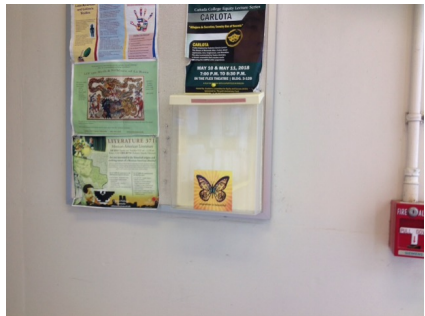
<input type="checkbox"/> Staff Only Priority 2 Severity 2						
Brochure Bins						
21	<ul style="list-style-type: none"> As-Built Description: Information brochure bins mounted above accessible height of 48". As-Built: 60" AFF Proposed Solution: Relocate/remount bins at accessible height. 	PCODE IN08 ADAAG 91 4.2.5 & 6 ADA 2010 308.2.1 CBC 2007 1118B.5 CBC 2016 11B-308.2.1 Mitigated: <input type="radio"/> YES <input checked="" type="radio"/> NO	1	JOB	\$300	\$300

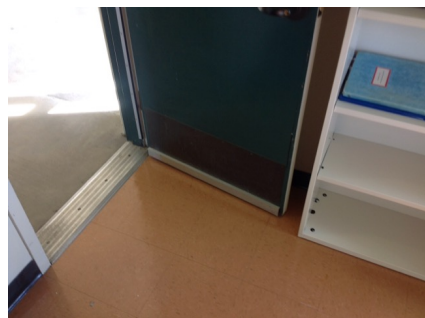
Item no., Rm no. and Name	Existing Architectural Barrier and Proposed Solution	Codes / Mitigation Info	Qty	Unit	Cost	Total
Door Swing						
30	<ul style="list-style-type: none">• <i>As-Built Description:</i> Front approach: At pull side, door does not have clear and level maneuvering space measuring door width plus 18" x 60". (24" x 60" at exterior doors).• <i>Proposed Solution:</i> Remove or relocate furniture or storage items.	<p>PCODE ID23A</p> <p>ADAAG 91 Fig. 25(a)</p> <p>ADA 2010 404.2.4</p> <p>CBC 2007 11B-26A(a)</p> <p>CBC 2016 11B-404.2.4</p> <p>Mitigated:</p> <p><input type="radio"/> YES</p> <p><input checked="" type="radio"/> NO</p>	1	JOB	\$150	\$150

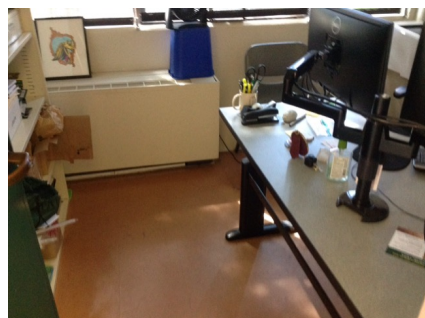
<input type="checkbox"/> Staff Only			
			Priority 2 Severity 3			
Turn Space						
32	<ul style="list-style-type: none">• <i>As-Built Description:</i> Less than 60" diameter or T-shaped space provided for wheelchair turns.• <i>Proposed Solution:</i> Retrofit space to provide 60" diameter or T-turn.• <i>Notes:</i> No 60" turning space is provided. If no students or public visit offices for office hours, a 60" circle does not need to be maintained.	<p>PCODE IN04</p> <p>ADAAG 91 4.2.3</p> <p>ADA 2010 304.1</p> <p>CBC 2007 1118B.3</p> <p>CBC 2016 11B-304.1</p> <p>Mitigated:</p> <p><input type="radio"/> YES</p> <p><input checked="" type="radio"/> NO</p>	1	JOB	\$2,775	\$2,775

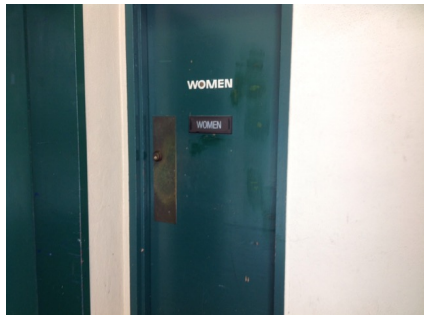
Item no., Rm no. and Name	Existing Architectural Barrier and Proposed Solution	Codes / Mitigation Info	Qty	Unit	Cost	Total
Signage						
33	<ul style="list-style-type: none"> • <i>As-Built Description:</i> Entrance to toilet or bathing facility identified with California signage on door leaf not identified with ADAAG compliant signage. • <i>Proposed Solution:</i> Provide ADAAG compliant sign with raised letters and pictogram, mounted 5' high on center on nearest adjacent wall, on latch side of a single door. 	PCODE SA11AREF ADAAG 91 4.1.3(16)(a) ADA 2010 216.8 CBC 2016 11B-216.8 Mitigated: <input type="radio"/> YES <input checked="" type="radio"/> NO				
			REF

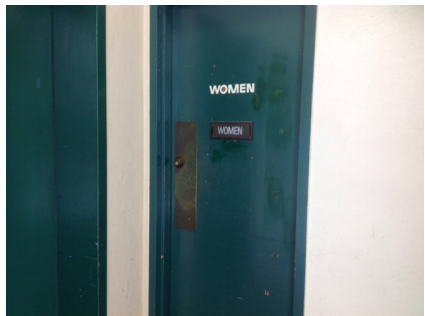
<input type="checkbox"/> Staff Only			
			Priority		Severity	
			3		3	
34	<ul style="list-style-type: none"> • <i>As-Built Description:</i> Required in CA only: identification symbol centered 58" to 60" high on sanitary facility door that contrasts with the door not provided (women: 12" ø circle, men: 12" triangle, unisex: combined symbol). • <i>Proposed Solution:</i> Provide properly mounted sanitary facility symbol when altering area. If wheelchair accessible, include International Symbol of Accessibility on sign. 	PCODE SA15REF CBC 2007 1115B.6 CBC 2016 11B-703.7.2.6 Mitigated: <input type="radio"/> YES <input checked="" type="radio"/> NO

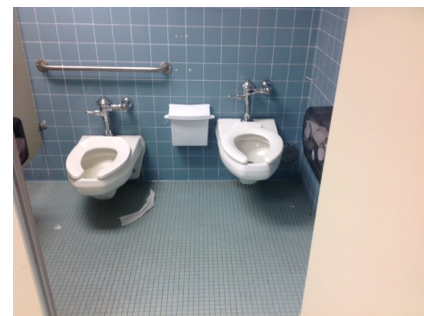
Multiple accommodation restroom not accessible;
multiple compliance violations.

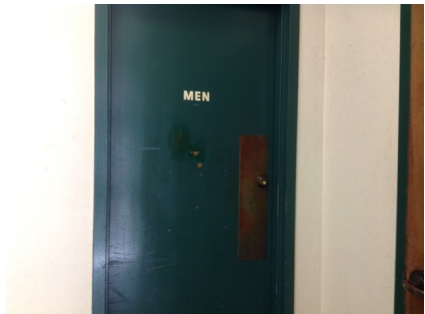
Item no., Rm no. and Name	Existing Architectural Barrier and Proposed Solution	Codes / Mitigation Info	Qty	Unit	Cost	Total
37	<ul style="list-style-type: none"> As-Built Description: Required in CA only: identification symbol centered 58" to 60" high on sanitary facility door that contrasts with the door not provided (women: 12" ø circle, men: 12" triangle, unisex: combined symbol). Proposed Solution: Provide properly mounted sanitary facility symbol when altering area. If wheelchair accessible, include International Symbol of Accessibility on sign. 	PCODE SA15 CBC 2007 1115B.6 CBC 2016 11B-703.7.2.6 Mitigated: <input type="radio"/> YES <input checked="" type="radio"/> NO	1	JOB	\$270	\$270

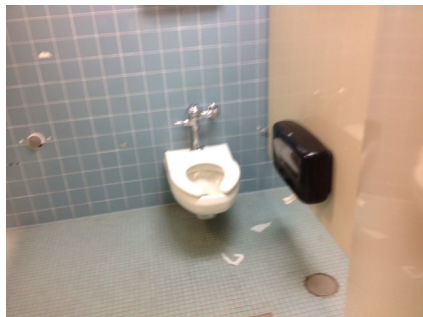
48	<ul style="list-style-type: none"> As-Built Description: Grab bars not provided or are not code compliant. Proposed Solution: Provide accessible grab bars. 	PCODE WB07 ADAAG 91 4.17.6 ADA 2010 604.5 CBC 2007 1115B.4.1.3 CBC 2016 11B-604.5 Mitigated: <input type="radio"/> YES <input checked="" type="radio"/> NO	1	JOB	\$1,500	\$1,500

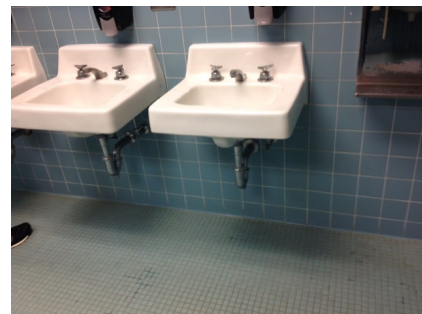
Item no., Rm no. and Name	Existing Architectural Barrier and Proposed Solution	Codes / Mitigation Info	Qty	Unit	Cost	Total
44	<ul style="list-style-type: none"> • <i>As-Built Description:</i> Hot or sharp-surfaced water/drain pipe not insulated or covered. • <i>Proposed Solution:</i> Insulate or cover water/drain pipe. 	PCODE WD05 ADAAG 91 4.19.4 ADA 2010 606.5 CBC 2007 1115B.4.3.4 CBC 2016 11B-606.5 Mitigated: <input type="radio"/> YES <input checked="" type="radio"/> NO	1	JOB	\$360	\$360

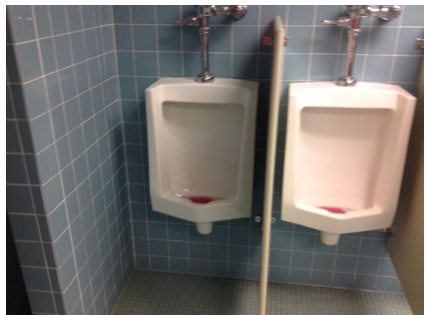
<input type="checkbox"/> Staff Only Priority 3 Severity 2						
<hr/>						
41	<ul style="list-style-type: none"> • <i>As-Built Description:</i> Urinal flush control lever more than 48" above floor. (CA Only: 44" max.) • <i>As-Built:</i> 50" AFF • <i>Proposed Solution:</i> Provide accessible urinal flush control. 	PCODE WE03 ADAAG 91 4.18.4 ADA 2010 605.4 CBC 2007 1115B.4.2.2 CBC 2016 11B-605.4 Mitigated: <input type="radio"/> YES <input checked="" type="radio"/> NO	1	JOB	\$1,500	\$1,500

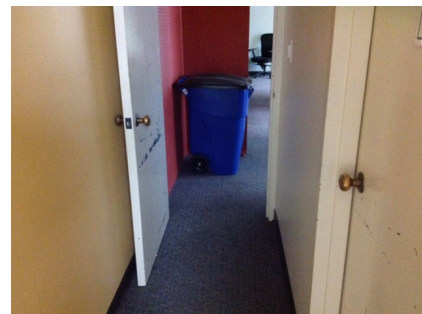
Item no., Rm no. and Name	Existing Architectural Barrier and Proposed Solution	Codes / Mitigation Info	Qty	Unit	Cost	Total
56	<ul style="list-style-type: none"> As-Built Description: Front approach: At push side, door does not have clear and level maneuvering space measuring door width x 48" (door width plus 12" if door has both, latch and closer). As-Built: 10" Proposed Solution: Provide door operator. Notes: Or remove closer or latch 	PCODE ID24C ADAAG 91 Fig. 25(a) ADA 2010 404.2.4 CBC 2007 11B-26A(a) CBC 2016 11B-404.2.4 Mitigated: <input type="radio"/> YES <input checked="" type="radio"/> NO	1	JOB	\$15,000	\$15,000

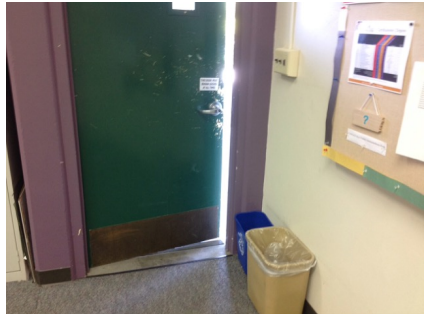
55	<ul style="list-style-type: none"> As-Built Description: Door inaccessible due to threshold or step at door exceeding 1/2". As-Built: 0.75" Proposed Solution: Modify threshold to be no more than 1/2" by removing existing paving at door and providing landing with edge ramping (slope 1:20 max). 	PCODE ID02A ADAAG 91 4.13.8 ADA 2010 404.2.5 CBC 2007 1133B.2.4.1 CBC 2016 11B-404.2.5 Mitigated: <input type="radio"/> YES <input checked="" type="radio"/> NO	2	JOB	\$1,200	\$2,400

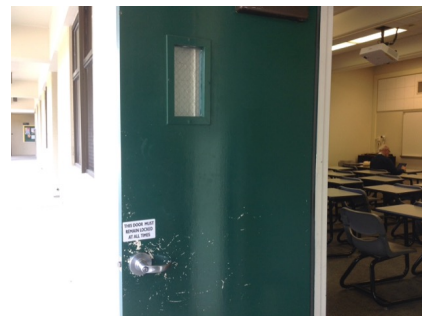
Item no., Rm no. and Name	Existing Architectural Barrier and Proposed Solution	Codes / Mitigation Info	Qty	Unit	Cost	Total
Door Swing						
65	<ul style="list-style-type: none">As-Built Description: Front approach: At push side, door does not have clear and level maneuvering space measuring door width x 48" (door width plus 12" if door has both, latch and closer).As-Built: 9"Proposed Solution: Provide door operator.	<p>PCODE ID24C</p> <p>ADAAG 91 Fig. 25(a)</p> <p>ADA 2010 404.2.4</p> <p>CBC 2007 11B-26A(a)</p> <p>CBC 2016 11B-404.2.4</p> <p>Mitigated:</p> <p><input type="radio"/> YES</p> <p><input checked="" type="radio"/> NO</p>	2	JOB	\$15,000	\$30,000

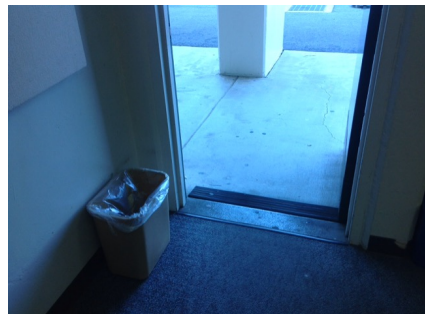
<input type="checkbox"/> Staff Only			
			Priority	Severity		
			<input checked="" type="radio"/> 2	<input checked="" type="radio"/> 4		
Door Threshold						
63	<ul style="list-style-type: none">As-Built Description: Door inaccessible due to threshold or step at door exceeding 1/2".As-Built: 1" AFFProposed Solution: Modify threshold to be no more than 1/2" by removing existing paving at door and providing landing with edge ramping (slope 1:20 max).	<p>PCODE ID02A</p> <p>ADAAG 91 4.13.8</p> <p>ADA 2010 404.2.5</p> <p>CBC 2007 1133B.2.4.1</p> <p>CBC 2016 11B-404.2.5</p> <p>Mitigated:</p> <p><input type="radio"/> YES</p> <p><input checked="" type="radio"/> NO</p>	2	JOB	\$1,200	\$2,400

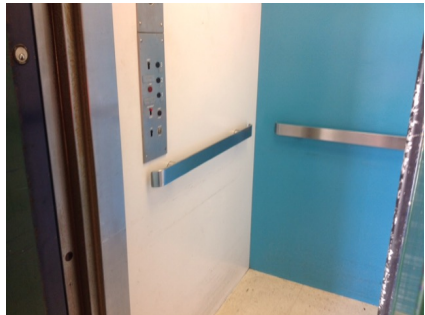
<input type="checkbox"/> Staff Only			
			Priority 2 Severity 3			
74	<ul style="list-style-type: none"> As-Built Description: The button for the main entry floor is not designated by a raised star. Proposed Solution: Provide a raise star to the left of the main entry floor button located on the control panel. 	PCODE IK07EREF ADAAG 91 4.10.12(2) ADA 2010 407.4.7.1.3 CBC 2007 1116B.1.9 CBC 2016 11B-407.4.7.1.3 Mitigated: <input type="radio"/> YES <input checked="" type="radio"/> NO		REF

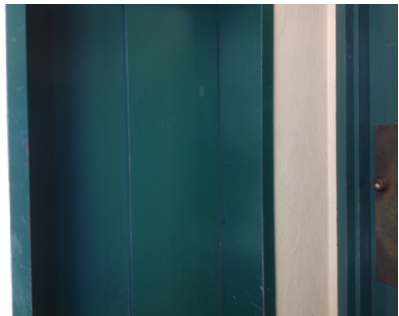
<input type="checkbox"/> Staff Only			
			Priority 2 Severity 3			
68	<ul style="list-style-type: none"> As-Built Description: Visual hall lantern, minimum 2-1/2" x 2-1/2", not provided, or installed less than 72" above floor. Proposed Solution: Provide or raise proper visual hall lantern for elevator. 	PCODE IK10A ADAAG 91 4.10.4(1) ADA 2010 407.2.2.2 CBC 2007 1116B.1.13 CBC 2016 11B-407.2.2.2 Mitigated: <input type="radio"/> YES <input checked="" type="radio"/> NO	1	JOB	\$4,650	\$4,650

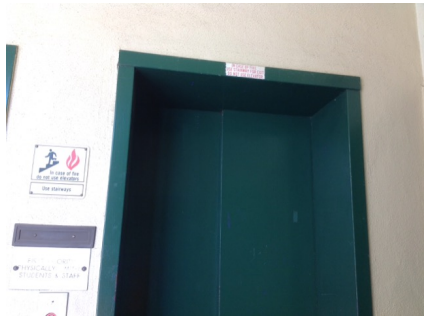
Item no., Rm no. and Name	Existing Architectural Barrier and Proposed Solution	Codes / Mitigation Info	Qty	Unit	Cost	Total
75	<ul style="list-style-type: none"> As-Built Description: Audible signal not provided (one for up, two for down). Proposed Solution: Provide proper audible hall signal for elevator. 	PCODE IK10B ADAAG 91 4.10.4 ADA 2010 407.2.2.3 CBC 2007 1116B.1.13 CBC 2016 11B-407.2.2.3 Mitigated: <input type="radio"/> YES <input checked="" type="radio"/> NO	1	JOB	\$4,650	\$4,650

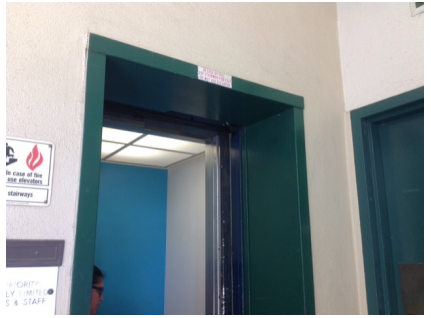
<input type="checkbox"/> Staff Only			
			Priority 2 Severity 3			
69	<ul style="list-style-type: none"> As-Built Description: Braille and raised floor numbers on entrance jambs located more or less than 5' above floor. Proposed Solution: Relocate Braille and raised floor numbers on entrance jambs to 5' above floor. 	PCODE IK11C ADAAG 91 4.10.5 ADA 2010 703.4.1 CBC 2007 1116B.1.14 CBC 2016 11B-703.4.1 Mitigated: <input type="radio"/> YES <input checked="" type="radio"/> NO	6	JOB	\$360	\$2,160

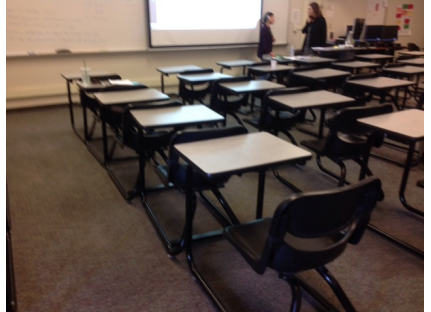
Item no., Rm no. and Name	Existing Architectural Barrier and Proposed Solution	Codes / Mitigation Info	Qty	Unit	Cost	Total
Non-Fixed Desk						
81	<ul style="list-style-type: none"> • <i>As-Built Description:</i> Accessible non-fixed table or desk (top 28" to 34" high; knee space at least 27" high x 19" deep x 30" wide) not provided. • <i>Proposed Solution:</i> Provide table or desk with accessible dimensions when purchasing new furniture. • <i>Notes:</i> 34 total seats with no accessible tables provided 	PCODE IN02A ADAAG 91 4.32.3 & .4 ADA 2010 306.1 CBC 2007 1122B.3 & 4 CBC 2016 11B-306.1 & 11B-902.3	1	JOB	\$4,800	\$4,800
Mitigated: <input type="radio"/> YES <input checked="" type="radio"/> NO

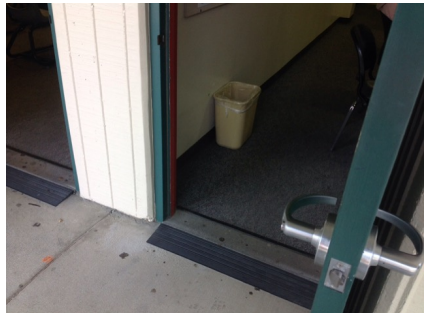
Item no., Rm no. and Name	Existing Architectural Barrier and Proposed Solution	Codes / Mitigation Info	Qty	Unit	Cost	Total
Door Swing						
86	<ul style="list-style-type: none"> As-Built Description: Front approach: At push side, door does not have clear and level maneuvering space measuring door width x 48" (door width plus 12" if door has both, latch and closer). As-Built: 9.5" Proposed Solution: Provide door operator. 	PCODE ID24C ADAAG 91 Fig. 25(a) ADA 2010 404.2.4 CBC 2007 11B-26A(a) CBC 2016 11B-404.2.4 Mitigated: <input type="radio"/> YES <input checked="" type="radio"/> NO	1	JOB	\$15,000	\$15,000

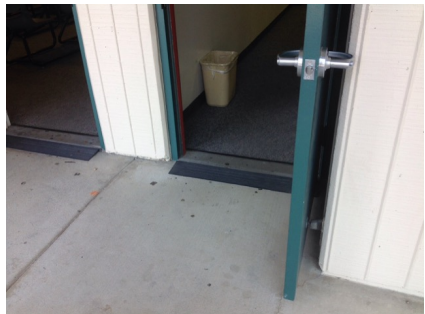
Door Threshold						
84	<ul style="list-style-type: none"> As-Built Description: Door inaccessible due to threshold or step at door exceeding 1/2". As-Built: 0.75" AFF Proposed Solution: Modify threshold to be no more than 1/2" by removing existing paving at door and providing landing with edge ramping (slope 1:20 max). 	PCODE ID02A ADAAG 91 4.13.8 ADA 2010 404.2.5 CBC 2007 1133B.2.4.1 CBC 2016 11B-404.2.5 Mitigated: <input type="radio"/> YES <input checked="" type="radio"/> NO	2	JOB	\$1,200	\$2,400

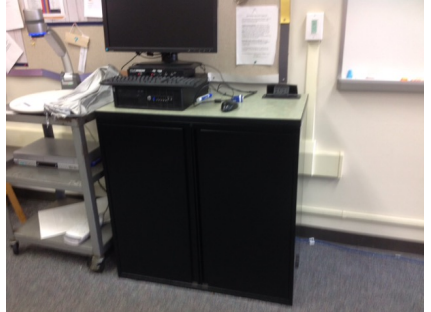
Item no., Rm no. and Name	Existing Architectural Barrier and Proposed Solution	Codes / Mitigation Info	Qty	Unit	Cost	Total
Public Counter						
114	<ul style="list-style-type: none"> As-Built Description: Service counter (stand-up): Accessible section min. 36" length and 36" max. height (in CA: 28" to 34" high) not provided. As-Built: 36" high to top of surface Proposed Solution: Retrofit existing counter to provide accessible section. Interim solution: Provide auxiliary counter, table, or clipboard. Notes: Teacher's work station. Unsure if students use this for presentations. 	PCODE IN03 ADAAG 91 7.2(2) ADA 2010 904.4 CBC 2007 1122B.4 CBC 2016 11B-904.4 Mitigated: <input type="radio"/> YES <input checked="" type="radio"/> NO	1	JOB	\$6,000	\$6,000

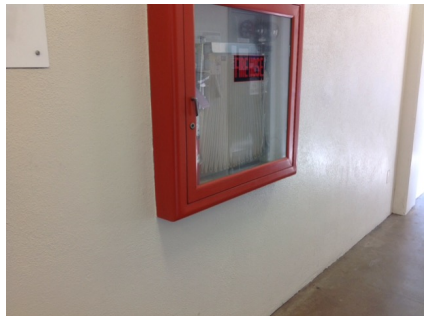
Item no., Rm no. and Name	Existing Architectural Barrier and Proposed Solution	Codes / Mitigation Info	Qty	Unit	Cost	Total
95	<ul style="list-style-type: none"> As-Built Description: Protruding objects more than 4" from wall, when bottom of object more than 27" or less than 80" above finished floor. As-Built: Fire extinguisher housing 4.5" protrusion at 40" high. Proposed Solution: Provide cane-detectable railing to mark area of low clearance. 	PCODE EG04A ADAAG 91 4.4.1 ADA 2010 307.2 CBC 2007 1133B.8.6.1 CBC 2016 11B-307.2 Mitigated: <input type="radio"/> YES <input checked="" type="radio"/> NO	6	LF	\$300	\$1,800

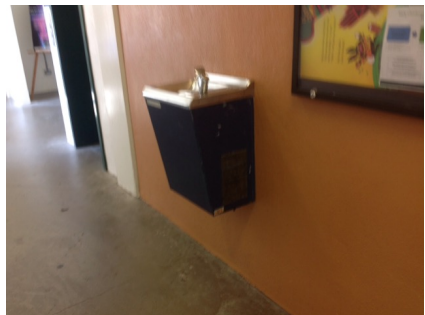
<div> <input type="checkbox"/> Staff Only </div> <div> Priority 2 Severity 4 </div>						
Drinking Fountain						
92	<ul style="list-style-type: none"> As-Built Description: Where only one drinking fountain is provided per floor: Fountain is not accessible to individuals who use wheelchairs, or to those who have difficulty bending or stooping. Proposed Solution: Provide additional fountain or hi-lo combination fountain. 	PCODE IA01A ADAAG 91 4.1.3(10)(a) ADA 2010 211.1 CBC 2007 1115B.4.6.1 CBC 2016 11B-211.1 Mitigated: <input type="radio"/> YES <input checked="" type="radio"/> NO	1	JOB	\$6,000	\$6,000

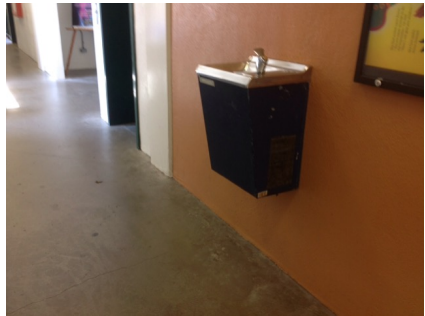
<div> <input type="checkbox"/> Staff Only </div> <div> Priority 3 Severity 2 </div>						
94	<ul style="list-style-type: none"> As-Built Description: Wall- and post-mounted cantilevered units: Knee space not provided at drinking fountain (27" high, 8" deep, 30" wide from front of drinking fountain). Proposed Solution: Provide new, accessible fountain. 	PCODE IA02REF ADAAG 91 4.15.5(1) ADA 2010 602.2 CBC 2007 1115B.4.6.2 CBC 2016 11B-602.2 Mitigated: <input type="radio"/> YES <input checked="" type="radio"/> NO	REF

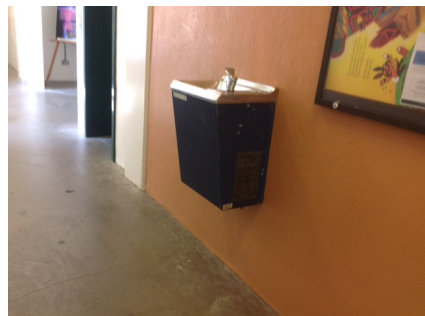
Item no., Rm no. and Name	Existing Architectural Barrier and Proposed Solution	Codes / Mitigation Info	Qty	Unit	Cost	Total
93	<ul style="list-style-type: none">As-Built Description: Drinking fountain lacks protection for visually impaired persons.Proposed Solution: Provide cane-detectable rails.	PCODE IA05C ADAAG 91 4.4.1 ADA 2010 307.2 CBC 2007 1115B.4.6.3 CBC 2016 11B-307.2 Mitigated: <div><input type="radio"/> YES</div> <div><input checked="" type="radio"/> NO</div>	1	JOB	\$1,500	\$1,500

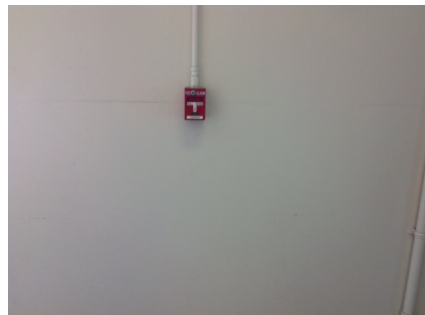
<div><input type="checkbox"/> Staff Only</div> <div>Priority <div>3</div>Severity <div>3</div></div>			
Reach Range						
90	<ul style="list-style-type: none">As-Built Description: Reach height to control or access point, exceeds 48" or is less than 15".As-Built: 49" AFFProposed Solution: Modify equipment or mounting.	PCODE IE01 ADAAG 91 4.2.5 ADA 2010 308.2.1 CBC 2007 1118B.5 CBC 2016 11B-308.2.1 Mitigated: <div><input type="radio"/> YES</div> <div><input checked="" type="radio"/> NO</div>	1	JOB	\$300	\$300

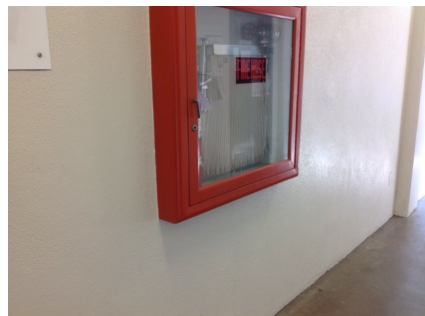
<div><input type="checkbox"/> Staff Only</div> <div>Priority <div>2</div>Severity <div>4</div></div>			
214	<ul style="list-style-type: none">As-Built Description: Reach height to control or access point, exceeds 48" or is less than 15".As-Built: 50" highProposed Solution: Modify equipment or mounting.	PCODE IE01 ADAAG 91 4.2.5 ADA 2010 308.2.1 CBC 2007 1118B.5 CBC 2016 11B-308.2.1 Mitigated: <div><input type="radio"/> YES</div> <div><input checked="" type="radio"/> NO</div>	1	JOB	\$300	\$300

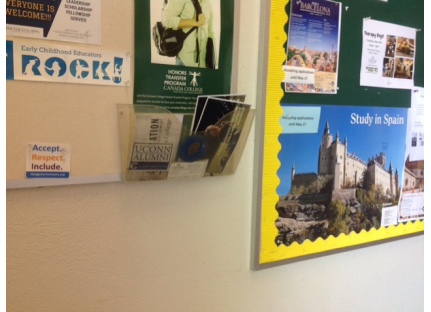
Item no., Rm no. and Name	Existing Architectural Barrier and Proposed Solution	Codes / Mitigation Info	Qty	Unit	Cost	Total
Brochure Bins						
91	<ul style="list-style-type: none"> • <i>As-Built Description:</i> Information brochure bins mounted above accessible height of 48". • <i>As-Built:</i> Brochures 54" AFF • <i>Proposed Solution:</i> Relocate/remount bins at accessible height. 	PCODE IN08 ADAAG 91 4.2.5 & 6 ADA 2010 308.2.1 CBC 2007 1118B.5 CBC 2016 11B-308.2.1 Mitigated: <input type="radio"/> YES <input checked="" type="radio"/> NO	1	JOB	\$300	\$300

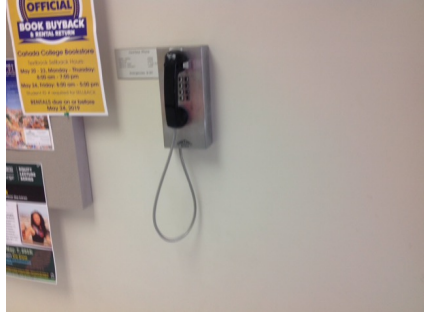
Item no., Rm no. and Name	Existing Architectural Barrier and Proposed Solution	Codes / Mitigation Info	Qty	Unit	Cost	Total
Reach Range						
98	<ul style="list-style-type: none"> • <i>As-Built Description:</i> Reach height to control or access point, exceeds 48" or is less than 15". • <i>As-Built:</i> 50" AFF • <i>Proposed Solution:</i> Modify equipment or mounting. 	PCODE IE01 ADAAG 91 4.2.5 ADA 2010 308.2.1 CBC 2007 1118B.5 CBC 2016 11B-308.2.1 Mitigated: <input type="radio"/> YES <input checked="" type="radio"/> NO	1	JOB	\$300	\$300

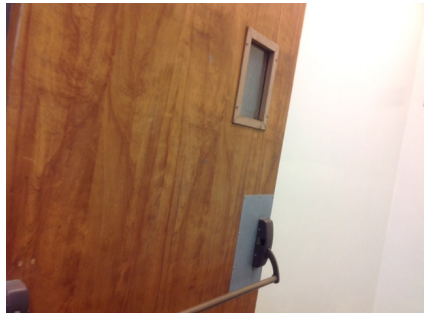
Item no., Rm no. and Name	Existing Architectural Barrier and Proposed Solution	Codes / Mitigation Info	Qty	Unit	Cost	Total
Door						
104	<ul style="list-style-type: none"> • <i>As-Built Description:</i> Vision Light at door that permits viewing, does not have bottom of at least one glazed panel located 43 inches maximum above the finish floor. (Exception: More than 66" above finished floor.) • <i>As-Built:</i> 60" AFF • <i>Proposed Solution:</i> Provide new door with vision panel at 43" max. • <i>Notes:</i> Door to stairwell 	PCODE ID06C ADA 2010 404.2.11 CBC 2016 11B-404.2.11 Mitigated: <input type="radio"/> YES <input checked="" type="radio"/> NO	1	JOB	\$7,500	\$7,500

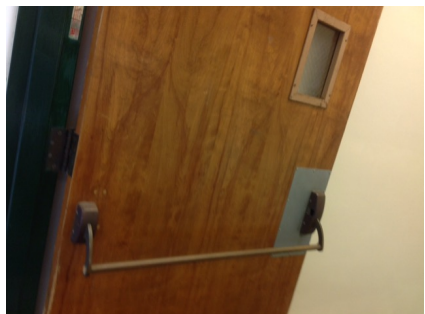
<input type="checkbox"/> Staff Only Priority 2 Severity 1			
107	<ul style="list-style-type: none"> • <i>As-Built Description:</i> Vision Light at door that permits viewing, does not have bottom of at least one glazed panel located 43" maximum above the finish floor. (Exception: More than 66" above finished floor.) • <i>As-Built:</i> 60" AFF • <i>Proposed Solution:</i> Provide new door with vision panel at 43" max. 	PCODE ID06C ADA 2010 404.2.11 CBC 2016 11B-404.2.11 Mitigated: <input type="radio"/> YES <input checked="" type="radio"/> NO	1	JOB	\$7,500	\$7,500

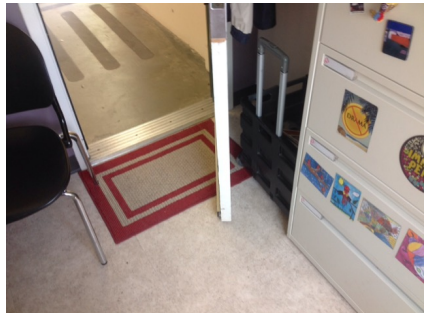
Item no., Rm no. and Name	Existing Architectural Barrier and Proposed Solution	Codes / Mitigation Info	Qty	Unit	Cost	Total
Door Swing						
110	<ul style="list-style-type: none"> • As-Built Description: Front approach: At pull side, door does not have clear and level maneuvering space measuring door width plus 18" x 60". (24" x 60" at exterior doors). • Proposed Solution: Remove or relocate furniture or storage items. 	PCODE ID23A ADAAG 91 Fig. 25(a) ADA 2010 404.2.4 CBC 2007 11B-26A(a) CBC 2016 11B-404.2.4 Mitigated: <input type="radio"/> YES <input checked="" type="radio"/> NO	1	JOB	\$150	\$150

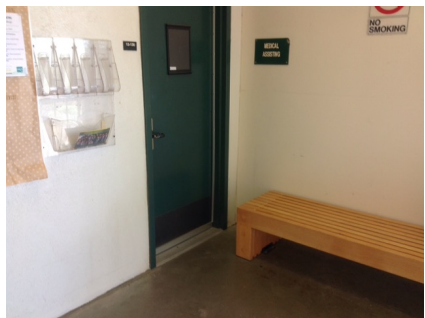
<input type="checkbox"/> Staff Only Priority 2 Severity 2			
111	<ul style="list-style-type: none"> • As-Built Description: Front approach: At push side, door does not have clear and level maneuvering space measuring door width x 48" (door width plus 12" if door has both, latch and closer). • Proposed Solution: Remove or relocate furniture or storage items. • Notes: Bench is blocking door clear spaces. Remove to mitigate this issue. 	PCODE ID24A ADAAG 91 Fig. 25(a) ADA 2010 404.2.4 CBC 2007 11B-26A(a) CBC 2016 11B-404.2.4 Mitigated: <input type="radio"/> YES <input checked="" type="radio"/> NO	1	JOB	\$150	\$150

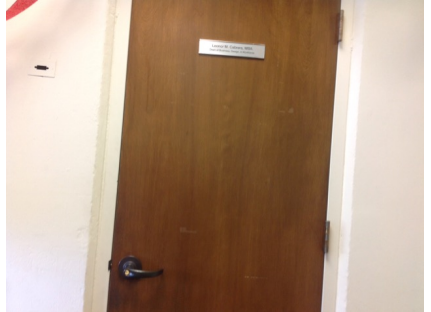
Item no., Rm no. and Name	Existing Architectural Barrier and Proposed Solution	Codes / Mitigation Info	Qty	Unit	Cost	Total
Signage						
129	<ul style="list-style-type: none"> • <i>As-Built Description:</i> Sign designating a permanent room or space does not include Grade 2 Braille. • <i>Proposed Solution:</i> Provide new compliant signage including California Grade 2 Braille (1/10" on center dots with 2/10" space between cells). 	PCODE SA07A ADAAG 91 4.30.4 ADA 2010 703.2 CBC 2007 1117B.5.6 CBC 2016 11B-703.3 Mitigated: <input type="radio"/> YES <input checked="" type="radio"/> NO	1	JOB	\$270	\$270

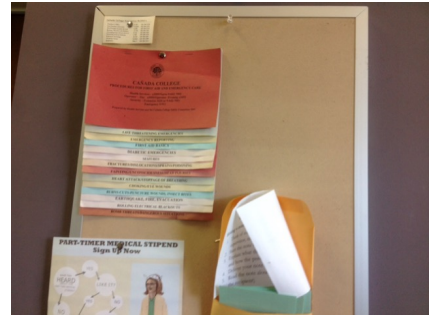
Item no., Rm no. and Name	Existing Architectural Barrier and Proposed Solution	Codes / Mitigation Info	Qty	Unit	Cost	Total
124	<ul style="list-style-type: none"> As-Built Description: Reach height to control or access point, exceeds 48" or is less than 15". As-Built: 60" AFF Proposed Solution: Modify equipment or mounting. 	PCODE IE01 ADAAG 91 4.2.5 ADA 2010 308.2.1 CBC 2007 1118B.5 CBC 2016 11B-308.2.1 Mitigated: <input type="radio"/> YES <input checked="" type="radio"/> NO	1	JOB	\$300	\$300

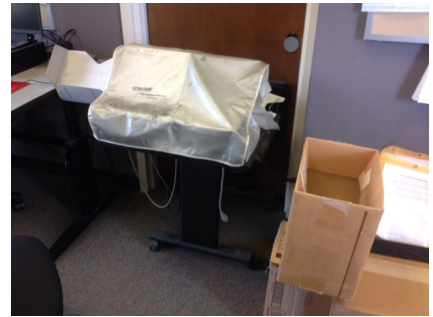
Non-Fixed Desk

123	<ul style="list-style-type: none"> As-Built Description: Accessible non-fixed table or desk (top 28" to 34" high; knee space at least 27" high x 19" deep x 30" wide) not provided. As-Built: 12" deep Proposed Solution: Provide table or desk with accessible dimensions when purchasing new furniture. 	PCODE IN02A ADAAG 91 4.32.3 & .4 ADA 2010 306.1 CBC 2007 1122B.3 & 4 CBC 2016 11B-306.1 & 11B-902.3 Mitigated: <input type="radio"/> YES <input checked="" type="radio"/> NO	1	JOB	\$4,800	\$4,800

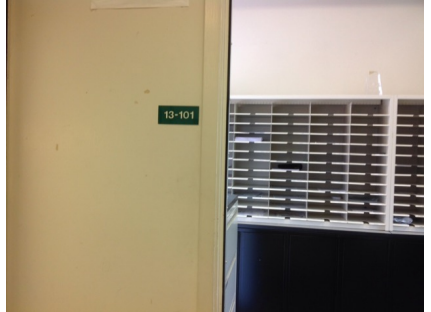
Item no., Rm no. and Name	Existing Architectural Barrier and Proposed Solution	Codes / Mitigation Info	Qty	Unit	Cost	Total
Signage						
120	<ul style="list-style-type: none"> • <i>As-Built Description:</i> Sign designating a permanent room or space does not include Grade 2 Braille. • <i>Proposed Solution:</i> Provide new compliant signage including California Grade 2 Braille (1/10" on center dots with 2/10" space between cells). • <i>Notes:</i> Braille not provided on tactile signage. 	PCODE SA07A ADAAG 91 4.30.4 ADA 2010 703.2 CBC 2007 1117B.5.6 CBC 2016 11B-703.3 Mitigated: <input type="radio"/> YES <input checked="" type="radio"/> NO	1	JOB	\$270	\$270

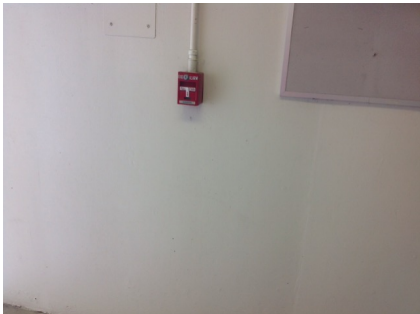
Item no., Rm no. and Name	Existing Architectural Barrier and Proposed Solution	Codes / Mitigation Info	Qty	Unit	Cost	Total
Electrical						
137	<ul style="list-style-type: none">As-Built Description: Electric switch or control mounted less than 15" measured to the bottom of the outlet box or greater than 48 inches measured to the top of the outlet box.As-Built: 48.5" AFFProposed Solution: Relocate light switches or control to between 15" and 48" height.	<p>PCODE IC01</p> <p>ADAAG 91 4.2.5 & 6</p> <p>ADA 2010 308.2.1 & 308.2.2</p> <p>CBC 2007 1117B.6.3</p> <p>CBC 2016 11B-308.2.1 & 11B-308.2.2</p> <p>Mitigated:</p> <p><input type="radio"/> YES</p> <p><input checked="" type="radio"/> NO</p>	1	JOB	\$900	\$900

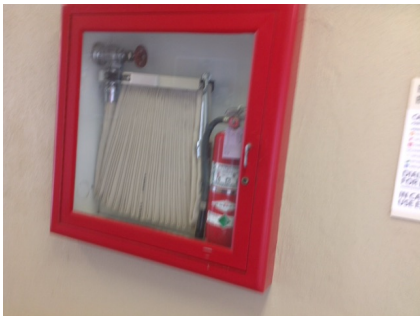
<input type="checkbox"/> Staff Only			
			Priority		Severity	
			2		4	
Reach Range						
139	<ul style="list-style-type: none">As-Built Description: Reach height to control or access point, exceeds 48" or is less than 15".As-Built: 50" AFFProposed Solution: Modify equipment or mounting.	<p>PCODE IE01</p> <p>ADAAG 91 4.2.5</p> <p>ADA 2010 308.2.1</p> <p>CBC 2007 1118B.5</p> <p>CBC 2016 11B-308.2.1</p> <p>Mitigated:</p> <p><input type="radio"/> YES</p> <p><input checked="" type="radio"/> NO</p>	2	JOB	\$300	\$600

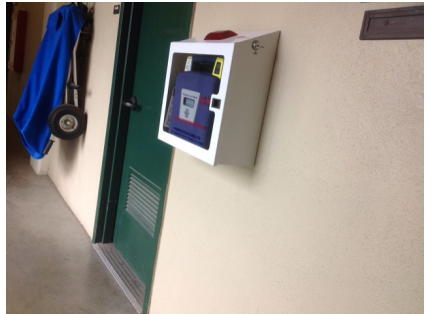
Item no., Rm no. and Name	Existing Architectural Barrier and Proposed Solution	Codes / Mitigation Info	Qty	Unit	Cost	Total
146	<ul style="list-style-type: none"> As-Built Description: Protruding objects more than 4" from wall, when bottom of object more than 27" or less than 80" above finished floor. As-Built: AED 6" protrusion at 45" high. Proposed Solution: Provide cane-detectable railing to mark area of low clearance. 	PCODE EG04A ADAAG 91 4.4.1 ADA 2010 307.2 CBC 2007 1133B.8.6.1 CBC 2016 11B-307.2 Mitigated: <input type="radio"/> YES <input checked="" type="radio"/> NO	2	LF	\$300	\$600

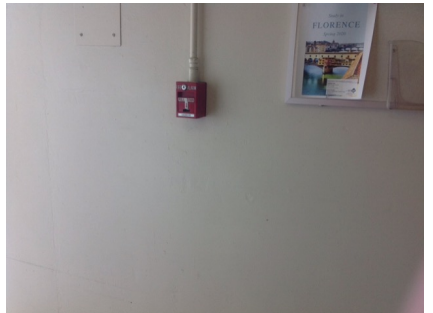
144	<ul style="list-style-type: none"> As-Built Description: Reach height to control or access point, exceeds 48" or is less than 15". As-Built: 48.5" AFF Proposed Solution: Modify equipment or mounting. 	PCODE IE01 ADAAG 91 4.2.5 ADA 2010 308.2.1 CBC 2007 1118B.5 CBC 2016 11B-308.2.1 Mitigated: <input type="radio"/> YES <input checked="" type="radio"/> NO	2	JOB	\$300	\$600

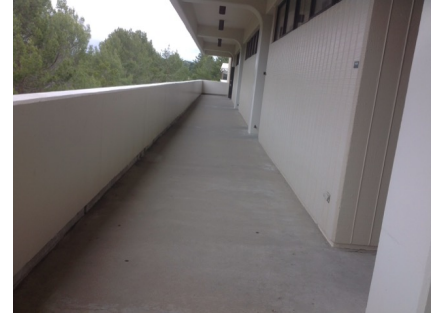
Cross slope extends the entire length of the hallway.

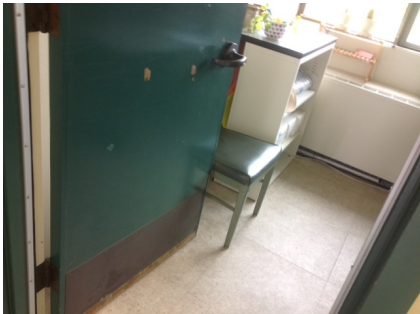
Item no., Rm no. and Name	Existing Architectural Barrier and Proposed Solution	Codes / Mitigation Info	Qty	Unit	Cost	Total
Door Swing						
151	<ul style="list-style-type: none">• <i>As-Built Description:</i> Front approach: At pull side, door does not have clear and level maneuvering space measuring door width plus 18" x 60". (24" x 60" at exterior doors).• <i>Proposed Solution:</i> Remove or relocate furniture or storage items.	PCODE ID23A ADAAG 91 Fig. 25(a) ADA 2010 404.2.4 CBC 2007 11B-26A(a) CBC 2016 11B-404.2.4 Mitigated: <div><input type="radio"/> YES</div> <div><input checked="" type="radio"/> NO</div>	6	JOB	\$150	\$900

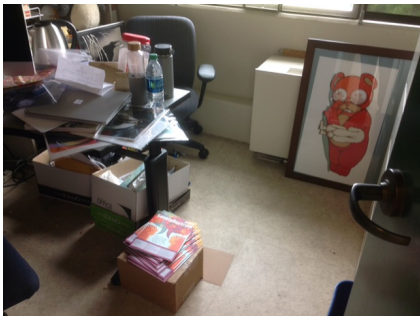
<div><input type="checkbox"/> Staff Only</div> <div><div>Priority</div><div>2</div><div>Severity</div><div>3</div></div>			
Turning Space						
152	<ul style="list-style-type: none">• <i>As-Built Description:</i> The area does not provide a minimum 60" diameter turning space within to allow maneuvering through the space.• <i>Proposed Solution:</i> Modify area to provide sufficient maneuvering space.• <i>Notes:</i> 60" turning space is required if students or public use the office for meetings.	PCODE IH05 ADA 2010 304.3 CBC 2016 11B-304.3 Mitigated: <div><input type="radio"/> YES</div> <div><input checked="" type="radio"/> NO</div>	1	JOB	\$1,500	\$1,500

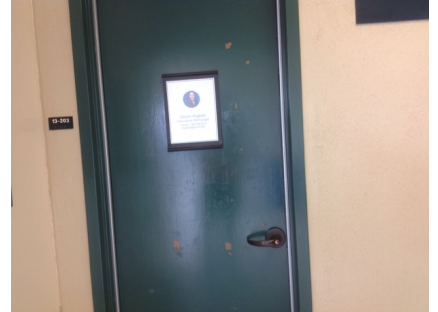
Item no., Rm no. and Name	Existing Architectural Barrier and Proposed Solution	Codes / Mitigation Info	Qty	Unit	Cost	Total
Signage						
149	<ul style="list-style-type: none"> As-Built Description: Sign not located on latch side of door and/or not located at 48" min. above to baseline of the lowest Braille cells and 60" max. to baseline of the highest line of raised characters. Proposed Solution: Provide compliant signage including tactile characters and Grade II Braille on latch side of door located at compliant height. 	PCODE SA07 ADAAG 91 4.30.6 ADA 2010 703.4.1 CBC 2007 1117B.5.7 CBC 2016 11B-703.4.1 Mitigated: <input type="radio"/> YES <input checked="" type="radio"/> NO	1	JOB	\$150	\$150

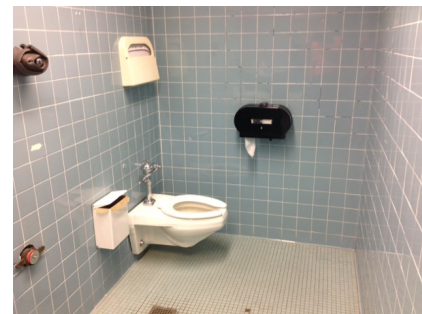
Single accommodation restroom not accessible; multiple compliance violations.

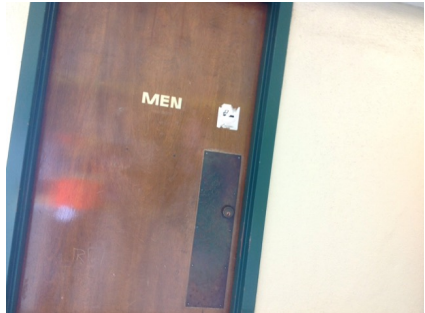
Item no., Rm no. and Name	Existing Architectural Barrier and Proposed Solution	Codes / Mitigation Info	Qty	Unit	Cost	Total
Signage						
160	<ul style="list-style-type: none"> • As-Built Description: Entrance to toilet or bathing facility identified with California signage on door leaf not identified with ADAAG compliant signage. • Proposed Solution: Provide ADAAG compliant sign with raised letters and pictogram, mounted 5' high on center on nearest adjacent wall, on latch side of a single door. 	PCODE SA11AREF ADAAG 91 4.1.3(16)(a) ADA 2010 216.8 CBC 2016 11B-216.8 Mitigated: <input type="radio"/> YES <input checked="" type="radio"/> NO				
			REF

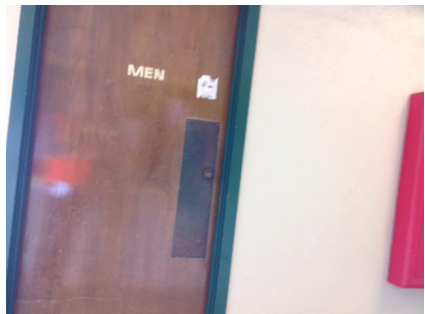
<input type="checkbox"/> Staff Only Priority 3 Severity 3			
161	<ul style="list-style-type: none"> • As-Built Description: Required in CA only: identification symbol centered 58" to 60" high on sanitary facility door that contrasts with the door not provided (women: 12" ø circle, men: 12" triangle, unisex: combined symbol). • Proposed Solution: Provide properly mounted sanitary facility symbol when altering area. If wheelchair accessible, include International Symbol of Accessibility on sign. 	PCODE SA15REF CBC 2007 1115B.6 CBC 2016 11B-703.7.2.6 Mitigated: <input type="radio"/> YES <input checked="" type="radio"/> NO

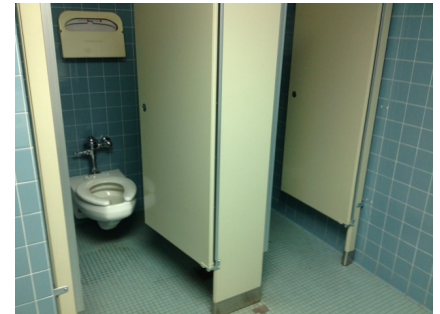
Multiple accommodation restroom not accessible;
multiple compliance violations.

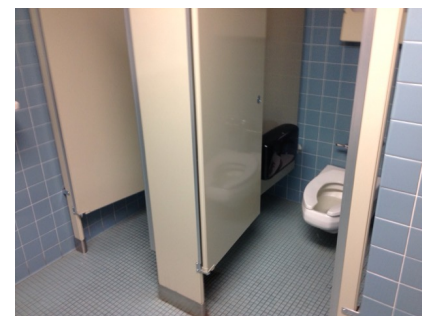
Multiple accommodation restroom not accessible; multiple compliance violations.

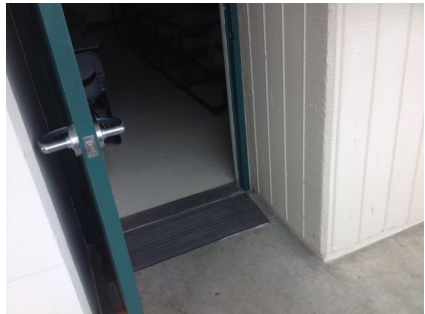
Item no., Rm no. and Name	Existing Architectural Barrier and Proposed Solution	Codes / Mitigation Info	Qty	Unit	Cost	Total
Door Swing						
171	<ul style="list-style-type: none"> As-Built Description: Front approach: At pull side, door does not have clear and level maneuvering space measuring door width plus 18" x 60". (24" x 60" at exterior doors). Proposed Solution: Provide power door operator. 	PCODE ID23C ADAAG 91 Fig. 25(a) ADA 2010 404.2.4 CBC 2007 11B-26A(a) CBC 2016 11B-404.2.4 Mitigated: <input type="radio"/> YES <input checked="" type="radio"/> NO	2	JOB	\$15,000	\$30,000

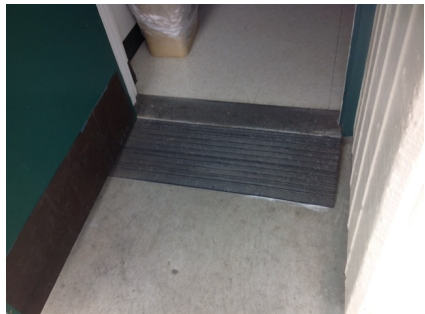
<input type="checkbox"/> Staff Only			
			Priority		Severity	
			2		2	
Door Threshold						
172	<ul style="list-style-type: none"> As-Built Description: Door inaccessible due to threshold or step at door exceeding 1/2". As-Built: 1.5" AFF Proposed Solution: Modify threshold to be no more than 1/2" by removing existing paving at door and providing landing with edge ramping (slope 1:20 max). 	PCODE ID02A ADAAG 91 4.13.8 ADA 2010 404.2.5 CBC 2007 1133B.2.4.1 CBC 2016 11B-404.2.5 Mitigated: <input type="radio"/> YES <input checked="" type="radio"/> NO	2	JOB	\$1,200	\$2,400

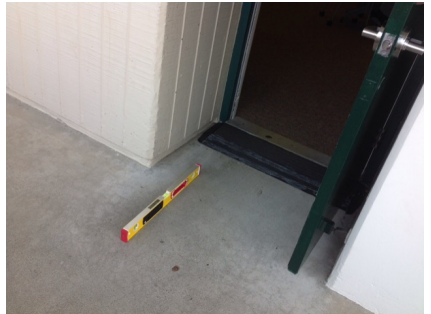
Item no., Rm no. and Name	Existing Architectural Barrier and Proposed Solution	Codes / Mitigation Info	Qty	Unit	Cost	Total
194	<ul style="list-style-type: none"> As-Built Description: Surface of required maneuvering clearance at door slopes more than 1/4":12" (2.0%). As-Built: 3.6% Proposed Solution: Modify surface slope at door. 	PCODE ID11 ADAAG 91 4.13.6 ADA 2010 404.2.4.4 CBC 2007 1133B.2.4 CBC 2016 11B-404.2.4 Mitigated: <input type="radio"/> YES <input checked="" type="radio"/> NO	25	SF	\$120	\$3,000

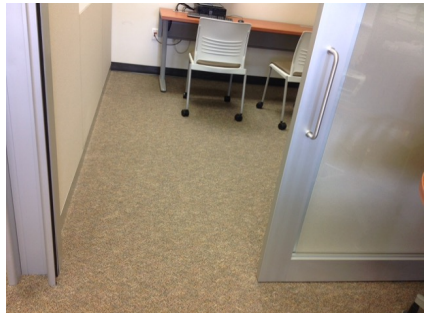
197	<ul style="list-style-type: none"> As-Built Description: Excessive force required to open door. As-Built: 10 lbs. Proposed Solution: Adjust regular door closer to accessible standards (5 lbs. max). 	PCODE ID03 ADAAG 91 4.13.11 ADA 2010 404.2.9 CBC 2007 1133B.2.5 CBC 2016 11B-404.2.9 Mitigated: <input type="radio"/> YES <input checked="" type="radio"/> NO	1	JOB	\$75	\$75

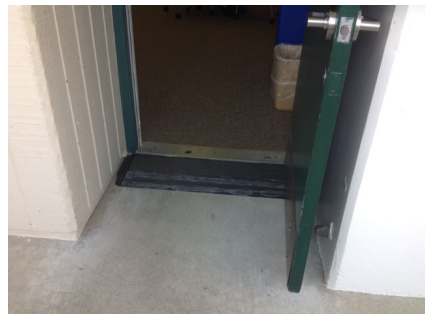
Item no., Rm no. and Name	Existing Architectural Barrier and Proposed Solution	Codes / Mitigation Info	Qty	Unit	Cost	Total
Door Swing						
192	<ul style="list-style-type: none">• <i>As-Built Description:</i> Front approach: At pull side, door does not have clear and level maneuvering space measuring door width plus 18" x 60". (24" x 60" at exterior doors).• <i>Proposed Solution:</i> Provide power door operator.	PCODE ID23C ADAAG 91 Fig. 25(a) ADA 2010 404.2.4 CBC 2007 11B-26A(a) CBC 2016 11B-404.2.4 Mitigated: <div><input type="radio"/> YES</div> <div><input checked="" type="radio"/> NO</div>	1	JOB	\$15,000	\$15,000

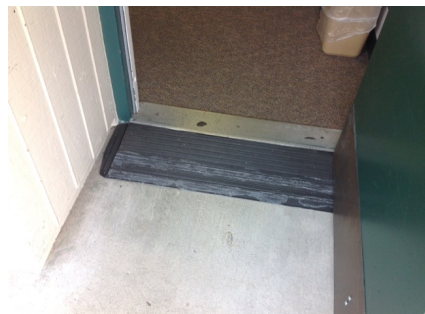
<div><input type="checkbox"/> Staff Only</div> <div><div>Priority</div><div>2</div><div>Severity</div><div>2</div></div>			
Door Threshold						
193	<ul style="list-style-type: none">• <i>As-Built Description:</i> Door inaccessible due to threshold or step at door exceeding 1/2".• <i>As-Built:</i> 1.5" AFF• <i>Proposed Solution:</i> Modify threshold to be no more than 1/2" by removing existing paving at door and providing landing with edge ramping (slope 1:20 max).	PCODE ID02A ADAAG 91 4.13.8 ADA 2010 404.2.5 CBC 2007 1133B.2.4.1 CBC 2016 11B-404.2.5 Mitigated: <div><input type="radio"/> YES</div> <div><input checked="" type="radio"/> NO</div>	1	JOB	\$1,200	\$1,200

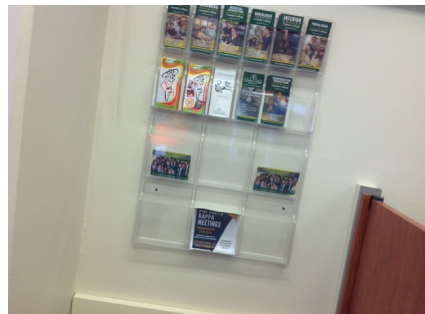
Item no., Rm no. and Name	Existing Architectural Barrier and Proposed Solution	Codes / Mitigation Info	Qty	Unit	Cost	Total
Brochure Bins						
195	<ul style="list-style-type: none">As-Built Description: Information brochure bins mounted above accessible height of 48".As-Built: 60" AFFProposed Solution: Relocate/remount bins at accessible height.	PCODE IN08 ADAAG 91 4.2.5 & 6 ADA 2010 308.2.1 CBC 2007 1118B.5 CBC 2016 11B-308.2.1 Mitigated: <input type="radio"/> YES <input checked="" type="radio"/> NO	1	JOB	\$300	\$300

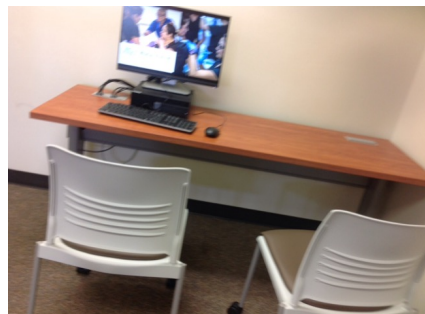
<input type="checkbox"/> Staff Only			
			Priority	Severity		
			2	2		
Non-Fixed Desk						
198	<ul style="list-style-type: none">As-Built Description: Accessible non-fixed table or desk (top 28" to 34" high; knee space at least 27" high x 19" deep x 30" wide) not provided.As-Built: 16" deep knee spaceProposed Solution: Provide table or desk with accessible dimensions when purchasing new furniture.	PCODE IN02A ADAAG 91 4.32.3 & .4 ADA 2010 306.1 CBC 2007 1122B.3 & 4 CBC 2016 11B-306.1 & 11B-902.3 Mitigated: <input type="radio"/> YES <input checked="" type="radio"/> NO	1	JOB	\$4,800	\$4,800

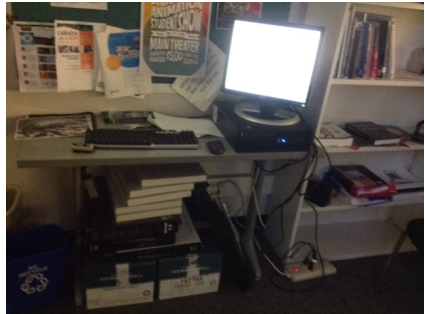
Item no., Rm no. and Name	Existing Architectural Barrier and Proposed Solution	Codes / Mitigation Info	Qty	Unit	Cost	Total
206	<ul style="list-style-type: none"> As-Built Description: Accessible non-fixed table or desk (top 28" to 34" high; knee space at least 27" high x 19" deep x 30" wide) not provided. As-Built: No knee clearance Proposed Solution: Provide table or desk with accessible dimensions when purchasing new furniture. Notes: Check in desk 	PCODE IN02A ADAAG 91 4.32.3 & .4 ADA 2010 306.1 CBC 2007 1122B.3 & 4 CBC 2016 11B-306.1 & 11B-902.3 Mitigated: <input type="radio"/> YES <input checked="" type="radio"/> NO	1	JOB	\$4,800	\$4,800

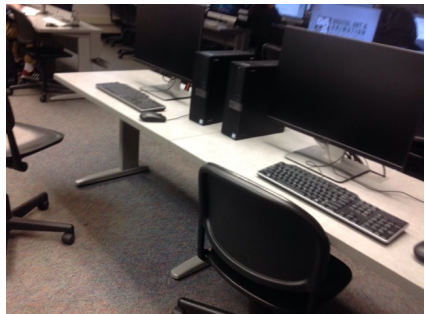
<input type="checkbox"/> Staff Only			
			Priority 2 Severity 2			
207	<ul style="list-style-type: none"> As-Built Description: Accessible non-fixed table or desk (top 28" to 34" high; knee space at least 27" high x 19" deep x 30" wide) not provided. As-Built: 26" high knee Proposed Solution: Provide table or desk with accessible dimensions when purchasing new furniture. Notes: 25 total seats 	PCODE IN02A ADAAG 91 4.32.3 & .4 ADA 2010 306.1 CBC 2007 1122B.3 & 4 CBC 2016 11B-306.1 & 11B-902.3 Mitigated: <input type="radio"/> YES <input checked="" type="radio"/> NO	1	JOB	\$4,800	\$4,800

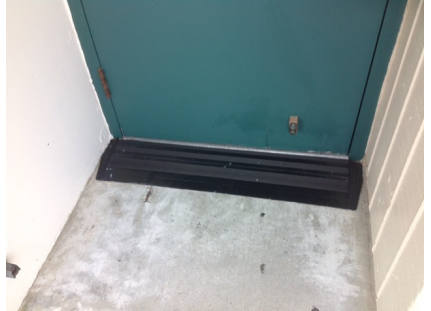
Item no., Rm no. and Name	Existing Architectural Barrier and Proposed Solution	Codes / Mitigation Info	Qty	Unit	Cost	Total
Door Threshold						
209	<ul style="list-style-type: none"> • <i>As-Built Description:</i> Door inaccessible due to threshold or step at door exceeding 1/2". • <i>As-Built:</i> 1" AFF • <i>Proposed Solution:</i> Modify threshold to be no more than 1/2" by removing existing paving at door and providing landing with edge ramping (slope 1:20 max). 	PCODE ID02A ADAAG 91 4.13.8 ADA 2010 404.2.5 CBC 2007 1133B.2.4.1 CBC 2016 11B-404.2.5 Mitigated: <input type="radio"/> YES <input checked="" type="radio"/> NO	4	JOB	\$1,200	\$4,800

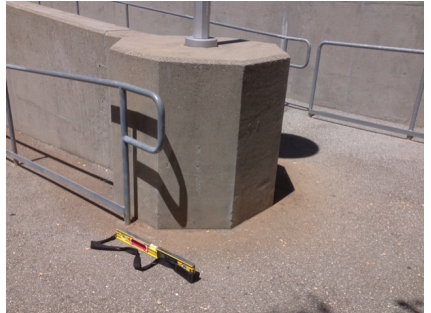
Item no., Rm no. and Name	Existing Architectural Barrier and Proposed Solution	Codes / Mitigation Info	Qty	Unit	Cost	Total
483	<ul style="list-style-type: none"> As-Built Description: Level 2% max. landing for ramp not provided. As-Built: 3.5% Proposed Solution: Rebuild ramp to provide landings for each ramp run with slopes no greater than 2% 	PCODE EB05A ADAAG 91 4.8.4 ADA 2010 405.7.1 CBC 2007 1133B.5.4.1 CBC 2016 11B-405.7.1 Mitigated: <input type="radio"/> YES <input checked="" type="radio"/> NO	100	SF	\$300	\$30,000

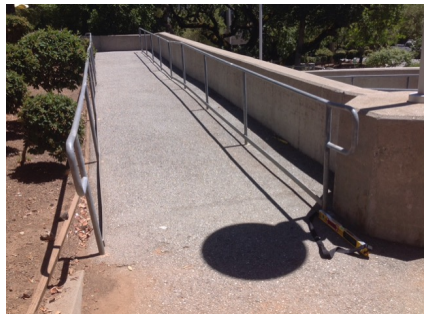
<input type="checkbox"/> Staff Only Priority 1 Severity 4			
484	<ul style="list-style-type: none"> As-Built Description: Level 2% max. landing for ramp not provided. As-Built: 2.8% Proposed Solution: Rebuild ramp to provide landings for each ramp run with slopes no greater than 2% 	PCODE EB05A ADAAG 91 4.8.4 ADA 2010 405.7.1 CBC 2007 1133B.5.4.1 CBC 2016 11B-405.7.1 Mitigated: <input type="radio"/> YES <input checked="" type="radio"/> NO	75	SF	\$300	\$22,500

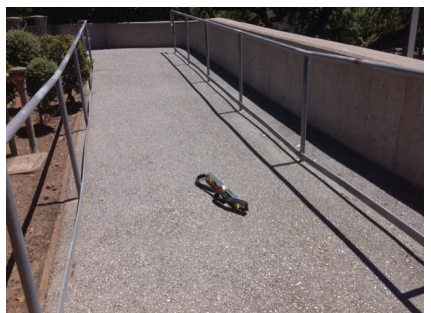
<input type="checkbox"/> Staff Only Priority 1 Severity 4			
485	<ul style="list-style-type: none"> As-Built Description: Level 2% max. landing for ramp not provided. As-Built: 4.9% Proposed Solution: Rebuild ramp to provide landings for each ramp run with slopes no greater than 2% Notes: At intermediate landing 	PCODE EB05A ADAAG 91 4.8.4 ADA 2010 405.7.1 CBC 2007 1133B.5.4.1 CBC 2016 11B-405.7.1 Mitigated: <input type="radio"/> YES <input checked="" type="radio"/> NO	100	SF	\$300	\$30,000
