SMCCCD - Cañada College

Appendix H: Facilities

Access Compliance Survey Report

Building 2 - Bookstore

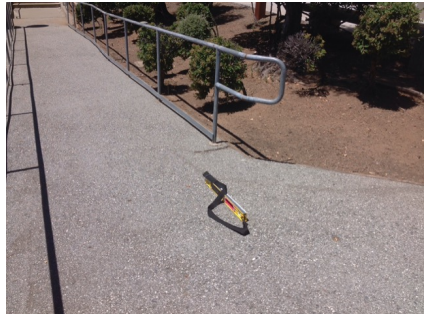
Item no., Rm no. and Name	Existing Architectural Barrier and Proposed Solution	Codes / Mitigation Info	Qty	Unit	Cost	Total
486	<ul style="list-style-type: none"> As-Built Description: Level 2% max. landing for ramp not provided. As-Built: 4.9% Proposed Solution: Rebuild ramp to provide landings for each ramp run with slopes no greater than 2% 	PCODE EB05A ADAAG 91 4.8.4 ADA 2010 405.7.1 CBC 2007 1133B.5.4.1 CBC 2016 11B-405.7.1 Mitigated: <input type="radio"/> YES <input checked="" type="radio"/> NO	100	SF	\$300	\$30,000

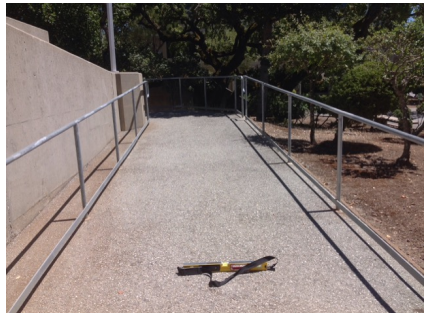
482	<ul style="list-style-type: none"> As-Built Description: Cross slope more than 1":48" (2.083%). Proposed Solution: Modify cross slope. 	PCODE EF07 ADAAG 91 4.3.7 ADA 2010 403.3 CBC 2007 1133B.7.1.3 CBC 2016 11B-403.3 Mitigated: <input type="radio"/> YES <input checked="" type="radio"/> NO	100	SF	\$75	\$7,500

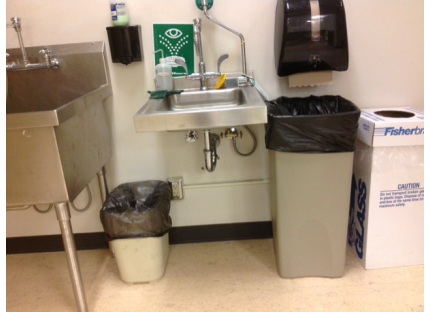
Item no., Rm no. and Name	Existing Architectural Barrier and Proposed Solution	Codes / Mitigation Info	Qty	Unit	Cost	Total
Lavatory						
394	<ul style="list-style-type: none"> • <i>As-Built Description:</i> Hot or sharp-surfaced water/drain pipe not insulated or covered. • <i>Proposed Solution:</i> Insulate or cover water/drain pipe. 	PCODE WD05 ADAAG 91 4.19.4 ADA 2010 606.5 CBC 2007 1115B.4.3.4 CBC 2016 11B-606.5 Mitigated: <input type="radio"/> YES <input checked="" type="radio"/> NO	1	JOB	\$360	\$360

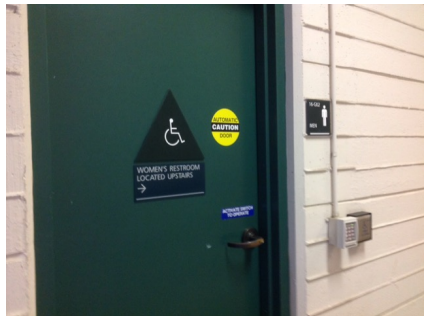
Item no., Rm no. and Name	Existing Architectural Barrier and Proposed Solution	Codes / Mitigation Info	Qty	Unit	Cost	Total
400	<ul style="list-style-type: none"> As-Built Description: Required in CA only: identification symbol centered 58" to 60" high on sanitary facility door that contrasts with the door not provided (women: 12" ø circle, men: 12" triangle, unisex: combined symbol). As-Built: No contrast Proposed Solution: Provide properly mounted sanitary facility symbol when altering area. If wheelchair accessible, include International Symbol of Accessibility on sign. 	PCODE SA15 CBC 2007 1115B.6 CBC 2016 11B-703.7.2.6 Mitigated: <input type="radio"/> YES <input checked="" type="radio"/> NO	1	JOB	\$270	\$270

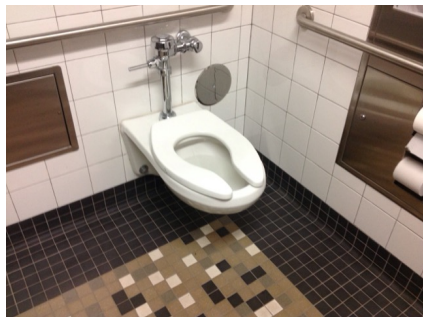
407	<ul style="list-style-type: none"> As-Built Description: Water closet not 16"-18" (CA: 17"-18") from near side wall to center line of water closet (2010 ADAAG: 16"-18"). As-Built: 19" o.c. Proposed Solution: Relocate existing water closet and plumbing, remount with offset closet flange to provide 18" max. from side wall. 	PCODE WB02C ADAAG 91 Fig. 28 ADA 2010 604.2 CBC 2007 1115B.4.1.1 CBC 2016 11B-604.2 Mitigated: <input type="radio"/> YES <input checked="" type="radio"/> NO	1	JOB	\$1,500	\$1,500

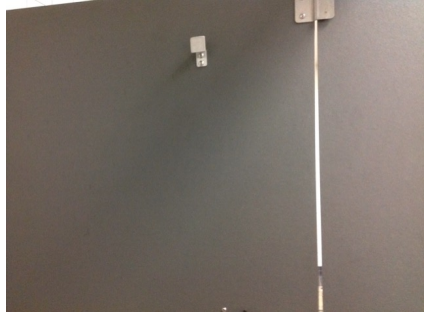
Item no., Rm no. and Name	Existing Architectural Barrier and Proposed Solution	Codes / Mitigation Info	Qty	Unit	Cost	Total
Coat Hook						
406	<ul style="list-style-type: none"> As-Built Description: Accessible coat hook not within reach range. As-Built: 72" high Proposed Solution: Adjust existing or provide new coat hook at maximum 48" height. 	PCODE WG03A ADAAG 91 4.2.5 ADA 2010 603.4 CBC 2007 1118B.5 CBC 2016 11B-603.4 Mitigated: <input type="radio"/> YES <input checked="" type="radio"/> NO	1	JOB	\$150	\$150

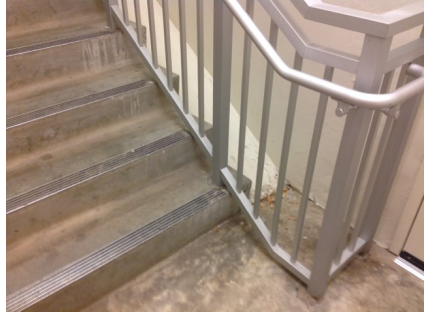
Item no., Rm no. and Name	Existing Architectural Barrier and Proposed Solution	Codes / Mitigation Info	Qty	Unit	Cost	Total
<u>Stairway</u>						
415	<ul style="list-style-type: none"> • <i>As-Built Description:</i> The leading 2" of the tread does not have visual contrast of dark-on-light or light-on-dark from the remainder of the tread. • <i>Proposed Solution:</i> Provide 2" min., 4" max. wide contrasting color strip 1" max. from nosing on top & bottom treads when altering area. 	PCODE II02B ADA 2010 504.4 CBC 2007 1133B.4.4 CBC 2016 11B-504.4.1 Mitigated: <input type="radio"/> YES <input checked="" type="radio"/> NO	24	LF	\$42	\$1,008

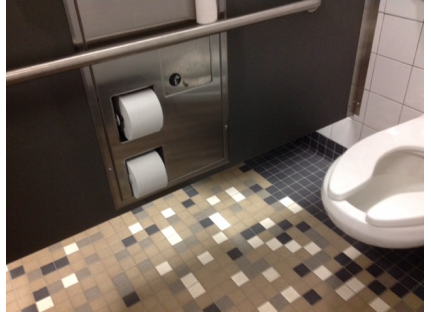
Item no., Rm no. and Name	Existing Architectural Barrier and Proposed Solution	Codes / Mitigation Info	Qty	Unit	Cost	Total
<u>Accessories</u>						
422	<ul style="list-style-type: none"> • <i>As-Built Description:</i> Toilet paper dispenser less than 15" (CA: 19") or more than 48" above floor or not within 7" to 9" from front of water closet (Note: CA pre-2010 is allowed within 12" from front of water closet). • <i>As-Built:</i> 13" o.c. • <i>Proposed Solution:</i> Relocate or provide new toilet paper dispenser. 	PCODE WG02 ADAAG 91 4.16.6 ADA 2010 604.7 CBC 2007 1115B.8.4 CBC 2016 11B-604.7 Mitigated: <input type="radio"/> YES <input checked="" type="radio"/> NO	1	JOB	\$225	\$225

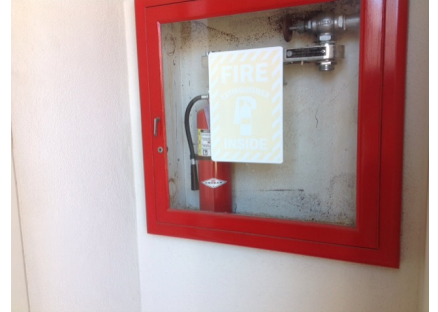
Item no., Rm no. and Name	Existing Architectural Barrier and Proposed Solution	Codes / Mitigation Info	Qty	Unit	Cost	Total
Reach Range						
428	<ul style="list-style-type: none"> As-Built Description: Reach height to control or access point, exceeds 48" or is less than 15". As-Built: 49" high Proposed Solution: Modify equipment or mounting. 	PCODE IE01 ADAAG 91 4.2.5 ADA 2010 308.2.1 CBC 2007 1118B.5 CBC 2016 11B-308.2.1 Mitigated: <input type="radio"/> YES <input checked="" type="radio"/> NO	1	JOB	\$300	\$300

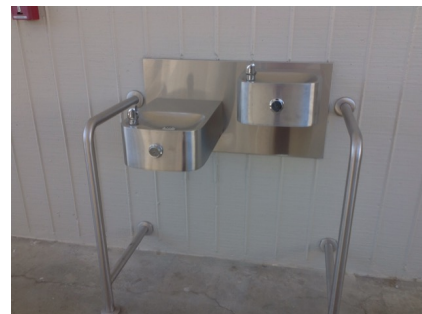
Item no., Rm no. and Name	Existing Architectural Barrier and Proposed Solution	Codes / Mitigation Info	Qty	Unit	Cost	Total
Reach Range						
443	<ul style="list-style-type: none"> • <i>As-Built Description:</i> Reach height to control or access point, exceeds 48" or is less than 15". • <i>As-Built:</i> 48.5" high • <i>Proposed Solution:</i> Modify equipment or mounting. 	PCODE IE01 ADAAG 91 4.2.5 ADA 2010 308.2.1 CBC 2007 1118B.5 CBC 2016 11B-308.2.1	1	JOB	\$300	\$300
Mitigated: <input type="radio"/> YES <input checked="" type="radio"/> NO

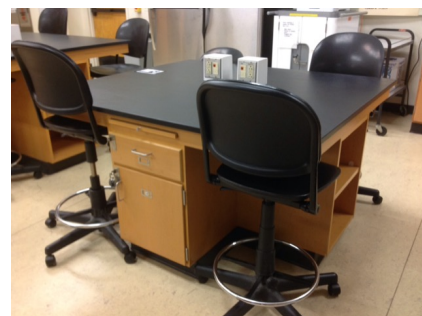
Item no., Rm no. and Name	Existing Architectural Barrier and Proposed Solution	Codes / Mitigation Info	Qty	Unit	Cost	Total
466	<ul style="list-style-type: none"> As-Built Description: Accessible non-fixed table or desk (top 28" to 34" high; knee space at least 27" high x 19" deep x 30" wide) not provided. Proposed Solution: Provide table or desk with accessible dimensions when purchasing new furniture. 	PCODE IN02A ADAAG 91 4.32.3 & .4 ADA 2010 306.1 CBC 2007 1122B.3 & 4 CBC 2016 11B-306.1 & 11B-902.3 Mitigated: <input type="radio"/> YES <input checked="" type="radio"/> NO	1	JOB	\$4,800	\$4,800

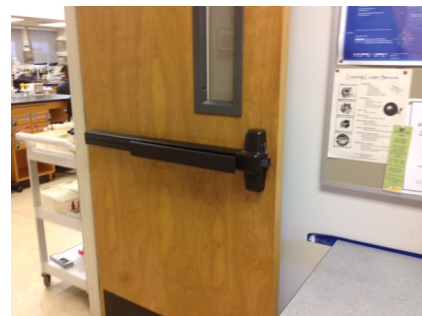
Item no., Rm no. and Name	Existing Architectural Barrier and Proposed Solution	Codes / Mitigation Info	Qty	Unit	Cost	Total
Door Swing						
451	<ul style="list-style-type: none">As-Built Description: Front approach: At push side, door does not have clear and level maneuvering space measuring door width x 48" (door width plus 12" if door has both, latch and closer).As-Built: 7" push sideProposed Solution: Change door swing.	PCODE ID24 ADAAG 91 Fig. 25(a) ADA 2010 404.2.4 CBC 2007 11B-26A(a) CBC 2016 11B-404.2.4 Mitigated: <div><input type="radio"/> YES</div> <div><input checked="" type="radio"/> NO</div>	1	JOB	\$1,500	\$1,500

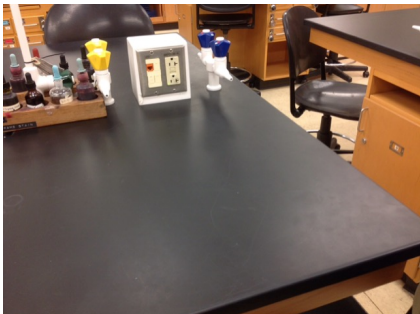
Item no., Rm no. and Name	Existing Architectural Barrier and Proposed Solution	Codes / Mitigation Info	Qty	Unit	Cost	Total
457	<ul style="list-style-type: none"> As-Built Description: Reach height to control or access point, exceeds 48" or is less than 15". As-Built: 58" high Proposed Solution: Modify equipment or mounting. 	PCODE IE01 ADAAG 91 4.2.5 ADA 2010 308.2.1 CBC 2007 1118B.5 CBC 2016 11B-308.2.1 Mitigated: <input type="radio"/> YES <input checked="" type="radio"/> NO	1	JOB	\$300	\$300

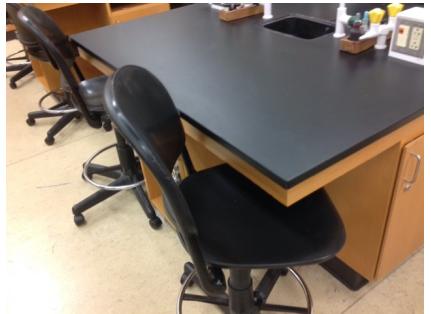
<input type="checkbox"/> Staff Only Priority 2 Severity 2						
456	<ul style="list-style-type: none"> As-Built Description: Accessible non-fixed table or desk (top 28" to 34" high; knee space at least 27" high x 19" deep x 30" wide) not provided. Proposed Solution: Provide table or desk with accessible dimensions when purchasing new furniture. 	PCODE IN02A ADAAG 91 4.32.3 & .4 ADA 2010 306.1 CBC 2007 1122B.3 & 4 CBC 2016 11B-306.1 & 11B-902.3 Mitigated: <input type="radio"/> YES <input checked="" type="radio"/> NO	1	JOB	\$4,800	\$4,800

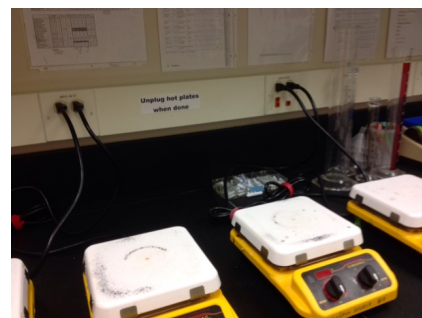
Item no., Rm no. and Name	Existing Architectural Barrier and Proposed Solution	Codes / Mitigation Info	Qty	Unit	Cost	Total
462	<ul style="list-style-type: none"> As-Built Description: Reach height to control or access point, exceeds 48" or is less than 15". As-Built: 53" high Proposed Solution: Modify equipment or mounting. 	PCODE IE01 ADAAG 91 4.2.5 ADA 2010 308.2.1 CBC 2007 1118B.5 CBC 2016 11B-308.2.1 Mitigated: <input type="radio"/> YES <input checked="" type="radio"/> NO	1	JOB	\$300	\$300

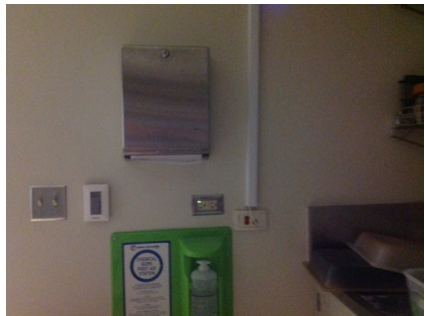
<input type="checkbox"/> Staff Only Priority 2 Severity 4						
463	<ul style="list-style-type: none"> As-Built Description: Reach height to control or access point, exceeds 48" or is less than 15". As-Built: General reach ranges Proposed Solution: Modify equipment or mounting. 	PCODE IE01 ADAAG 91 4.2.5 ADA 2010 308.2.1 CBC 2007 1118B.5 CBC 2016 11B-308.2.1 Mitigated: <input type="radio"/> YES <input checked="" type="radio"/> NO	1	JOB	\$300	\$300

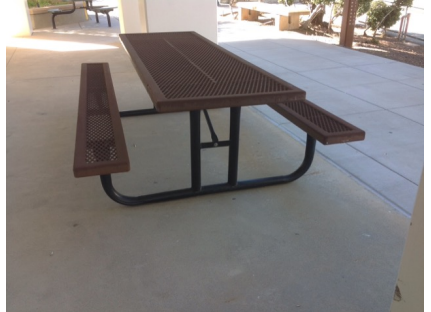
Item no., Rm no. and Name	Existing Architectural Barrier and Proposed Solution	Codes / Mitigation Info	Qty	Unit	Cost	Total
Non-Fixed Desk						
493	<ul style="list-style-type: none"> • <i>As-Built Description:</i> Accessible non-fixed table or desk (top 28" to 34" high; knee space at least 27" high x 19" deep x 30" wide) not provided. • <i>Proposed Solution:</i> Provide table or desk with accessible dimensions when purchasing new furniture. • <i>Notes:</i> 5 tables, no accessible 	PCODE IN02A ADAAG 91 4.32.3 & .4 ADA 2010 306.1 CBC 2007 1122B.3 & 4 CBC 2016 11B-306.1 & 11B-902.3 Mitigated: <input type="radio"/> YES <input checked="" type="radio"/> NO	1	JOB	\$4,800	\$4,800

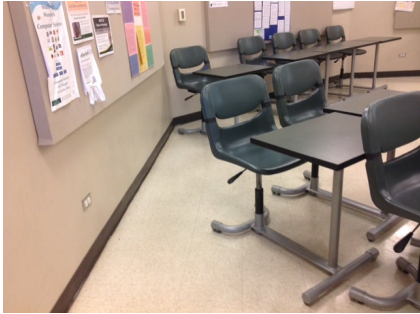
Item no., Rm no. and Name	Existing Architectural Barrier and Proposed Solution	Codes / Mitigation Info	Qty	Unit	Cost	Total
<u>Corridor</u>						
501	<ul style="list-style-type: none">• <i>As-Built Description:</i> Corridor, for occupant load less than 10, less than 36" wide.• <i>As-Built:</i> 22" wide• <i>Proposed Solution:</i> Remove or relocate furniture and storage items.• <i>Notes:</i> Path of travel to accessible seating	<p>PCODE IH03A</p> <p>ADAAG 91 4.3.3</p> <p>ADA 2010 403.5.1</p> <p>CBC 2007 1133B.3.1</p> <p>CBC 2016 11B-403.5.1</p> <p>Mitigated:</p> <p><input type="radio"/> YES</p> <p><input checked="" type="radio"/> NO</p>	1	JOB	\$150	\$150

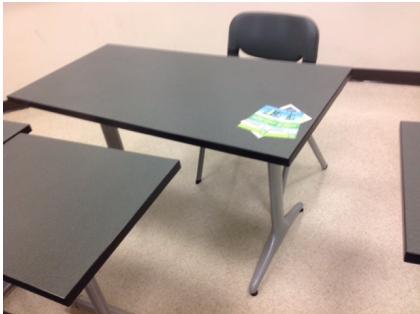
<input type="checkbox"/> Staff Only			
			Priority		Severity	
			2		1	
<u>Non-Fixed Desk</u>						
502	<ul style="list-style-type: none">• <i>As-Built Description:</i> Accessible non-fixed table or desk (top 28" to 34" high; knee space at least 27" high x 19" deep x 30" wide) not provided.• <i>Proposed Solution:</i> Provide table or desk with accessible dimensions when purchasing new furniture.• <i>Notes:</i> 44 seats, 1 accessible	<p>PCODE IN02A</p> <p>ADAAG 91 4.32.3 & .4</p> <p>ADA 2010 306.1</p> <p>CBC 2007 1122B.3 & 4</p> <p>CBC 2016 11B-306.1 & 11B-902.3</p> <p>Mitigated:</p> <p><input type="radio"/> YES</p> <p><input checked="" type="radio"/> NO</p>	4	JOB	\$4,800	\$19,200

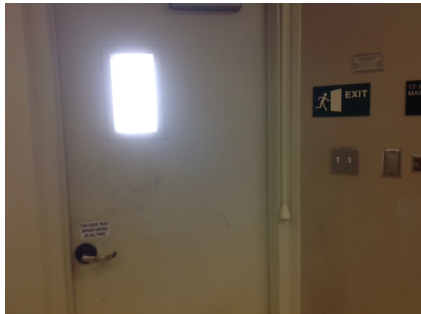
Item no., Rm no. and Name	Existing Architectural Barrier and Proposed Solution	Codes / Mitigation Info	Qty	Unit	Cost	Total
Signage						
499	<ul style="list-style-type: none">As-Built Description: Sign not located on latch side of door and/or not located at 48" min. above to baseline of the lowest Braille cells and 60" max. to baseline of the highest line of raised characters.Proposed Solution: Provide compliant signage including tactile characters and Grade II Braille on latch side of door located at compliant height.	<p>PCODE SA07 ADAAG 91 4.30.6 ADA 2010 703.4.1 CBC 2007 1117B.5.7 CBC 2016 11B-703.4.1</p> <p>Mitigated:</p> <p><input type="radio"/> YES <input checked="" type="radio"/> NO</p>	8	JOB	\$150	\$1,200

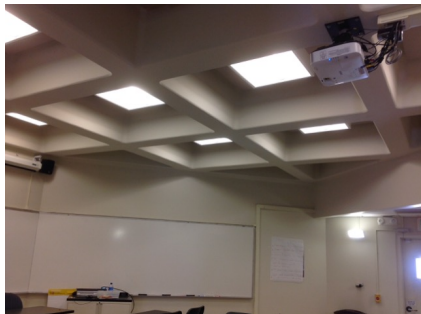
Assistive Listening						
504	<ul style="list-style-type: none">As-Built Description: No signs at the building or assembly area entrance to notify patrons that an assistive listening system is available.Proposed Solution: Provide assistive listening signage.Notes: No assistive listening signage	<p>PCODE GI02 ADAAG 91 4.1.3(19)(b) ADA 2010 703.7.2.4 CBC 2007 1104B.2.4 CBC 2016 11B-703.7.2.4</p> <p>Mitigated:</p> <p><input type="radio"/> YES <input checked="" type="radio"/> NO</p>	1	JOB	\$300	\$300

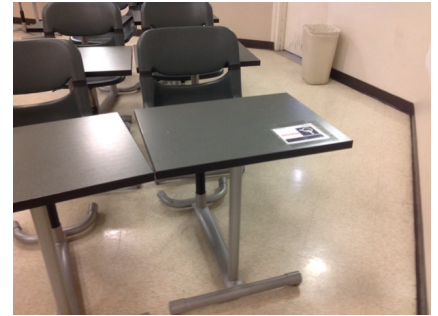
• *Proposed Solution:*CBC 2016 11B-306.1 & 11B
-902.3• **Notes:****Non-accessible desk marked with ISA. Remove
ISA from table.****Mitigated:**☐ YES☒ NO

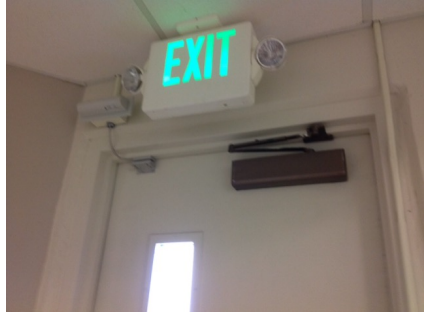
Item no., Rm no. and Name	Existing Architectural Barrier and Proposed Solution	Codes / Mitigation Info	Qty	Unit	Cost	Total
Signage						
511	<ul style="list-style-type: none"> • <i>As-Built Description:</i> At door leading into exit corridor: Where required exit signs are installed, signs to provide exiting information for people with vision impairment are not provided. • <i>Proposed Solution:</i> Provide raised letter/Braille "EXIT ROUTE" sign at door. 	PCODE SA10D ADAAG 91 4.1.3(16) ADA 2010 216.4.1 CBC 2007 1011.3 CBC 2016 11B-216.4.1 Mitigated: <input type="radio"/> YES <input checked="" type="radio"/> NO	8	JOB	\$270	\$2,160

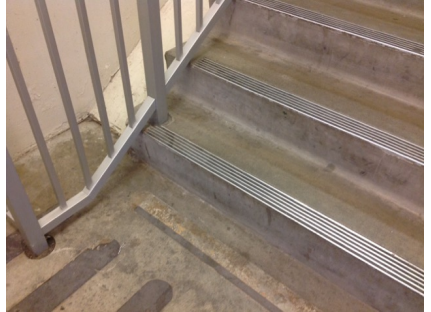
Item no., Rm no. and Name	Existing Architectural Barrier and Proposed Solution	Codes / Mitigation Info	Qty	Unit	Cost	Total
<u>Stairway</u>						
521	<ul style="list-style-type: none"> • <i>As-Built Description:</i> The leading 2" of the tread does not have visual contrast of dark-on-light or light-on-dark from the remainder of the tread. • <i>Proposed Solution:</i> Provide 2" min., 4" max. wide contrasting color strip 1" max. from nosing on top & bottom treads when altering area. 	PCODE II02B ADA 2010 504.4 CBC 2007 1133B.4.4 CBC 2016 11B-504.4.1 Mitigated: <input type="radio"/> YES <input checked="" type="radio"/> NO	40	LF	\$42	\$1,680

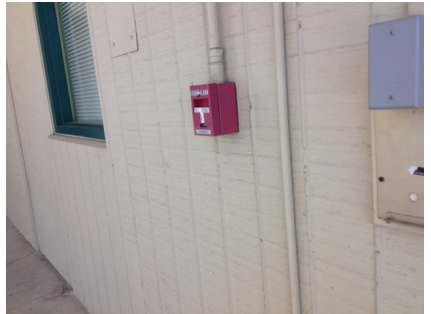
Item no., Rm no. and Name	Existing Architectural Barrier and Proposed Solution	Codes / Mitigation Info	Qty	Unit	Cost	Total
524	<ul style="list-style-type: none"> As-Built Description: Reach height to control or access point, exceeds 48" or is less than 15". As-Built: 48.5" high Proposed Solution: Modify equipment or mounting. 	PCODE IE01 ADAAG 91 4.2.5 ADA 2010 308.2.1 CBC 2007 1118B.5 CBC 2016 11B-308.2.1 Mitigated: <input type="radio"/> YES <input checked="" type="radio"/> NO	1	JOB	\$300	\$300

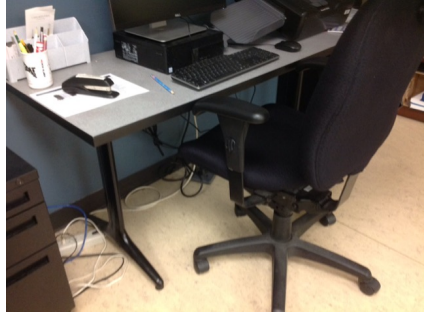
Item no., Rm no. and Name	Existing Architectural Barrier and Proposed Solution	Codes / Mitigation Info	Qty	Unit	Cost	Total
Non-Fixed Desk						
530	<ul style="list-style-type: none"> • <i>As-Built Description:</i> Accessible non-fixed table or desk (top 28" to 34" high; knee space at least 27" high x 19" deep x 30" wide) not provided. • <i>As-Built:</i> 12" knee depth • <i>Proposed Solution:</i> Provide table or desk with accessible dimensions when purchasing new furniture. 	PCODE IN02A ADAAG 91 4.32.3 & .4 ADA 2010 306.1 CBC 2007 1122B.3 & 4 CBC 2016 11B-306.1 & 11B-902.3	1	JOB	\$4,800	\$4,800
Mitigated: <input type="radio"/> YES <input checked="" type="radio"/> NO

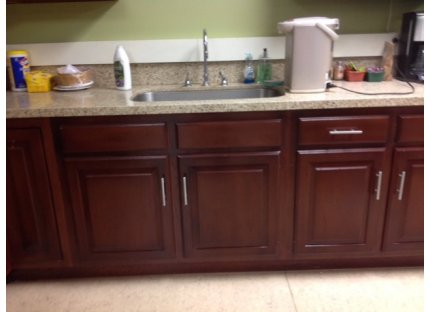
Item no., Rm no. and Name	Existing Architectural Barrier and Proposed Solution	Codes / Mitigation Info	Qty	Unit	Cost	Total
Sink						
538	<ul style="list-style-type: none"> As-Built Description: Sink rim higher than 34" above floor. As-Built: 37.5" high Proposed Solution: Remodel sink cabinet to lower sink. 	PCODE IN06 ADAAG 91 4.24.2 ADA 2010 606.3 CBC 2007 1115B.4.7.1 CBC 2016 11B-606.3 Mitigated: <input type="radio"/> YES <input checked="" type="radio"/> NO	1	JOB	\$5,250	\$5,250

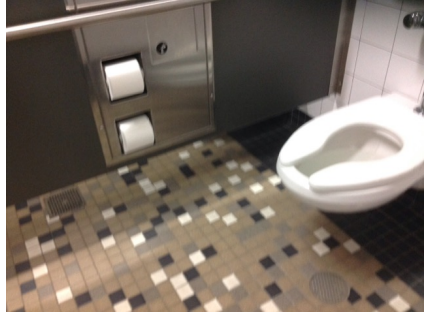
Item no., Rm no. and Name	Existing Architectural Barrier and Proposed Solution	Codes / Mitigation Info	Qty	Unit	Cost	Total
<u>Accessories</u>						
542	<ul style="list-style-type: none"> • <i>As-Built Description:</i> Toilet paper dispenser less than 15" (CA: 19") or more than 48" above floor or not within 7" to 9" from front of water closet (Note: CA pre-2010 is allowed within 12" from front of water closet). • <i>As-Built:</i> 12" o.c. • <i>Proposed Solution:</i> Relocate or provide new toilet paper dispenser. 	PCODE WG02 ADAAG 91 4.16.6 ADA 2010 604.7 CBC 2007 1115B.8.4 CBC 2016 11B-604.7 Mitigated: <input type="radio"/> YES <input checked="" type="radio"/> NO	1	JOB	\$225	\$225

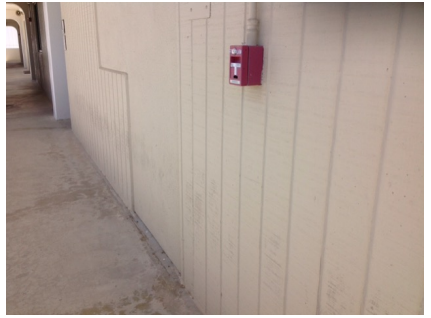
Item no., Rm no. and Name	Existing Architectural Barrier and Proposed Solution	Codes / Mitigation Info	Qty	Unit	Cost	Total
560	<ul style="list-style-type: none">As-Built Description: Reach height to control or access point, exceeds 48" or is less than 15".As-Built: 48.5" highProposed Solution: Modify equipment or mounting.	PCODE IE01 ADAAG 91 4.2.5 ADA 2010 308.2.1 CBC 2007 1118B.5 CBC 2016 11B-308.2.1 Mitigated: <input type="radio"/> YES <input checked="" type="radio"/> NO	1	JOB	\$300	\$300

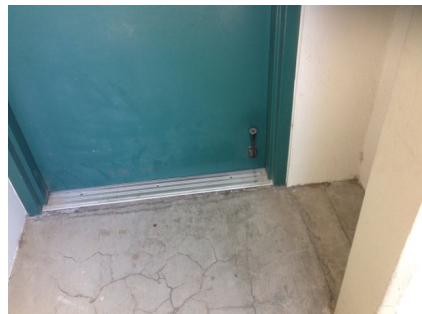
Item no., Rm no. and Name	Existing Architectural Barrier and Proposed Solution	Codes / Mitigation Info	Qty	Unit	Cost	Total
<u>Door Stopper</u>						
571	<ul style="list-style-type: none">• <i>As-Built Description:</i> At push side of door on accessible route, bottom 10" does not have a smooth, uninterrupted surface.• <i>Proposed Solution:</i> Remove door stopper when altering area. Provide rubber wedge.• <i>Notes:</i> Exterior door to Director's office	<p>PCODE ID06A</p> <p>ADA 2010 404.2.10</p> <p>CBC 2007 1133B.2.6</p> <p>CBC 2016 11B-404.2.10</p> <p>Mitigated:</p> <p><input type="radio"/> YES</p> <p><input checked="" type="radio"/> NO</p>	1	JOB	\$75	\$75

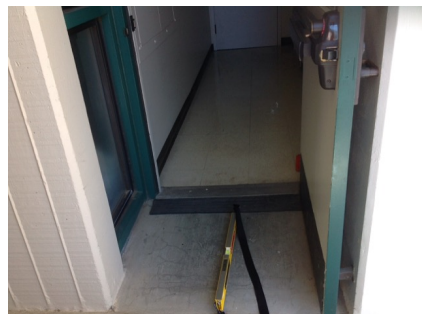
<input type="checkbox"/> Staff Only			
			Priority		Severity	
			<input checked="" type="radio"/> 4		<input checked="" type="radio"/> 3	
<u>Door Swing</u>						
563	<ul style="list-style-type: none">• <i>As-Built Description:</i> Front approach: At pull side, door does not have clear and level maneuvering space measuring door width plus 18" x 60". (24" x 60" at exterior doors).• <i>Proposed Solution:</i> Provide power door operator.	<p>PCODE ID23C</p> <p>ADAAG 91 Fig. 25(a)</p> <p>ADA 2010 404.2.4</p> <p>CBC 2007 11B-26A(a)</p> <p>CBC 2016 11B-404.2.4</p> <p>Mitigated:</p> <p><input type="radio"/> YES</p> <p><input checked="" type="radio"/> NO</p>	1	JOB	\$15,000	\$15,000

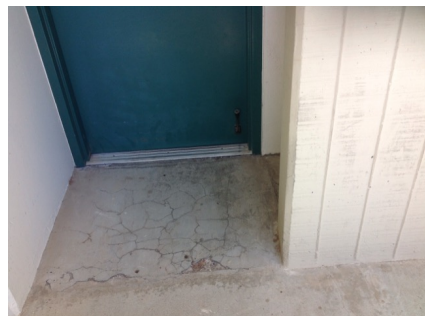
Item no., Rm no. and Name	Existing Architectural Barrier and Proposed Solution	Codes / Mitigation Info	Qty	Unit	Cost	Total
570	<ul style="list-style-type: none">• As-Built Description: Front approach: At push side, door does not have clear and level maneuvering space measuring door width x 48" (door width plus 12" if door has both, latch and closer).• Proposed Solution: Provide door operator.• Notes: Exterior door to Director's office	<p>PCODE ID24C</p> <p>ADAAG 91 Fig. 25(a)</p> <p>ADA 2010 404.2.4</p> <p>CBC 2007 11B-26A(a)</p> <p>CBC 2016 11B-404.2.4</p> <p>Mitigated:</p> <p><input type="radio"/> YES</p> <p><input checked="" type="radio"/> NO</p>	1	JOB	\$15,000	\$15,000

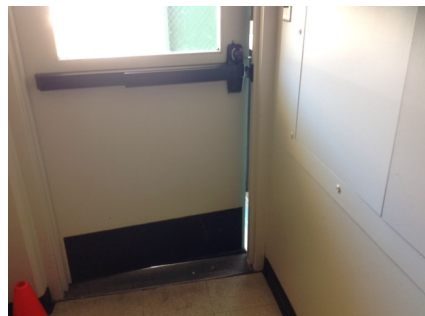
<input type="checkbox"/> Staff Only			
			Priority		Severity	
			<input checked="" type="radio"/> 4		<input checked="" type="radio"/> 2	
565	<ul style="list-style-type: none">• As-Built Description: Front approach: At push side, door does not have clear and level maneuvering space measuring door width x 48" (door width plus 12" if door has both, latch and closer).• Proposed Solution: Provide door operator.	<p>PCODE ID24CREF</p> <p>ADAAG 91 Fig. 25(a)</p> <p>ADA 2010 404.2.4</p> <p>CBC 2007 11B-26A(a)</p> <p>CBC 2016 11B-404.2.4</p> <p>Mitigated:</p> <p><input type="radio"/> YES</p> <p><input checked="" type="radio"/> NO</p>		REF

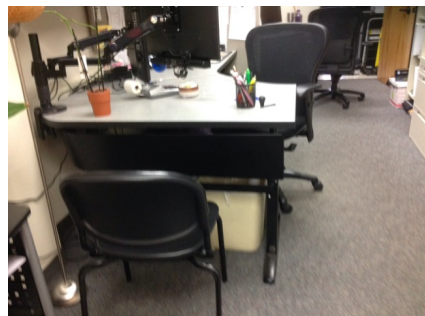
<input type="checkbox"/> Staff Only			
			Priority		Severity	
			<input checked="" type="radio"/> 4		<input checked="" type="radio"/> 2	
<u>Non-Fixed Desk</u>						
567	<ul style="list-style-type: none">• As-Built Description: Accessible non-fixed table or desk (top 28" to 34" high; knee space at least 27" high x 19" deep x 30" wide) not provided.• As-Built: No knee clearance on student side if used as work surface.• Proposed Solution: Provide table or desk with accessible dimensions when purchasing new furniture.	<p>PCODE IN02A</p> <p>ADAAG 91 4.32.3 & .4</p> <p>ADA 2010 306.1</p> <p>CBC 2007 1122B.3 & 4</p> <p>CBC 2016 11B-306.1 & 11B-902.3</p> <p>Mitigated:</p> <p><input type="radio"/> YES</p> <p><input checked="" type="radio"/> NO</p>	1	JOB	\$4,800	\$4,800

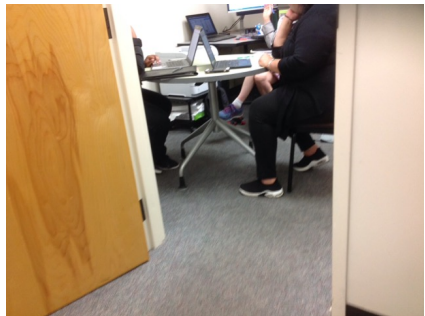
Item no., Rm no. and Name	Existing Architectural Barrier and Proposed Solution	Codes / Mitigation Info	Qty	Unit	Cost	Total
569	<ul style="list-style-type: none"> • <i>As-Built Description:</i> Accessible non-fixed table or desk (top 28" to 34" high; knee space at least 27" high x 19" deep x 30" wide) not provided. • <i>Proposed Solution:</i> Provide table or desk with accessible dimensions when purchasing new furniture. 	PCODE IN02A ADAAG 91 4.32.3 & .4 ADA 2010 306.1 CBC 2007 1122B.3 & 4 CBC 2016 11B-306.1 & 11B-902.3 Mitigated: <input type="radio"/> YES <input checked="" type="radio"/> NO	1	JOB	\$4,800	\$4,800

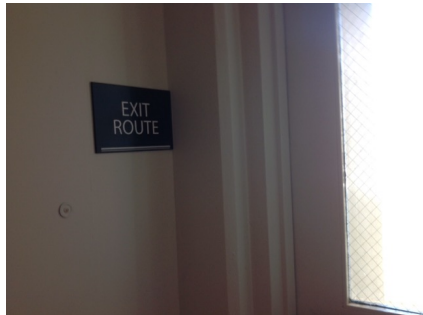
Signage

566	<ul style="list-style-type: none"> • <i>As-Built Description:</i> Sign not located on latch side of door and/or not located at 48" min. above to baseline of the lowest Braille cells and 60" max. to baseline of the highest line of raised characters. • <i>Proposed Solution:</i> Provide compliant signage including tactile characters and Grade II Braille on latch side of door located at compliant height. 	PCODE SA07 ADAAG 91 4.30.6 ADA 2010 703.4.1 CBC 2007 1117B.5.7 CBC 2016 11B-703.4.1 Mitigated: <input type="radio"/> YES <input checked="" type="radio"/> NO	1	JOB	\$150	\$150

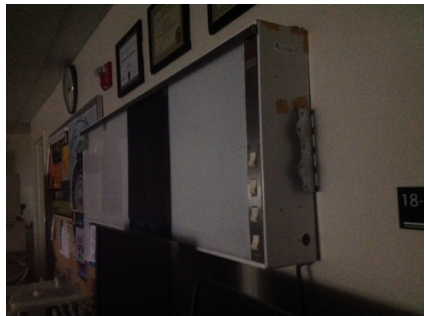
Item no., Rm no. and Name	Existing Architectural Barrier and Proposed Solution	Codes / Mitigation Info	Qty	Unit	Cost	Total
580	<ul style="list-style-type: none"> As-Built Description: Reach height to control or access point, exceeds 48" or is less than 15". As-Built: 60" high Proposed Solution: Modify equipment or mounting. 	PCODE IE01 ADAAG 91 4.2.5 ADA 2010 308.2.1 CBC 2007 1118B.5 CBC 2016 11B-308.2.1 Mitigated: <input type="radio"/> YES <input checked="" type="radio"/> NO	1	JOB	\$300	\$300

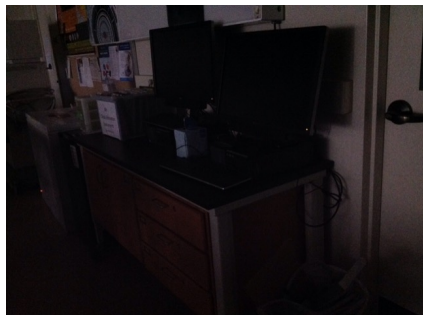
Non-Fixed Desk

579	<ul style="list-style-type: none"> As-Built Description: Accessible non-fixed table or desk (top 28" to 34" high; knee space at least 27" high x 19" deep x 30" wide) not provided. As-Built: No knee clearance Proposed Solution: Provide table or desk with accessible dimensions when purchasing new furniture. 	PCODE IN02A ADAAG 91 4.32.3 & .4 ADA 2010 306.1 CBC 2007 1122B.3 & 4 CBC 2016 11B-306.1 & 11B-902.3 Mitigated: <input type="radio"/> YES <input checked="" type="radio"/> NO	1	JOB	\$4,800	\$4,800

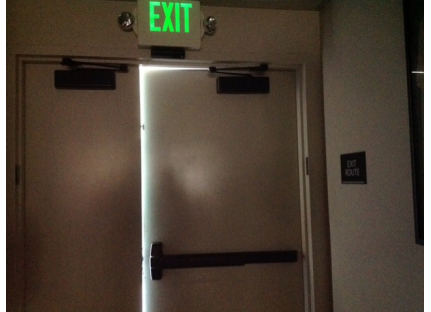
Item no., Rm no. and Name	Existing Architectural Barrier and Proposed Solution	Codes / Mitigation Info	Qty	Unit	Cost	Total
Signage						
577	<ul style="list-style-type: none"> As-Built Description: Sign not located on latch side of door and/or not located at 48" min. above to baseline of the lowest Braille cells and 60" max. to baseline of the highest line of raised characters. Proposed Solution: Provide compliant signage including tactile characters and Grade II Braille on latch side of door located at compliant height. 	PCODE SA07 ADAAG 91 4.30.6 ADA 2010 703.4.1 CBC 2007 1117B.5.7 CBC 2016 11B-703.4.1 Mitigated: <input type="radio"/> YES <input checked="" type="radio"/> NO	1	JOB	\$150	\$150

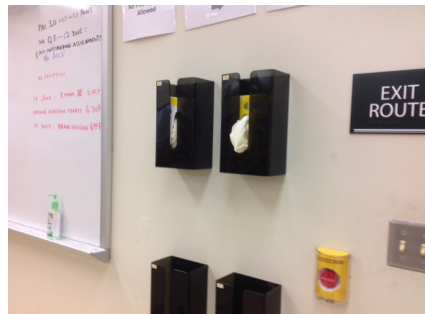
Item no., Rm no. and Name	Existing Architectural Barrier and Proposed Solution	Codes / Mitigation Info	Qty	Unit	Cost	Total
<u>Reach Range</u>						
584	<ul style="list-style-type: none">As-Built Description: Reach height to control or access point, exceeds 48" or is less than 15".As-Built: 57" highProposed Solution: Modify equipment or mounting.	<p>PCODE IE01</p> <p>ADAAG 91 4.2.5</p> <p>ADA 2010 308.2.1</p> <p>CBC 2007 1118B.5</p> <p>CBC 2016 11B-308.2.1</p> <p>Mitigated:</p> <p><input type="radio"/> YES</p> <p><input checked="" type="radio"/> NO</p>	1	JOB	\$300	\$300

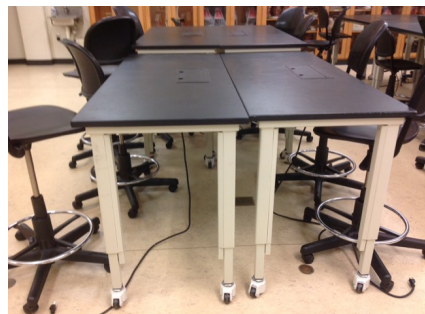
<input type="checkbox"/> Staff Only			
			Priority		Severity	
			2		3	
<u>Non-Fixed Desk</u>						
585	<ul style="list-style-type: none">As-Built Description: Accessible non-fixed table or desk (top 28" to 34" high; knee space at least 27" high x 19" deep x 30" wide) not provided.Proposed Solution: Provide table or desk with accessible dimensions when purchasing new furniture.Notes: 32 seats, no accessible	<p>PCODE IN02A</p> <p>ADAAG 91 4.32.3 & .4</p> <p>ADA 2010 306.1</p> <p>CBC 2007 1122B.3 & 4</p> <p>CBC 2016 11B-306.1 & 11B-902.3</p> <p>Mitigated:</p> <p><input type="radio"/> YES</p> <p><input checked="" type="radio"/> NO</p>	1	JOB	\$4,800	\$4,800

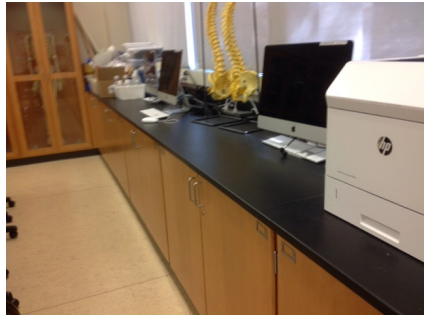
Item no., Rm no. and Name	Existing Architectural Barrier and Proposed Solution	Codes / Mitigation Info	Qty	Unit	Cost	Total
587	<ul style="list-style-type: none"> As-Built Description: Accessible non-fixed table or desk (top 28" to 34" high; knee space at least 27" high x 19" deep x 30" wide) not provided. Proposed Solution: Provide table or desk with accessible dimensions when purchasing new furniture. 	PCODE IN02A ADAAG 91 4.32.3 & .4 ADA 2010 306.1 CBC 2007 1122B.3 & 4 CBC 2016 11B-306.1 & 11B-902.3 Mitigated: <input type="radio"/> YES <input checked="" type="radio"/> NO	1	JOB	\$4,800	\$4,800

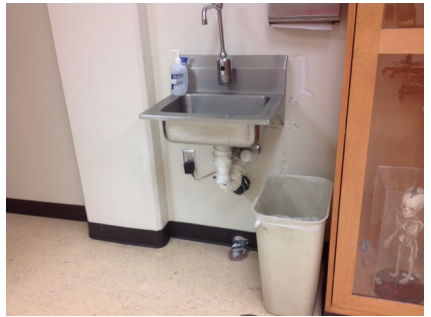
586	<ul style="list-style-type: none"> As-Built Description: Sink does not have knee space min. 27" high x 19" deep x 30" wide. Proposed Solution: Remodel sink cabinet. 	PCODE IN06A ADAAG 91 4.24.3 ADA 2010 606.2 CBC 2007 1115B.4.7.1 CBC 2016 11B-606.2 Mitigated: <input type="radio"/> YES <input checked="" type="radio"/> NO	1	JOB	\$5,250	\$5,250

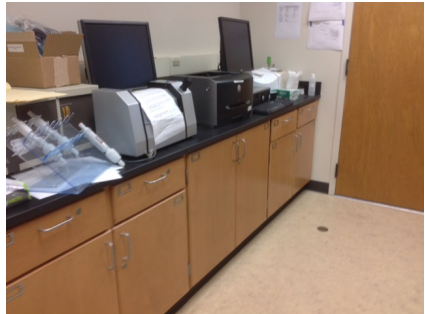
Item no., Rm no. and Name	Existing Architectural Barrier and Proposed Solution	Codes / Mitigation Info	Qty	Unit	Cost	Total
600	<ul style="list-style-type: none"> As-Built Description: Accessible non-fixed table or desk (top 28" to 34" high; knee space at least 27" high x 19" deep x 30" wide) not provided. As-Built: No knee clearance Proposed Solution: Provide table or desk with accessible dimensions when purchasing new furniture. Notes: Staff Area 	PCODE IN02A ADAAG 91 4.32.3 & .4 ADA 2010 306.1 CBC 2007 1122B.3 & 4 CBC 2016 11B-306.1 & 11B-902.3 Mitigated: <input type="radio"/> YES <input checked="" type="radio"/> NO	1	JOB	\$4,800	\$4,800

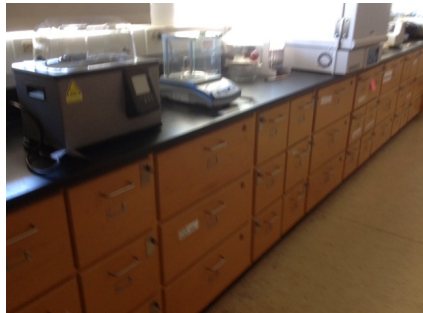
Public Counter

599	<ul style="list-style-type: none"> As-Built Description: Service counter (stand-up): Accessible section min. 36" length and 36" max. height (in CA: 28" to 34" high) not provided. As-Built: 36" high Proposed Solution: Retrofit existing counter to provide accessible section. Interim solution: Provide auxiliary counter, table, or clipboard. 	PCODE IN03 ADAAG 91 7.2(2) ADA 2010 904.4 CBC 2007 1122B.4 CBC 2016 11B-904.4 Mitigated: <input type="radio"/> YES <input checked="" type="radio"/> NO	1	JOB	\$6,000	\$6,000

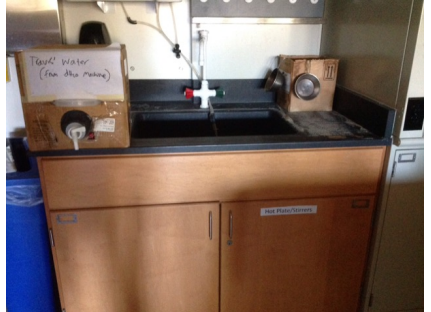
Item no., Rm no. and Name	Existing Architectural Barrier and Proposed Solution	Codes / Mitigation Info	Qty	Unit	Cost	Total
Sink						
596	<ul style="list-style-type: none"> • <i>As-Built Description:</i> Sink does not have knee space min. 27" high x 19" deep x 30" wide. • <i>Proposed Solution:</i> Remodel sink cabinet. 	PCODE IN06A ADAAG 91 4.24.3 ADA 2010 606.2 CBC 2007 1115B.4.7.1 CBC 2016 11B-606.2 Mitigated: <input type="radio"/> YES <input checked="" type="radio"/> NO	1	JOB	\$5,250	\$5,250

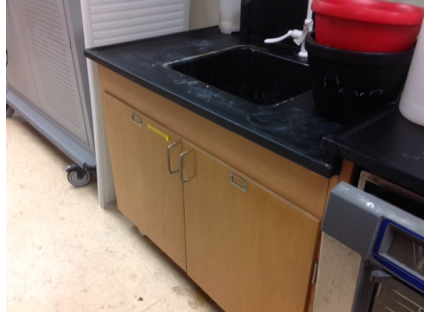
Item no., Rm no. and Name	Existing Architectural Barrier and Proposed Solution	Codes / Mitigation Info	Qty	Unit	Cost	Total
Sink						
602	<ul style="list-style-type: none"> • <i>As-Built Description:</i> Sink does not have knee space min. 27" high x 19" deep x 30" wide. • <i>Proposed Solution:</i> Remodel sink cabinet. 	PCODE IN06A ADAAG 91 4.24.3 ADA 2010 606.2 CBC 2007 1115B.4.7.1 CBC 2016 11B-606.2 Mitigated: <input type="radio"/> YES <input checked="" type="radio"/> NO	1	JOB	\$5,250	\$5,250

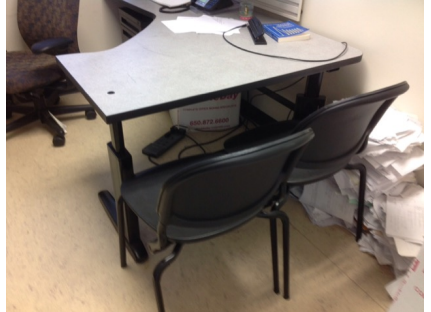
Item no., Rm no. and Name	Existing Architectural Barrier and Proposed Solution	Codes / Mitigation Info	Qty	Unit	Cost	Total
Non-Fixed Desk						
605	<ul style="list-style-type: none"> • <i>As-Built Description:</i> Accessible non-fixed table or desk (top 28" to 34" high; knee space at least 27" high x 19" deep x 30" wide) not provided. • <i>As-Built:</i> No knee on student side if used as work surface • <i>Proposed Solution:</i> Provide table or desk with accessible dimensions when purchasing new furniture. 	PCODE IN02A ADAAG 91 4.32.3 & .4 ADA 2010 306.1 CBC 2007 1122B.3 & 4 CBC 2016 11B-306.1 & 11B-902.3 Mitigated: <input type="radio"/> YES <input checked="" type="radio"/> NO	6	JOB	\$4,800	\$28,800

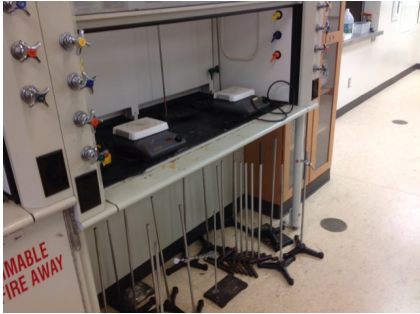
Item no., Rm no. and Name	Existing Architectural Barrier and Proposed Solution	Codes / Mitigation Info	Qty	Unit	Cost	Total
<u>Reach Range</u>						
611	<ul style="list-style-type: none">As-Built Description: Reach height to control or access point, exceeds 48" or is less than 15".As-Built: 54" reachProposed Solution: Modify equipment or mounting.	PCODE IE01 ADAAG 91 4.2.5 ADA 2010 308.2.1 CBC 2007 1118B.5 CBC 2016 11B-308.2.1 Mitigated: <input type="radio"/> YES <input checked="" type="radio"/> NO	1	JOB	\$300	\$300

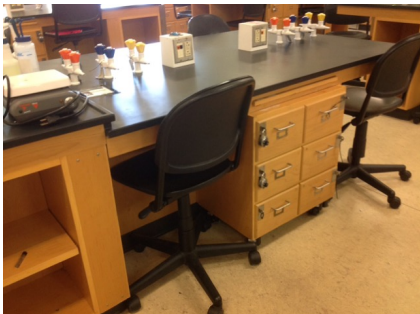
<u>Non-Fixed Desk</u>						
609	<ul style="list-style-type: none">As-Built Description: Accessible non-fixed table or desk (top 28" to 34" high; knee space at least 27" high x 19" deep x 30" wide) not provided.As-Built: 24" wideProposed Solution: Provide table or desk with accessible dimensions when purchasing new furniture.	PCODE IN02A ADAAG 91 4.32.3 & .4 ADA 2010 306.1 CBC 2007 1122B.3 & 4 CBC 2016 11B-306.1 & 11B-902.3 Mitigated: <input type="radio"/> YES <input checked="" type="radio"/> NO	1	JOB	\$4,800	\$4,800

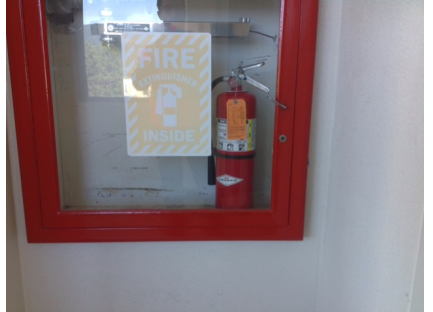
Item no., Rm no. and Name	Existing Architectural Barrier and Proposed Solution	Codes / Mitigation Info	Qty	Unit	Cost	Total
Reach Range						
612	<ul style="list-style-type: none"> As-Built Description: Reach height to control or access point, exceeds 48" or is less than 15". As-Built: 52" high Proposed Solution: Modify equipment or mounting. 	PCODE IE01 ADAAG 91 4.2.5 ADA 2010 308.2.1 CBC 2007 1118B.5 CBC 2016 11B-308.2.1 Mitigated: <input type="radio"/> YES <input checked="" type="radio"/> NO	2	JOB	\$300	\$600

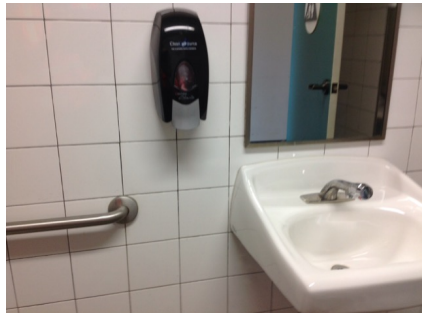
Item no., Rm no. and Name	Existing Architectural Barrier and Proposed Solution	Codes / Mitigation Info	Qty	Unit	Cost	Total
Accessories						
616	<ul style="list-style-type: none"> As-Built Description: Dispensers in sanitary facilities, such as for towels, soap, sanitary napkins, seat covers, etc., and waste receptacles more than 48" (CA only: 40") from floor to highest operating slot or control. As-Built: 43" high Proposed Solution: Relocate existing restroom accessories. 	PCODE WG01A ADAAG 91 4.23.7 ADA 2010 308.2.1 CBC 2007 1115B.8.3 CBC 2016 11B-603.5 Mitigated: <input type="radio"/> YES <input checked="" type="radio"/> NO	1	JOB	\$300	\$300

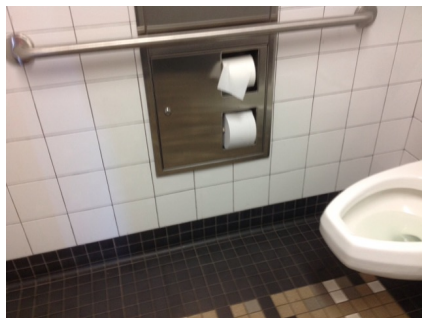
<input type="checkbox"/> Staff Only			
			Priority		Severity	
			3		4	
619	<ul style="list-style-type: none"> As-Built Description: Toilet paper dispenser less than 15" (CA: 19") or more than 48" above floor or not within 7" to 9" from front of water closet (Note: CA pre-2010 is allowed within 12" from front of water closet). As-Built: 5" o.c. Proposed Solution: Relocate or provide new toilet paper dispenser. 	PCODE WG02 ADAAG 91 4.16.6 ADA 2010 604.7 CBC 2007 1115B.8.4 CBC 2016 11B-604.7 Mitigated: <input type="radio"/> YES <input checked="" type="radio"/> NO	1	JOB	\$225	\$225

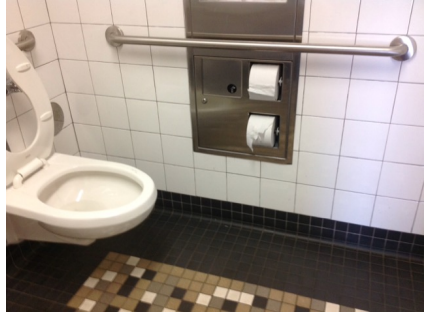
Item no., Rm no. and Name	Existing Architectural Barrier and Proposed Solution	Codes / Mitigation Info	Qty	Unit	Cost	Total
Accessories						
622	<ul style="list-style-type: none"> • <i>As-Built Description:</i> Toilet paper dispenser less than 15" (CA: 19") or more than 48" above floor or not within 7" to 9" from front of water closet (Note: CA pre-2010 is allowed within 12" from front of water closet). • <i>As-Built:</i> 12" o.c. • <i>Proposed Solution:</i> Relocate or provide new toilet paper dispenser. 	PCODE WG02 ADAAG 91 4.16.6 ADA 2010 604.7 CBC 2007 1115B.8.4 CBC 2016 11B-604.7 Mitigated: <input type="radio"/> YES <input checked="" type="radio"/> NO	1	JOB	\$225	\$225

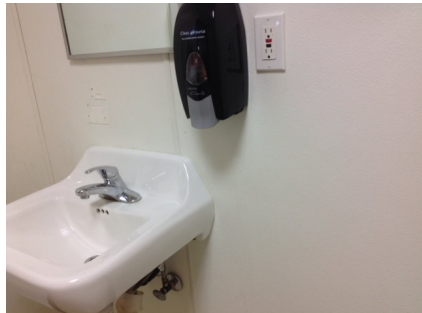
Item no., Rm no. and Name	Existing Architectural Barrier and Proposed Solution	Codes / Mitigation Info	Qty	Unit	Cost	Total
Accessories						
304	<ul style="list-style-type: none"> • <i>As-Built Description:</i> Dispensers in sanitary facilities, such as for towels, soap, sanitary napkins, seat covers, etc., and waste receptacles more than 48" (CA only: 40") from floor to highest operating slot or control. • <i>As-Built:</i> 42" high • <i>Proposed Solution:</i> Relocate existing restroom accessories. 	PCODE WG01A ADAAG 91 4.23.7 ADA 2010 308.2.1 CBC 2007 1115B.8.3 CBC 2016 11B-603.5 Mitigated: <input type="radio"/> YES <input checked="" type="radio"/> NO	1	JOB	\$300	\$300

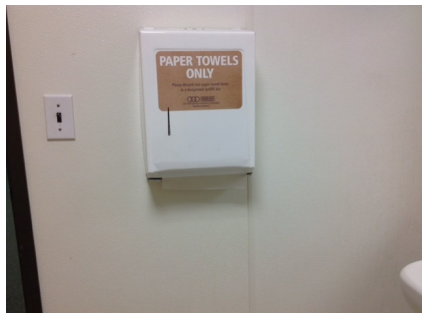
<input type="checkbox"/> Staff Only Priority 3 Severity 4			
305	<ul style="list-style-type: none"> • <i>As-Built Description:</i> Dispensers in sanitary facilities, such as for towels, soap, sanitary napkins, seat covers, etc., and waste receptacles more than 48" (CA only: 40") from floor to highest operating slot or control. • <i>As-Built:</i> 42" high • <i>Proposed Solution:</i> Relocate existing restroom accessories. 	PCODE WG01A ADAAG 91 4.23.7 ADA 2010 308.2.1 CBC 2007 1115B.8.3 CBC 2016 11B-603.5 Mitigated: <input type="radio"/> YES <input checked="" type="radio"/> NO	1	JOB	\$300	\$300

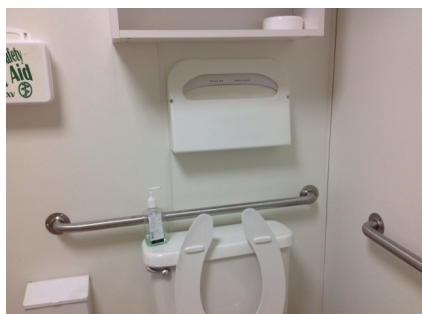
<input type="checkbox"/> Staff Only Priority 3 Severity 4			
306	<ul style="list-style-type: none"> • <i>As-Built Description:</i> Dispensers in sanitary facilities, such as for towels, soap, sanitary napkins, seat covers, etc., and waste receptacles more than 48" (CA only: 40") from floor to highest operating slot or control. • <i>As-Built:</i> 50" high • <i>Proposed Solution:</i> Relocate existing restroom accessories. • <i>Notes:</i> First aid and seat cover 	PCODE WG01A ADAAG 91 4.23.7 ADA 2010 308.2.1 CBC 2007 1115B.8.3 CBC 2016 11B-603.5 Mitigated: <input type="radio"/> YES <input checked="" type="radio"/> NO	1	JOB	\$300	\$300

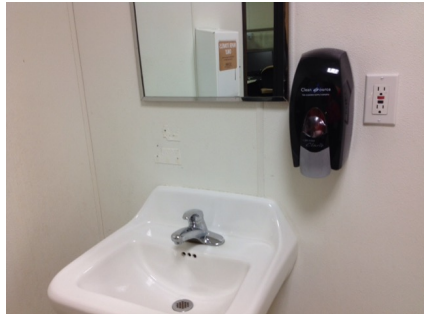
Item no., Rm no. and Name	Existing Architectural Barrier and Proposed Solution	Codes / Mitigation Info	Qty	Unit	Cost	Total
303	<ul style="list-style-type: none"> As-Built Description: Bottom of mirror located above lavatories or countertops more than 40" above floor. As-Built: 48" high Proposed Solution: Relocate or provide new accessible mirror. 	PCODE WG03 ADAAG 91 4.19.6 ADA 2010 603.3 CBC 2007 1115B.8.1 CBC 2016 11B-603.3 Mitigated: <input type="radio"/> YES <input checked="" type="radio"/> NO	1	JOB	\$450	\$450

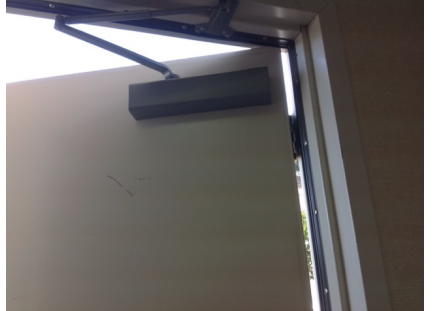
Item no., Rm no. and Name	Existing Architectural Barrier and Proposed Solution	Codes / Mitigation Info	Qty	Unit	Cost	Total
Door Closer						
285	<ul style="list-style-type: none"> • <i>As-Built Description:</i> Excessive force required to open door. • <i>As-Built:</i> 9 lbs. • <i>Proposed Solution:</i> Adjust regular door closer to accessible standards (5 lbs. max). 	PCODE ID03 ADAAG 91 4.13.11 ADA 2010 404.2.9 CBC 2007 1133B.2.5 CBC 2016 11B-404.2.9 Mitigated: <input type="radio"/> YES <input checked="" type="radio"/> NO	1	JOB	\$75	\$75

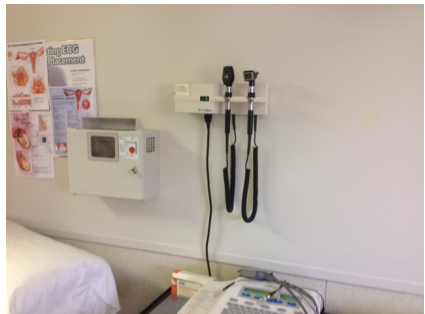
Item no., Rm no. and Name	Existing Architectural Barrier and Proposed Solution	Codes / Mitigation Info	Qty	Unit	Cost	Total
288	<ul style="list-style-type: none"> As-Built Description: Reach height to control or access point, exceeds 48" or is less than 15". As-Built: Nursing equipment 60" high Proposed Solution: Modify equipment or mounting. 	PCODE IE01 ADAAG 91 4.2.5 ADA 2010 308.2.1 CBC 2007 1118B.5 CBC 2016 11B-308.2.1 Mitigated: <input type="radio"/> YES <input checked="" type="radio"/> NO	1	JOB	\$300	\$300

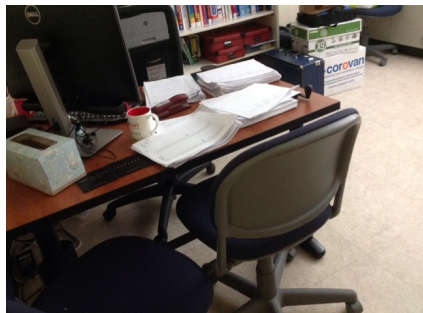
290	<ul style="list-style-type: none"> As-Built Description: Accessible non-fixed table or desk (top 28" to 34" high; knee space at least 27" high x 19" deep x 30" wide) not provided. As-Built: No knee clearance if used as work surface for students Proposed Solution: Provide table or desk with accessible dimensions when purchasing new furniture. Notes: Lounge used as staff offices. 	PCODE IN02A ADAAG 91 4.32.3 & .4 ADA 2010 306.1 CBC 2007 1122B.3 & 4 CBC 2016 11B-306.1 & 11B-902.3 Mitigated: <input type="radio"/> YES <input checked="" type="radio"/> NO	1	JOB	\$4,800	\$4,800

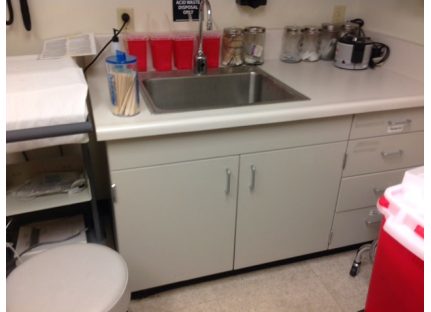
Item no., Rm no. and Name	Existing Architectural Barrier and Proposed Solution	Codes / Mitigation Info	Qty	Unit	Cost	Total
Sink						
289	<ul style="list-style-type: none"> • <i>As-Built Description:</i> Sink does not have knee space min. 27" high x 19" deep x 30" wide. • <i>Proposed Solution:</i> Remodel sink cabinet. 	PCODE IN06A ADAAG 91 4.24.3 ADA 2010 606.2 CBC 2007 1115B.4.7.1 CBC 2016 11B-606.2 Mitigated: <input type="radio"/> YES <input checked="" type="radio"/> NO	1	JOB	\$5,250	\$5,250

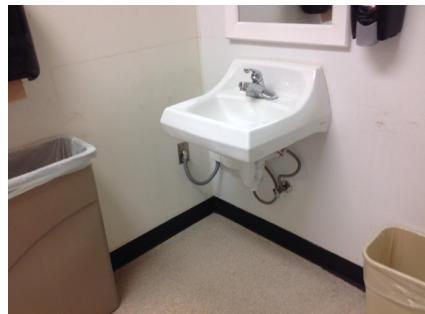
Item no., Rm no. and Name	Existing Architectural Barrier and Proposed Solution	Codes / Mitigation Info	Qty	Unit	Cost	Total
<u>Lavatory</u>						
291	<ul style="list-style-type: none">As-Built Description: Wheelchair clearance under lavatory apron or lavatory counter front edge less than 29" high.As-Built: 28" highProposed Solution: Provide new accessible lavatory. Remodel restroom as needed.	PCODE WD03 ADAAG 91 4.19.2 ADA 2010 606.3 CBC 2007 1115B.4.3.3 CBC 2016 11B-306.3.1 Mitigated: <input type="radio"/> YES <input checked="" type="radio"/> NO	1	JOB	\$10,200	\$10,200

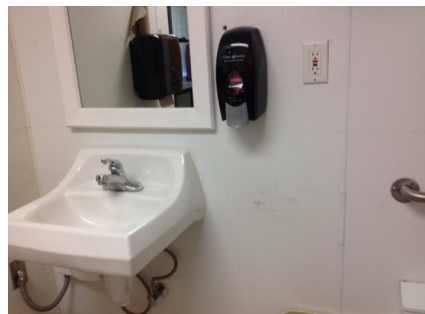
<input type="checkbox"/> Staff Only			
			Priority		Severity	
			3		2	
<u>Accessories</u>						
293	<ul style="list-style-type: none">As-Built Description: Dispensers in sanitary facilities, such as for towels, soap, sanitary napkins, seat covers, etc., and waste receptacles more than 48" (CA only: 40") from floor to highest operating slot or control.As-Built: Soap 42" highProposed Solution: Relocate existing restroom accessories.	PCODE WG01A ADAAG 91 4.23.7 ADA 2010 308.2.1 CBC 2007 1115B.8.3 CBC 2016 11B-603.5 Mitigated: <input type="radio"/> YES <input checked="" type="radio"/> NO	1	JOB	\$300	\$300

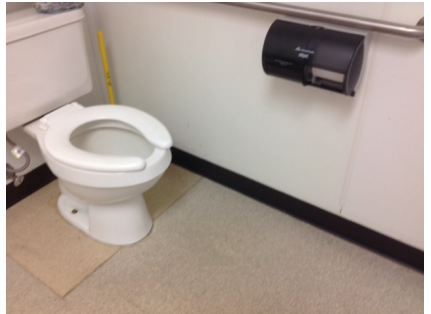
Item no., Rm no. and Name	Existing Architectural Barrier and Proposed Solution	Codes / Mitigation Info	Qty	Unit	Cost	Total
296	<ul style="list-style-type: none"> As-Built Description: Toilet paper dispenser less than 15" (CA: 19") or more than 48" above floor or not within 7" to 9" from front of water closet (Note: CA pre-2010 is allowed within 12" from front of water closet). As-Built: 14" o.c. Proposed Solution: Relocate or provide new toilet paper dispenser. 	PCODE WG02 ADAAG 91 4.16.6 ADA 2010 604.7 CBC 2007 1115B.8.4 CBC 2016 11B-604.7 Mitigated: <input type="radio"/> YES <input checked="" type="radio"/> NO	1	JOB	\$225	\$225

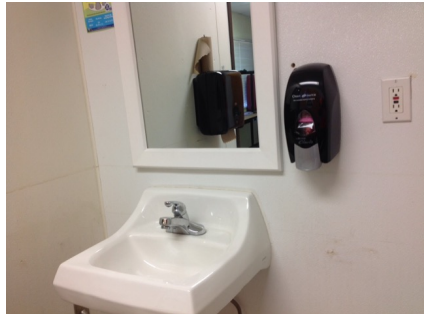
<input type="checkbox"/> Staff Only Priority 3 Severity 3			
292	<ul style="list-style-type: none"> As-Built Description: Bottom of mirror located above lavatories or countertops more than 40" above floor. As-Built: 43" high Proposed Solution: Relocate or provide new accessible mirror. 	PCODE WG03 ADAAG 91 4.19.6 ADA 2010 603.3 CBC 2007 1115B.8.1 CBC 2016 11B-603.3 Mitigated: <input type="radio"/> YES <input checked="" type="radio"/> NO	1	JOB	\$450	\$450

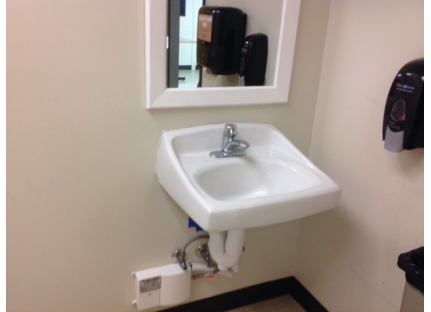
Item no., Rm no. and Name	Existing Architectural Barrier and Proposed Solution	Codes / Mitigation Info	Qty	Unit	Cost	Total
<u>Accessories</u>						
314	<ul style="list-style-type: none"> • <i>As-Built Description:</i> Bottom of mirror located above lavatories or countertops more than 40" above floor. • <i>As-Built:</i> 43" high • <i>Proposed Solution:</i> Relocate or provide new accessible mirror. 	PCODE WG03 ADAAG 91 4.19.6 ADA 2010 603.3 CBC 2007 1115B.8.1 CBC 2016 11B-603.3 Mitigated: <input type="radio"/> YES <input checked="" type="radio"/> NO	1	JOB	\$450	\$450

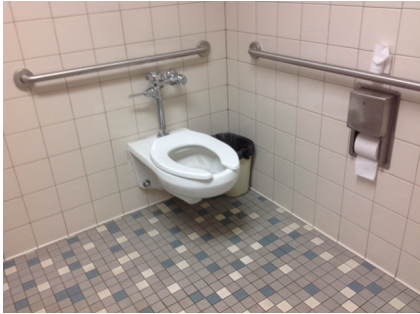
Item no., Rm no. and Name	Existing Architectural Barrier and Proposed Solution	Codes / Mitigation Info	Qty	Unit	Cost	Total
Water Closet						
345	<ul style="list-style-type: none">As-Built Description: Water closet not 16"-18" (CA: 17"-18") from near side wall to center line of water closet (2010 ADAAG: 16"-18").As-Built: 19" o.c.Proposed Solution: Relocate existing water closet and plumbing, remount with offset closet flange to provide 18" max. from side wall.	<p>PCODE WB02C</p> <p>ADAAG 91 Fig. 28</p> <p>ADA 2010 604.2</p> <p>CBC 2007 1115B.4.1.1</p> <p>CBC 2016 11B-604.2</p> <p>Mitigated:</p> <p><input type="radio"/> YES</p> <p><input checked="" type="radio"/> NO</p>	1	JOB	\$1,500	\$1,500

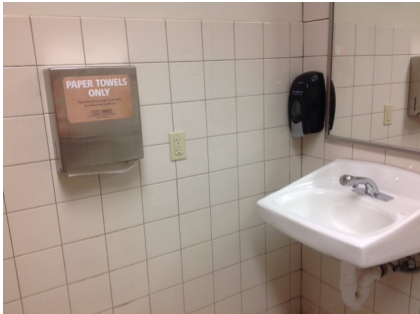
Accessories						
343	<ul style="list-style-type: none">As-Built Description: Dispensers in sanitary facilities, such as for towels, soap, sanitary napkins, seat covers, etc., and waste receptacles more than 48" (CA only: 40") from floor to highest operating slot or control.As-Built: 41" highProposed Solution: Relocate existing restroom accessories.	<p>PCODE WG01A</p> <p>ADAAG 91 4.23.7</p> <p>ADA 2010 308.2.1</p> <p>CBC 2007 1115B.8.3</p> <p>CBC 2016 11B-603.5</p> <p>Mitigated:</p> <p><input type="radio"/> YES</p> <p><input checked="" type="radio"/> NO</p>	2	JOB	\$300	\$600

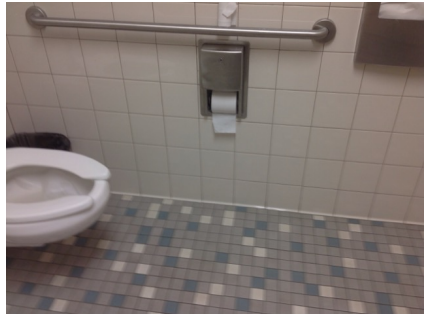
Item no., Rm no. and Name	Existing Architectural Barrier and Proposed Solution	Codes / Mitigation Info	Qty	Unit	Cost	Total
347	<ul style="list-style-type: none"> As-Built Description: Toilet paper dispenser less than 15" (CA: 19") or more than 48" above floor or not within 7" to 9" from front of water closet (Note: CA pre-2010 is allowed within 12" from front of water closet). As-Built: 13" o.c. Proposed Solution: Relocate or provide new toilet paper dispenser. 	PCODE WG02 ADAAG 91 4.16.6 ADA 2010 604.7 CBC 2007 1115B.8.4 CBC 2016 11B-604.7 Mitigated: <input type="radio"/> YES <input checked="" type="radio"/> NO	1	JOB	\$225	\$225

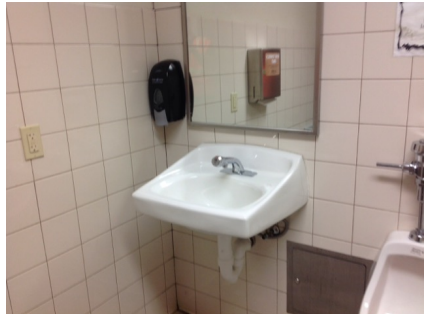
<input type="checkbox"/> Staff Only			
			Priority		Severity	
			3		3	
342	<ul style="list-style-type: none"> As-Built Description: Bottom of mirror located above lavatories or countertops more than 40" above floor. As-Built: 41" high Proposed Solution: Relocate or provide new accessible mirror. 	PCODE WG03 ADAAG 91 4.19.6 ADA 2010 603.3 CBC 2007 1115B.8.1 CBC 2016 11B-603.3 Mitigated: <input type="radio"/> YES <input checked="" type="radio"/> NO	1	JOB	\$450	\$450

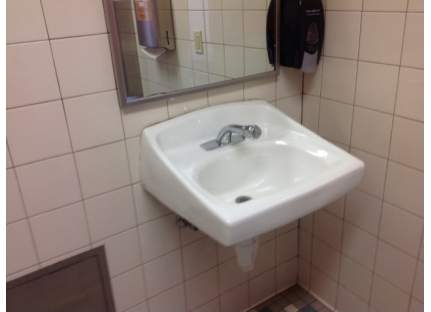
Item no., Rm no. and Name	Existing Architectural Barrier and Proposed Solution	Codes / Mitigation Info	Qty	Unit	Cost	Total
<u>Accessories</u>						
350	<ul style="list-style-type: none"> • <i>As-Built Description:</i> Bottom of mirror located above lavatories or countertops more than 40" above floor. • <i>As-Built:</i> 41" high • <i>Proposed Solution:</i> Relocate or provide new accessible mirror. 	PCODE WG03 ADAAG 91 4.19.6 ADA 2010 603.3 CBC 2007 1115B.8.1 CBC 2016 11B-603.3 Mitigated: <input type="radio"/> YES <input checked="" type="radio"/> NO	1	JOB	\$450	\$450

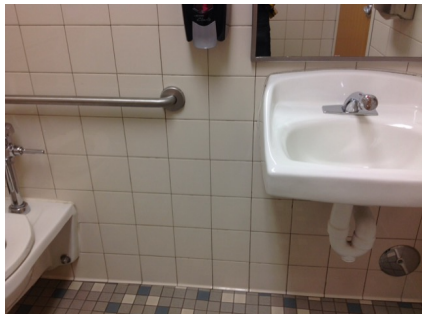
Item no., Rm no. and Name	Existing Architectural Barrier and Proposed Solution	Codes / Mitigation Info	Qty	Unit	Cost	Total
<u>Lavatory</u>						
369	<ul style="list-style-type: none">• <i>As-Built Description:</i> Clear floor space, 30" x 48" in front of fixture, extending 19" max. under the lavatory, not provided (CA only: Less than 18" from side wall to centerline of lavatory).• <i>As-Built:</i> 16" o.c.• <i>Proposed Solution:</i> Provide new accessible lavatory. Remodel restroom as needed.	<p>PCODE WD01</p> <p>ADAAG 91 4.19.3</p> <p>ADA 2010 606.2</p> <p>CBC 2007 1115B.4.3</p> <p>CBC 2016 11B-606.2, 11B-606.6</p> <p>Mitigated:</p> <p><input type="radio"/> YES</p> <p><input checked="" type="radio"/> NO</p>	1	JOB	\$10,200	\$10,200

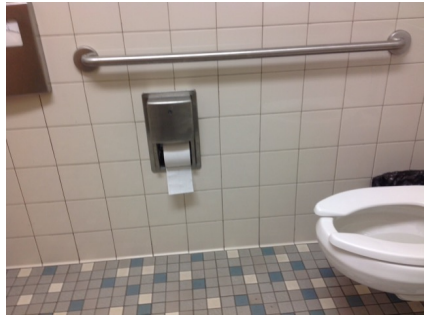
370	<ul style="list-style-type: none">• <i>As-Built Description:</i> Dispensers in sanitary facilities, such as for towels, soap, sanitary napkins, seat covers, etc., and waste receptacles more than 48" (CA only: 40") from floor to highest operating slot or control.• <i>As-Built:</i> 40.5" high• <i>Proposed Solution:</i> Relocate existing restroom accessories.	<p>PCODE WG01A</p> <p>ADAAG 91 4.23.7</p> <p>ADA 2010 308.2.1</p> <p>CBC 2007 1115B.8.3</p> <p>CBC 2016 11B-603.5</p> <p>Mitigated:</p> <p><input type="radio"/> YES</p> <p><input checked="" type="radio"/> NO</p>	1	JOB	\$300	\$300
