SMCCCD - Cañada College

Appendix H: Facilities

Access Compliance Survey Report

Building 2 - Bookstore

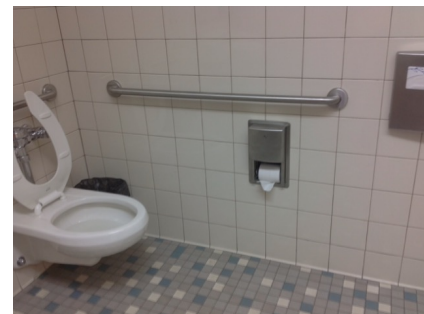
Item no., Rm no. and Name	Existing Architectural Barrier and Proposed Solution	Codes / Mitigation Info	Qty	Unit	Cost	Total
375	<ul style="list-style-type: none"> As-Built Description: Toilet paper dispenser less than 15" (CA: 19") or more than 48" above floor or not within 7" to 9" from front of water closet (Note: CA pre-2010 is allowed within 12" from front of water closet). As-Built: 18" o.c. Proposed Solution: Relocate or provide new toilet paper dispenser. 	PCODE WG02 ADAAG 91 4.16.6 ADA 2010 604.7 CBC 2007 1115B.8.4 CBC 2016 11B-604.7 Mitigated: <input type="radio"/> YES <input checked="" type="radio"/> NO	1	JOB	\$225	\$225

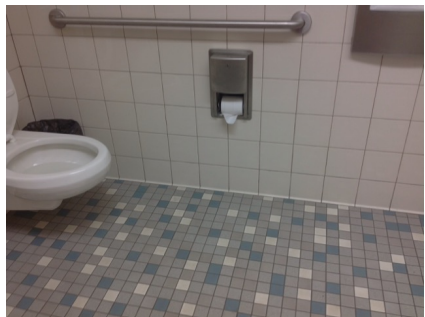
Item no., Rm no. and Name	Existing Architectural Barrier and Proposed Solution	Codes / Mitigation Info	Qty	Unit	Cost	Total
Accessories						
378	<ul style="list-style-type: none"> • <i>As-Built Description:</i> Dispensers in sanitary facilities, such as for towels, soap, sanitary napkins, seat covers, etc., and waste receptacles more than 48" (CA only: 40") from floor to highest operating slot or control. • <i>As-Built:</i> 41" high • <i>Proposed Solution:</i> Relocate existing restroom accessories. 	PCODE WG01A ADAAG 91 4.23.7 ADA 2010 308.2.1 CBC 2007 1115B.8.3 CBC 2016 11B-603.5 Mitigated: <input type="radio"/> YES <input checked="" type="radio"/> NO	1	JOB	\$300	\$300

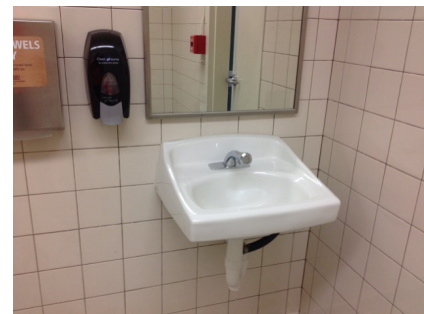
Item no., Rm no. and Name	Existing Architectural Barrier and Proposed Solution	Codes / Mitigation Info	Qty	Unit	Cost	Total
<u>Coat Hook</u>						
382	<ul style="list-style-type: none"> As-Built Description: Accessible coat hook not within reach range. As-Built: 70" high Proposed Solution: Adjust existing or provide new coat hook at maximum 48" height. 	PCODE WG03A ADAAG 91 4.2.5 ADA 2010 603.4 CBC 2007 1118B.5 CBC 2016 11B-603.4 Mitigated: <input type="radio"/> YES <input checked="" type="radio"/> NO	1	JOB	\$150	\$150

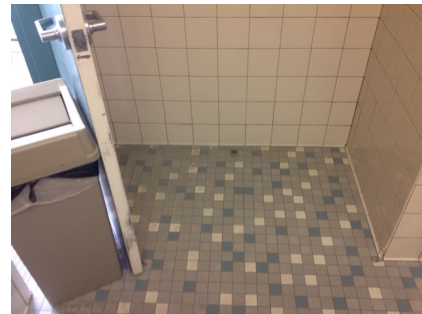
387	<ul style="list-style-type: none"> As-Built Description: Accessible coat hook not within reach range. As-Built: 55" high Proposed Solution: Adjust existing or provide new coat hook at maximum 48" height. 	PCODE WG03A ADAAG 91 4.2.5 ADA 2010 603.4 CBC 2007 1118B.5 CBC 2016 11B-603.4 Mitigated: <input type="radio"/> YES <input checked="" type="radio"/> NO	1	JOB	\$150	\$150

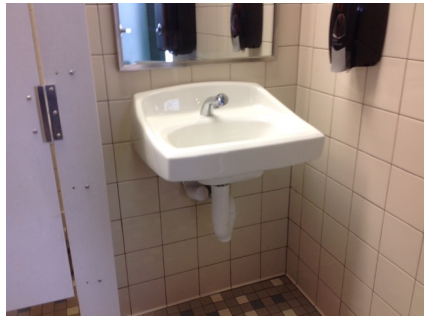
<input type="checkbox"/> Staff Only						
Priority 3 Severity 2						
391	<ul style="list-style-type: none"> • <i>As-Built Description:</i> Bottom of mirror located above lavatories or countertops more than 40" above floor. • <i>As-Built:</i> 41" high • <i>Proposed Solution:</i> Relocate or provide new accessible mirror. 	PCODE WG03 ADAAG 91 4.19.6 ADA 2010 603.3 CBC 2007 1115B.8.1 CBC 2016 11B-603.3 Mitigated: <input type="radio"/> YES <input checked="" type="radio"/> NO	1	JOB	\$450	\$450

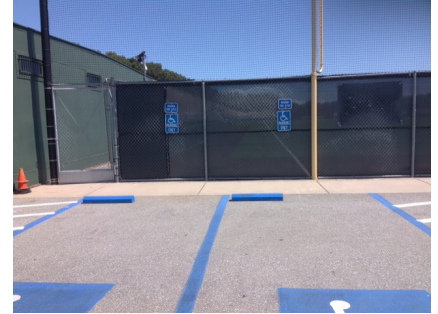
Sign for accessible parking space is missing or non-compliant.

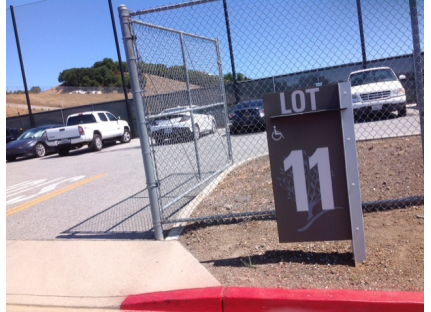
Item no., Rm no. and Name	Existing Architectural Barrier and Proposed Solution	Codes / Mitigation Info	Qty	Unit	Cost	Total
<u>Parking Signage</u>						
68	<ul style="list-style-type: none">• <i>As-Built Description:</i> No "Tow Away" sign at parking lot entrance (required in CA only).• <i>Proposed Solution:</i> Provide "Tow Away" sign at parking lot entrance when altering area.	<p>PCODE EA04C</p> <p>CBC 2007 1129B.4</p> <p>CBC 2016 11B-502.8.2</p> <p>Mitigated:</p> <p><input type="radio"/> YES</p> <p><input checked="" type="radio"/> NO</p>	1	JOB	\$975	\$975

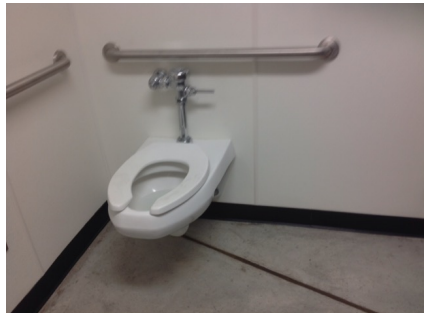
80	<ul style="list-style-type: none"> As-Built Description: Accessories/dispensers in accessible stall located closer than 1-1/2" below or 12" above grab bar impedes its use. As-Built: 1" below Proposed Solution: Relocate accessories/dispensers to be no closer than 1-1/2" below and 12" above grab bars (except if accessories are recessed, flush with wall, and have no sharp edges). 	PCODE WB071 ADAAG 91 4.26.2 ADA 2010 609.3 CBC 2007 1133B.4.2.5 CBC 2016 11B-609.3 Mitigated: <input type="radio"/> YES <input checked="" type="radio"/> NO	1	JOB	\$225	\$225

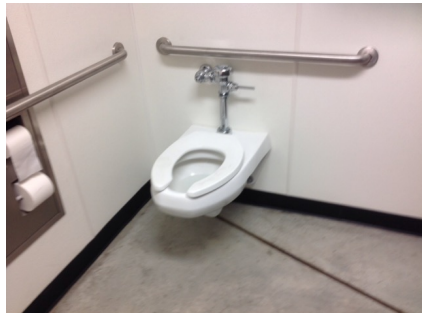
Item no., Rm no. and Name	Existing Architectural Barrier and Proposed Solution	Codes / Mitigation Info	Qty	Unit	Cost	Total
Water Closet						
79	<ul style="list-style-type: none"> • <i>As-Built Description:</i> Water closet not 16"-18" (CA: 17"-18") from near side wall to center line of water closet (2010 ADAAG: 16"-18"). • <i>As-Built:</i> 18.5" o.c. • <i>Proposed Solution:</i> Relocate existing water closet and plumbing, remount with offset closet flange to provide 18" max. from side wall. 	PCODE WB02C ADAAG 91 Fig. 28 ADA 2010 604.2 CBC 2007 1115B.4.1.1 CBC 2016 11B-604.2 Mitigated: <input type="radio"/> YES <input checked="" type="radio"/> NO	1	JOB	\$1,500	\$1,500

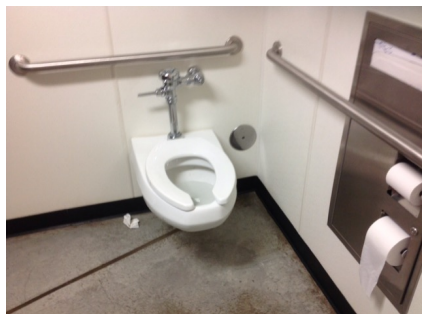
<input type="checkbox"/> Staff Only Priority 3 Severity 4			
83	<ul style="list-style-type: none"> • <i>As-Built Description:</i> Water closet not 16"-18" (CA: 17"-18") from near side wall to center line of water closet (2010 ADAAG: 16"-18"). • <i>As-Built:</i> 18.5" o.c. • <i>Proposed Solution:</i> Relocate existing water closet and plumbing, remount with offset closet flange to provide 18" max. from side wall. 	PCODE WB02C ADAAG 91 Fig. 28 ADA 2010 604.2 CBC 2007 1115B.4.1.1 CBC 2016 11B-604.2 Mitigated: <input type="radio"/> YES <input checked="" type="radio"/> NO	1	JOB	\$1,500	\$1,500

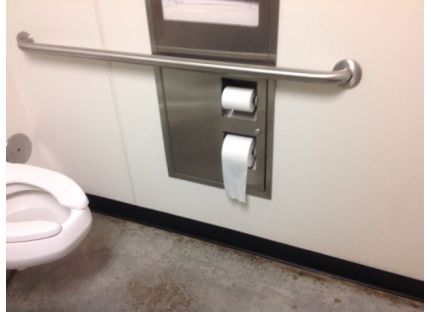
Item no., Rm no. and Name	Existing Architectural Barrier and Proposed Solution	Codes / Mitigation Info	Qty	Unit	Cost	Total
Accessories						
84	<ul style="list-style-type: none"> • <i>As-Built Description:</i> Toilet paper dispenser less than 15" (CA: 19") or more than 48" above floor or not within 7" to 9" from front of water closet (Note: CA pre-2010 is allowed within 12" from front of water closet). • <i>As-Built:</i> 14" o.c. • <i>Proposed Solution:</i> Relocate or provide new toilet paper dispenser. 	PCODE WG02 ADAAG 91 4.16.6 ADA 2010 604.7 CBC 2007 1115B.8.4 CBC 2016 11B-604.7 Mitigated: <input type="radio"/> YES <input checked="" type="radio"/> NO	1	JOB	\$225	\$225

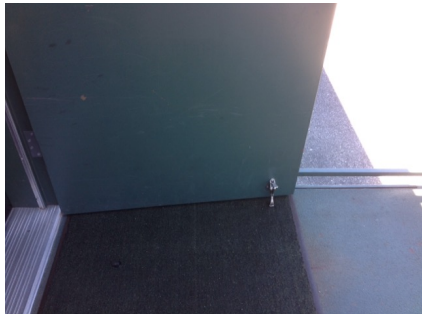
Item no., Rm no. and Name	Existing Architectural Barrier and Proposed Solution	Codes / Mitigation Info	Qty	Unit	Cost	Total
<u>Door Stopper</u>						
88	<ul style="list-style-type: none">• <i>As-Built Description:</i> At push side of door on accessible route, bottom 10" does not have a smooth, uninterrupted surface.• <i>Proposed Solution:</i> Remove door stopper when altering area. Provide rubber wedge.	<p>PCODE ID06A</p> <p>ADA 2010 404.2.10</p> <p>CBC 2007 1133B.2.6</p> <p>CBC 2016 11B-404.2.10</p> <p>Mitigated:</p> <p><input type="radio"/> YES</p> <p><input checked="" type="radio"/> NO</p>	1	JOB	\$75	\$75

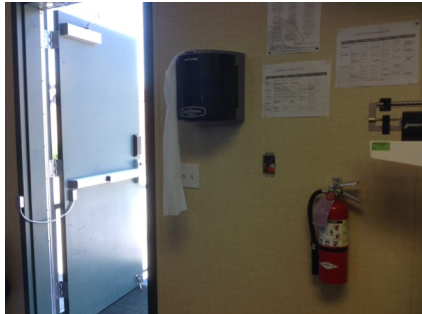
<input type="checkbox"/> Staff Only			
			Priority		Severity	
			2		3	
<u>Reach Range</u>						
89	<ul style="list-style-type: none">• <i>As-Built Description:</i> Reach height to control or access point, exceeds 48" or is less than 15".• <i>As-Built:</i> 62" high• <i>Proposed Solution:</i> Modify equipment or mounting.	<p>PCODE IE01</p> <p>ADAAG 91 4.2.5</p> <p>ADA 2010 308.2.1</p> <p>CBC 2007 1118B.5</p> <p>CBC 2016 11B-308.2.1</p> <p>Mitigated:</p> <p><input type="radio"/> YES</p> <p><input checked="" type="radio"/> NO</p>	2	JOB	\$300	\$600

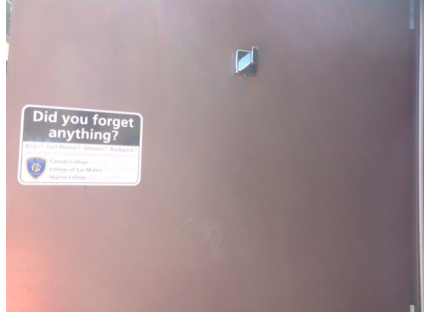
Item no., Rm no. and Name	Existing Architectural Barrier and Proposed Solution	Codes / Mitigation Info	Qty	Unit	Cost	Total
Coat Hook						
65	<ul style="list-style-type: none"> As-Built Description: Accessible coat hook not within reach range. As-Built: 65" high Proposed Solution: Adjust existing or provide new coat hook at maximum 48" height. 	PCODE WG03A ADAAG 91 4.2.5 ADA 2010 603.4 CBC 2007 1118B.5 CBC 2016 11B-603.4 Mitigated: <input type="radio"/> YES <input checked="" type="radio"/> NO	1	JOB	\$150	\$150

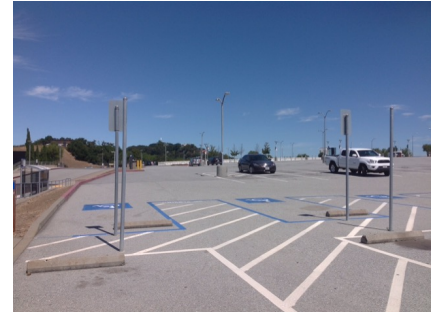
Sign for accessible parking space is missing or non-compliant.

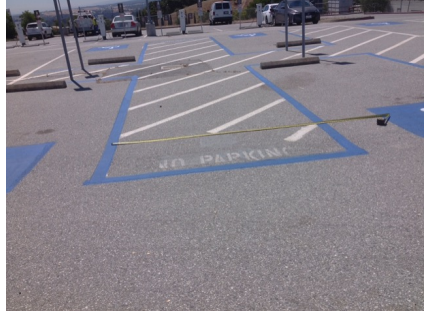
Item no., Rm no. and Name	Existing Architectural Barrier and Proposed Solution	Codes / Mitigation Info	Qty	Unit	Cost	Total
Parking						
647	<ul style="list-style-type: none"> As-Built Description: Accessible parking space does not have 5' wide access aisle; 8' wide for van accessible aisle. As-Built: 7'9" wide Proposed Solution: Modify parking aisle(s) to create accessible space by restriping. 	PCODE EA02B ADAAG 91 4.6.3 ADA 2010 502.3 CBC 2007 1129B.3.1 CBC 2016 11B-502.2; 11B-502.3.1 Mitigated: <input type="radio"/> YES <input checked="" type="radio"/> NO	1	JOB	\$600	\$600

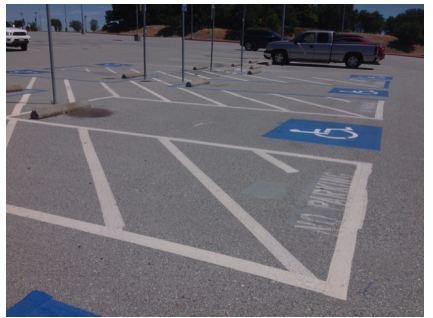
<input type="checkbox"/> Staff Only Priority 1 Severity 4			
650	<ul style="list-style-type: none"> As-Built Description: An accessible parking space shall be outlined or painted blue (required in CA only). Proposed Solution: Identify accessible parking space using blue markings. Notes: No contrast for all access aisles 	PCODE EA04K CBC 2016 11B-502.6 Mitigated: <input type="radio"/> YES <input checked="" type="radio"/> NO	1	JOB	\$360	\$360

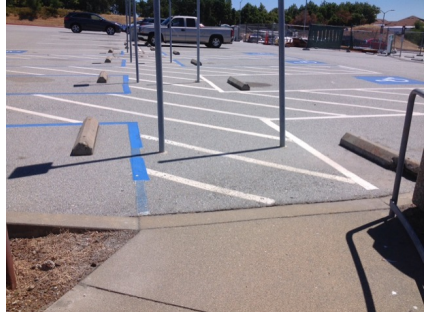
Item no., Rm no. and Name	Existing Architectural Barrier and Proposed Solution	Codes / Mitigation Info	Qty	Unit	Cost	Total
<u>Curb Ramp</u>						
652	<ul style="list-style-type: none"> • <i>As-Built Description:</i> Detectable warning not provided where pedestrian crosses vehicular area. • <i>Proposed Solution:</i> Provide detectable warning surface (i.e. in-line truncated domes) at regular curb ramp. 	PCODE EH07A ADAAG 91 4.7.7 ADA 2010 705.1 CBC 2007 1127B.5.7 CBC 2016 11B-705.1.2.2 Mitigated: <input type="radio"/> YES <input checked="" type="radio"/> NO	1	JOB	\$750	\$750

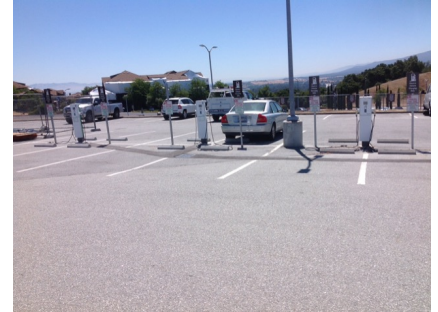
No accessible EV charger provided.**Mitigated:**☐ YES☒ NO

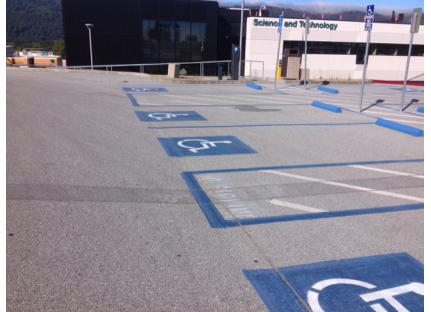
Item no., Rm no. and Name	Existing Architectural Barrier and Proposed Solution	Codes / Mitigation Info	Qty	Unit	Cost	Total
<u>Parking</u>						
732	<ul style="list-style-type: none"> As-Built Description: The words "NO PARKING" not painted on the ground within loading and unloading access aisle (12" min high white letters), located so that it is visible to traffic enforcement officials (required in CA only). Proposed Solution: Provide the words "NO PARKING" in each access aisle, painted in 12" high letters, when altering area. "No Parking" faded 	PCODE EA04D CBC 2007 1129B.3.1 CBC 2016 11B-502.3.3 Mitigated: <input type="radio"/> YES <input checked="" type="radio"/> NO	4	JOB	\$300	\$1,200

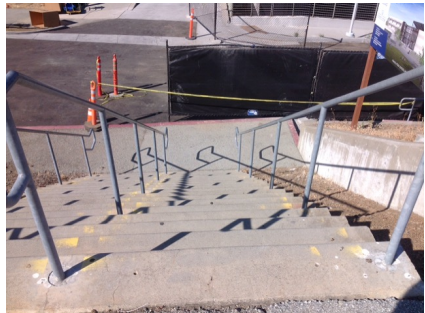
Item no., Rm no. and Name	Existing Architectural Barrier and Proposed Solution	Codes / Mitigation Info	Qty	Unit	Cost	Total
Tread Surface						
736	<ul style="list-style-type: none"> As-Built Description: The leading 2" of the tread does not have visual contrast of dark-on-light or light-on-dark from the remainder of the tread. Proposed Solution: Provide contrasting color strips at all exterior stair treads. 	PCODE EC02 ADA 2010 504.4 CBC 2007 1133B.4.4 CBC 2016 11B-504.4.1 Mitigated: <input type="radio"/> YES <input checked="" type="radio"/> NO	300	LF	\$27	\$8,100

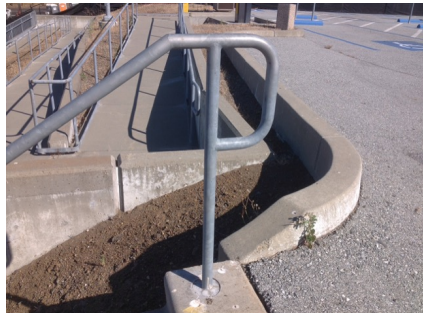
735	<ul style="list-style-type: none"> As-Built Description: Stair handrail does not extend horizontally 12" minimum beyond top nosing, and one tread width sloped, plus 12" minimum horizontally beyond the bottom nosing. Proposed Solution: Extend stair handrail at top and bottom (cost for each extension piece). 	PCODE ED06 ADAAG 91 4.9.4(2) ADA 2010 505.10.2; CBC 2007 1133B.4.2.2 CBC 2016 11B-505.10.2; 11B-505.10.3 Mitigated: <input type="radio"/> YES <input checked="" type="radio"/> NO	3	JOB	\$510	\$1,530

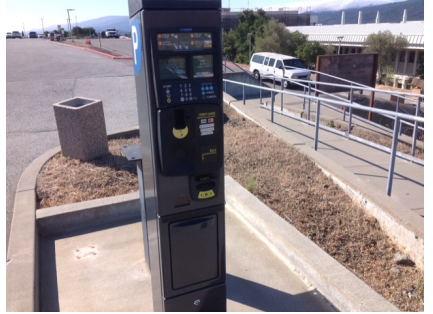
Item no., Rm no. and Name	Existing Architectural Barrier and Proposed Solution	Codes / Mitigation Info	Qty	Unit	Cost	Total
Reach Range						
737	<ul style="list-style-type: none"> As-Built Description: Reach height to control or access point, exceeds 48" or is less than 15". As-Built: 49" high Proposed Solution: Modify equipment or mounting. 	PCODE IE01 ADAAG 91 4.2.5 ADA 2010 308.2.1 CBC 2007 1118B.5 CBC 2016 11B-308.2.1 Mitigated: <input type="radio"/> YES <input checked="" type="radio"/> NO	1	JOB	\$300	\$300

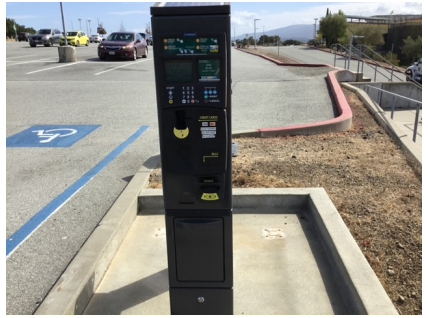
Item no., Rm no. and Name	Existing Architectural Barrier and Proposed Solution	Codes / Mitigation Info	Qty	Unit	Cost	Total
90	<ul style="list-style-type: none"> As-Built Description: Reach height to control or access point, exceeds 48" or is less than 15". As-Built: 49.5" to highest button Proposed Solution: Modify equipment or mounting. 	PCODE IE01 ADAAG 91 4.2.5 ADA 2010 308.2.1 CBC 2007 1118B.5 CBC 2016 11B-308.2.1 Mitigated: <input type="radio"/> YES <input checked="" type="radio"/> NO	1	JOB	\$300	\$300

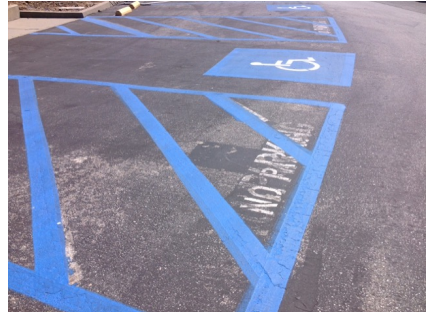
Item no., Rm no. and Name	Existing Architectural Barrier and Proposed Solution	Codes / Mitigation Info	Qty	Unit	Cost	Total
<u>Parking</u>						
639	<ul style="list-style-type: none">As-Built Description: The words "NO PARKING" not painted on the ground within loading and unloading access aisle (12" min high white letters), located so that it is visible to traffic enforcement officials (required in CA only).As-Built: FadedProposed Solution: Provide the words “NO PARKING” in each access aisle, painted in 12” high letters, when altering area.	<p>PCODE EA04D</p> <p>CBC 2007 1129B.3.1</p> <p>CBC 2016 11B-502.3.3</p> <p>Mitigated:</p> <p><input type="radio"/> YES</p> <p><input checked="" type="radio"/> NO</p>	3	JOB	\$300	\$900

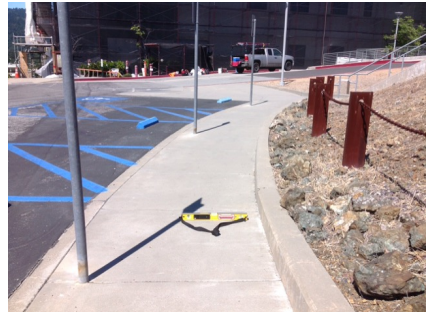
<div><input type="checkbox"/> Staff Only</div> <div><div>Priority</div><div>1</div><div>Severity</div><div>4</div></div>			
<u>Cross Slope</u>						
641	<ul style="list-style-type: none">As-Built Description: Cross slope more than 1":48" (2.083%).As-Built: 4.0%Proposed Solution: Modify cross slope.	<p>PCODE EF07</p> <p>ADAAG 91 4.3.7</p> <p>ADA 2010 403.3</p> <p>CBC 2007 1133B.7.1.3</p> <p>CBC 2016 11B-403.3</p> <p>Mitigated:</p> <p><input type="radio"/> YES</p> <p><input checked="" type="radio"/> NO</p>	400	SF	\$75	\$30,000

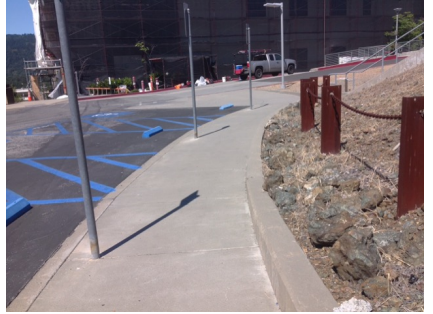
Item no., Rm no. and Name	Existing Architectural Barrier and Proposed Solution	Codes / Mitigation Info	Qty	Unit	Cost	Total
<u>Curb Ramp</u>						
640	<ul style="list-style-type: none"> • <i>As-Built Description:</i> Detectable warning not provided where pedestrian crosses vehicular area. • <i>Proposed Solution:</i> Provide detectable warning surface (i.e. in-line truncated domes) at regular curb ramp. 	PCODE EH07A ADAAG 91 4.7.7 ADA 2010 705.1 CBC 2007 1127B.5.7 CBC 2016 11B-705.1.2.2 Mitigated: <input type="radio"/> YES <input checked="" type="radio"/> NO	1	JOB	\$750	\$750

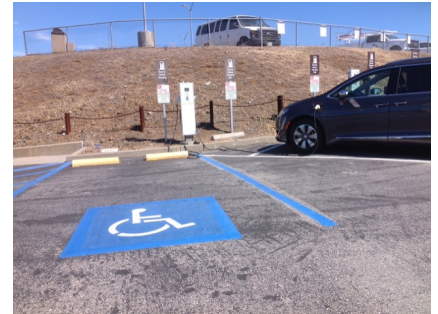
No accessible charging station**Mitigated:**☐ YES☒ NO

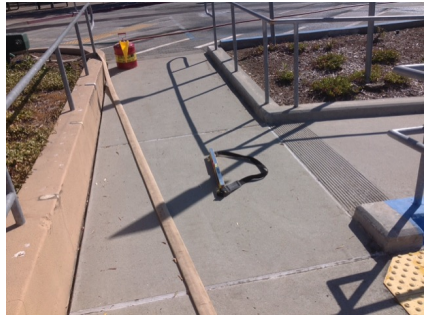
Item no., Rm no. and Name	Existing Architectural Barrier and Proposed Solution	Codes / Mitigation Info	Qty	Unit	Cost	Total
748	<ul style="list-style-type: none"> As-Built Description: Level 2% max. landing for ramp not provided. As-Built: 3.9% Proposed Solution: Rebuild ramp to provide landings for each ramp run with slopes no greater than 2% 	PCODE EB05A ADAAG 91 4.8.4 ADA 2010 405.7.1 CBC 2007 1133B.5.4.1 CBC 2016 11B-405.7.1 Mitigated: <input type="radio"/> YES <input checked="" type="radio"/> NO	50	SF	\$300	\$15,000

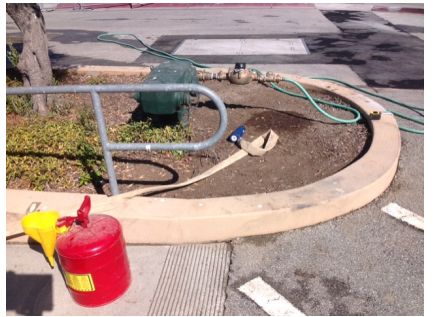
Top and Bottom Extension at Ramps

750	<ul style="list-style-type: none"> As-Built Description: Ramp handrail does not extend horizontally 12" past top and / or bottom of ramp. Proposed Solution: Provide ramp handrail extension (cost for each extension piece). 	PCODE ED05 ADAAG 91 4.8.5(2) ADA 2010 505.10.1 CBC 2007 1133B.4.2.2 & 1133B.5.5.1 CBC 2016 11B-505.10.1 Mitigated: <input type="radio"/> YES <input checked="" type="radio"/> NO	1	JOB	\$510	\$510

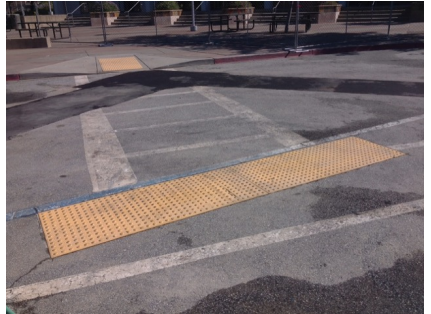
Item no., Rm no. and Name	Existing Architectural Barrier and Proposed Solution	Codes / Mitigation Info	Qty	Unit	Cost	Total
753	<ul style="list-style-type: none"> As-Built Description: Detectable warning not provided where pedestrian crosses vehicular area. As-Built: 24" deep Proposed Solution: Provide detectable warning surface (i.e. in-line truncated domes) at regular curb ramp. 	PCODE EH07A ADAAG 91 4.7.7 ADA 2010 705.1 CBC 2007 1127B.5.7 CBC 2016 11B-705.1.2.2 Mitigated: <input type="radio"/> YES <input checked="" type="radio"/> NO	1	JOB	\$750	\$750

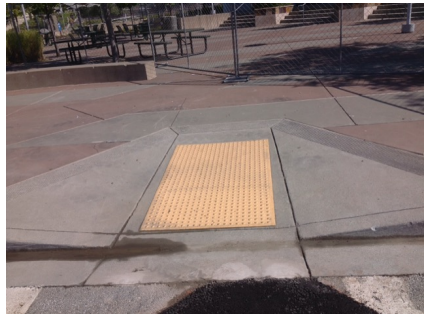
<input type="checkbox"/> Staff Only			
			Priority 1 Severity 3			
755	<ul style="list-style-type: none"> As-Built Description: Detectable warning not provided where pedestrian crosses vehicular area. As-Built: 36" wide domes Proposed Solution: Provide detectable warning surface (i.e. in-line truncated domes) at regular curb ramp. 	PCODE EH07A ADAAG 91 4.7.7 ADA 2010 705.1 CBC 2007 1127B.5.7 CBC 2016 11B-705.1.2.2 Mitigated: <input type="radio"/> YES <input checked="" type="radio"/> NO	1	JOB	\$750	\$750

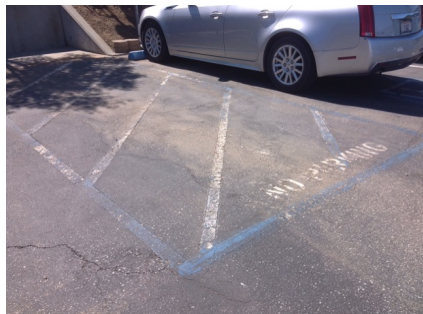
Item no., Rm no. and Name	Existing Architectural Barrier and Proposed Solution	Codes / Mitigation Info	Qty	Unit	Cost	Total
<u>Parking</u>						
628	<ul style="list-style-type: none">As-Built Description: The words "NO PARKING" not painted on the ground within loading and unloading access aisle (12" min high white letters), located so that it is visible to traffic enforcement officials (required in CA only).As-Built: FadedProposed Solution: Provide the words "NO PARKING" in each access aisle, painted in 12" high letters, when altering area.	<p>PCODE EA04D</p> <p>CBC 2007 1129B.3.1</p> <p>CBC 2016 11B-502.3.3</p> <p>Mitigated:</p> <p><input type="radio"/> YES</p> <p><input checked="" type="radio"/> NO</p>	1	JOB	\$300	\$300

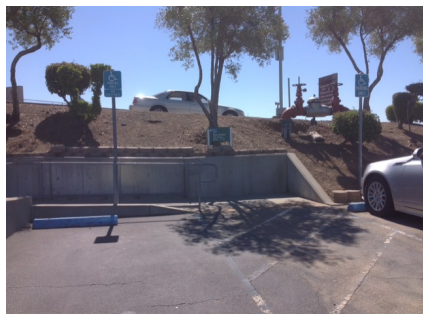
<input type="checkbox"/> Staff Only			
			<div><div>Priority</div><div>1</div></div> <div><div>Severity</div><div>4</div></div>			
<u>Parking Signage</u>						
627	<ul style="list-style-type: none">As-Built Description: CA only: Additional Sign or additional language below the symbol of accessibility stating "Minimum Fine \$250" not provided.Proposed Solution: Provide compliant parking signage that includes fine information.	<p>PCODE EA04G</p> <p>CBC 2007 1129B.4</p> <p>CBC 2016 11B-502.6.2</p> <p>Mitigated:</p> <p><input type="radio"/> YES</p> <p><input checked="" type="radio"/> NO</p>	2	JOB	\$300	\$600

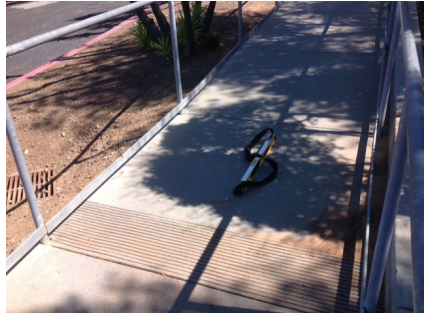
Item no., Rm no. and Name	Existing Architectural Barrier and Proposed Solution	Codes / Mitigation Info	Qty	Unit	Cost	Total
629	<ul style="list-style-type: none"> As-Built Description: Level 2% max. landing for ramp not provided. As-Built: 3.2% Proposed Solution: Rebuild ramp to provide landings for each ramp run with slopes no greater than 2% 	PCODE EB05A ADAAG 91 4.8.4 ADA 2010 405.7.1 CBC 2007 1133B.5.4.1 CBC 2016 11B-405.7.1 Mitigated: <input type="radio"/> YES <input checked="" type="radio"/> NO	30	SF	\$300	\$9,000

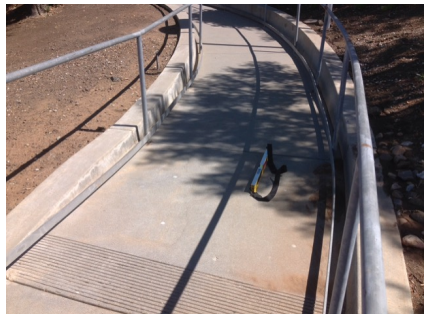
<input type="checkbox"/> Staff Only Priority 1 Severity 4			
630	<ul style="list-style-type: none"> As-Built Description: Level 2% max. landing for ramp not provided. As-Built: 2.8% Proposed Solution: Rebuild ramp to provide landings for each ramp run with slopes no greater than 2% 	PCODE EB05A ADAAG 91 4.8.4 ADA 2010 405.7.1 CBC 2007 1133B.5.4.1 CBC 2016 11B-405.7.1 Mitigated: <input type="radio"/> YES <input checked="" type="radio"/> NO	60	SF	\$300	\$18,000

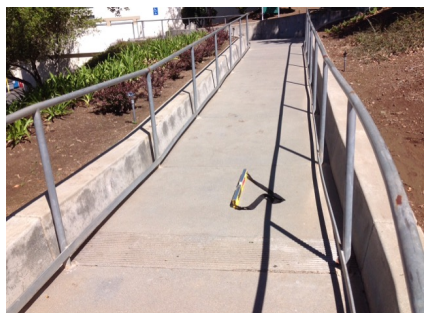
<input type="checkbox"/> Staff Only Priority 1 Severity 4			
633	<ul style="list-style-type: none"> As-Built Description: Level 2% max. landing for ramp not provided. As-Built: 4.5% Proposed Solution: Rebuild ramp to provide landings for each ramp run with slopes no greater than 2% 	PCODE EB05A ADAAG 91 4.8.4 ADA 2010 405.7.1 CBC 2007 1133B.5.4.1 CBC 2016 11B-405.7.1 Mitigated: <input type="radio"/> YES <input checked="" type="radio"/> NO	60	SF	\$300	\$18,000

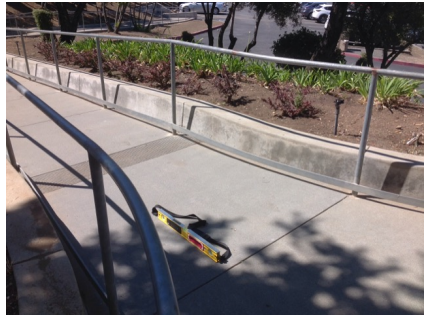
Item no., Rm no. and Name	Existing Architectural Barrier and Proposed Solution	Codes / Mitigation Info	Qty	Unit	Cost	Total
635	<ul style="list-style-type: none"> As-Built Description: Level 2% max. landing for ramp not provided. As-Built: Top landing: 4.4% Proposed Solution: Rebuild ramp to provide landings for each ramp run with slopes no greater than 2% 	PCODE EB05A ADAAG 91 4.8.4 ADA 2010 405.7.1 CBC 2007 1133B.5.4.1 CBC 2016 11B-405.7.1 Mitigated: <input type="radio"/> YES <input checked="" type="radio"/> NO	100	SF	\$300	\$30,000

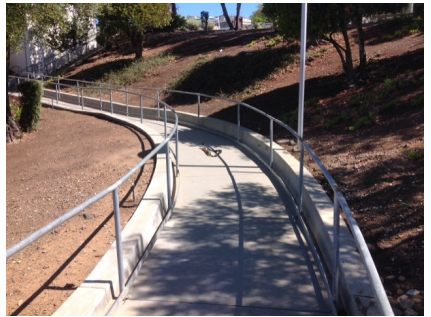
632	<ul style="list-style-type: none"> As-Built Description: Ramp landing(s): Change of direction less than 60" long. (CA Only: 72" long.) Proposed Solution: Modify ramp landing to 60" length. (Ca Only: 72' length.) 	PCODE IJ05D ADA 2010 405.7.4 CBC 2007 1133B.5.4.6 CBC 2016 11B-405.7.4 Mitigated: <input type="radio"/> YES <input checked="" type="radio"/> NO	100	SF	\$162	\$16,200

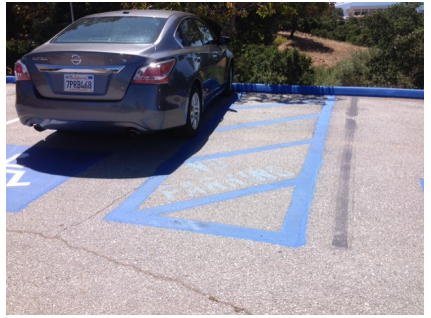
Item no., Rm no. and Name	Existing Architectural Barrier and Proposed Solution	Codes / Mitigation Info	Qty	Unit	Cost	Total
323	<ul style="list-style-type: none"> As-Built Description: The words "NO PARKING" not painted on the ground within loading and unloading access aisle (12" min high white letters), located so that it is visible to traffic enforcement officials (required in CA only). Proposed Solution: Provide the words "NO PARKING" in each access aisle, painted in 12" high letters, when altering area. 	PCODE EA04D CBC 2007 1129B.3.1 CBC 2016 11B-502.3.3 Mitigated: <input type="radio"/> YES <input checked="" type="radio"/> NO	2	JOB	\$300	\$600

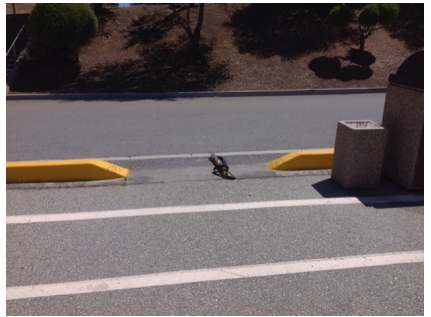
327	<ul style="list-style-type: none"> As-Built Description: Walk: Slope greater than 1:20 (5.0%), and walk does not comply with requirements for ramps. As-Built: 8% - 16.5% Proposed Solution: Modify walk/sidewalk slope to 1:20 or less. 	PCODE EF01 ADAAG 91 4.3.7 ADA 2010 403.3 CBC 2007 1133B.7.3 CBC 2016 11B-403.3 Mitigated: <input type="radio"/> YES <input checked="" type="radio"/> NO	25	SF	\$75	\$1,875

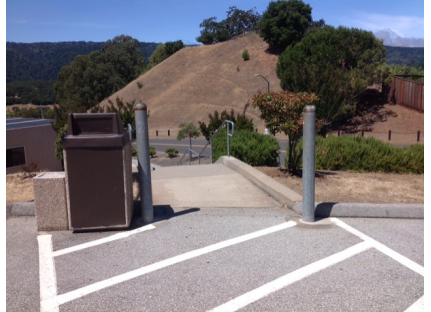
Item no., Rm no. and Name	Existing Architectural Barrier and Proposed Solution	Codes / Mitigation Info	Qty	Unit	Cost	Total
Route Sign						
326	<ul style="list-style-type: none"> • <i>As-Built Description:</i> No sign by inaccessible route directing persons to an accessible route. • <i>Proposed Solution:</i> Provide directional sign. 	PCODE SA20 ADAAG 91 35.163(b) ADA 2010 216.3 CBC 2007 1127B.3 CBC 2016 11B-216.3 Mitigated: <input type="radio"/> YES <input checked="" type="radio"/> NO	1	JOB	\$510	\$510

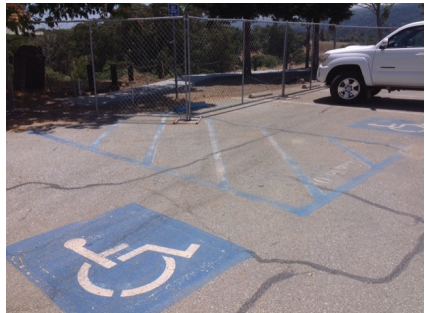
Item no., Rm no. and Name	Existing Architectural Barrier and Proposed Solution	Codes / Mitigation Info	Qty	Unit	Cost	Total
Parking						
277	<ul style="list-style-type: none"> • <i>As-Built Description:</i> Accessible parking space smaller than 8' wide (CA only: 9' x 18'). • <i>As-Built:</i> 17'7" • <i>Proposed Solution:</i> Modify parking space(s) to create accessible space. 	PCODE EA02A ADAAG 91 4.6.3 ADA 2010 502.2 CBC 2007 1129B.3.1 CBC 2016 11B-502.2 Mitigated: <input type="radio"/> YES <input checked="" type="radio"/> NO	1	JOB	\$600	\$600

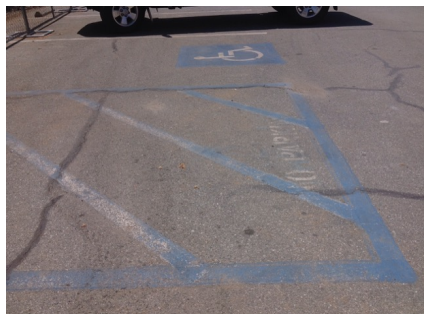
<input type="checkbox"/> Staff Only			
			Priority <input checked="" type="radio"/> 1	Severity <input checked="" type="radio"/> 4		
278	<ul style="list-style-type: none"> • <i>As-Built Description:</i> The words "NO PARKING" not painted on the ground within loading and unloading access aisle (12" min high white letters), located so that it is visible to traffic enforcement officials (required in CA only). • <i>Proposed Solution:</i> Provide the words "NO PARKING" in each access aisle, painted in 12" high letters, when altering area. 	PCODE EA04D CBC 2007 1129B.3.1 CBC 2016 11B-502.3.3 Mitigated: <input type="radio"/> YES <input checked="" type="radio"/> NO	1	JOB	\$300	\$300

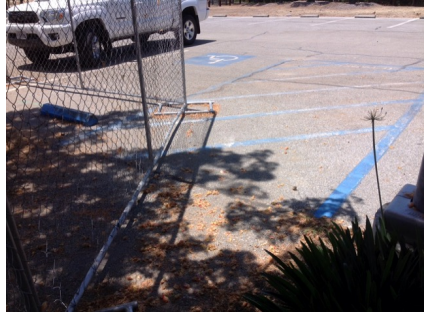
Item no., Rm no. and Name	Existing Architectural Barrier and Proposed Solution	Codes / Mitigation Info	Qty	Unit	Cost	Total
<u>Curb Ramp</u>						
279	<ul style="list-style-type: none"> • <i>As-Built Description:</i> Detectable warning not provided where pedestrian crosses vehicular area. • <i>Proposed Solution:</i> Provide detectable warning surface (i.e. in-line truncated domes) at regular curb ramp. 	PCODE EH07A ADAAG 91 4.7.7 ADA 2010 705.1 CBC 2007 1127B.5.7 CBC 2016 11B-705.1.2.2 Mitigated: <input type="radio"/> YES <input checked="" type="radio"/> NO	1	JOB	\$750	\$750
