SMCCCD - College of San Mateo

Appendix L: Facilities

Access Compliance Survey Report

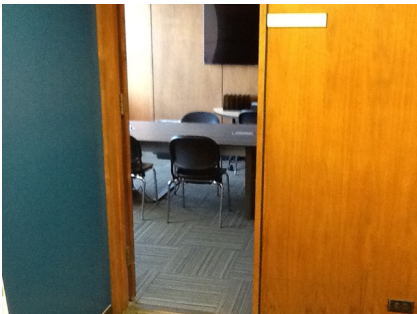
Item no., Rm no. and Name	Existing Architectural Barrier and Proposed Solution	Codes / Mitigation Info	Qty	Unit	Cost	Total
342	<ul style="list-style-type: none"> As-Built Description: Door on accessible route has less than 32" clear and 80" (78" min. to closer if provided) opening width when 90° open. As-Built: 30" wide Proposed Solution: Provide new, larger door and frame with new accessible hardware. Notes: Entry to conference room 	PCODE ID01 ADAAG 91 4.13.5 ADA 2010 404.2.3 CBC 2007 1133B.1.1.1.1 CBC 2016 11B-404.2.3 Mitigated: <input type="radio"/> YES <input checked="" type="radio"/> NO	1	JOB	\$7,800	\$7,800

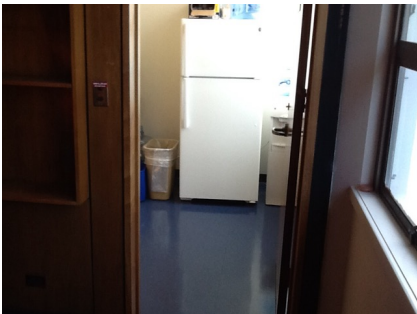
<input type="checkbox"/> Staff Only			
			Priority	Severity		
			2	3		
345	<ul style="list-style-type: none"> As-Built Description: Door on accessible route has less than 32" clear and 80" (78" min. to closer if provided) opening width when 90° open. As-Built: 29" wide Proposed Solution: Provide new, larger door and frame with new accessible hardware. Notes: Conference Room/Kitchen 	PCODE ID01 ADAAG 91 4.13.5 ADA 2010 404.2.3 CBC 2007 1133B.1.1.1.1 CBC 2016 11B-404.2.3 Mitigated: <input type="radio"/> YES <input checked="" type="radio"/> NO	1	JOB	\$7,800	\$7,800

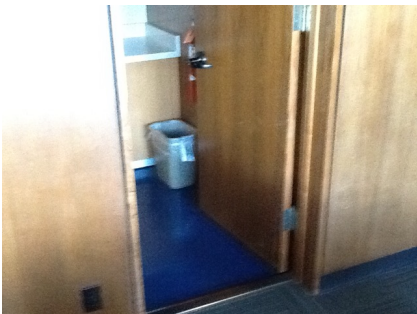
<input type="checkbox"/> Staff Only			
			Priority	Severity		
			2	3		
349	<ul style="list-style-type: none"> As-Built Description: Door on accessible route has less than 32" clear and 80" (78" min. to closer if provided) opening width when 90° open. As-Built: 27" - 29" Proposed Solution: Provide new, larger door and frame with new accessible hardware. Notes: Path of travel to squad room 	PCODE ID01 ADAAG 91 4.13.5 ADA 2010 404.2.3 CBC 2007 1133B.1.1.1.1 CBC 2016 11B-404.2.3 Mitigated: <input type="radio"/> YES <input checked="" type="radio"/> NO	2	JOB	\$7,800	\$15,600

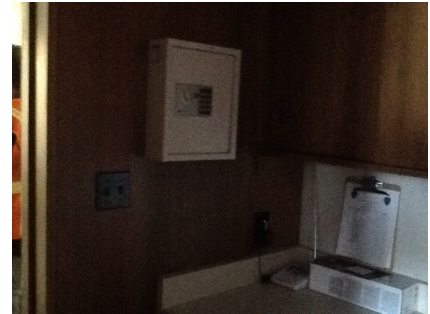
Item no., Rm no. and Name	Existing Architectural Barrier and Proposed Solution	Codes / Mitigation Info	Qty	Unit	Cost	Total
351	<ul style="list-style-type: none"> As-Built Description: Reach height to control or access point, exceeds 48" or is less than 15". As-Built: 62" AFF Proposed Solution: Modify equipment or mounting. 	PCODE IE01 ADAAG 91 4.2.5 ADA 2010 308.2.1 CBC 2007 1118B.5 CBC 2016 11B-308.2.1	1	JOB	\$300	\$300
<div>Mitigated:</div> <div> <input type="radio"/> YES <input checked="" type="radio"/> NO </div> <div> <input type="checkbox"/> Staff Only </div> <div> Priority 2 Severity 2 </div>

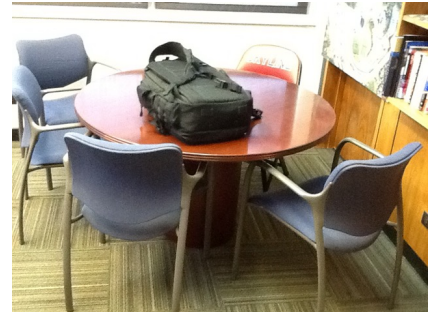
**Non-Fixed Desk**

341	<ul style="list-style-type: none"> As-Built Description: Accessible non-fixed table or desk (top 28" to 34" high; knee space at least 27" high x 19" deep x 30" wide) not provided. Proposed Solution: Provide table or desk with accessible dimensions when purchasing new furniture. 	PCODE IN02A ADAAG 91 4.32.3 & .4 ADA 2010 306.1 CBC 2007 1122B.3 & 4 CBC 2016 11B-306.1 & 11B-902.3	1	JOB	\$4,800	\$4,800
<div>Mitigated:</div> <div> <input type="radio"/> YES <input checked="" type="radio"/> NO </div> <div> <input type="checkbox"/> Staff Only </div> <div> Priority 2 Severity 2 </div>

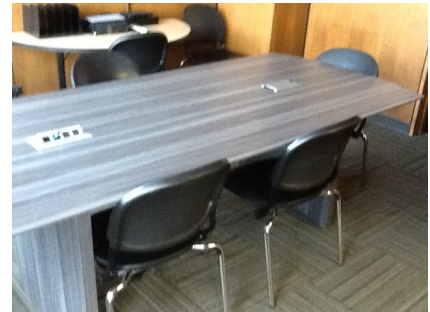
343	<ul style="list-style-type: none"> As-Built Description: Accessible non-fixed table or desk (top 28" to 34" high; knee space at least 27" high x 19" deep x 30" wide) not provided. As-Built: 14" deep Proposed Solution: Provide table or desk with accessible dimensions when purchasing new furniture. Notes: Conference Room 	PCODE IN02A ADAAG 91 4.32.3 & .4 ADA 2010 306.1 CBC 2007 1122B.3 & 4 CBC 2016 11B-306.1 & 11B-902.3	1	JOB	\$4,800	\$4,800
<div>Mitigated:</div> <div> <input type="radio"/> YES <input checked="" type="radio"/> NO </div> <div> <input type="checkbox"/> Staff Only </div> <div> Priority 2 Severity 2 </div>

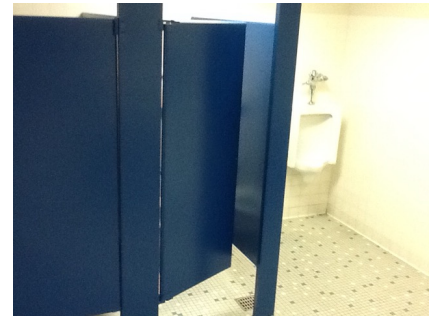
Multiple accommodation restroom not accessible; multiple compliance violations.

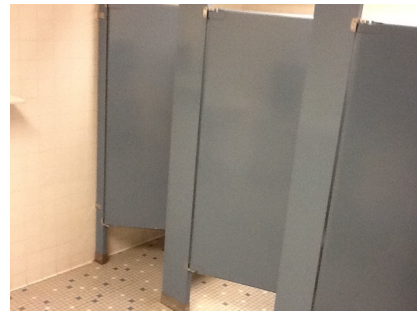
Multiple accommodation restroom not accessible; multiple compliance violations.

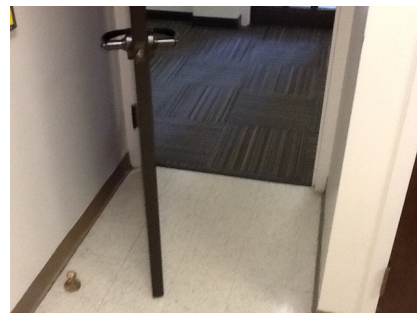
407

☐ **Staff Only****Priority****4****Severity****2****Non-Fixed Desk**

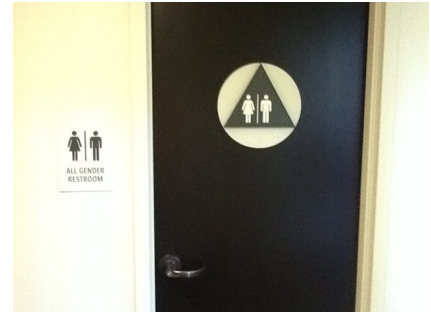
411

☐ **Staff Only****Priority****3****Severity****3****Restroom**

Single accommodation restroom not accessible; multiple compliance violations.

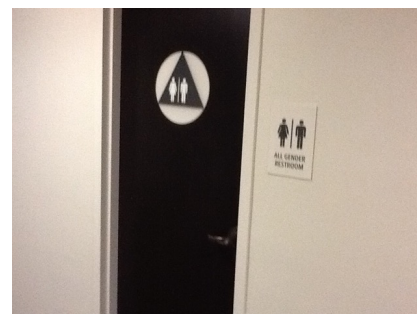
413

☐ **Staff Only****Priority****3****Severity****3****Restroom**

Single accommodation restroom not accessible; multiple compliance violations.

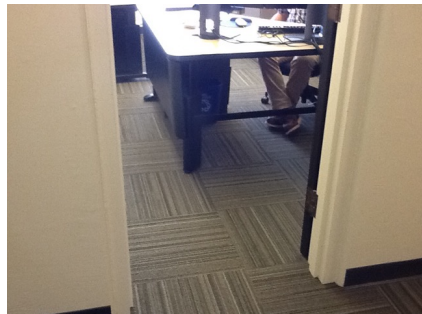
Item no., Rm no. and Name	Existing Architectural Barrier and Proposed Solution	Codes / Mitigation Info	Qty	Unit	Cost	Total
414	<ul style="list-style-type: none"> As-Built Description: Front approach: At push side, door does not have clear and level maneuvering space measuring door width x 48" (door width plus 12" if door has both, latch and closer). As-Built: 35" pull landing Proposed Solution: Remove or relocate furniture or storage items. 	PCODE ID24A ADAAG 91 Fig. 25(a) ADA 2010 404.2.4 CBC 2007 11B-26A(a) CBC 2016 11B-404.2.4 Mitigated: <input type="radio"/> YES <input checked="" type="radio"/> NO	1	JOB	\$150	\$150

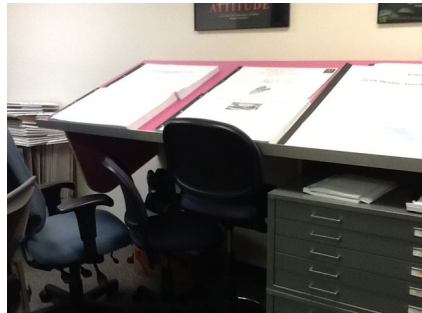
417	<ul style="list-style-type: none"> As-Built Description: Accessible non-fixed table or desk (top 28" to 34" high; knee space at least 27" high x 19" deep x 30" wide) not provided. As-Built: 42" AFF Proposed Solution: Provide table or desk with accessible dimensions when purchasing new furniture. 	PCODE IN02A ADAAG 91 4.32.3 & .4 ADA 2010 306.1 CBC 2007 1122B.3 & 4 CBC 2016 11B-306.1 & 11B-902.3 Mitigated: <input type="radio"/> YES <input checked="" type="radio"/> NO	1	JOB	\$4,800	\$4,800

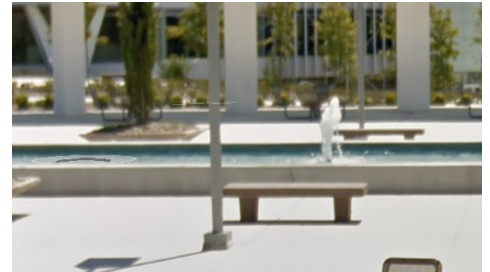
Benches throughout campus are not accessible.**Mitigated:**☐ YES☒ NO

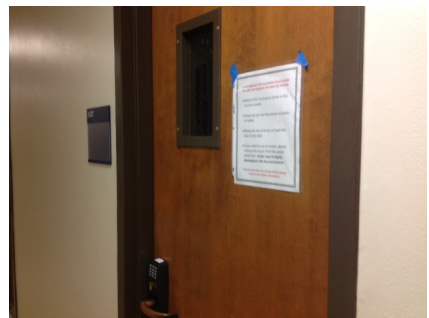
Item no., Rm no. and Name	Existing Architectural Barrier and Proposed Solution	Codes / Mitigation Info	Qty	Unit	Cost	Total
18	<ul style="list-style-type: none">As-Built Description: Vision Light at door that permits viewing, does not have bottom of at least one glazed panel located 43 inches maximum above the finish floor. (Exception: More than 66" above finished floor.)As-Built: 55" highProposed Solution: Provide new door with vision panel at 43" max.	PCODE ID06C ADA 2010 404.2.11 CBC 2016 11B-404.2.11 Mitigated: <input type="radio"/> YES <input checked="" type="radio"/> NO	6	JOB	\$7,500	\$45,000

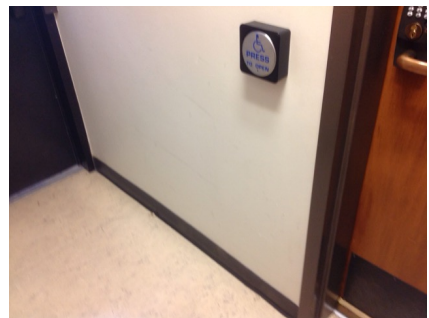
<input type="checkbox"/> Staff Only Priority 2 Severity 2			
22	<ul style="list-style-type: none">As-Built Description: Lower push plate located at 7" minimum and 8" maximum above the floor or ground surface not provided.Proposed Solution: Provide lower push plate.Notes: Accessible door to exterior	PCODE ID13B CBC 2007 1133B.2.3.2 CBC 2016 11B-404.2.9 2.C Mitigated: <input type="radio"/> YES <input checked="" type="radio"/> NO	2	JOB	\$1,500	\$3,000

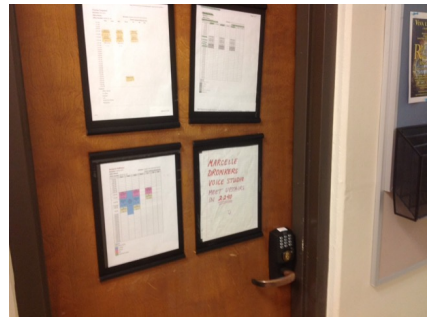
<input type="checkbox"/> Staff Only Priority 2 Severity 2			
<u>Door Clearance</u>						
21	<ul style="list-style-type: none">As-Built Description: Door on accessible route has less than 32" clear and 80" (78" min. to closer if provided) opening width when 90° open.As-Built: 28" wideProposed Solution: Provide new, larger door and frame with new accessible hardware.	PCODE ID01 ADAAG 91 4.13.5 ADA 2010 404.2.3 CBC 2007 1133B.1.1.1.1 CBC 2016 11B-404.2.3 Mitigated: <input type="radio"/> YES <input checked="" type="radio"/> NO	10	JOB	\$7,800	\$78,000

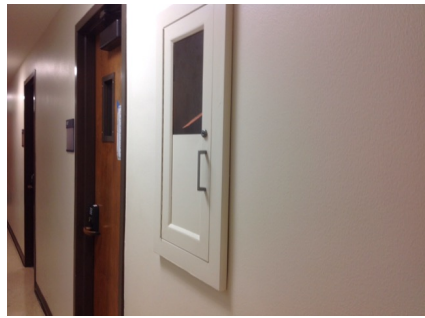
Item no., Rm no. and Name	Existing Architectural Barrier and Proposed Solution	Codes / Mitigation Info	Qty	Unit	Cost	Total
17	<ul style="list-style-type: none"> As-Built Description: Reach height to control or access point, exceeds 48" or is less than 15". As-Built: 56" AFF Proposed Solution: Modify equipment or mounting. 	PCODE IE01 ADAAG 91 4.2.5 ADA 2010 308.2.1 CBC 2007 1118B.5 CBC 2016 11B-308.2.1	1	JOB	\$300	\$300

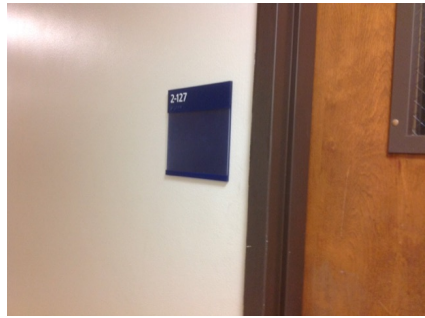
19	<ul style="list-style-type: none"> As-Built Description: Sign not located on latch side of door and/or not located at 48" min. above to baseline of the lowest Braille cells and 60" max. to baseline of the highest line of raised characters. As-Built: 62" Proposed Solution: Provide compliant signage including tactile characters and Grade II Braille on latch side of door located at compliant height. 	PCODE SA07 ADAAG 91 4.30.6 ADA 2010 703.4.1 CBC 2007 1117B.5.7 CBC 2016 11B-703.4.1	10	JOB	\$150	\$1,500

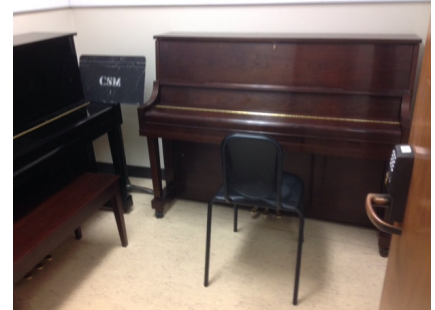
There are several individual study/practice rooms. Room 127 provides the required turning space and door landing. Provide an accessible piano in this room.

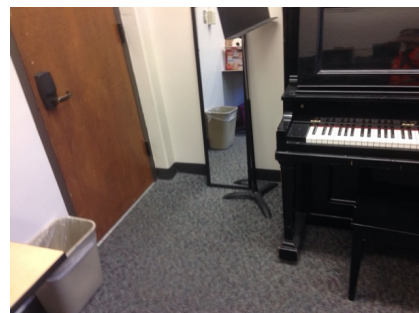
- 8
- *As-Built Description:*
Accessible non-fixed table or desk (top 28" to 34" high; knee space at least 27" high x 19" deep x 30" wide) not provided.

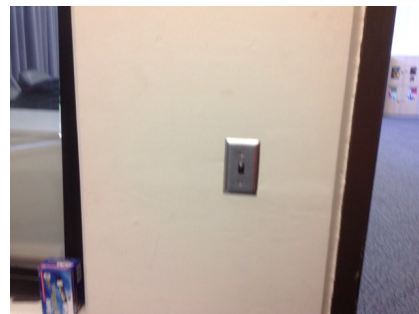
- 36 • *As-Built Description:*
Electric switch or control mounted less than 15" measured to the bottom of the outlet box or greater than 48 inches measured to the top of the outlet box.

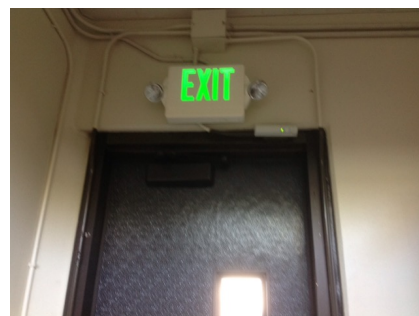
- 33
- **As-Built Description:**
Excessive force required to open door and/or door closing time of less than 5 seconds.
 - **As-Built:** **8 lbs., 2 seconds**
 - **Proposed Solution:**
Provide new door closer adjusted to accessible standards.

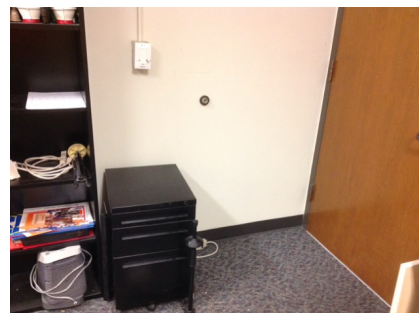
- 41
- **As-Built Description:**
Front approach: At pull side, door does not have clear and level maneuvering space measuring door width plus 18" x 60". (24" x 60" at exterior doors).
 - **As-Built:** **53"**
 - **Proposed Solution:**
Remove or relocate furniture or storage items.

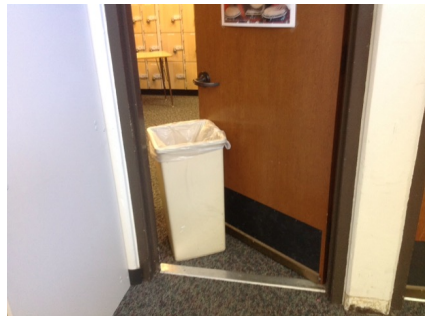
Item no., Rm no. and Name	Existing Architectural Barrier and Proposed Solution	Codes / Mitigation Info	Qty	Unit	Cost	Total
38	<ul style="list-style-type: none"> As-Built Description: Front approach: At push side, door does not have clear and level maneuvering space measuring door width x 48" (door width plus 12" if door has both, latch and closer). Proposed Solution: Remove or relocate furniture or storage items. 	PCODE ID24A ADAAG 91 Fig. 25(a) ADA 2010 404.2.4 CBC 2007 11B-26A(a) CBC 2016 11B-404.2.4 Mitigated: <input type="radio"/> YES <input checked="" type="radio"/> NO	1	JOB	\$150	\$150

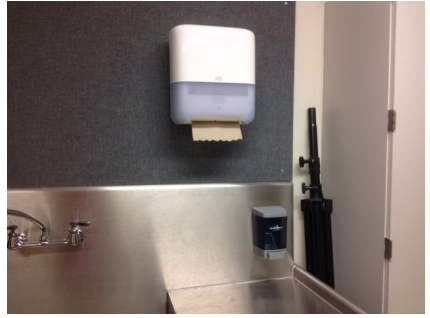
40	<ul style="list-style-type: none"> As-Built Description: Reach height to control or access point, exceeds 48" or is less than 15". As-Built: 70" high Proposed Solution: Modify equipment or mounting. 	PCODE IE01 ADAAG 91 4.2.5 ADA 2010 308.2.1 CBC 2007 1118B.5 CBC 2016 11B-308.2.1 Mitigated: <input type="radio"/> YES <input checked="" type="radio"/> NO	1	JOB	\$300	\$300

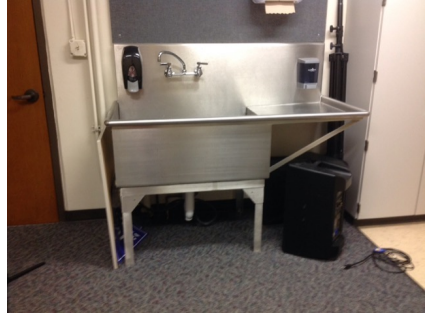
39	<ul style="list-style-type: none"> As-Built Description: Sink does not have knee space min. 27" high x 19" deep x 30" wide. Proposed Solution: Remodel sink cabinet. Notes: Unclear whether it is used by students. 	PCODE IN06A ADAAG 91 4.24.3 ADA 2010 606.2 CBC 2007 1115B.4.7.1 CBC 2016 11B-606.2 Mitigated: <input type="radio"/> YES <input checked="" type="radio"/> NO	1	JOB	\$5,250	\$5,250

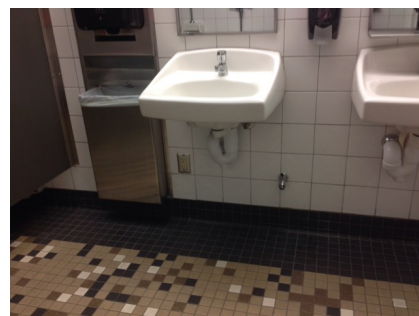
- 44
- *As-Built Description:*
Knee clearance 27" min. high starting 8" back from the front edge of the lavatory towards the wall is not provided.
 - *As-Built:* **26" knee clearance**
 - *Proposed Solution:*
Remount compliant fixture to accessible height.

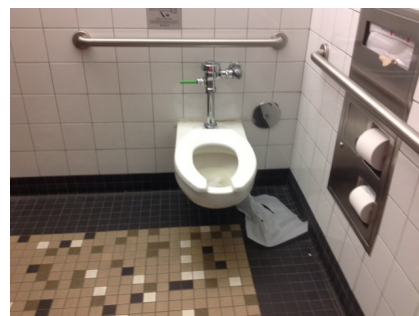
- 50
- *As-Built Description:*
Water closet not 16"-18" (CA: 17"-18") from near side wall to center line of water closet (2010 ADAAG: 16"-18").
 - *As-Built:* **18.75" o.c.**
 - *Proposed Solution:*
Relocate existing water closet and plumbing, remount with offset closet flange to provide 18" max. from side wall.

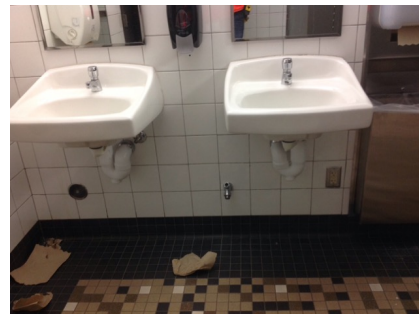
- 48
- *As-Built Description:*
Knee clearance 27" min. high starting 8" back from the front edge of the lavatory towards the wall is not provided.
 - *As-Built:* **26.75" knee high**
 - *Proposed Solution:*
Remount compliant fixture to accessible height.

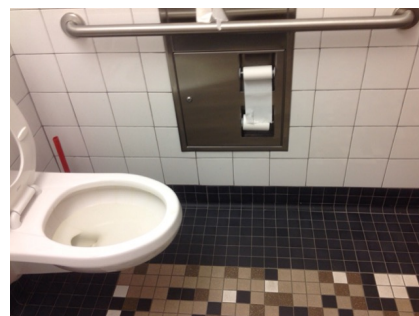
- 72
- *As-Built Description:*
Toilet paper dispenser less than 15" (CA: 19") or more than 48" above floor or not within 7" to 9" from front of water closet (Note: CA pre-2010 is allowed within 12" from front of water closet).

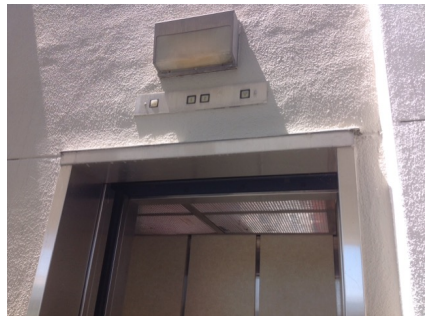
Item no., Rm no. and Name	Existing Architectural Barrier and Proposed Solution	Codes / Mitigation Info	Qty	Unit	Cost	Total
77	<ul style="list-style-type: none"> As-Built Description: Audible signal not provided (one for up, two for down). Proposed Solution: Provide proper audible hall signal for elevator. 	PCODE IK10B ADAAG 91 4.10.4 ADA 2010 407.2.2.3 CBC 2007 1116B.1.13 CBC 2016 11B-407.2.2.3 Mitigated: <input type="radio"/> YES <input checked="" type="radio"/> NO	1	JOB	\$4,650	\$4,650

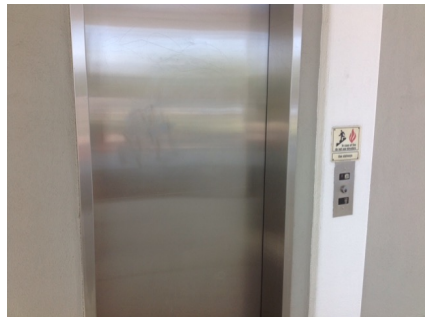
<input type="checkbox"/> Staff Only						
Priority 1 Severity 3						
74	<ul style="list-style-type: none"> As-Built Description: Grade 2 Braille (1/10" dot spacing) not provided at floor identifying jamb signs. Proposed Solution: Provide compliant floor numbering on elevator door jambs (each floor). 	PCODE IK11A ADA 2010 407.2.3.1 CBC 2007 1116B.1.14 CBC 2016 11B-407.2.3.1 Mitigated: <input type="radio"/> YES <input checked="" type="radio"/> NO	2	SET	\$150	\$300

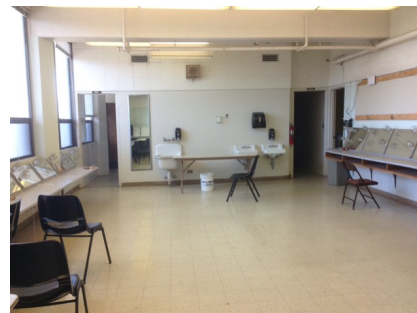
Second story of theater has no elevator access.
Restrooms, locker rooms and sound booth all
located on second floor.

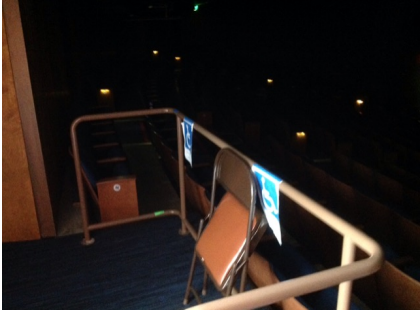
Item no., Rm no. and Name	Existing Architectural Barrier and Proposed Solution	Codes / Mitigation Info	Qty	Unit	Cost	Total
Fixed Seating						
177	<ul style="list-style-type: none"> As-Built Description: Proper amount of seating for disabled persons at public seating is not provided (4 to 25=1; 26 to 50=2; 51 to 150=4; 151 to 300=5; 301 to 500=6; 501 to 5000=6+1 for each hundred; >5001=46+1 for each 200. Proposed Solution: Modify seating to provide clear and level wheelchair space 33" x 48" or 33" x 60", including companion seat, as required. Notes: 400 seats, 4 accessible. No vertical dispersion provided. 	PCODE GE01 ADAAG 91 4.1.2(19)a ADA 2010 221.2.1 CBC 2007 1104B.3.4 CBC 2016 11B-221.2.1	1	EA	\$1,800	\$1,800

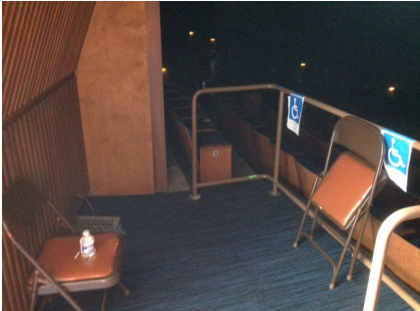
<input type="radio"/> YES <input checked="" type="radio"/> NO			
			<input type="checkbox"/> Staff Only			
			Priority 2 Severity 2			
10	<ul style="list-style-type: none"> As-Built Description: Less than five percent of the total number of aisle seats are accessible. Proposed Solution: Provide aisle seats with no or removable armrest and post availability at ticket office. Notes: 400 total seats, 6 aisle seats 	PCODE GE01A ADAAG 91 4.1.2(19)a ADA 2010 221.4 CBC 2007 1104B.3.4 CBC 2016 11B-221.4	1	EA	\$1,050	\$1,050

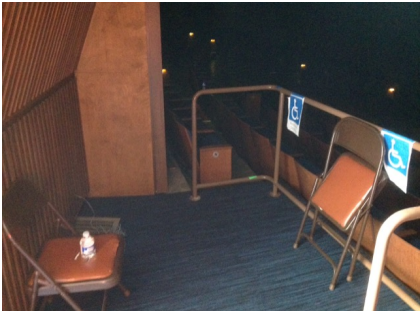
<input type="radio"/> YES <input checked="" type="radio"/> NO			
			<input type="checkbox"/> Staff Only			
			Priority 2 Severity 3			
9	<ul style="list-style-type: none"> As-Built Description: At least one fixed companion seat next to each wheelchair seating area is not provided. Proposed Solution: Provide one companion seat next to each accessible wheelchair space(s). Notes: 4 accessible spaces, no companion spaces provided 	PCODE GE01B ADAAG 91 4.33.3 ADA 2010 221.3 CBC 2007 1104B.3.5 CBC 2016 11B-221.3	1	EA	\$1,050	\$1,050

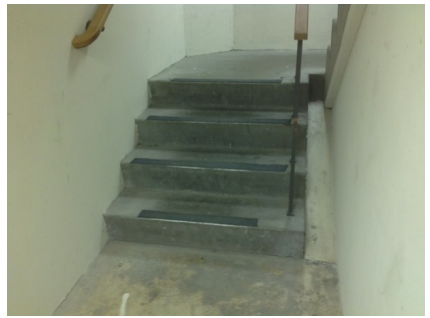
Item no., Rm no. and Name	Existing Architectural Barrier and Proposed Solution	Codes / Mitigation Info	Qty	Unit	Cost	Total
12	<ul style="list-style-type: none">• <i>As-Built Description:</i> Stairs serving as an accessible means of egress shall have a clear width of 48" minimum between handrails.• <i>Proposed Solution:</i> Rebuild stair as needed.	<i>PCODE</i> II02H <i>CBC 2016</i> 1007.3 Mitigated: <input type="radio"/> YES <input checked="" type="radio"/> NO	150	LF	\$60	\$9,000

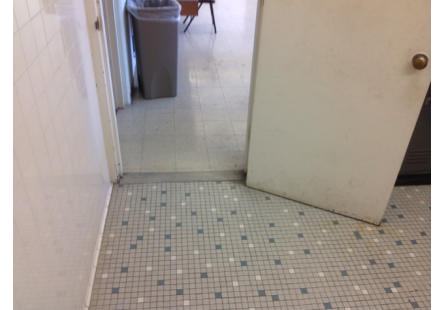
216

Multiple accommodation restroom not accessible; multiple compliance violations.

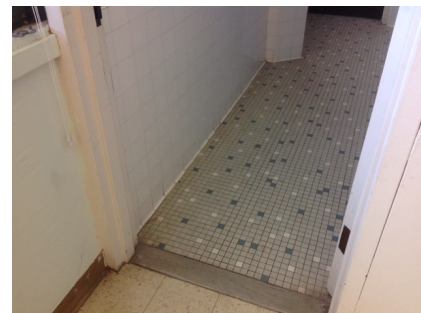
223

Multiple accommodation restroom not accessible; multiple compliance violations.

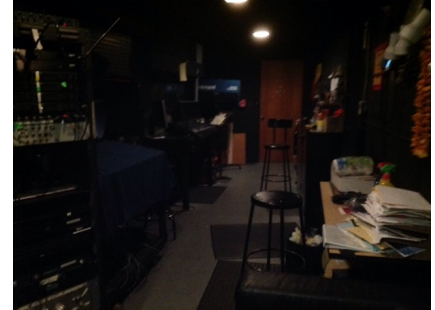
• **Notes:****The sound control room does not provide any accessible features or elements.****Mitigated:**☐ YES☒ NO

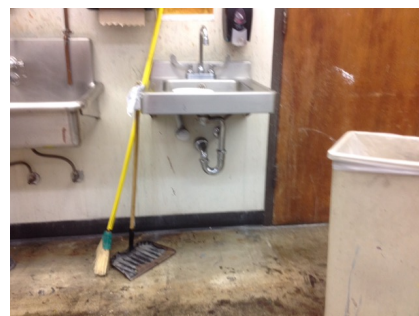
- 89
- *As-Built Description:*
Hot or sharp-surfaced water/drain pipe not insulated or covered.
 - *Proposed Solution:*
Insulate or cover water/drain pipe.

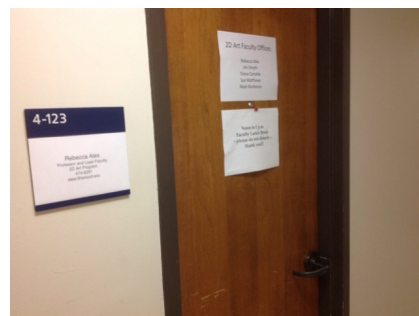
- 98 • *As-Built Description:*
Door on accessible route has less than 32" clear and 80" (78" min. to closer if provided) opening width when 90° open.

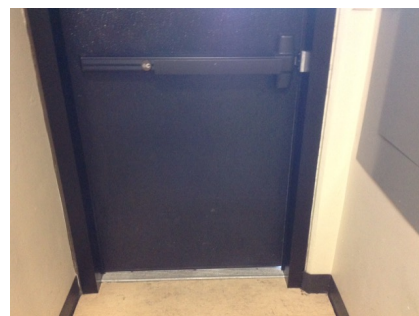
- 95
- *As-Built Description:*
Front approach: At push side, door does not have clear and level maneuvering space measuring door width x 48" (door width plus 12" if door has both, latch and closer).
 - *Proposed Solution:*
Provide door operator.
 - *Notes:*
**Second door to hallway has power operator.
Provide signage at this entrance to the accessible entry.**

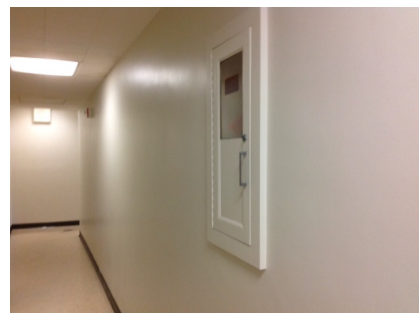
- 96
- *As-Built Description:*
Reach height to control or access point, exceeds 48" or is less than 15".
 - *As-Built:* **56" high**
 - *Proposed Solution:*
Modify equipment or mounting.

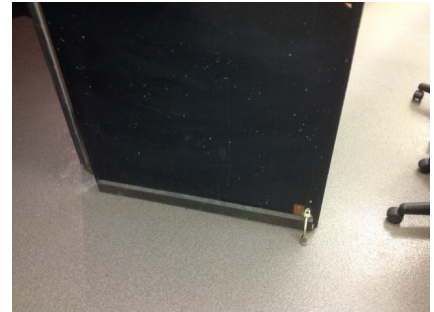
125

**Mitigated:**☐ YES☒ NO☐ **Staff Only****Priority****2****Severity****3****Door Stopper**

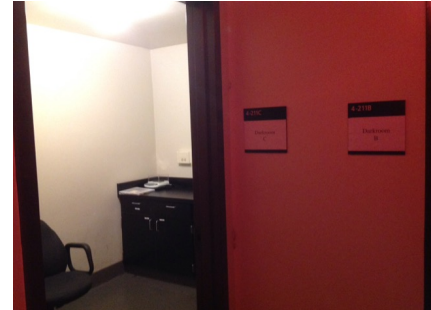
• **Notes:****3 dark rooms provided, room C accessible****Mitigated:**☐ YES☒ NO

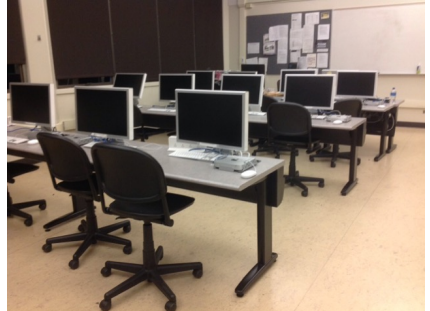
Item no., Rm no. and Name	Existing Architectural Barrier and Proposed Solution	Codes / Mitigation Info	Qty	Unit	Cost	Total
Non-Fixed Desk						
143	<ul style="list-style-type: none"> • <i>As-Built Description:</i> Accessible non-fixed table or desk (top 28" to 34" high; knee space at least 27" high x 19" deep x 30" wide) not provided. • <i>Proposed Solution:</i> Provide table or desk with accessible dimensions when purchasing new furniture. • <i>Notes:</i> 28 total, 0 accessible 	PCODE IN02A ADAAG 91 4.32.3 & .4 ADA 2010 306.1 CBC 2007 1122B.3 & 4 CBC 2016 11B-306.1 & 11B-902.3	1	JOB	\$4,800	\$4,800
Mitigated: <input type="radio"/> YES <input checked="" type="radio"/> NO

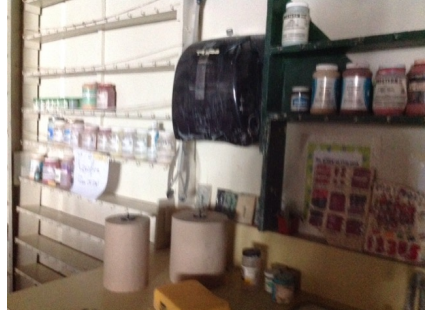
Item no., Rm no. and Name	Existing Architectural Barrier and Proposed Solution	Codes / Mitigation Info	Qty	Unit	Cost	Total
Reach Range						
258	<ul style="list-style-type: none"> As-Built Description: Reach height to control or access point, exceeds 48" or is less than 15". As-Built: 54" high Proposed Solution: Modify equipment or mounting. 	PCODE IE01 ADAAG 91 4.2.5 ADA 2010 308.2.1 CBC 2007 1118B.5 CBC 2016 11B-308.2.1	1	JOB	\$300	\$300
Mitigated: <input type="radio"/> YES <input checked="" type="radio"/> NO

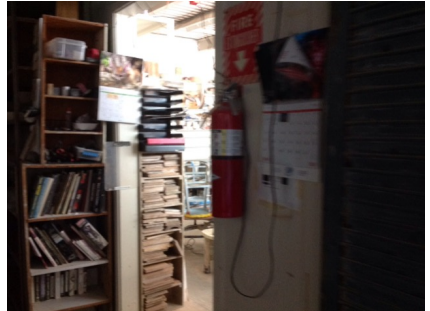
<input type="checkbox"/> Staff Only			
			Priority 2 Severity 3			
259	<ul style="list-style-type: none"> As-Built Description: Reach height to control or access point, exceeds 48" or is less than 15". As-Built: 61" high Proposed Solution: Modify equipment or mounting. 	PCODE IE01 ADAAG 91 4.2.5 ADA 2010 308.2.1 CBC 2007 1118B.5 CBC 2016 11B-308.2.1	1	JOB	\$300	\$300
Mitigated: <input type="radio"/> YES <input checked="" type="radio"/> NO

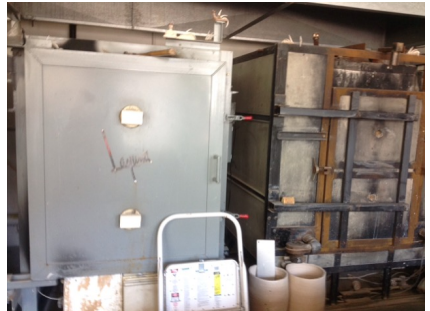
<input type="checkbox"/> Staff Only			
			Priority 2 Severity 2			
260	<ul style="list-style-type: none"> As-Built Description: Reach height to control or access point, exceeds 48" or is less than 15". Proposed Solution: Modify equipment or mounting. 	PCODE IE01 ADAAG 91 4.2.5 ADA 2010 308.2.1 CBC 2007 1118B.5 CBC 2016 11B-308.2.1	1	JOB	\$300	\$300
Mitigated: <input type="radio"/> YES <input checked="" type="radio"/> NO

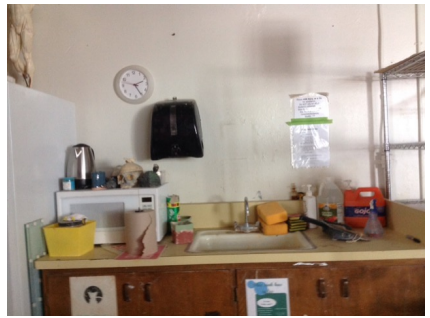
Item no., Rm no. and Name	Existing Architectural Barrier and Proposed Solution	Codes / Mitigation Info	Qty	Unit	Cost	Total
266	<ul style="list-style-type: none"> As-Built Description: Reach height to control or access point, exceeds 48" or is less than 15". As-Built: 56" high Proposed Solution: Modify equipment or mounting. 	PCODE IE01 ADAAG 91 4.2.5 ADA 2010 308.2.1 CBC 2007 1118B.5 CBC 2016 11B-308.2.1 Mitigated: <input type="radio"/> YES <input checked="" type="radio"/> NO	1	JOB	\$300	\$300

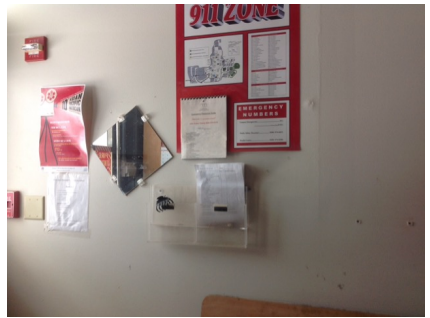
<input type="checkbox"/> Staff Only Priority 2 Severity 3			
269	<ul style="list-style-type: none"> As-Built Description: Reach height to control or access point, exceeds 48" or is less than 15". As-Built: 57" high Proposed Solution: Modify equipment or mounting. 	PCODE IE01 ADAAG 91 4.2.5 ADA 2010 308.2.1 CBC 2007 1118B.5 CBC 2016 11B-308.2.1 Mitigated: <input type="radio"/> YES <input checked="" type="radio"/> NO	1	JOB	\$300	\$300

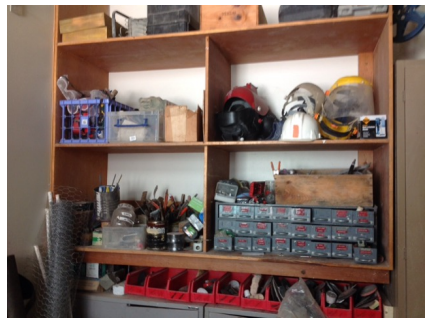
<input type="checkbox"/> Staff Only Priority 2 Severity 3			
270	<ul style="list-style-type: none"> As-Built Description: Reach height to control or access point, exceeds 48" or is less than 15". Proposed Solution: Modify equipment or mounting. Notes: Provide items within reach ranges if used by students. 	PCODE IE01 ADAAG 91 4.2.5 ADA 2010 308.2.1 CBC 2007 1118B.5 CBC 2016 11B-308.2.1 Mitigated: <input type="radio"/> YES <input checked="" type="radio"/> NO	1	JOB	\$300	\$300

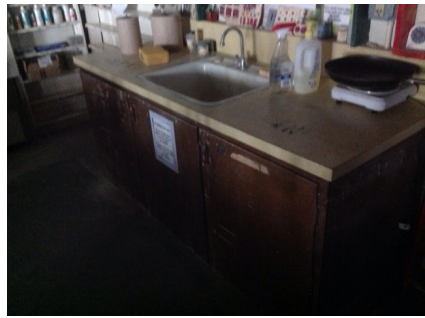
Item no., Rm no. and Name	Existing Architectural Barrier and Proposed Solution	Codes / Mitigation Info	Qty	Unit	Cost	Total
256	<ul style="list-style-type: none"> • <i>As-Built Description:</i> Sink does not have knee space min. 27" high x 19" deep x 30" wide. • <i>Proposed Solution:</i> Remodel sink cabinet. 	PCODE IN06A ADAAG 91 4.24.3 ADA 2010 606.2 CBC 2007 1115B.4.7.1 CBC 2016 11B-606.2 Mitigated: <input type="radio"/> YES <input checked="" type="radio"/> NO	1	JOB	\$5,250	\$5,250

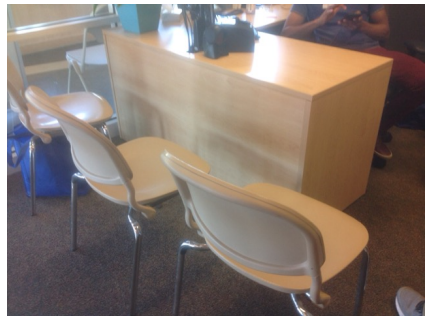
Item no., Rm no. and Name	Existing Architectural Barrier and Proposed Solution	Codes / Mitigation Info	Qty	Unit	Cost	Total
619	<ul style="list-style-type: none"> As-Built Description: Accessible non-fixed table or desk (top 28" to 34" high; knee space at least 27" high x 19" deep x 30" wide) not provided. As-Built: No knee clearance if used as work surface. Proposed Solution: Provide table or desk with accessible dimensions when purchasing new furniture. 	PCODE IN02A ADAAG 91 4.32.3 & .4 ADA 2010 306.1 CBC 2007 1122B.3 & 4 CBC 2016 11B-306.1 & 11B-902.3 Mitigated: <input type="radio"/> YES <input checked="" type="radio"/> NO	1	JOB	\$4,800	\$4,800

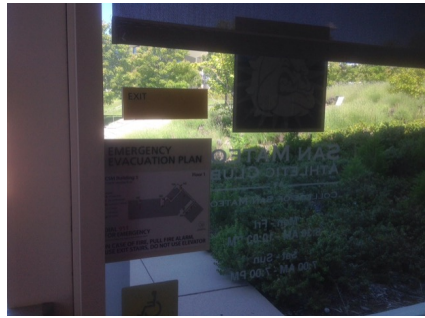
617	<ul style="list-style-type: none"> As-Built Description: Sign not located on latch side of door and/or not located at 48" min. above to baseline of the lowest Braille cells and 60" max. to baseline of the highest line of raised characters. As-Built: 60.5" high Proposed Solution: Provide compliant signage including tactile characters and Grade II Braille on latch side of door located at compliant height. 	PCODE SA07 ADAAG 91 4.30.6 ADA 2010 703.4.1 CBC 2007 1117B.5.7 Mitigated: <input type="radio"/> YES <input checked="" type="radio"/> NO	1	JOB	\$150	\$150

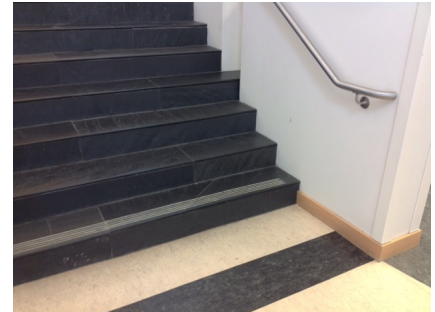
PCODE **II02B**ADA 2010 **504.4**CBC 2007 **1133B.4.4**CBC 2016 **11B-504.4.1****Mitigated:**☐ **YES**☒ **NO**20 LF \$42 **\$840**

Provide 2" min., 4" max. wide contrasting color strip 1" max. from nosing on top & bottom treads when altering area.

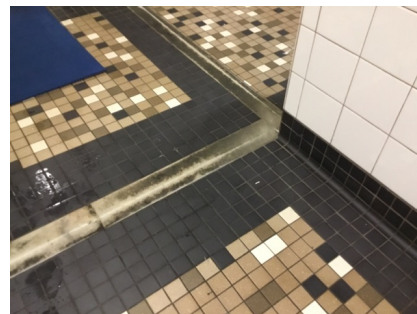
- 20
- *As-Built Description:*
Walk: Pavement dislocation creates abrupt change in level exceeding 1/2" in accessible route.
 - *As-Built:* **0.75" level change not beveled properly**
 - *Proposed Solution:*
Remove, replace or repair area of pavement sufficient to correct abrupt change in level.

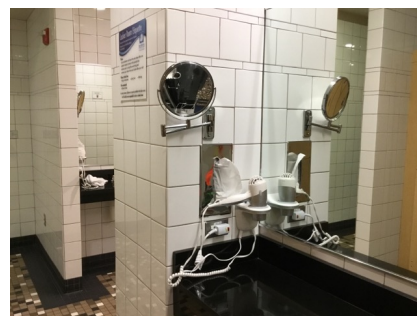
- 3
- *As-Built Description:*
Reach height to control or access point, exceeds 48" or is less than 15".
 - *As-Built:* **58.25" high**
 - *Proposed Solution:*
Modify equipment or mounting.

PCODE le01
ADAAG 91 4.2.5
ADA 2010 308.2.1
CBC 2007 1118B.5
CBC 2016 11B-308.2.1

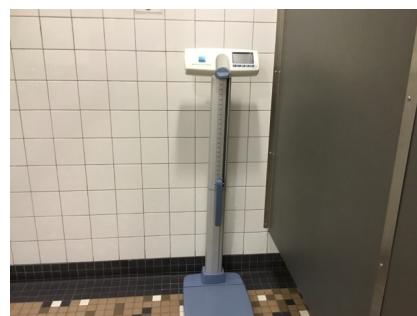
- 9
- *As-Built Description:*
Reach height to control or access point, exceeds 48" or is less than 15".
 - *As-Built:* **51.5" high**
 - *Proposed Solution:*
Modify equipment or mounting.

PCODE IE01
ADAAG 91 4.2.5
ADA 2010 308.2.1
CBC 2007 1118B.5
CBC 2016 11B-308.2.1

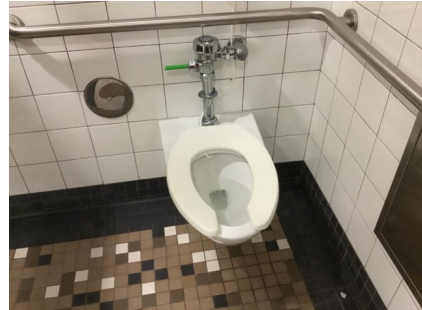
Item no., Rm no. and Name	Existing Architectural Barrier and Proposed Solution	Codes / Mitigation Info	Qty	Unit	Cost	Total
Water Closet						
7	<ul style="list-style-type: none">• <i>As-Built Description:</i> Water closet not 16"-18" (CA: 17"-18") from near side wall to center line of water closet (2010 ADAAG: 16"-18").• <i>As-Built:</i> 18.25" o.c.• <i>Proposed Solution:</i> Relocate existing water closet and plumbing, remount with offset closet flange to provide 18" max. from side wall.	<p>PCODE WB02C ADAAG 91 Fig. 28 ADA 2010 604.2 CBC 2007 1115B.4.1.1 CBC 2016 11B-604.2</p> <p>Mitigated:</p> <p><input type="radio"/> YES <input checked="" type="radio"/> NO</p>	1	JOB	\$1,500	\$1,500

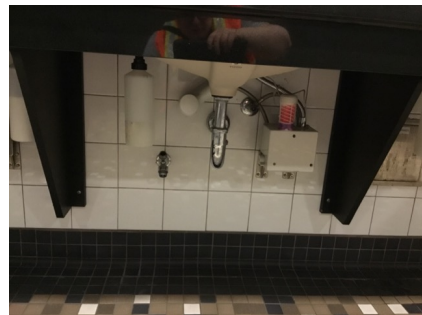
<input type="checkbox"/> Staff Only			
			Priority		Severity	
			3		4	
Lavatory						
4	<ul style="list-style-type: none">• <i>As-Built Description:</i> Hot or sharp-surfaced water/drain pipe not insulated or covered.• <i>Proposed Solution:</i> Insulate or cover water/drain pipe.• Notes: 3 other sinks have cover.	<p>PCODE WD05 ADAAG 91 4.19.4 ADA 2010 606.5 CBC 2007 1115B.4.3.4 CBC 2016 11B-606.5</p> <p>Mitigated:</p> <p><input type="radio"/> YES <input checked="" type="radio"/> NO</p>	1	JOB	\$360	\$360

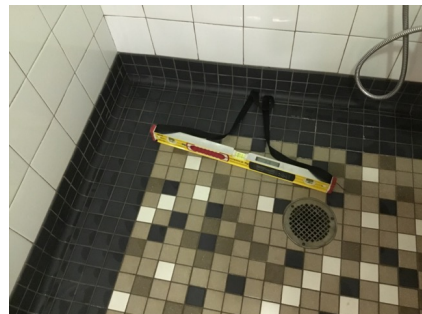
<input type="checkbox"/> Staff Only			
			Priority		Severity	
			3		3	
Shower						
14	<ul style="list-style-type: none">• <i>As-Built Description:</i> Floor surface sloped greater than 2.0% (1:48) due to drain.• <i>As-Built:</i> 2.3%• <i>Proposed Solution:</i> Remodel floor surface to compliance.	<p>PCODE WF06A ADA 2010 608.9 CBC 2016 11B-608.9</p> <p>Mitigated:</p> <p><input type="radio"/> YES <input checked="" type="radio"/> NO</p>	1	JOB	\$1,500	\$1,500

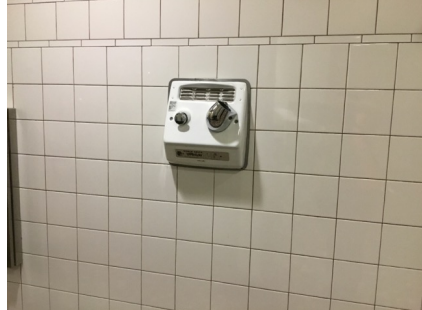
Item no., Rm no. and Name	Existing Architectural Barrier and Proposed Solution	Codes / Mitigation Info	Qty	Unit	Cost	Total
Accessories						
11	<ul style="list-style-type: none"> As-Built Description: Dispensers in sanitary facilities, such as for towels, soap, sanitary napkins, seat covers, etc., and waste receptacles more than 48" (CA only: 40") from floor to highest operating slot or control. As-Built: 55" high Proposed Solution: Relocate existing restroom accessories. 	PCODE WG01A ADAAG 91 4.23.7 ADA 2010 308.2.1 CBC 2007 1115B.8.3 CBC 2016 11B-603.5	1	JOB	\$300	\$300
Mitigated: <input type="radio"/> YES <input checked="" type="radio"/> NO

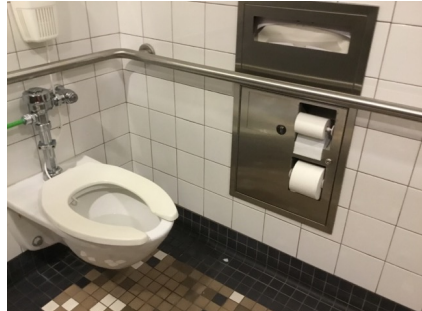
<input type="checkbox"/> Staff Only			
			Priority 3 Severity 2			
8	<ul style="list-style-type: none"> As-Built Description: Toilet paper dispenser less than 15" (CA: 19") or more than 48" above floor or not within 7" to 9" from front of water closet (Note: CA pre-2010 is allowed within 12" from front of water closet). As-Built: 12" in front of water closet Proposed Solution: Relocate or provide new toilet paper dispenser. 	PCODE WG02 ADAAG 91 4.16.6 ADA 2010 604.7 CBC 2007 1115B.8.4 CBC 2016 11B-604.7	1	JOB	\$225	\$225

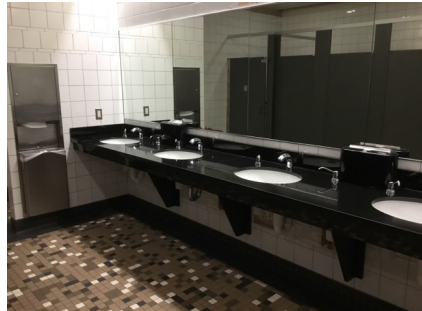
<input type="checkbox"/> Staff Only			
			Priority 3 Severity 3			
10	<ul style="list-style-type: none"> As-Built Description: Bottom of mirror located above lavatories or countertops more than 40" above floor. As-Built: 40.5" high Proposed Solution: Relocate or provide new accessible mirror. 	PCODE WG03 ADAAG 91 4.19.6 ADA 2010 603.3 CBC 2007 1115B.8.1 CBC 2016 11B-603.3	1	JOB	\$450	\$450
Mitigated: <input type="radio"/> YES <input checked="" type="radio"/> NO

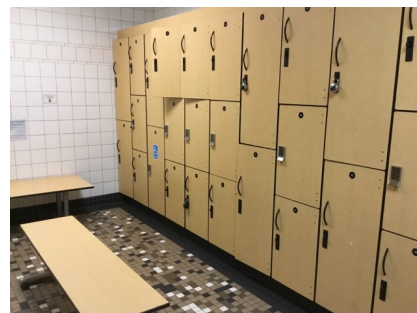
- 12
- *As-Built Description:*
Accessible locker(s) in dressing room not provided (5% of lockers; not less than one).
 - *As-Built:* **2 designated accessible lockers, 140 total lockers**
 - *Proposed Solution:*
Provide new locker(s) with accessible locking hardware that is operable with one hand and does not require grasping, pinching or twisting.

PCODE GG04
ADAAG 91 4.1.3(12)(a)
ADA 2010 222.1
CBC 2007 1115B.8.5
CBC 2016 11B-222.1

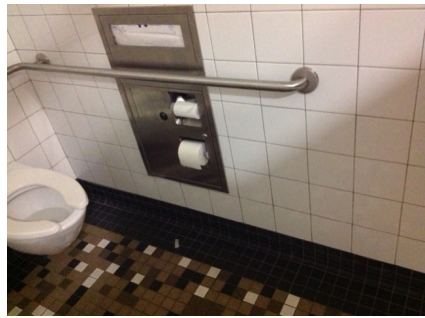
Item no., Rm no. and Name	Existing Architectural Barrier and Proposed Solution	Codes / Mitigation Info	Qty	Unit	Cost	Total
684	<ul style="list-style-type: none"> As-Built Description: Toilet paper dispenser less than 15" (CA: 19") or more than 48" above floor or not within 7" to 9" from front of water closet (Note: CA pre-2010 is allowed within 12" from front of water closet). As-Built: 12" o.c. Proposed Solution: Relocate or provide new toilet paper dispenser. 	PCODE WG02 ADAAG 91 4.16.6 ADA 2010 604.7 CBC 2007 1115B.8.4 CBC 2016 11B-604.7 Mitigated: <input type="radio"/> YES <input checked="" type="radio"/> NO	1	JOB	\$225	\$225

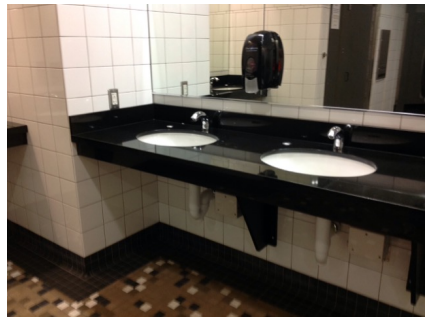
<input type="checkbox"/> Staff Only			
			Priority		Severity	
			3		3	
681	<ul style="list-style-type: none"> As-Built Description: Bottom of mirror located above lavatories or countertops more than 40" above floor. As-Built: 41" high Proposed Solution: Relocate or provide new accessible mirror. 	PCODE WG03 ADAAG 91 4.19.6 ADA 2010 603.3 CBC 2007 1115B.8.1 CBC 2016 11B-603.3 Mitigated: <input type="radio"/> YES <input checked="" type="radio"/> NO	1	JOB	\$450	\$450

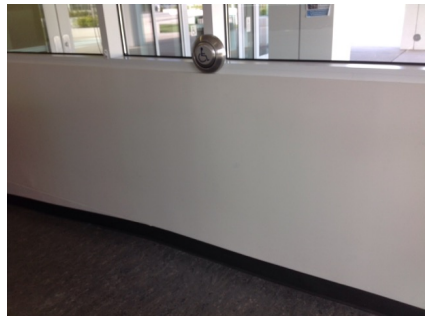
Item no., Rm no. and Name	Existing Architectural Barrier and Proposed Solution	Codes / Mitigation Info	Qty	Unit	Cost	Total
687	<ul style="list-style-type: none"> As-Built Description: High push plate located at 30" minimum and 44" maximum above the floor or ground surface not provided. As-Built: 46" high o.c. Proposed Solution: Provide higher push plate. 	PCODE ID13E CBC 2007 1133B.2.3.2 CBC 2016 11B-404.2.9 2.C Mitigated: <input type="radio"/> YES <input checked="" type="radio"/> NO	1	JOB	\$1,500	\$1,500

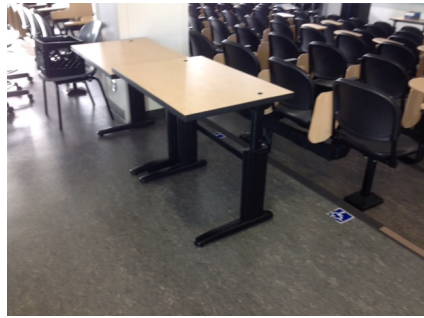
Non-Fixed Desk

690	<ul style="list-style-type: none"> As-Built Description: Accessible non-fixed table or desk (top 28" to 34" high; knee space at least 27" high x 19" deep x 30" wide) not provided. As-Built: 28" wide Proposed Solution: Provide table or desk with accessible dimensions when purchasing new furniture. Notes: 90 total, no accessible provided 	PCODE IN02A ADAAG 91 4.32.3 & .4 ADA 2010 306.1 CBC 2007 1122B.3 & 4 CBC 2016 11B-306.1 & 11B-902.3 Mitigated: <input type="radio"/> YES <input checked="" type="radio"/> NO	1	JOB	\$4,800	\$4,800

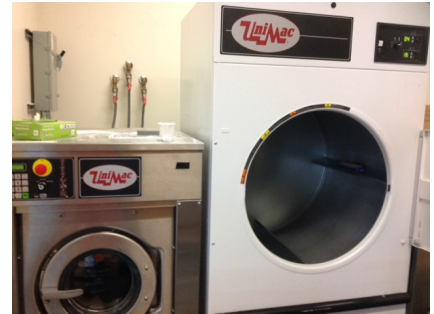
Item no., Rm no. and Name	Existing Architectural Barrier and Proposed Solution	Codes / Mitigation Info	Qty	Unit	Cost	Total
699	<ul style="list-style-type: none"> As-Built Description: Reach height to control or access point, exceeds 48" or is less than 15". As-Built: 69" high Proposed Solution: Modify equipment or mounting. 	PCODE IE01 ADAAG 91 4.2.5 ADA 2010 308.2.1 CBC 2007 1118B.5 CBC 2016 11B-308.2.1	1	JOB	\$300	\$300
<div>Mitigated:</div> <div> <input type="radio"/> YES <input checked="" type="radio"/> NO </div>

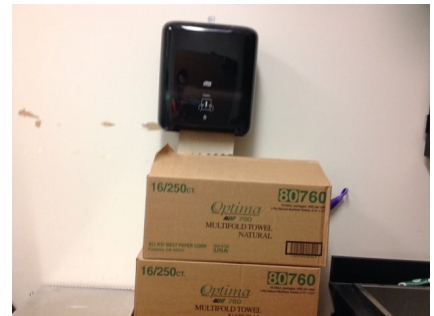
700	<ul style="list-style-type: none"> As-Built Description: Reach height to control or access point, exceeds 48" or is less than 15". As-Built: 58" high Proposed Solution: Modify equipment or mounting. 	PCODE IE01 ADAAG 91 4.2.5 ADA 2010 308.2.1 CBC 2007 1118B.5 CBC 2016 11B-308.2.1	1	JOB	\$300	\$300
<div>Mitigated:</div> <div> <input type="radio"/> YES <input checked="" type="radio"/> NO </div>						
<div><input type="checkbox"/> Staff Only</div> <div> Priority 2 Severity 3 </div>

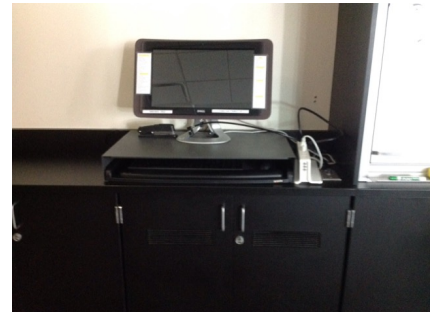
3**Non-Fixed Desk**

696	<ul style="list-style-type: none"> As-Built Description: Accessible non-fixed table or desk (top 28" to 34" high; knee space at least 27" high x 19" deep x 30" wide) not provided. As-Built: No knee space Proposed Solution: Provide table or desk with accessible dimensions when purchasing new furniture. 	PCODE IN02A ADAAG 91 4.32.3 & .4 ADA 2010 306.1 CBC 2007 1122B.3 & 4 CBC 2016 11B-306.1 & 11B-902.3	1	JOB	\$4,800	\$4,800
<div>Mitigated:</div> <div> <input type="radio"/> YES <input checked="" type="radio"/> NO </div>						
<div><input type="checkbox"/> Staff Only</div> <div> Priority 2 Severity 2 </div>

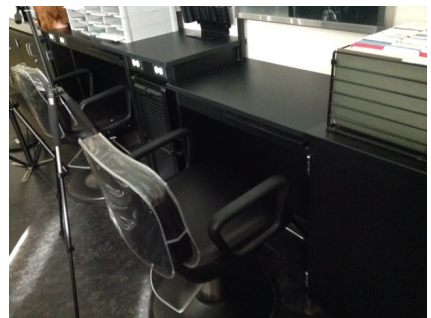
Item no., Rm no. and Name	Existing Architectural Barrier and Proposed Solution	Codes / Mitigation Info	Qty	Unit	Cost	Total
697	<ul style="list-style-type: none">• As-Built Description: Accessible non-fixed table or desk (top 28" to 34" high; knee space at least 27" high x 19" deep x 30" wide) not provided.• Proposed Solution: Provide table or desk with accessible dimensions when purchasing new furniture.• Notes: Approximately 85 total stations, one accessible provided	<p>PCODE IN02A</p> <p>ADAAG 91 4.32.3 & .4</p> <p>ADA 2010 306.1</p> <p>CBC 2007 1122B.3 & 4</p> <p>CBC 2016 11B-306.1 & 11B-902.3</p> <p>Mitigated:</p> <p><input type="radio"/> YES</p> <p><input checked="" type="radio"/> NO</p>	1	JOB	\$4,800	\$4,800

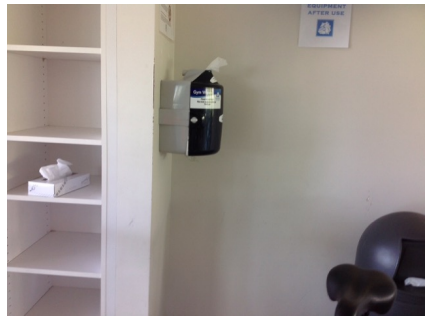
Item no., Rm no. and Name	Existing Architectural Barrier and Proposed Solution	Codes / Mitigation Info	Qty	Unit	Cost	Total
711	<ul style="list-style-type: none"> As-Built Description: Reach height to control or access point, exceeds 48" or is less than 15". As-Built: 56" high Proposed Solution: Modify equipment or mounting. 	PCODE IE01 ADAAG 91 4.2.5 ADA 2010 308.2.1 CBC 2007 1118B.5 CBC 2016 11B-308.2.1 Mitigated: <input type="radio"/> YES <input checked="" type="radio"/> NO	1	JOB	\$300	\$300

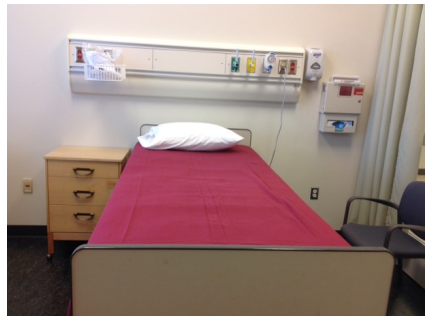
Item no., Rm no. and Name	Existing Architectural Barrier and Proposed Solution	Codes / Mitigation Info	Qty	Unit	Cost	Total
739	<ul style="list-style-type: none"> As-Built Description: Reach height to control or access point, exceeds 48" or is less than 15". As-Built: 67" reach to equipment Proposed Solution: Modify equipment or mounting. 	PCODE IE01 ADAAG 91 4.2.5 ADA 2010 308.2.1 CBC 2007 1118B.5 CBC 2016 11B-308.2.1 Mitigated: <input type="radio"/> YES <input checked="" type="radio"/> NO	1	JOB	\$300	\$300

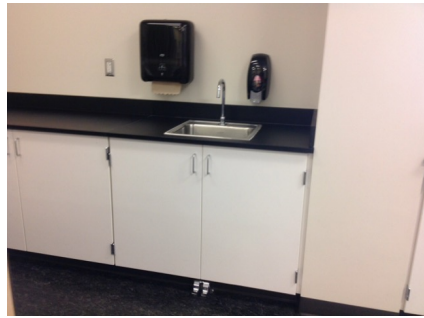
740	<ul style="list-style-type: none"> As-Built Description: Sink rim higher than 34" above floor. As-Built: 36" high no knee clearance Proposed Solution: Remodel sink cabinet to lower sink. 	PCODE IN06 ADAAG 91 4.24.2 ADA 2010 606.3 CBC 2007 1115B.4.7.1 CBC 2016 11B-606.3 Mitigated: <input type="radio"/> YES <input checked="" type="radio"/> NO	1	JOB	\$5,250	\$5,250

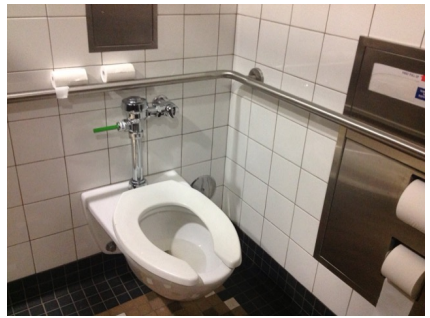
Item no., Rm no. and Name	Existing Architectural Barrier and Proposed Solution	Codes / Mitigation Info	Qty	Unit	Cost	Total
748	<ul style="list-style-type: none"> As-Built Description: Accessories/dispensers in accessible stall located closer than 1-1/2" below or 12" above grab bar impedes its use. As-Built: 1" below Proposed Solution: Relocate accessories/dispensers to be no closer than 1-1/2" below and 12" above grab bars (except if accessories are recessed, flush with wall, and have no sharp edges). 	PCODE WB071 ADAAG 91 4.26.2 ADA 2010 609.3 CBC 2007 1133B.4.2.5 CBC 2016 11B-609.3 Mitigated: <input type="radio"/> YES <input checked="" type="radio"/> NO	1	JOB	\$225	\$225

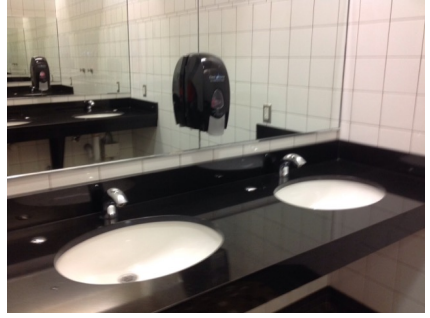
Accessories

744	<ul style="list-style-type: none"> As-Built Description: Dispensers in sanitary facilities, such as for towels, soap, sanitary napkins, seat covers, etc., and waste receptacles more than 48" (CA only: 40") from floor to highest operating slot or control. As-Built: 43" high Proposed Solution: Relocate existing restroom accessories. 	PCODE WG01A ADAAG 91 4.23.7 ADA 2010 308.2.1 CBC 2007 1115B.8.3 Mitigated: <input type="radio"/> YES <input checked="" type="radio"/> NO	1	JOB	\$300	\$300

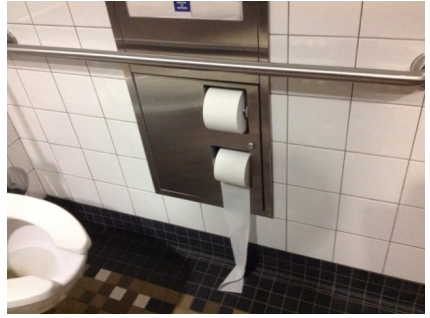
<input type="checkbox"/> Staff Only Priority 3 Severity 4						
746	<ul style="list-style-type: none"> As-Built Description: Toilet paper dispenser less than 15" (CA: 19") or more than 48" above floor or not within 7" to 9" from front of water closet (Note: CA pre-2010 is allowed within 12" from front of water closet). As-Built: 12" o.c. Proposed Solution: Relocate or provide new toilet paper dispenser. 	PCODE WG02 ADAAG 91 4.16.6 ADA 2010 604.7 CBC 2007 1115B.8.4 Mitigated: <input type="radio"/> YES <input checked="" type="radio"/> NO	1	JOB	\$225	\$225

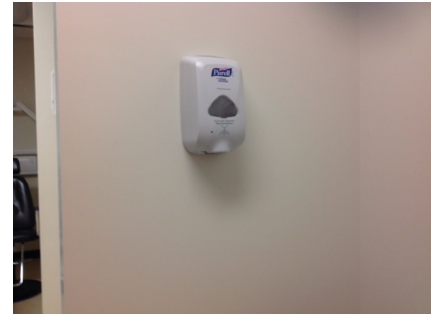
Item no., Rm no. and Name	Existing Architectural Barrier and Proposed Solution	Codes / Mitigation Info	Qty	Unit	Cost	Total
760	<ul style="list-style-type: none"> As-Built Description: Reach height to control or access point, exceeds 48" or is less than 15". As-Built: 56" high Proposed Solution: Modify equipment or mounting. 	PCODE IE01 ADAAG 91 4.2.5 ADA 2010 308.2.1 CBC 2007 1118B.5 CBC 2016 11B-308.2.1	3	JOB	\$300	\$900

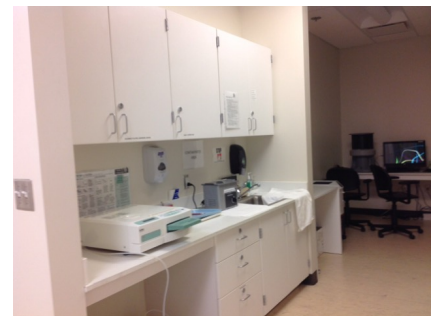
762	<ul style="list-style-type: none"> As-Built Description: Reach height to control or access point, exceeds 48" or is less than 15". Proposed Solution: Modify equipment or mounting. Notes: Several high cabinets. Unsure if used by students or faculty. 	PCODE IE01 ADAAG 91 4.2.5 ADA 2010 308.2.1 CBC 2007 1118B.5 CBC 2016 11B-308.2.1	1	JOB	\$300	\$300
-----	--	--	---	-----	-------	-------

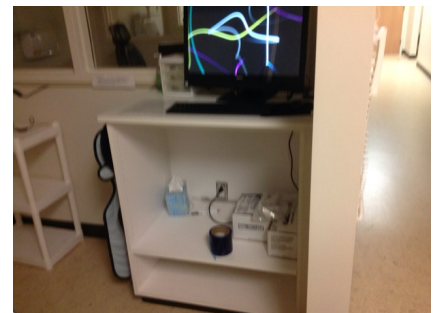
759	<ul style="list-style-type: none"> As-Built Description: Accessible non-fixed table or desk (top 28" to 34" high; knee space at least 27" high x 19" deep x 30" wide) not provided. As-Built: 42" high Proposed Solution: Provide table or desk with accessible dimensions when purchasing new furniture. Notes: Patient room computer station 	PCODE IN02A ADAAG 91 4.32.3 & .4 ADA 2010 306.1 CBC 2007 1122B.3 & 4 CBC 2016 11B-306.1 & 11B-902.3	1	JOB	\$4,800	\$4,800
-----	--	---	---	-----	---------	---------

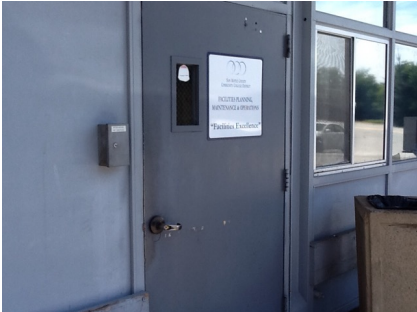
Item no., Rm no. and Name	Existing Architectural Barrier and Proposed Solution	Codes / Mitigation Info	Qty	Unit	Cost	Total
Door						
241	<ul style="list-style-type: none">As-Built Description: Vision Light at door that permits viewing, does not have bottom of at least one glazed panel located 43 inches maximum above the finish floor. (Exception: More than 66" above finished floor.)56.75" AFFProposed Solution: Provide new door with vision panel at 43" max.	PCODE ID06C ADA 2010 404.2.11 CBC 2016 11B-404.2.11	1	JOB	\$7,500	\$7,500

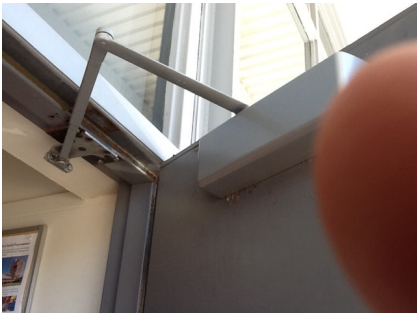
<input type="checkbox"/> Staff Only			
			Priority 2 Severity 1			
Door Closer						
242	<ul style="list-style-type: none">As-Built Description: Excessive force required to open door.As-Built: 10 lbs.Proposed Solution: Adjust regular door closer to accessible standards (5 lbs. max).	PCODE ID03 ADAAG 91 4.13.11 ADA 2010 404.2.9 CBC 2007 1133B.2.5 CBC 2016 11B-404.2.9	1	JOB	\$75	\$75

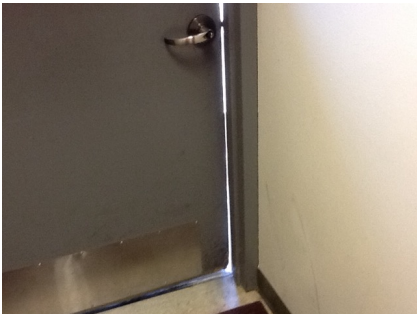
<input type="checkbox"/> Staff Only			
			Priority 2 Severity 4			
Door Swing						
243	<ul style="list-style-type: none">As-Built Description: Front approach: At push side, door does not have clear and level maneuvering space measuring door width x 48" (door width plus 12" if door has both, latch and closer).Proposed Solution: Provide door operator.	PCODE ID24C ADAAG 91 Fig. 25(a) ADA 2010 404.2.4 CBC 2007 11B-26A(a) CBC 2016 11B-404.2.4	1	JOB	\$15,000	\$15,000
