SMCCCD - College of San Mateo

Appendix L: Facilities

Access Compliance Survey Report

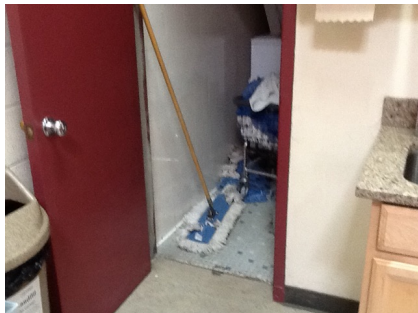
Item no., Rm no. and Name	Existing Architectural Barrier and Proposed Solution	Codes / Mitigation Info	Qty	Unit	Cost	Total
Door Clearance						
254	<ul style="list-style-type: none">As-Built Description: Door on accessible route has less than 32" clear and 80" (78" min. to closer if provided) opening width when 90° open.As-Built: 25" wideProposed Solution: Provide new, larger door and frame with new accessible hardware.	PCODE ID01 ADAAG 91 4.13.5 ADA 2010 404.2.3 CBC 2007 1133B.1.1.1.1 CBC 2016 11B-404.2.3 Mitigated: <div><input type="radio"/> YES</div> <div><input checked="" type="radio"/> NO</div>	1	JOB	\$7,800	\$7,800

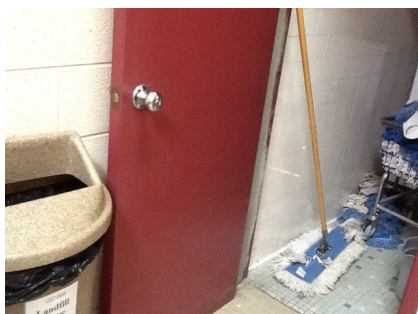
<div><input type="checkbox"/> Staff Only</div> <div>Priority <div>4</div>Severity <div>2</div></div>			
Door Hardware						
255	<ul style="list-style-type: none">As-Built Description: Non-common use areas within this facility, such as offices, do not have accessible door hardware.Proposed Solution: Provide lever handle or other accessible hardware when a specific need is identified in the future or when altering area.	PCODE ID07C ADAAG 91 4.13.9 ADA 2010 404.2.7 CBC 2007 1133B.2.5.2 CBC 2016 11B-404.2.7 Mitigated: <div><input type="radio"/> YES</div> <div><input checked="" type="radio"/> NO</div>	1	JOB	\$750	\$750

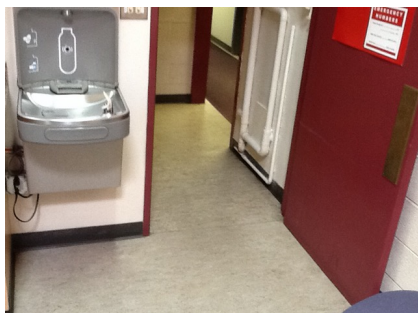
<div><input type="checkbox"/> Staff Only</div> <div>Priority <div>4</div>Severity <div>3</div></div>			
Door Swing						
248	<ul style="list-style-type: none">As-Built Description: Hinge approach: At pull side, door does not have clear and level maneuvering space measuring door width plus 36" x 60" or door width plus 42" x 54" (CA only: door width plus 36" x 60").As-Built: 8" to drinking fountainProposed Solution: Change door swing.Notes: Relocate drinking fountain/bottle filler.	PCODE ID25 ADAAG 91 Fig. 25(b) ADA 2010 404.2.4 CBC 2007 Fig. 11B-26A(b) CBC 2016 11B-404.2.4 Mitigated: <div><input type="radio"/> YES</div> <div><input checked="" type="radio"/> NO</div>	1	JOB	\$1,500	\$1,500

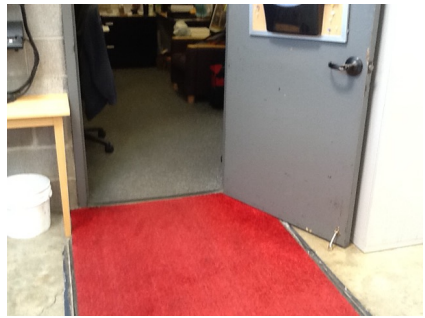
Item no., Rm no. and Name	Existing Architectural Barrier and Proposed Solution	Codes / Mitigation Info	Qty	Unit	Cost	Total
287	<ul style="list-style-type: none"> As-Built Description: At push side of door on accessible route, bottom 10" does not have a smooth, uninterrupted surface. Proposed Solution: Remove door stopper when altering area. Provide rubber wedge. 	PCODE ID06A ADA 2010 404.2.10 CBC 2007 1133B.2.6 CBC 2016 11B-404.2.10 Mitigated: <input type="radio"/> YES <input checked="" type="radio"/> NO	3	JOB	\$75	\$225

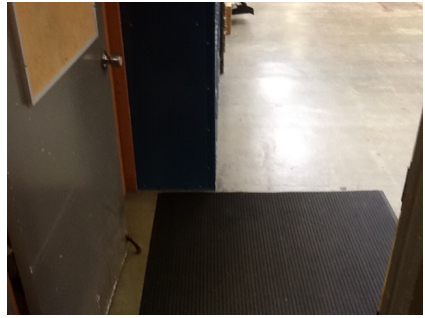
277	<ul style="list-style-type: none"> As-Built Description: Front approach: At pull side, door does not have clear and level maneuvering space measuring door width plus 18" x 60". (24" x 60" at exterior doors). As-Built: 55" to locker Proposed Solution: Remove or relocate furniture or storage items. 	PCODE ID23A ADAAG 91 Fig. 25(a) ADA 2010 404.2.4 CBC 2007 11B-26A(a) CBC 2016 11B-404.2.4 Mitigated: <input type="radio"/> YES <input checked="" type="radio"/> NO	1	JOB	\$150	\$150

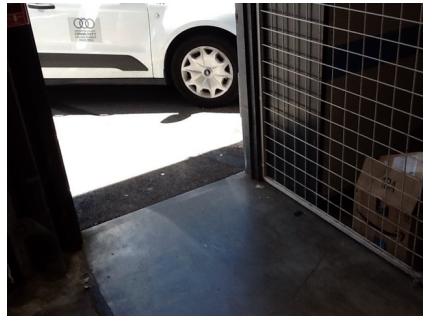
282	<ul style="list-style-type: none"> As-Built Description: Front approach: At push side, door does not have clear and level maneuvering space measuring door width x 48" (door width plus 12" if door has both, latch and closer). Proposed Solution: Change door swing. Notes: Remove closer or latch to mitigate this issue. 	PCODE ID24 ADAAG 91 Fig. 25(a) ADA 2010 404.2.4 CBC 2007 11B-26A(a) CBC 2016 11B-404.2.4 Mitigated: <input type="radio"/> YES <input checked="" type="radio"/> NO	1	JOB	\$1,500	\$1,500

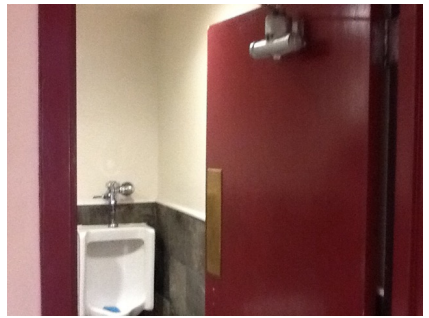
Item no., Rm no. and Name	Existing Architectural Barrier and Proposed Solution	Codes / Mitigation Info	Qty	Unit	Cost	Total
263	<ul style="list-style-type: none"> As-Built Description: Required in CA only: identification symbol centered 58" to 60" high on sanitary facility door that contrasts with the door not provided (women: 12" ø circle, men: 12" triangle, unisex: combined symbol). Proposed Solution: Provide properly mounted sanitary facility symbol when altering area. If wheelchair accessible, include International Symbol of Accessibility on sign. 	PCODE SA15 CBC 2007 1115B.6 CBC 2016 11B-703.7.2.6 Mitigated: <input type="radio"/> YES <input checked="" type="radio"/> NO	1	JOB	\$270	\$270

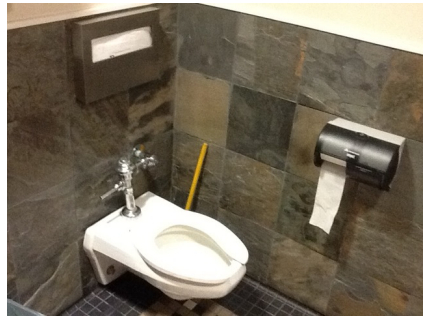
Grab Bars

269	<ul style="list-style-type: none"> As-Built Description: Grab bars not provided or are not code compliant. Proposed Solution: Provide accessible grab bars. 	PCODE WB07 ADAAG 91 4.17.6 ADA 2010 604.5 CBC 2007 1115B.4.1.3 CBC 2016 11B-604.5 Mitigated: <input type="radio"/> YES <input checked="" type="radio"/> NO	1	JOB	\$1,500	\$1,500

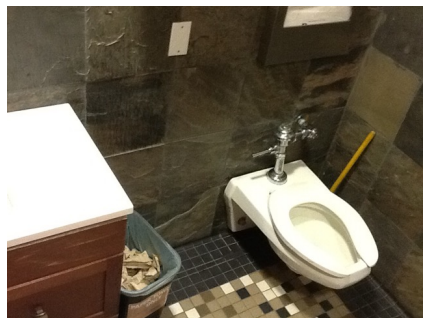
Toilet Stall

273	<ul style="list-style-type: none"> As-Built Description: 60" min. clearance around a water closet measured perpendicular from the side wall not provided (Fixtures are not allowed to overlap this clearance). As-Built: 50.25" wide Proposed Solution: Remove adjacent fixture and provide new enclosure at accessible water closet. 	PCODE WB01A ADA 2010 604.3.1; 604.3.2 CBC 2007 1115B.7.1.3 CBC 2016 11B-604.3.1; 11B-604.3.2 Mitigated: <input type="radio"/> YES <input checked="" type="radio"/> NO	1	JOB	\$6,000	\$6,000

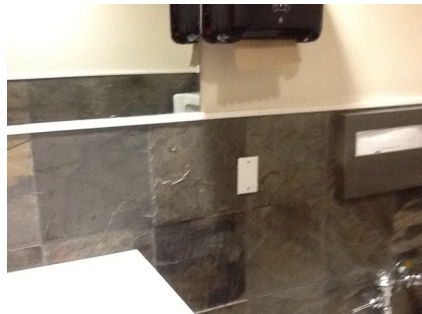
Item no., Rm no. and Name	Existing Architectural Barrier and Proposed Solution	Codes / Mitigation Info	Qty	Unit	Cost	Total
268	<ul style="list-style-type: none">As-Built Description: Bottom of mirror located above lavatories or countertops more than 40" above floor.As-Built: 49.5" AFF to bottom of mirrorProposed Solution: Relocate or provide new accessible mirror.	PCODE WG03 ADAAG 91 4.19.6 ADA 2010 603.3 CBC 2007 1115B.8.1 CBC 2016 11B-603.3 Mitigated: <input type="radio"/> YES <input checked="" type="radio"/> NO	1	JOB	\$450	\$450

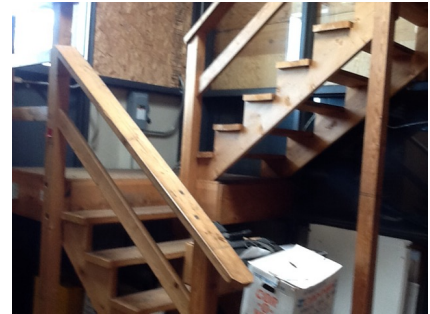
Item no., Rm no. and Name	Existing Architectural Barrier and Proposed Solution	Codes / Mitigation Info	Qty	Unit	Cost	Total
298	<ul style="list-style-type: none"> As-Built Description: Handrail not provided at stairs or ramp, required on both sides (not required at curb ramps or adjacent to seating areas). Proposed Solution: Provide new handrail for each side including extensions. 	PCODE ED01 ADAAG 91 4.8.5 & 4.9.4 ADA 2010 505.2 CBC 2007 1133B.4.1.1 & .5.5 CBC 2016 11B-505.2	25	LF	\$285	\$7,125
<div> <div>Mitigated:</div> <div> <input type="radio"/> YES <input checked="" type="radio"/> NO </div> </div> <div> <input type="checkbox"/> Staff Only </div> <div> <div>Priority</div> <div>4</div> </div> <div> <div>Severity</div> <div>2</div> </div>

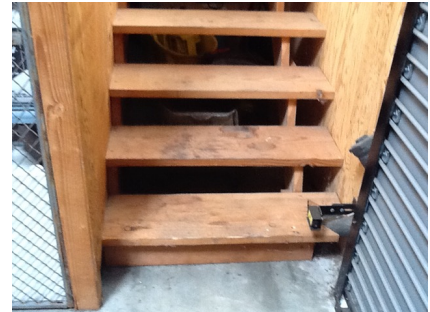
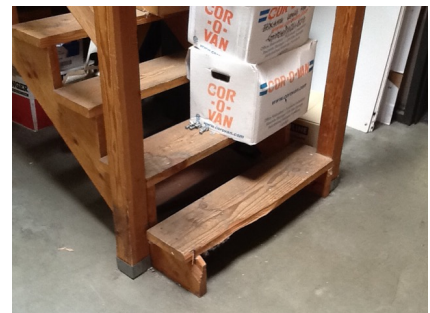
**Stairway**

296	<ul style="list-style-type: none"> As-Built Description: The leading 2" of the tread does not have visual contrast of dark-on-light or light-on-dark from the remainder of the tread. Proposed Solution: Provide 2" min., 4" max. wide contrasting color strip 1" max. from nosing on top & bottom treads when altering area. 	PCODE II02B ADA 2010 504.4 CBC 2007 1133B.4.4 CBC 2016 11B-504.4.1	8	LF	\$42	\$336
<div> <div>Mitigated:</div> <div> <input type="radio"/> YES <input checked="" type="radio"/> NO </div> </div> <div> <input type="checkbox"/> Staff Only </div> <div> <div>Priority</div> <div>4</div> </div> <div> <div>Severity</div> <div>3</div> </div>						
300	<ul style="list-style-type: none"> As-Built Description: The leading 2" of the tread does not have visual contrast of dark-on-light or light-on-dark from the remainder of the tread. Proposed Solution: Provide 2" min., 4" max. wide contrasting color strip 1" max. from nosing on top & bottom treads when altering area. 	PCODE II02B ADA 2010 504.4 CBC 2007 1133B.4.4 CBC 2016 11B-504.4.1	16	LF	\$42	\$672

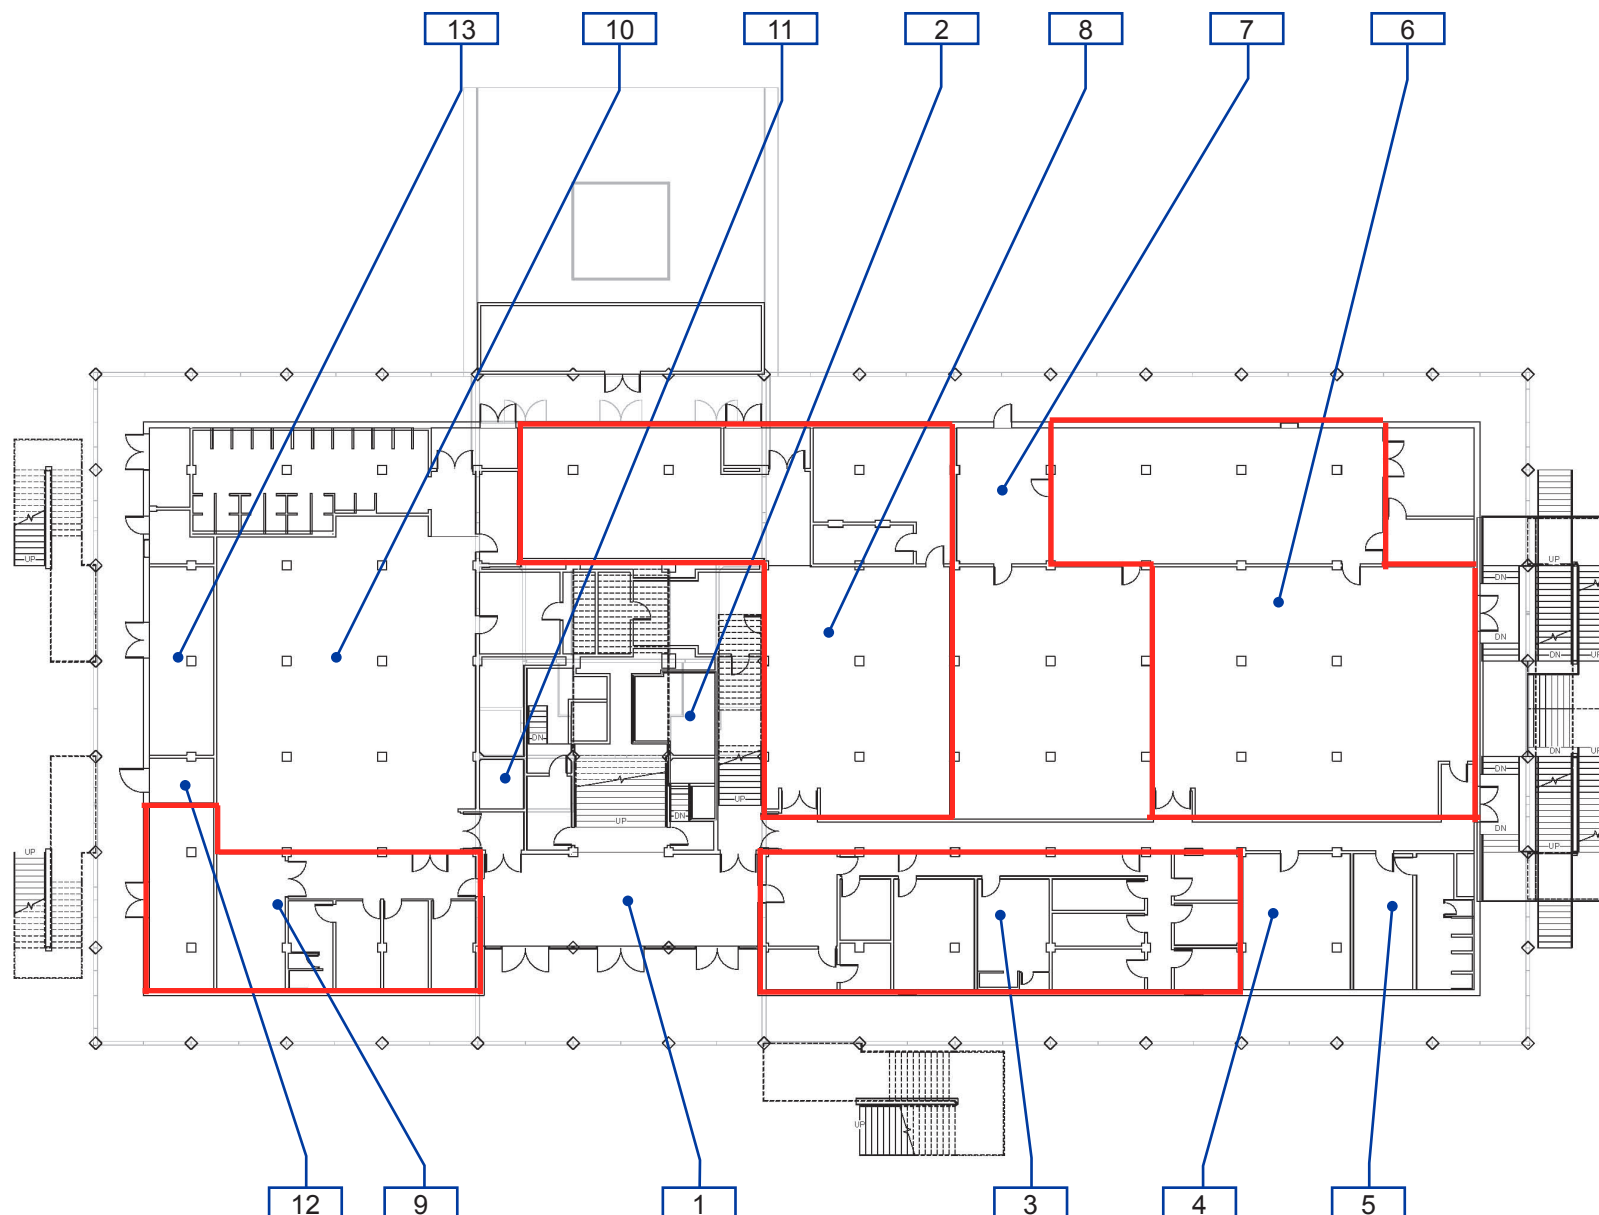
B8-1-1

Building 8 - Gymnasium
Interior- First Floor

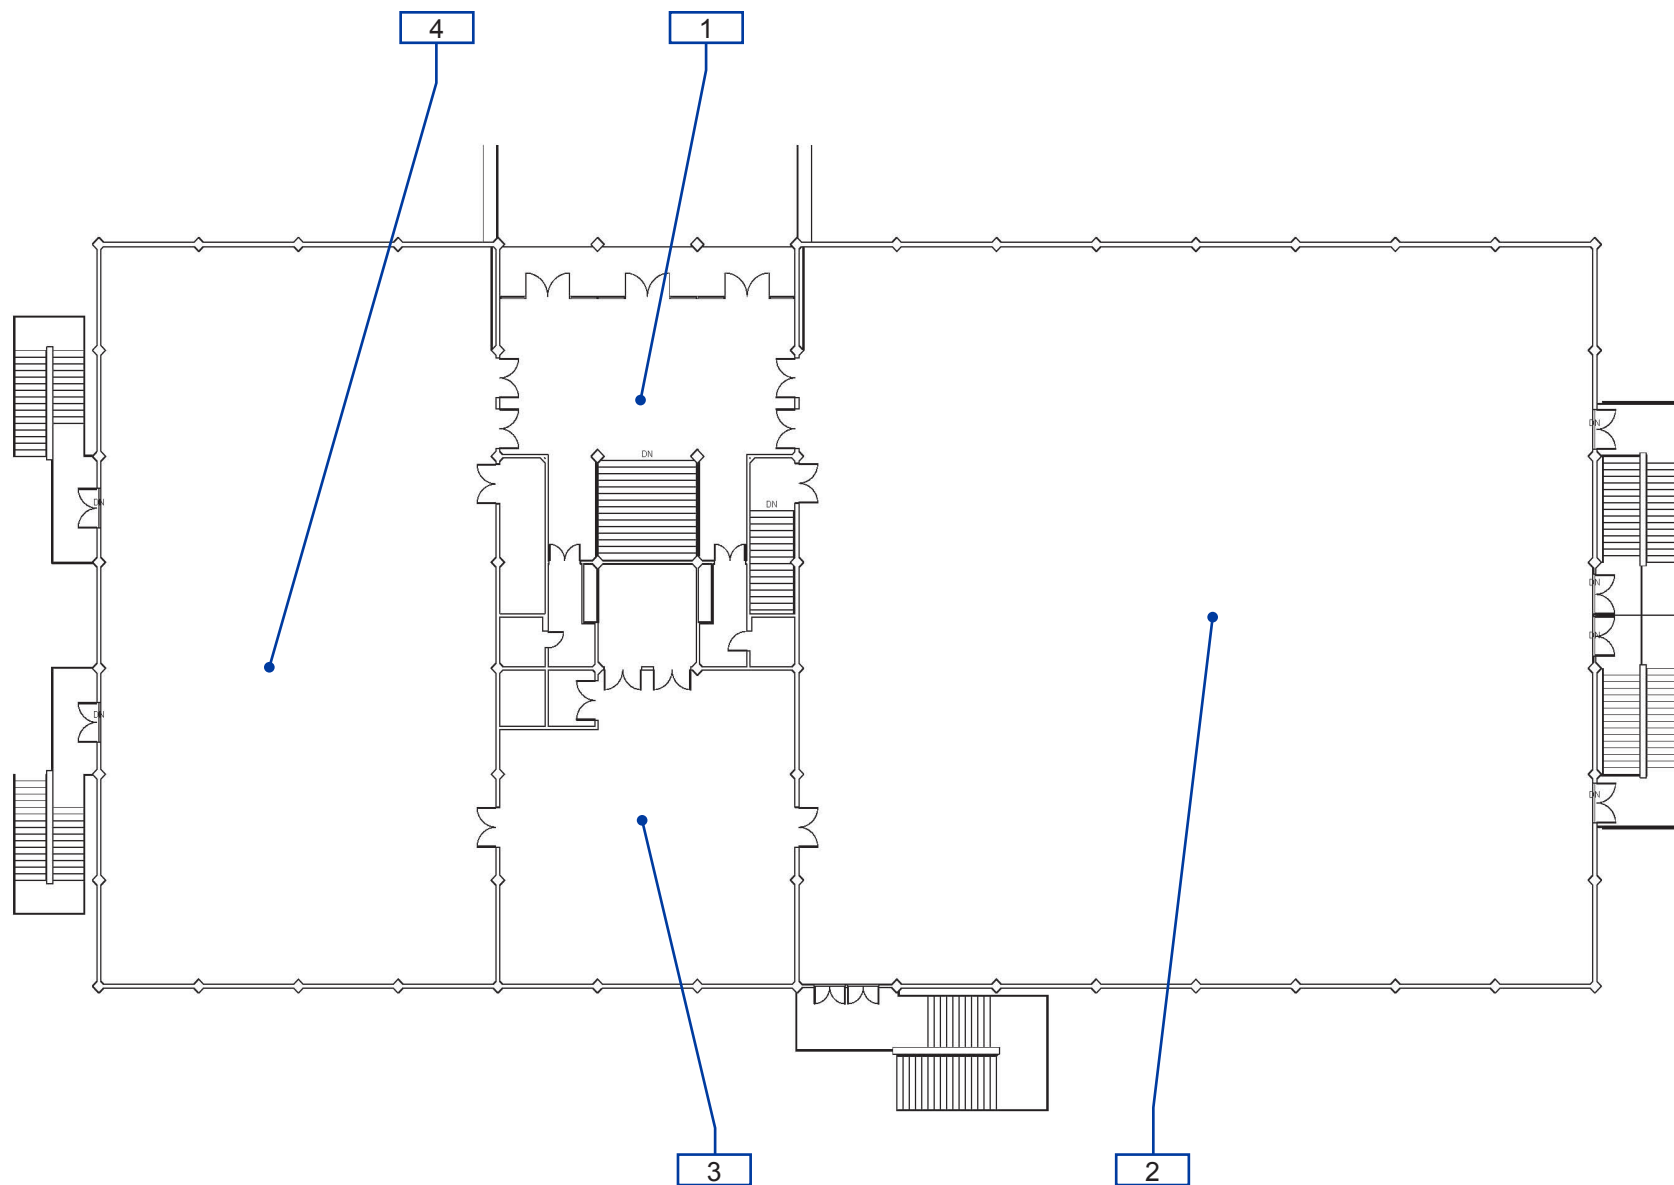
B8-1-2

Building 8 - Gymnasium
Interior- Second Floor

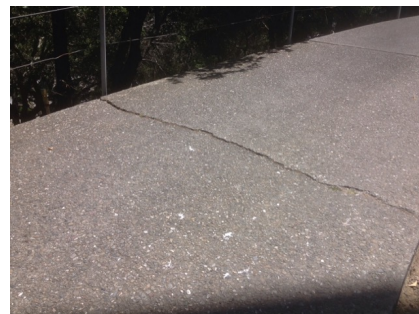
- *As-Built:* **1" high cracks**

CBC 2016 11B-403.2; 11B-302.3

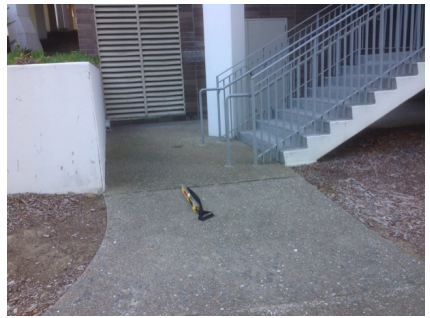
Item no., Rm no. and Name	Existing Architectural Barrier and Proposed Solution	Codes / Mitigation Info	Qty	Unit	Cost	Total
444	<ul style="list-style-type: none"> As-Built Description: Walk: Slope greater than 1:20 (5.0%), and walk does not comply with requirements for ramps. As-Built: 9.4% Proposed Solution: Modify walk/sidewalk slope to 1:20 or less. 	PCODE EF01 ADAAG 91 4.3.7 ADA 2010 403.3 CBC 2007 1133B.7.3 CBC 2016 11B-403.3 Mitigated: <input type="radio"/> YES <input checked="" type="radio"/> NO	200	SF	\$75	\$15,000

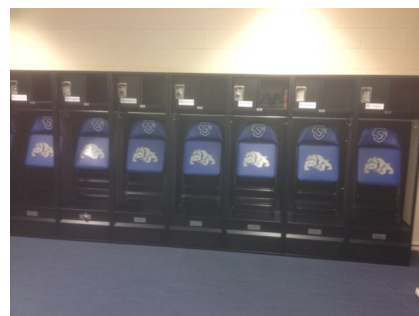
- 612
- *As-Built Description:*
Reach height to control or access point, exceeds 48" or is less than 15".
 - *As-Built:* **65" to lockers**
 - *Proposed Solution:*
Modify equipment or mounting.

PCODE IE01
ADAAG 91 4.2.5
ADA 2010 308.2.1
CBC 2007 1118B.5
CBC 2016 11B-308.2.1

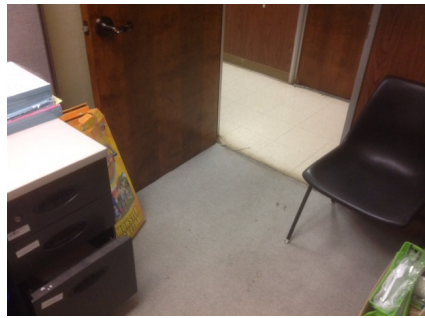
Item no., Rm no. and Name	Existing Architectural Barrier and Proposed Solution	Codes / Mitigation Info	Qty	Unit	Cost	Total
471	<ul style="list-style-type: none"> As-Built Description: Front approach: At pull side, door does not have clear and level maneuvering space measuring door width plus 18" x 60". (24" x 60" at exterior doors). Proposed Solution: Remove or relocate furniture or storage items. Notes: Typical Office 	PCODE ID23A ADAAG 91 Fig. 25(a) ADA 2010 404.2.4 CBC 2007 11B-26A(a) CBC 2016 11B-404.2.4 Mitigated: <input type="radio"/> YES <input checked="" type="radio"/> NO	6	JOB	\$150	\$900

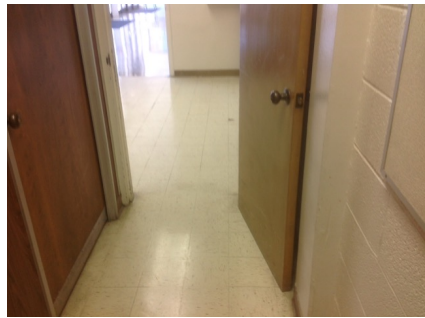
<input type="checkbox"/> Staff Only Priority 2 Severity 3			
461	<ul style="list-style-type: none"> As-Built Description: Front approach: At pull side, door does not have clear and level maneuvering space measuring door width plus 18" x 60". (24" x 60" at exterior doors). Proposed Solution: Provide power door operator. 	PCODE ID23C ADAAG 91 Fig. 25(a) ADA 2010 404.2.4 CBC 2007 11B-26A(a) CBC 2016 11B-404.2.4 Mitigated: <input type="radio"/> YES <input checked="" type="radio"/> NO	1	JOB	\$15,000	\$15,000

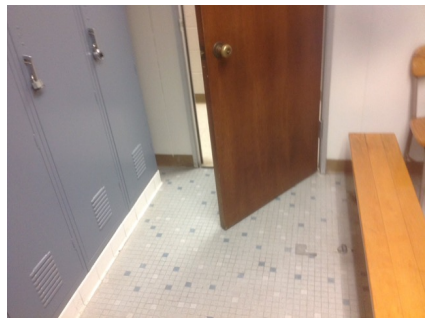
<input type="checkbox"/> Staff Only Priority 2 Severity 2			
465	<ul style="list-style-type: none"> As-Built Description: Front approach: At pull side, door does not have clear and level maneuvering space measuring door width plus 18" x 60". (24" x 60" at exterior doors). As-Built: 9" wide Proposed Solution: Provide power door operator. Notes: Faculty Locker Room 	PCODE ID23C ADAAG 91 Fig. 25(a) ADA 2010 404.2.4 CBC 2007 11B-26A(a) CBC 2016 11B-404.2.4 Mitigated: <input type="radio"/> YES <input checked="" type="radio"/> NO	1	JOB	\$15,000	\$15,000

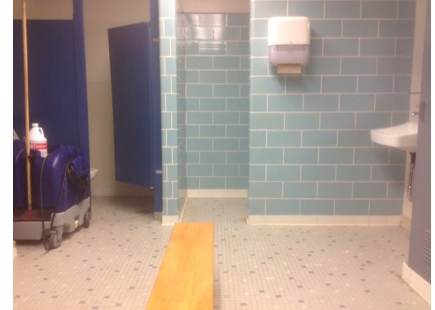
Multiple accommodation restroom not accessible;
multiple compliance violations.

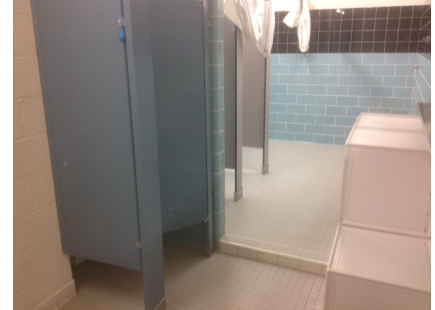
Multiple accommodation restroom not accessible;
multiple compliance violations.

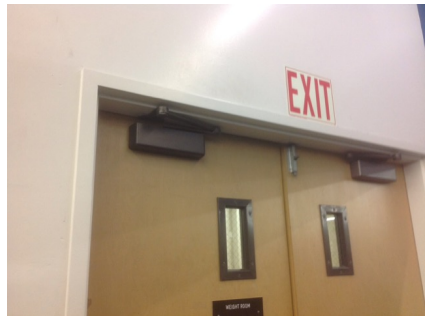
Item no., Rm no. and Name	Existing Architectural Barrier and Proposed Solution	Codes / Mitigation Info	Qty	Unit	Cost	Total
490	<ul style="list-style-type: none"> As-Built Description: Sign designating a permanent room or space does not include Grade 2 Braille. Proposed Solution: Provide new compliant signage including California Grade 2 Braille (1/10" on center dots with 2/10" space between cells). 	PCODE SA07A ADAAG 91 4.30.4 ADA 2010 703.2 CBC 2007 1117B.5.6 CBC 2016 11B-703.3 Mitigated: <input type="radio"/> YES <input checked="" type="radio"/> NO	3	JOB	\$270	\$810

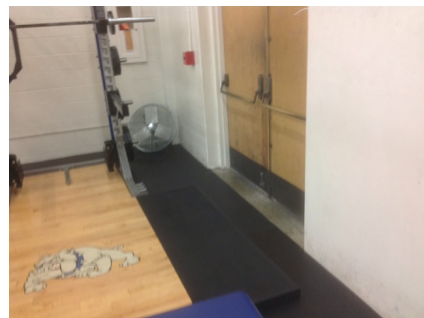
- **As-Built Description:**
Refer to notes for observation and recommendation.
- **Proposed Solution:**
- **Notes:**
Emergency exit blocked by weights.

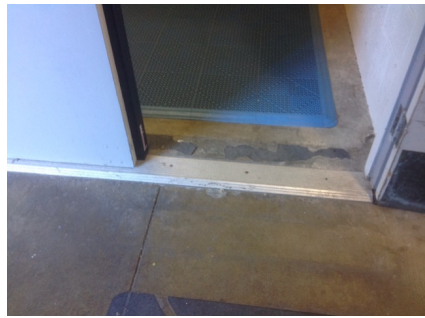
Item no., Rm no. and Name	Existing Architectural Barrier and Proposed Solution	Codes / Mitigation Info	Qty	Unit	Cost	Total
527	<ul style="list-style-type: none"> As-Built Description: Door inaccessible due to threshold or step at door exceeding 1/2". As-Built: 1" high Proposed Solution: Modify threshold to be no more than 1/2" by removing existing paving at door and providing landing with edge ramping (slope 1:20 max). Exterior Entrance	PCODE ID02A ADAAG 91 4.13.8 ADA 2010 404.2.5 CBC 2007 1133B.2.4.1 CBC 2016 11B-404.2.5 Mitigated: <input type="radio"/> YES <input checked="" type="radio"/> NO	1	JOB	\$1,200	\$1,200

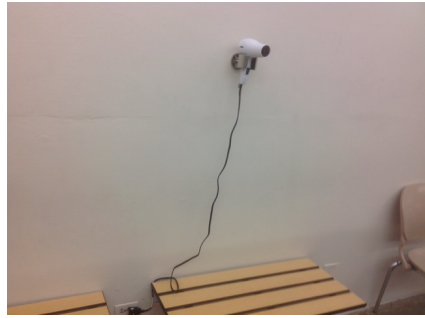
502	<ul style="list-style-type: none"> As-Built Description: Reach height to control or access point, exceeds 48" or is less than 15". As-Built: 58" high Proposed Solution: Modify equipment or mounting. 	PCODE IE01 ADAAG 91 4.2.5 ADA 2010 308.2.1 CBC 2007 1118B.5 CBC 2016 11B-308.2.1 Mitigated: <input type="radio"/> YES <input checked="" type="radio"/> NO	1	JOB	\$300	\$300

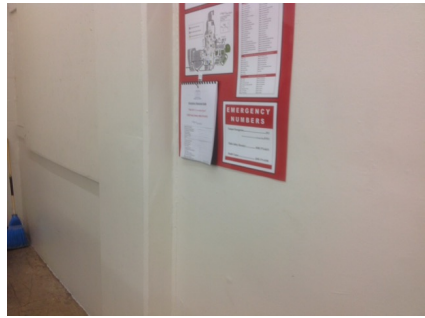
<input type="checkbox"/> Staff Only						
Priority 3 Severity 3						
503	<ul style="list-style-type: none"> As-Built Description: Reach height to control or access point, exceeds 48" or is less than 15". As-Built: 52" high Proposed Solution: Modify equipment or mounting. 	PCODE IE01 ADAAG 91 4.2.5 ADA 2010 308.2.1 CBC 2007 1118B.5 CBC 2016 11B-308.2.1 Mitigated: <input type="radio"/> YES <input checked="" type="radio"/> NO	1	JOB	\$300	\$300

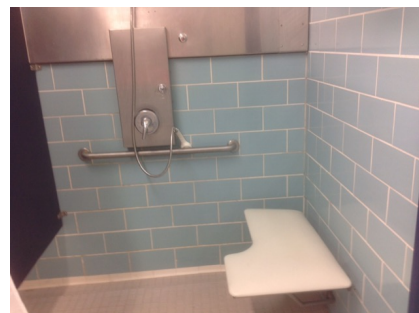
Shower not accessible; multiple compliance violations.

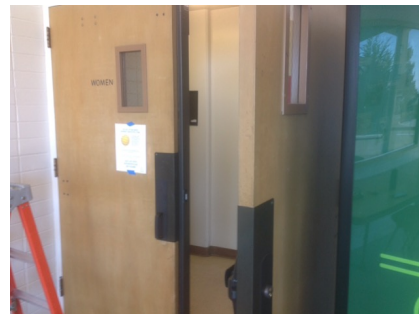
PCODE SA11A
ADAAG 91 4.1.3(16)(a)
ADA 2010 216.8
CBC 2016 11B-216.8

Provide ADA compliant sign mounted at 48" min. above to baseline of the lowest Braille cells and 60" max. to baseline of the highest line of raised characters on nearest adjacent wall, on latch side of a single door (located not to cause a Braille reader to stand within the door swing).

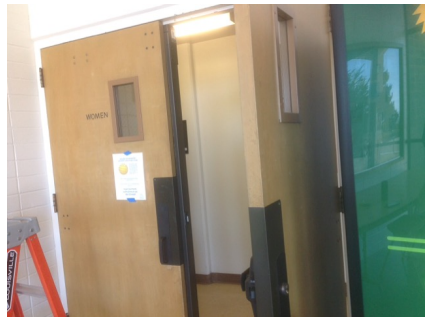
<input type="checkbox"/> Staff Only Priority 3 Severity 3			
538	<ul style="list-style-type: none"> As-Built Description: Required in CA only: identification symbol centered 58" to 60" high on sanitary facility door that contrasts with the door not provided (women: 12" ø circle, men: 12" triangle, unisex: combined symbol). Proposed Solution: Provide properly mounted sanitary facility symbol when altering area. If wheelchair accessible, include International Symbol of Accessibility on sign. 	PCODE SA15 CBC 2007 1115B.6 CBC 2016 11B-703.7.2.6 Mitigated: <input type="radio"/> YES <input checked="" type="radio"/> NO	1	JOB	\$270	\$270

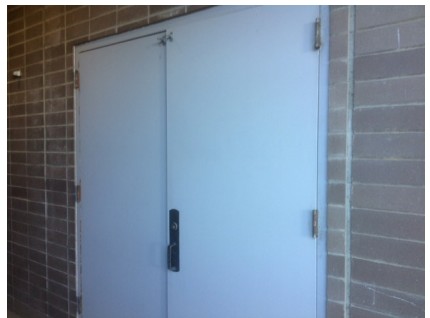
<input type="checkbox"/> Staff Only Priority 3 Severity 3			
560	<ul style="list-style-type: none"> As-Built Description: Required in CA only: identification symbol centered 58" to 60" high on sanitary facility door that contrasts with the door not provided (women: 12" ø circle, men: 12" triangle, unisex: combined symbol). Proposed Solution: Provide properly mounted sanitary facility symbol when altering area. If wheelchair accessible, include International Symbol of Accessibility on sign. Notes: Exterior entrance 	PCODE SA15 CBC 2007 1115B.6 CBC 2016 11B-703.7.2.6 Mitigated: <input type="radio"/> YES <input checked="" type="radio"/> NO	1	JOB	\$270	\$270

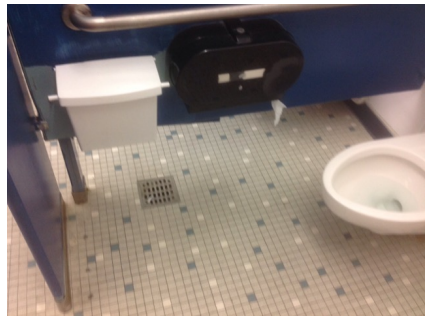
Item no., Rm no. and Name	Existing Architectural Barrier and Proposed Solution	Codes / Mitigation Info	Qty	Unit	Cost	Total
550	<ul style="list-style-type: none"> As-Built Description: CA only: In single-accommodation restroom less than 48" in front of water closet provided. As-Built: 35" Proposed Solution: Remodel restroom to provide at least 48" in front of water closet. 	PCODE WB03A CBC 2007 1115B.3.2.1 CBC 2016 11B-604.3.1 Mitigated: <input type="radio"/> YES <input checked="" type="radio"/> NO	1	JOB	\$15,000	\$15,000

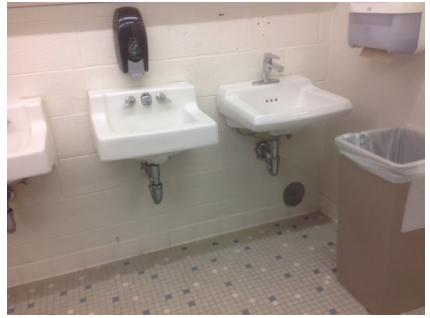
549	<ul style="list-style-type: none"> As-Built Description: Hot or sharp-surfaced water/drain pipe not insulated or covered. Proposed Solution: Insulate or cover water/drain pipe. 	PCODE WD05 ADAAG 91 4.19.4 ADA 2010 606.5 CBC 2007 1115B.4.3.4 CBC 2016 11B-606.5 Mitigated: <input type="radio"/> YES <input checked="" type="radio"/> NO	1	JOB	\$360	\$360

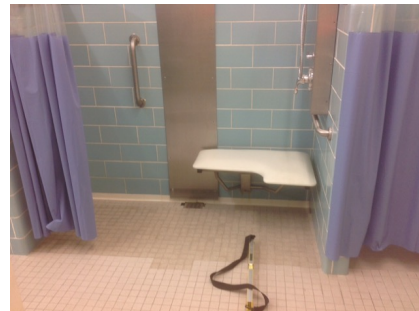
Shower not accessible; multiple compliance violations.

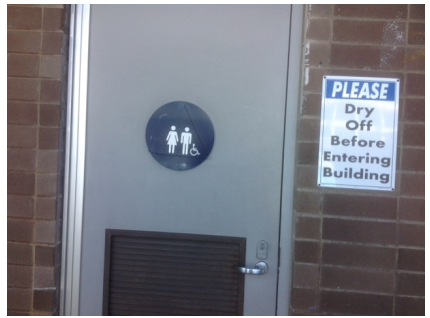
Item no., Rm no. and Name	Existing Architectural Barrier and Proposed Solution	Codes / Mitigation Info	Qty	Unit	Cost	Total
592	<ul style="list-style-type: none"> As-Built Description: Required in CA only: identification symbol centered 58" to 60" high on sanitary facility door that contrasts with the door not provided (women: 12" ø circle, men: 12" triangle, unisex: combined symbol). As-Built: Triangle not contrasting with circle. Proposed Solution: Provide properly mounted sanitary facility symbol when altering area. If wheelchair accessible, include International Symbol of Accessibility on sign. 	PCODE SA15 CBC 2007 1115B.6 CBC 2016 11B-703.7.2.6 Mitigated: <input type="radio"/> YES <input checked="" type="radio"/> NO	1	JOB	\$270	\$270

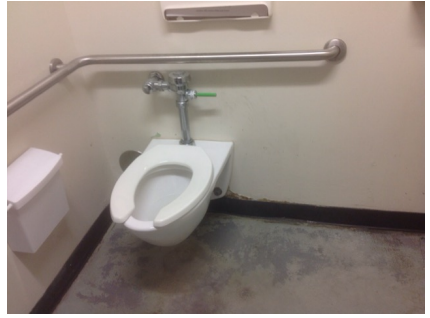
Grab Bars

597	<ul style="list-style-type: none"> As-Built Description: Accessories/dispensers in accessible stall located closer than 1-1/2" below or 12" above grab bar impedes its use. As-Built: 1" below Proposed Solution: Relocate accessories/dispensers to be no closer than 1-1/2" below and 12" above grab bars (except if accessories are recessed, flush with wall, and have no sharp edges). 	PCODE WB07I ADAAG 91 4.26.2 ADA 2010 609.3 CBC 2007 1133B.4.2.5 CBC 2016 11B-609.3 Mitigated: <input type="radio"/> YES <input checked="" type="radio"/> NO	1	JOB	\$225	\$225

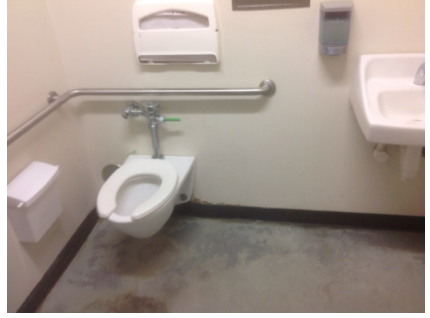
Toilet Stall

595	<ul style="list-style-type: none"> As-Built Description: Toilet stall less than 60" wide. As-Built: 58" Proposed Solution: Provide new accessible stall. Notes: 32" between WC and lavatory 	PCODE WB06 ADAAG 91 4.17.3 ADA 2010 604.8.1.1 CBC 2007 1115B.3.1.4.1 CBC 2016 11B-604.8.1.1 Mitigated: <input type="radio"/> YES <input checked="" type="radio"/> NO	1	JOB	\$4,500	\$4,500

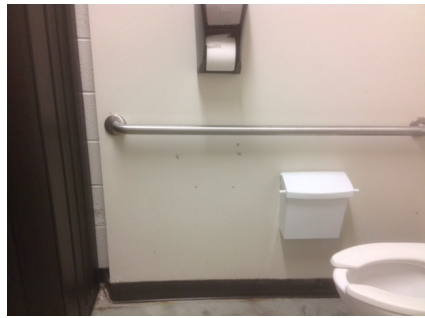
Item no., Rm no. and Name	Existing Architectural Barrier and Proposed Solution	Codes / Mitigation Info	Qty	Unit	Cost	Total
598	<ul style="list-style-type: none"> As-Built Description: Toilet paper dispenser less than 15" (CA: 19") or more than 48" above floor or not within 7" to 9" from front of water closet (Note: CA pre-2010 is allowed within 12" from front of water closet). As-Built: Toilet paper located above grab bar. Proposed Solution: Relocate or provide new toilet paper dispenser. 	PCODE WG02 ADAAG 91 4.16.6 ADA 2010 604.7 CBC 2007 1115B.8.4 CBC 2016 11B-604.7 Mitigated: <input type="radio"/> YES <input checked="" type="radio"/> NO	1	JOB	\$225	\$225

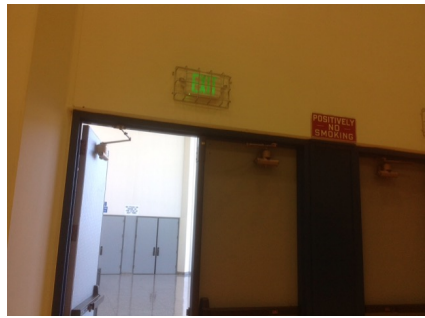
Item no., Rm no. and Name	Existing Architectural Barrier and Proposed Solution	Codes / Mitigation Info	Qty	Unit	Cost	Total
576	<ul style="list-style-type: none"> As-Built Description: At door leading into exit corridor: Where required exit signs are installed, signs to provide exiting information for people with vision impairment are not provided. Proposed Solution: Provide raised letter/Braille "EXIT ROUTE" sign at door. 	PCODE SA10D ADAAG 91 4.1.3(16) ADA 2010 216.4.1 CBC 2007 1011.3 CBC 2016 11B-216.4.1 Mitigated: <input type="radio"/> YES <input checked="" type="radio"/> NO	1	JOB	\$270	\$270

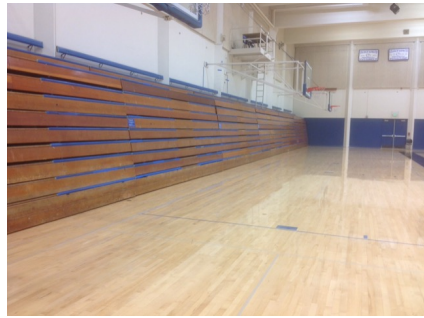
Fixed Seating

577	<ul style="list-style-type: none"> As-Built Description: Wheelchair locations not dispersed throughout seating area (n/a if floor slope greater than 1:20 or 5%). Proposed Solution: Disperse accessible wheelchair space(s). Notes: Gym not set up. Ensure seating for disabled provided. 	PCODE GE01C ADAAG 91 4.33.3 ADA 2010 221.2.3 CBC 2007 1104B.3.3 CBC 2016 11B-221.2.3 Mitigated: <input type="radio"/> YES <input checked="" type="radio"/> NO	1	EA	\$1,800	\$1,800

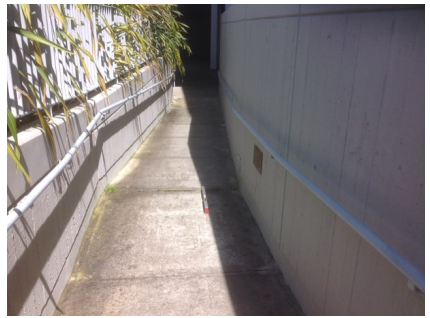
Item no., Rm no. and Name	Existing Architectural Barrier and Proposed Solution	Codes / Mitigation Info	Qty	Unit	Cost	Total
127	<ul style="list-style-type: none"> As-Built Description: Level 2% max. landing for ramp not provided. As-Built: 3.2% direction of travel Proposed Solution: Rebuild ramp to provide landings for each ramp run with slopes no greater than 2% Notes: Intermediate landing on the third ramp run. 	PCODE EB05A ADAAG 91 4.8.4 ADA 2010 405.7.1 CBC 2007 1133B.5.4.1 CBC 2016 11B-405.7.1 Mitigated: <input type="radio"/> YES <input checked="" type="radio"/> NO	24	SF	\$300	\$7,200

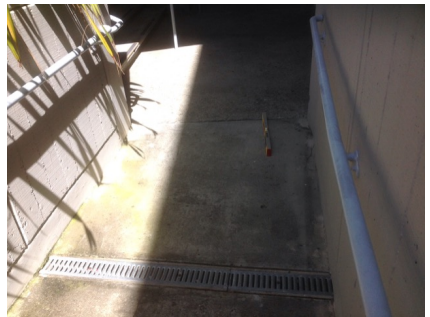
128	<ul style="list-style-type: none"> As-Built Description: Level 2% max. landing for ramp not provided. As-Built: 3.4% direction of travel Proposed Solution: Rebuild ramp to provide landings for each ramp run with slopes no greater than 2% Notes: Located at the bottom landing 	PCODE EB05A ADAAG 91 4.8.4 ADA 2010 405.7.1 CBC 2007 1133B.5.4.1 CBC 2016 11B-405.7.1 Mitigated: <input type="radio"/> YES <input checked="" type="radio"/> NO	40	SF	\$300	\$12,000

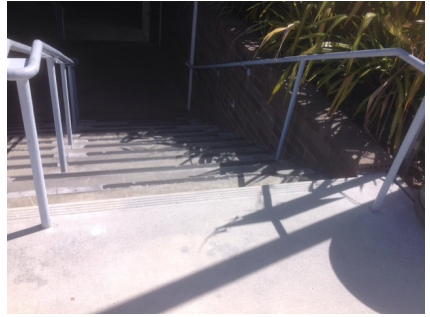
121	<ul style="list-style-type: none"> As-Built Description: The leading 2" of the tread does not have visual contrast of dark-on-light or light-on-dark from the remainder of the tread. Proposed Solution: Provide contrasting color strips at all exterior stair treads. 	PCODE EC02 ADA 2010 504.4 CBC 2007 1133B.4.4 CBC 2016 11B-504.4.1 Mitigated: <input type="radio"/> YES <input checked="" type="radio"/> NO	180	LF	\$27	\$4,860

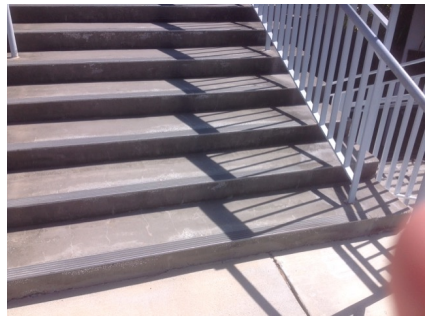
Item no., Rm no. and Name	Existing Architectural Barrier and Proposed Solution	Codes / Mitigation Info	Qty	Unit	Cost	Total
131	<ul style="list-style-type: none"> As-Built Description: The leading 2" of the tread does not have visual contrast of dark-on-light or light-on-dark from the remainder of the tread. Proposed Solution: Provide contrasting color strips at all exterior stair treads. 	PCODE EC02 ADA 2010 504.4 CBC 2007 1133B.4.4 CBC 2016 11B-504.4.1 Mitigated: <input type="radio"/> YES <input checked="" type="radio"/> NO	160	LF	\$27	\$4,320

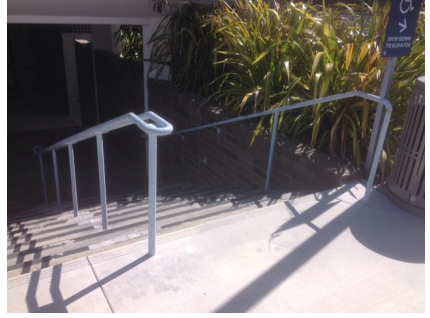
119	<ul style="list-style-type: none"> As-Built Description: Handrail gripping surface top not mounted between 34" and 38" above ramp surface or stair nosings. As-Built: 33" high Proposed Solution: Remove existing and provide new handrail. 	PCODE ED02 ADAAG 91 4.9.4(5) ADA 2010 505.4 CBC 2007 1133B.4.2.1 & B.5.5.1 CBC 2016 11B-505.4 Mitigated: <input type="radio"/> YES <input checked="" type="radio"/> NO	120	LF	\$225	\$27,000

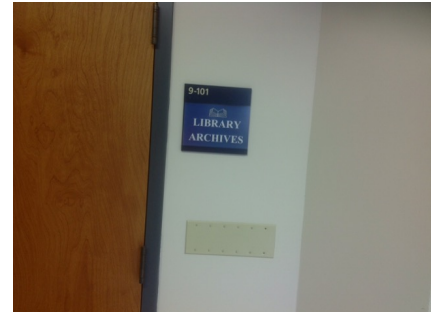
Entire building has incorrect Braille spacing.
Recommend providing Grade II Braille spacing.

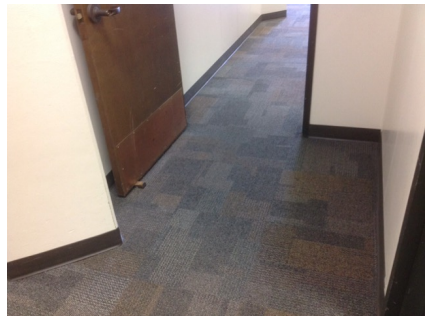
Item no., Rm no. and Name	Existing Architectural Barrier and Proposed Solution	Codes / Mitigation Info	Qty	Unit	Cost	Total
851	<ul style="list-style-type: none"> As-Built Description: Front approach: At pull side, door does not have clear and level maneuvering space measuring door width plus 18" x 60". (24" x 60" at exterior doors). As-Built: 48" to beam Proposed Solution: Provide power door operator. 	PCODE ID23C ADAAG 91 Fig. 25(a) ADA 2010 404.2.4 CBC 2007 11B-26A(a) CBC 2016 11B-404.2.4 Mitigated: <input type="radio"/> YES <input checked="" type="radio"/> NO	1	JOB	\$15,000	\$15,000

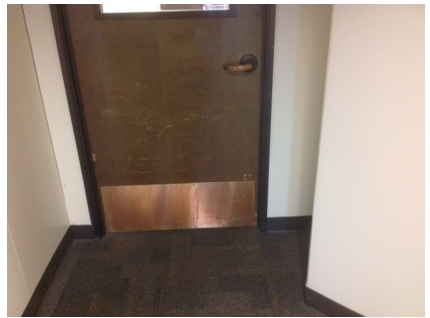
816	<ul style="list-style-type: none"> As-Built Description: Front approach: At push side, door does not have clear and level maneuvering space measuring door width x 48" (door width plus 12" if door has both, latch and closer). Proposed Solution: Provide door operator. Notes: Entry door from main lobby 	PCODE ID24CREF ADAAG 91 Fig. 25(a) ADA 2010 404.2.4 CBC 2007 11B-26A(a) CBC 2016 11B-404.2.4 Mitigated: <input type="radio"/> YES <input checked="" type="radio"/> NO

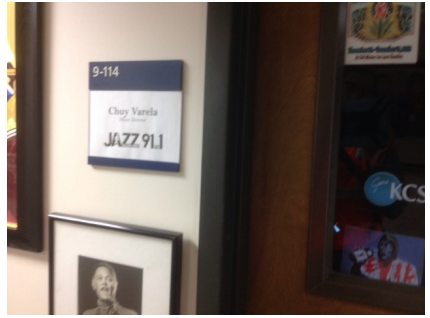
818	<ul style="list-style-type: none"> As-Built Description: Sign not located on latch side of door and/or not located at 48" min. above to baseline of the lowest Braille cells and 60" max. to baseline of the highest line of raised characters. As-Built: 62" above finished floor Proposed Solution: Provide compliant signage including tactile characters and Grade II Braille on latch side of door located at compliant height. 	PCODE SA07 ADAAG 91 4.30.6 ADA 2010 703.4.1 CBC 2007 1117B.5.7 CBC 2016 11B-703.4.1 Mitigated: <input type="radio"/> YES <input checked="" type="radio"/> NO	8	JOB	\$150	\$1,200

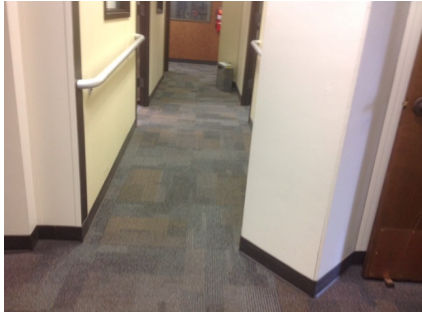
Item no., Rm no. and Name	Existing Architectural Barrier and Proposed Solution	Codes / Mitigation Info	Qty	Unit	Cost	Total
Slope						
827	<ul style="list-style-type: none">As-Built Description: Slope greater than 1:12 (8.3%).As-Built: 9.2% direction of travelProposed Solution: Demolish existing and provide new ramp with handrails.	PCODE EB02 ADAAG 91 4.8.2 ADA 2010 405.2 CBC 2007 1133B.5.3 CBC 2016 11B-405.2 Mitigated: <div><input type="radio"/> YES</div> <div><input checked="" type="radio"/> NO</div>	36	SF	\$300	\$10,800

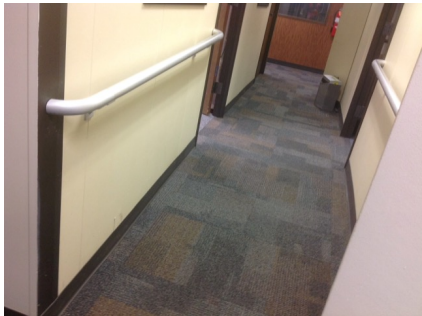
<div><input type="checkbox"/> Staff Only</div> <div><div>Priority</div><div>2</div><div>Severity</div><div>4</div></div>			
Top and Bottom Extension at						
828	<ul style="list-style-type: none">As-Built Description: Ramp handrail does not extend horizontally 12" past top and / or bottom of ramp.Proposed Solution: Provide ramp handrail extension (cost for each extension piece).	PCODE ED05 ADAAG 91 4.8.5(2) ADA 2010 505.10.1 CBC 2007 1133B.4.2.2 & 1133B.5.5.1 CBC 2016 11B-505.10.1 Mitigated: <div><input type="radio"/> YES</div> <div><input checked="" type="radio"/> NO</div>	4	JOB	\$510	\$2,040

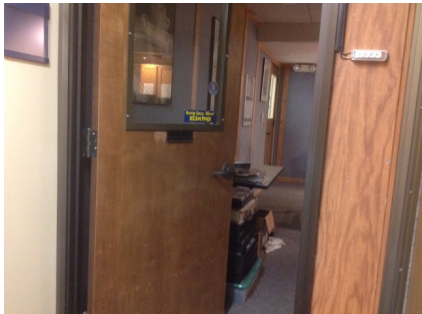
<div><input type="checkbox"/> Staff Only</div> <div><div>Priority</div><div>2</div><div>Severity</div><div>2</div></div>			
Door						
831	<ul style="list-style-type: none">As-Built Description: Vision Light at door that permits viewing, does not have bottom of at least one glazed panel located 43 inches maximum above the finish floor. (Exception: More than 66" above finished floor.)As-Built: 48" above finished floorProposed Solution: Provide new door with vision panel at 43" max.	PCODE ID06C ADA 2010 404.2.11 CBC 2016 11B-404.2.11 Mitigated: <div><input type="radio"/> YES</div> <div><input checked="" type="radio"/> NO</div>	6	JOB	\$7,500	\$45,000

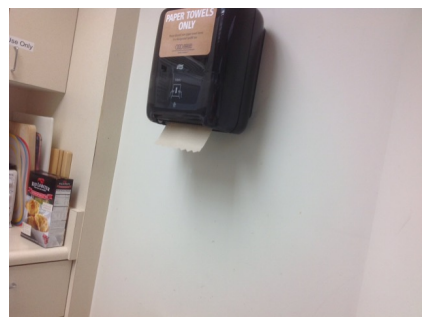
Item no., Rm no. and Name	Existing Architectural Barrier and Proposed Solution	Codes / Mitigation Info	Qty	Unit	Cost	Total
Reach Range						
873	<ul style="list-style-type: none">As-Built Description: Reach height to control or access point, exceeds 48" or is less than 15".As-Built: 60" above finished floorProposed Solution: Modify equipment or mounting.	PCODE IE01 ADAAG 91 4.2.5 ADA 2010 308.2.1 CBC 2007 1118B.5 CBC 2016 11B-308.2.1	1	JOB	\$300	\$300

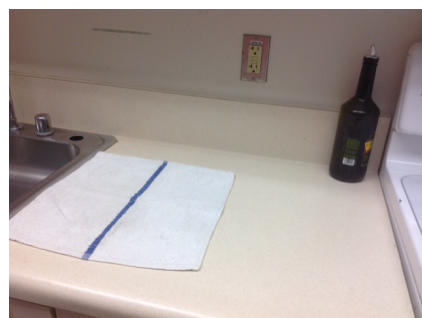
<input type="radio"/> YES <input checked="" type="radio"/> NO			
			<input type="checkbox"/> Staff Only			
			Priority 4 Severity 2			
875	<ul style="list-style-type: none">As-Built Description: Reach height to control or access point, exceeds 48" or is less than 15".As-Built: 25" reach to outletProposed Solution: Modify equipment or mounting.	PCODE IE01 ADAAG 91 4.2.5 ADA 2010 308.2.1 CBC 2007 1118B.5 CBC 2016 11B-308.2.1	3	JOB	\$300	\$900

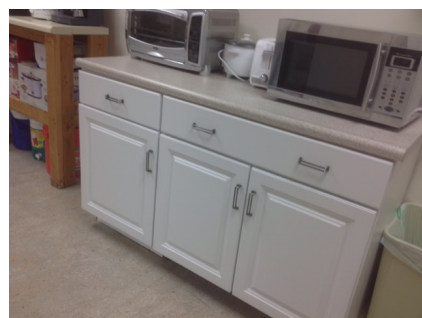
<input type="radio"/> YES <input checked="" type="radio"/> NO			
			<input type="checkbox"/> Staff Only			
			Priority 4 Severity 4			
Public Counter						
876	<ul style="list-style-type: none">As-Built Description: Service counter (stand-up): Accessible section min. 36" length and 36" max. height (in CA: 28" to 34" high) not provided.As-Built: 36" above finished floorProposed Solution: Retrofit existing counter to provide accessible section. Interim solution: Provide auxiliary counter, table, or clipboard.	PCODE IN03 ADAAG 91 7.2(2) ADA 2010 904.4 CBC 2007 1122B.4 CBC 2016 11B-904.4	2	JOB	\$6,000	\$12,000

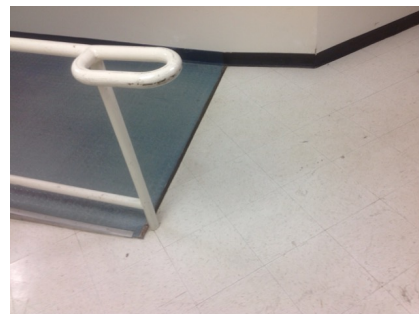
Bottom extension of handrail does not return creating a hazard for blind individuals.

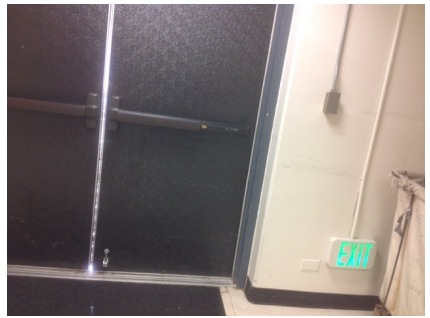
Item no., Rm no. and Name	Existing Architectural Barrier and Proposed Solution	Codes / Mitigation Info	Qty	Unit	Cost	Total
885	<ul style="list-style-type: none"> • <i>As-Built Description:</i> At final exit door to exterior: Where required exit signs are installed, signs to provide exiting information for people with vision impairment are not provided. • <i>Proposed Solution:</i> Provide raised letter/Braille "EXIT" sign at door. 	PCODE SA10A ADAAG 91 4.1.3(16) ADA 2010 216.4.1 CBC 2007 1011.3 CBC 2016 11B-216.4.1 Mitigated: <input type="radio"/> YES <input checked="" type="radio"/> NO	1	JOB	\$270	\$270

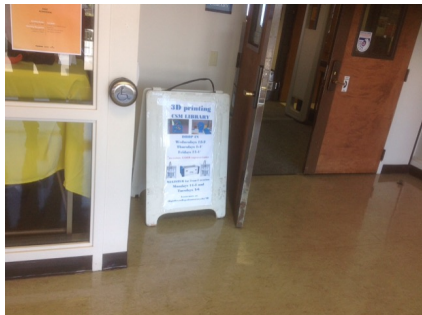
Item no., Rm no. and Name	Existing Architectural Barrier and Proposed Solution	Codes / Mitigation Info	Qty	Unit	Cost	Total
Door						
164	<ul style="list-style-type: none">• <i>As-Built Description:</i> Lower push plate located at 7" minimum and 8" maximum above the floor or ground surface not provided.• <i>Proposed Solution:</i> Provide lower push plate.	PCODE ID13B CBC 2007 1133B.2.3.2 CBC 2016 11B-404.2.9 2.C Mitigated: <div><input type="radio"/> YES</div> <div><input checked="" type="radio"/> NO</div>	1	JOB	\$1,500	\$1,500

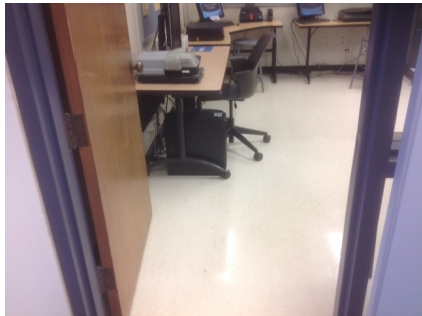
<div><input type="checkbox"/> Staff Only</div> <div><div>Priority</div><div>2</div><div>Severity</div><div>2</div></div>			
Door Hardware						
169	<ul style="list-style-type: none">• <i>As-Built Description:</i> Door does not have accessible operating hardware.• <i>Proposed Solution:</i> Provide lever handle or other accessible hardware.	PCODE ID07 ADAAG 91 4.13.9 ADA 2010 404.2.7 CBC 2007 1133B.2.5.2 CBC 2016 11B-404.2.7 Mitigated: <div><input type="radio"/> YES</div> <div><input checked="" type="radio"/> NO</div>	1	JOB	\$750	\$750

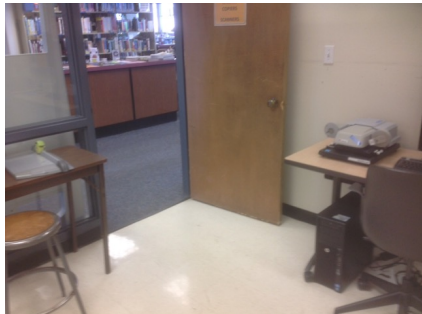
<div><input type="checkbox"/> Staff Only</div> <div><div>Priority</div><div>2</div><div>Severity</div><div>3</div></div>			
Door Swing						
170	<ul style="list-style-type: none">• <i>As-Built Description:</i> Front approach: At pull side, door does not have clear and level maneuvering space measuring door width plus 18" x 60". (24" x 60" at exterior doors).• <i>As-Built:</i> 6" strike side clearance, 48" pull landing• <i>Proposed Solution:</i> Remove or relocate furniture or storage items.	PCODE ID23A ADAAG 91 Fig. 25(a) ADA 2010 404.2.4 CBC 2007 11B-26A(a) CBC 2016 11B-404.2.4 Mitigated: <div><input type="radio"/> YES</div> <div><input checked="" type="radio"/> NO</div>	1	JOB	\$150	\$150

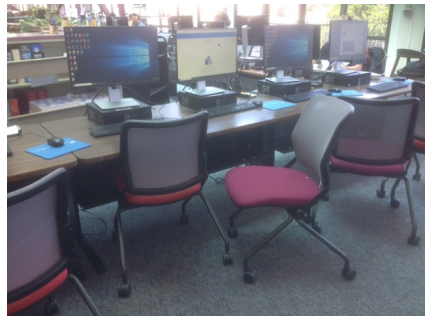
Item no., Rm no. and Name	Existing Architectural Barrier and Proposed Solution	Codes / Mitigation Info	Qty	Unit	Cost	Total
172	<ul style="list-style-type: none"> As-Built Description: Accessible non-fixed table or desk (top 28" to 34" high; knee space at least 27" high x 19" deep x 30" wide) not provided. As-Built: 25" knee height Proposed Solution: Provide table or desk with accessible dimensions when purchasing new furniture. Notes: Computer station 	PCODE IN02A ADAAG 91 4.32.3 & .4 ADA 2010 306.1 CBC 2007 1122B.3 & 4 CBC 2016 11B-306.1 & 11B-902.3 Mitigated: <input type="radio"/> YES <input checked="" type="radio"/> NO	1	JOB	\$4,800	\$4,800

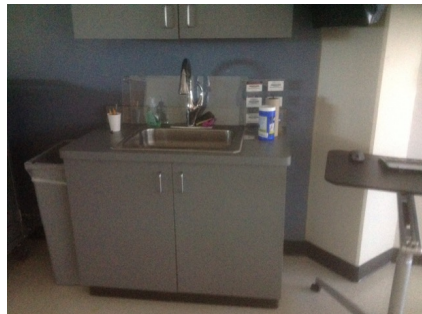
Item no., Rm no. and Name	Existing Architectural Barrier and Proposed Solution	Codes / Mitigation Info	Qty	Unit	Cost	Total
473	<ul style="list-style-type: none"> As-Built Description: Sink does not have knee space min. 27" high x 19" deep x 30" wide. Proposed Solution: Remodel sink cabinet. 	PCODE IN06A ADAAG 91 4.24.3 ADA 2010 606.2 CBC 2007 1115B.4.7.1 CBC 2016 11B-606.2 Mitigated: <input type="radio"/> YES <input checked="" type="radio"/> NO	1	JOB	\$5,250	\$5,250

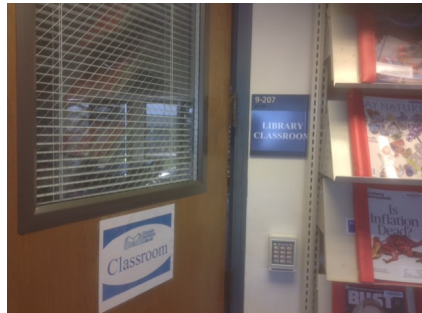
191	<ul style="list-style-type: none"> As-Built Description: Signs containing tactile characters is not located so that a clear floor space of 18" min x 18" min., centered on the tactile characters, is provided beyond the arc of any door swing between the closed position and 45 degree open position. As-Built: 62" above finished floor Proposed Solution: Relocate compliant signage on latch side of door located at compliant height with a clear floor space. 	PCODE SA07B ADA 2010 703.4.2 CBC 2016 11B-703.4.2 Mitigated: <input type="radio"/> YES <input checked="" type="radio"/> NO	1	JOB	\$150	\$150

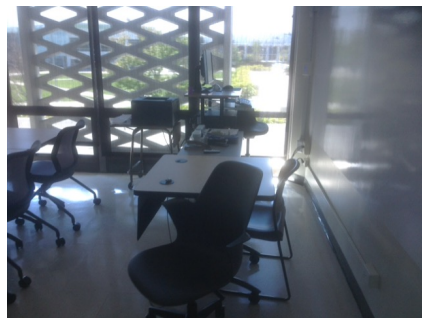
195	<ul style="list-style-type: none"> As-Built Description: No portable assistive listening system provided for small meeting room. Proposed Solution: Share existing portable assistive listening system from other facility. 	PCODE GI01E ADAAG 91 4.1.3(19)(b) & 4.33.7 ADA 2010 219.1 & 706.1 CBC 2007 1104B.2 CBC 2016 11B-219.1 & 11B-706.1 Mitigated: <input type="radio"/> YES <input checked="" type="radio"/> NO	REF

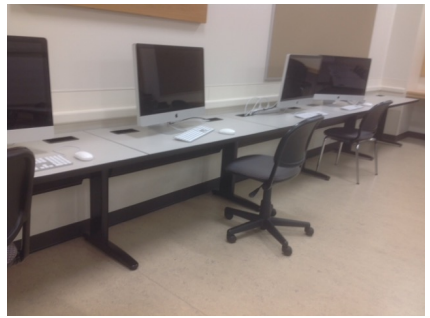
Item no., Rm no. and Name	Existing Architectural Barrier and Proposed Solution	Codes / Mitigation Info	Qty	Unit	Cost	Total
46	<ul style="list-style-type: none"> As-Built Description: Accessible non-fixed table or desk (top 28" to 34" high; knee space at least 27" high x 19" deep x 30" wide) not provided. As-Built: 26" knee height Proposed Solution: Provide table or desk with accessible dimensions when purchasing new furniture. Notes: 5 computers, no accessible 	PCODE IN02A ADAAG 91 4.32.3 & .4 ADA 2010 306.1 CBC 2007 1122B.3 & 4 CBC 2016 11B-306.1 & 11B-902.3 Mitigated: <input type="radio"/> YES <input checked="" type="radio"/> NO	1	JOB	\$4,800	\$4,800

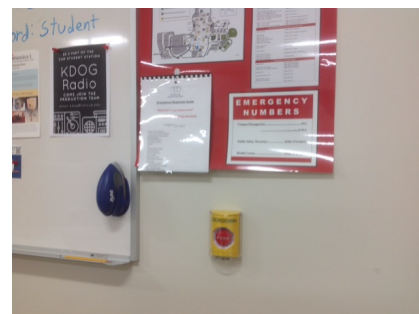
- 48
- *As-Built Description:*
Reach height to control or access point, exceeds 48" or is less than 15".
 - *As-Built:* **54" high**
 - *Proposed Solution:*
Lower item.

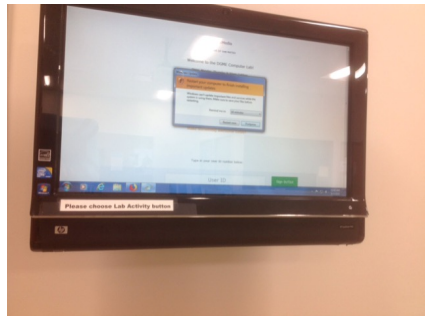
Item no., Rm no. and Name	Existing Architectural Barrier and Proposed Solution	Codes / Mitigation Info	Qty	Unit	Cost	Total
50	<ul style="list-style-type: none"> • <i>As-Built Description:</i> Reach height to control or access point, exceeds 48" or is less than 15". • <i>As-Built:</i> 62" high • <i>Proposed Solution:</i> Modify equipment or mounting. • <i>Notes:</i> If this remains an operable part 	PCODE IE01 ADAAG 91 4.2.5 ADA 2010 308.2.1 CBC 2007 1118B.5 CBC 2016 11B-308.2.1	1	JOB	\$300	\$300

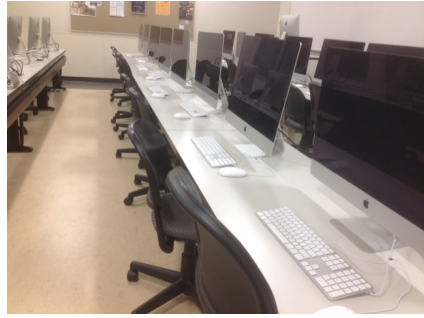
51	<ul style="list-style-type: none"> • <i>As-Built Description:</i> Accessible non-fixed table or desk (top 28" to 34" high; knee space at least 27" high x 19" deep x 30" wide) not provided. • <i>As-Built:</i> 25" knee • <i>Proposed Solution:</i> Provide table or desk with accessible dimensions when purchasing new furniture. • <i>Notes:</i> 27 total seats, no accessible 	PCODE IN02A ADAAG 91 4.32.3 & .4 ADA 2010 306.1 CBC 2007 1122B.3 & 4 CBC 2016 11B-306.1 & 11B-902.3	1	JOB	\$4,800	\$4,800

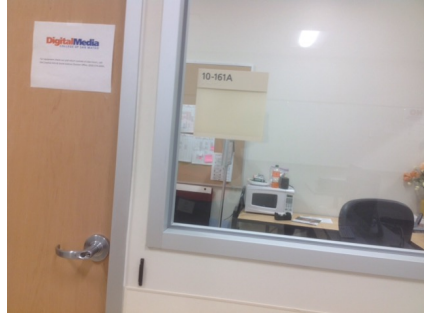
52	<ul style="list-style-type: none"> • <i>As-Built Description:</i> Sign not located on latch side of door and/or not located at 48" min. above to baseline of the lowest Braille cells and 60" max. to baseline of the highest line of raised characters. • <i>As-Built:</i> 62" high • <i>Proposed Solution:</i> Provide compliant signage including tactile characters and Grade II Braille on latch side of door located at compliant height. 	PCODE SA07 ADAAG 91 4.30.6 ADA 2010 703.4.1 CBC 2007 1117B.5.7 CBC 2016 11B-703.4.1	4	JOB	\$150	\$600
