SMCCCD - College of San Mateo

Appendix L: Facilities

Access Compliance Survey Report

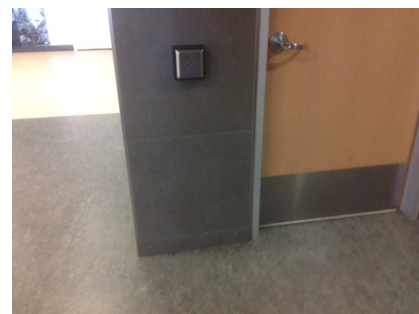
- 54
- *As-Built Description:*
Lower push plate located at 7" minimum and 8" maximum above the floor or ground surface not provided.
 - *Proposed Solution:*
Provide lower push plate.

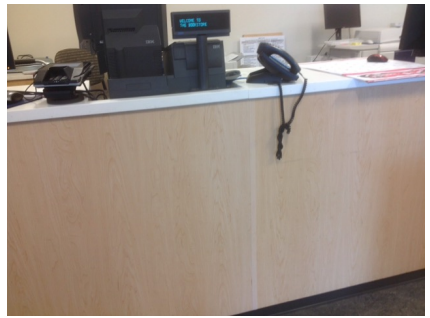
Item no., Rm no. and Name	Existing Architectural Barrier and Proposed Solution	Codes / Mitigation Info	Qty	Unit	Cost	Total
65	<ul style="list-style-type: none"> • <i>As-Built Description:</i> Service counter (stand-up): Accessible section min. 36" length and 36" max. height (in CA: 28" to 34" high) not provided. • <i>As-Built:</i> 44" high • <i>Proposed Solution:</i> Retrofit existing counter to provide accessible section. Interim solution: Provide auxiliary counter, table, or clipboard. 	PCODE IN03 ADAAG 91 7.2(2) ADA 2010 904.4 CBC 2007 1122B.4 CBC 2016 11B-904.4 Mitigated: <input type="radio"/> YES <input checked="" type="radio"/> NO	1	JOB	\$6,000	\$6,000

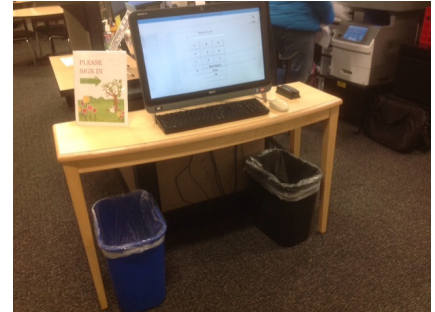
- 95
- *As-Built Description:*
Accessible non-fixed table or desk (top 28" to 34" high; knee space at least 27" high x 19" deep x 30" wide) not provided.
 - *As-Built:* **25" wide**
 - *Proposed Solution:*
Provide table or desk with accessible dimensions when purchasing new furniture.

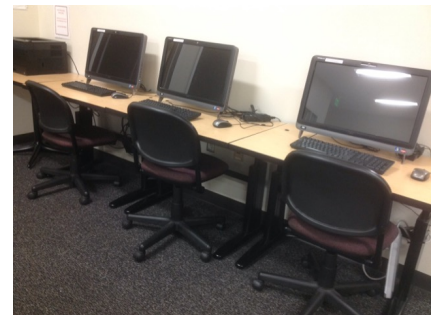
- 105
- *As-Built Description:*
Accessible non-fixed table or desk (top 28" to 34" high; knee space at least 27" high x 19" deep x 30" wide) not provided.
 - *As-Built:* **26" high**
 - *Proposed Solution:*
Provide table or desk with accessible dimensions when purchasing new furniture.

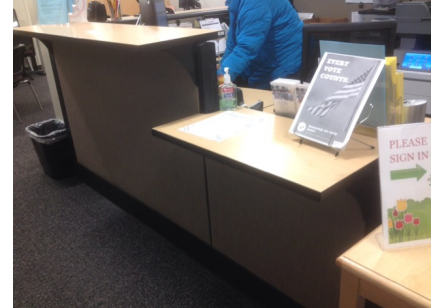
- 94 • *As-Built Description:*
Service counter (stand-up): Accessible section min. 36" length and 36" max. height (in CA: 28" to 34" high) not provided.

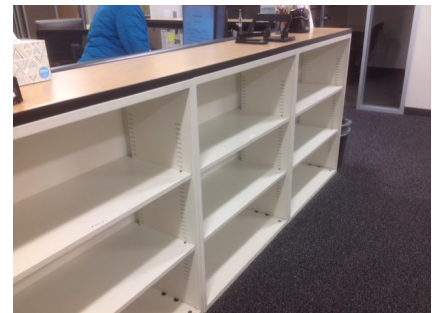
- 101 • *As-Built Description:*
Service counter (stand-up): Accessible section min. 36" length and 36" max. height (in CA: 28" to 34" high) not provided.

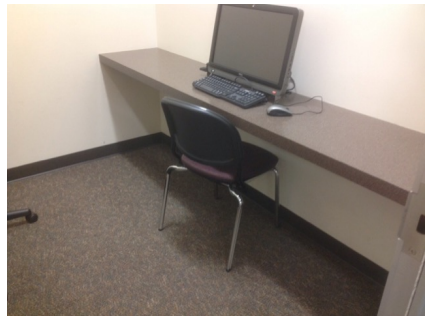
Item no., Rm no. and Name	Existing Architectural Barrier and Proposed Solution	Codes / Mitigation Info	Qty	Unit	Cost	Total
96	<ul style="list-style-type: none"> As-Built Description: Sales and service counter: Accessible section not provided (knee space min. 27" high x 19" deep x 30" wide) As-Built: 18" deep Proposed Solution: Retrofit existing counter to provide accessible seating section. Interim solution: Provide auxiliary counter, table, or clipboard. Notes: Typical Testing Room 	PCODE IN03A ADAAG 91 4.32.3 & 4 ADA 2010 306.3; 904.4 CBC 2007 1122B.3 & 4 CBC 2016 11B-306.3; 11B-904.4 Mitigated: <input type="radio"/> YES <input checked="" type="radio"/> NO	4	JOB	\$6,000	\$24,000

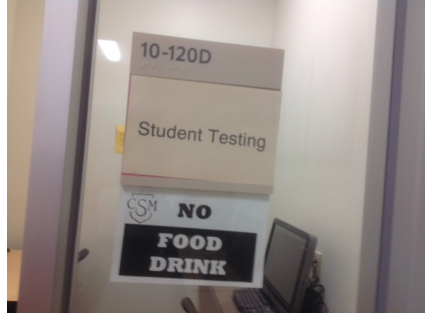
97	<ul style="list-style-type: none"> As-Built Description: Sign not located on latch side of door and/or not located at 48" min. above to baseline of the lowest Braille cells and 60" max. to baseline of the highest line of raised characters. As-Built: 62" high Proposed Solution: Provide compliant signage including tactile characters and Grade II Braille on latch side of door located at compliant height. Notes: Typical Testing Room 	PCODE SA07 ADAAG 91 4.30.6 ADA 2010 703.4.1 CBC 2007 1117B.5.7 Mitigated: <input type="radio"/> YES <input checked="" type="radio"/> NO	4	JOB	\$150	\$600

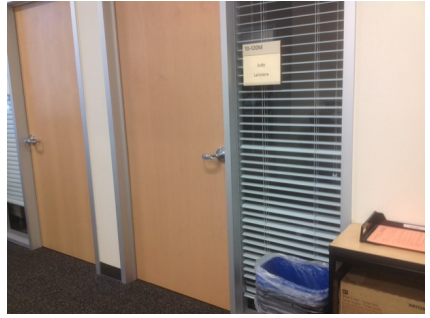
<input type="checkbox"/> Staff Only Priority 2 Severity 3						
99	<ul style="list-style-type: none"> As-Built Description: Sign not located on latch side of door and/or not located at 48" min. above to baseline of the lowest Braille cells and 60" max. to baseline of the highest line of raised characters. As-Built: 62" high Proposed Solution: Provide compliant signage including tactile characters and Grade II Braille on latch side of door located at compliant height. Notes: Typical Faculty Offices 	PCODE SA07 ADAAG 91 4.30.6 ADA 2010 703.4.1 CBC 2007 1117B.5.7 Mitigated: <input type="radio"/> YES <input checked="" type="radio"/> NO	1	JOB	\$150	\$150

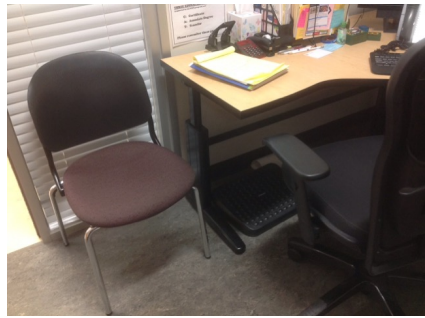
Item no., Rm no. and Name	Existing Architectural Barrier and Proposed Solution	Codes / Mitigation Info	Qty	Unit	Cost	Total
113	<ul style="list-style-type: none"> As-Built Description: Accessible non-fixed table or desk (top 28" to 34" high; knee space at least 27" high x 19" deep x 30" wide) not provided. As-Built: No knee space if used as writing surface. Proposed Solution: Provide table or desk with accessible dimensions when purchasing new furniture. 	PCODE IN02A ADAAG 91 4.32.3 & .4 ADA 2010 306.1 CBC 2007 112B.3 & 4 CBC 2016 11B-306.1 & 11B-902.3 Mitigated: <input type="radio"/> YES <input checked="" type="radio"/> NO	4	JOB	\$4,800	\$19,200

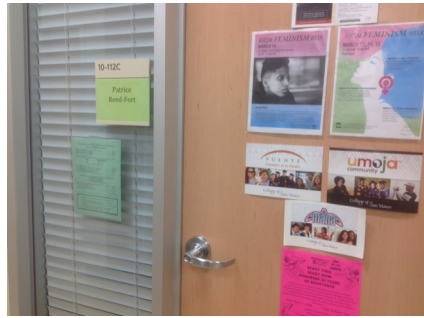
112	<ul style="list-style-type: none"> As-Built Description: Sign not located on latch side of door and/or not located at 48" min. above to baseline of the lowest Braille cells and 60" max. to baseline of the highest line of raised characters. As-Built: 62" high Proposed Solution: Provide compliant signage including tactile characters and Grade II Braille on latch side of door located at compliant height. 	PCODE SA07 ADAAG 91 4.30.6 ADA 2010 703.4.1 CBC 2007 1117B.5.7 Mitigated: <input type="radio"/> YES <input checked="" type="radio"/> NO	4	JOB	\$150	\$600

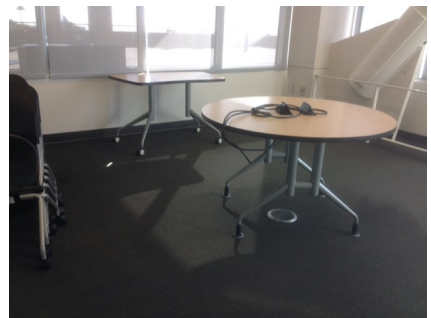
Item no., Rm no. and Name	Existing Architectural Barrier and Proposed Solution	Codes / Mitigation Info	Qty	Unit	Cost	Total
150	<ul style="list-style-type: none">• <i>As-Built Description:</i> Accessible non-fixed table or desk (top 28" to 34" high; knee space at least 27" high x 19" deep x 30" wide) not provided.• <i>Proposed Solution:</i> Provide table or desk with accessible dimensions when purchasing new furniture.• <i>Notes:</i> Group Study Room 220B,C,E	<p>PCODE IN02A</p> <p>ADAAG 91 4.32.3 & .4</p> <p>ADA 2010 306.1</p> <p>CBC 2007 1122B.3 & 4</p> <p>CBC 2016 11B-306.1 & 11B-902.3</p> <p>Mitigated:</p> <p><input type="radio"/> YES</p> <p><input checked="" type="radio"/> NO</p>	1	JOB	\$4,800	\$4,800

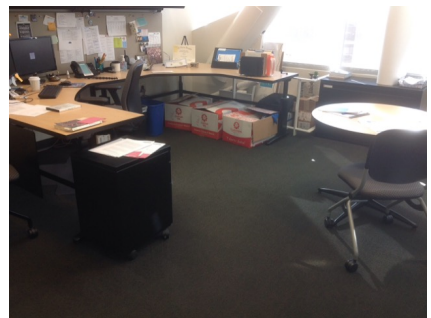
<input type="checkbox"/> Staff Only				
		Priority 2 Severity 2				
153	<ul style="list-style-type: none">• <i>As-Built Description:</i> Accessible non-fixed table or desk (top 28" to 34" high; knee space at least 27" high x 19" deep x 30" wide) not provided.• <i>Proposed Solution:</i> Provide table or desk with accessible dimensions when purchasing new furniture.• <i>Notes:</i> Faculty Office 220D	<p>PCODE IN02A</p> <p>ADAAG 91 4.32.3 & .4</p> <p>ADA 2010 306.1</p> <p>CBC 2007 1122B.3 & 4</p> <p>CBC 2016 11B-306.1 & 11B-902.3</p> <p>Mitigated:</p> <p><input type="radio"/> YES</p> <p><input checked="" type="radio"/> NO</p>	1	JOB	\$4,800	\$4,800

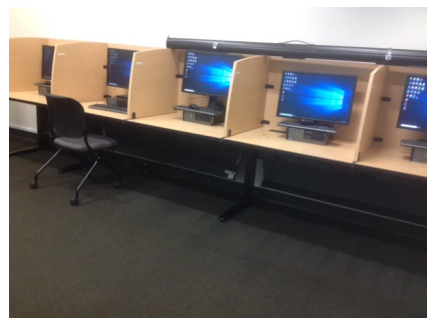
<input type="checkbox"/> Staff Only				
		Priority 2 Severity 2				
155	<ul style="list-style-type: none">• <i>As-Built Description:</i> Accessible non-fixed table or desk (top 28" to 34" high; knee space at least 27" high x 19" deep x 30" wide) not provided.• <i>As-Built:</i> 26" knee space• <i>Proposed Solution:</i> Provide table or desk with accessible dimensions when purchasing new furniture.• <i>Notes:</i> Proctoring Room 220F	<p>PCODE IN02A</p> <p>ADAAG 91 4.32.3 & .4</p> <p>ADA 2010 306.1</p> <p>CBC 2007 1122B.3 & 4</p> <p>CBC 2016 11B-306.1 & 11B-902.3</p> <p>Mitigated:</p> <p><input type="radio"/> YES</p> <p><input checked="" type="radio"/> NO</p>	1	JOB	\$4,800	\$4,800

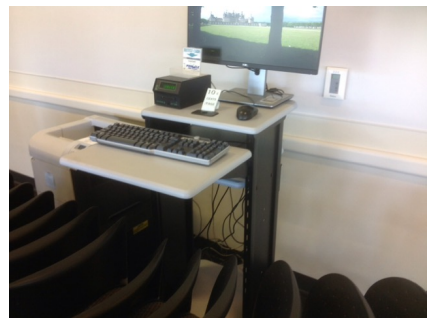
Item no., Rm no. and Name	Existing Architectural Barrier and Proposed Solution	Codes / Mitigation Info	Qty	Unit	Cost	Total
157	<ul style="list-style-type: none">• <i>As-Built Description:</i> Accessible non-fixed table or desk (top 28" to 34" high; knee space at least 27" high x 19" deep x 30" wide) not provided.• <i>Proposed Solution:</i> Provide table or desk with accessible dimensions when purchasing new furniture.• <i>Notes:</i> Printing computer	<p>PCODE IN02A</p> <p>ADAAG 91 4.32.3 & .4</p> <p>ADA 2010 306.1</p> <p>CBC 2007 1122B.3 & 4</p> <p>CBC 2016 11B-306.1 & 11B-902.3</p> <p>Mitigated:</p> <p><input type="radio"/> YES</p> <p><input checked="" type="radio"/> NO</p>	1	JOB	\$4,800	\$4,800

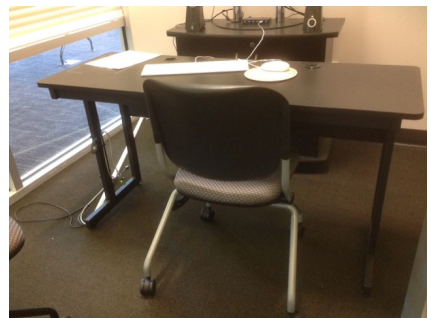
<input type="checkbox"/> Staff Only			
			Priority		Severity	
			2		2	
161	<ul style="list-style-type: none">• <i>As-Built Description:</i> Accessible non-fixed table or desk (top 28" to 34" high; knee space at least 27" high x 19" deep x 30" wide) not provided.• <i>As-Built:</i> 17.5" depth• <i>Proposed Solution:</i> Provide table or desk with accessible dimensions when purchasing new furniture.• <i>Notes:</i> Communications Studies Center 220N	<p>PCODE IN02A</p> <p>ADAAG 91 4.32.3 & .4</p> <p>ADA 2010 306.1</p> <p>CBC 2007 1122B.3 & 4</p> <p>CBC 2016 11B-306.1 & 11B-902.3</p> <p>Mitigated:</p> <p><input type="radio"/> YES</p> <p><input checked="" type="radio"/> NO</p>	2	JOB	\$4,800	\$9,600

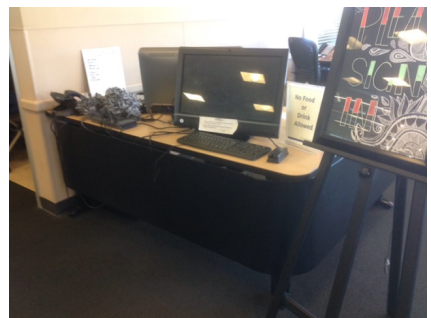
<input type="checkbox"/> Staff Only			
			Priority		Severity	
			2		2	
162	<ul style="list-style-type: none">• <i>As-Built Description:</i> Accessible non-fixed table or desk (top 28" to 34" high; knee space at least 27" high x 19" deep x 30" wide) not provided.• <i>Proposed Solution:</i> Provide table or desk with accessible dimensions when purchasing new furniture.• <i>Notes:</i> Communications Studies Center. Check-in desk no knee clearance.	<p>PCODE IN02A</p> <p>ADAAG 91 4.32.3 & .4</p> <p>ADA 2010 306.1</p> <p>CBC 2007 1122B.3 & 4</p> <p>CBC 2016 11B-306.1 & 11B-902.3</p> <p>Mitigated:</p> <p><input type="radio"/> YES</p> <p><input checked="" type="radio"/> NO</p>	1	JOB	\$4,800	\$4,800

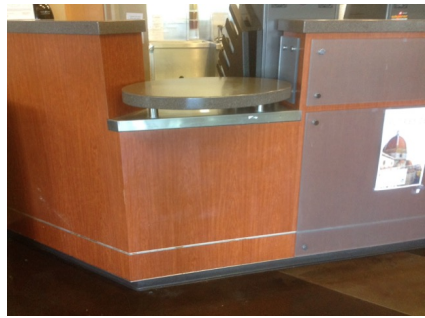
Item no., Rm no. and Name	Existing Architectural Barrier and Proposed Solution	Codes / Mitigation Info	Qty	Unit	Cost	Total
168	<ul style="list-style-type: none"> • <i>As-Built Description:</i> Service counter (stand-up): Accessible section min. 36" length and 36" max. height (in CA: 28" to 34" high) not provided. • <i>As-Built:</i> 42" high • <i>Proposed Solution:</i> Retrofit existing counter to provide accessible section. Interim solution: Provide auxiliary counter, table, or clipboard. • <i>Notes:</i> Coffee pick up counter 	PCODE IN03 ADAAG 91 7.2(2) ADA 2010 904.4 CBC 2007 1122B.4 CBC 2016 11B-904.4 Mitigated: <input type="radio"/> YES <input checked="" type="radio"/> NO	1	JOB	\$6,000	\$6,000

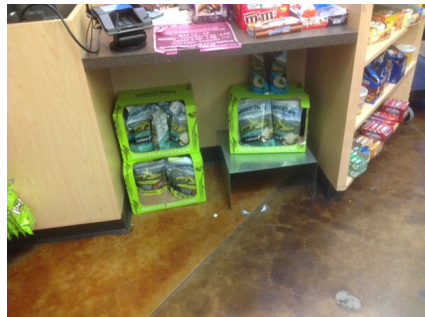
<input type="checkbox"/> Staff Only Priority 2 Severity 3				
169	<ul style="list-style-type: none"> • <i>As-Built Description:</i> Service counter (stand-up): Accessible section min. 36" length and 36" max. height (in CA: 28" to 34" high) not provided. • <i>As-Built:</i> 35" wide • <i>Proposed Solution:</i> Retrofit existing counter to provide accessible section. Interim solution: Provide auxiliary counter, table, or clipboard. 	PCODE IN03 ADAAG 91 7.2(2) ADA 2010 904.4 CBC 2007 1122B.4 CBC 2016 11B-904.4 Mitigated: <input type="radio"/> YES <input checked="" type="radio"/> NO	1	JOB	\$6,000	\$6,000

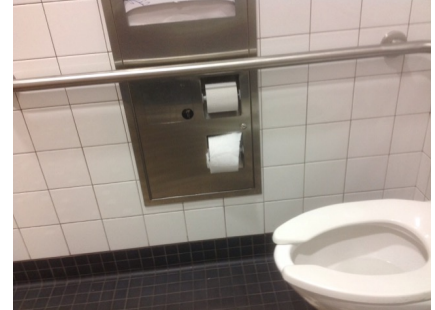
PCODE **WG02**ADAAG 91 **4.16.6**ADA 2010 **604.7**CBC 2007 **1115B.8.4**CBC 2016 **11B-604.7****Mitigated:**☐ **YES**☒ **NO**1 JOB \$225 **\$225**

Relocate or provide new toilet paper dispenser.

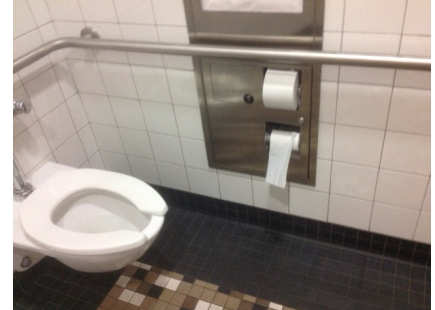
PCODE **WG02**ADAAG 91 **4.16.6**ADA 2010 **604.7**CBC 2007 **1115B.8.4**CBC 2016 **11B-604.7****Mitigated:**☐ **YES**☒ **NO**1 JOB \$225 **\$225**

Relocate or provide new toilet paper dispenser.

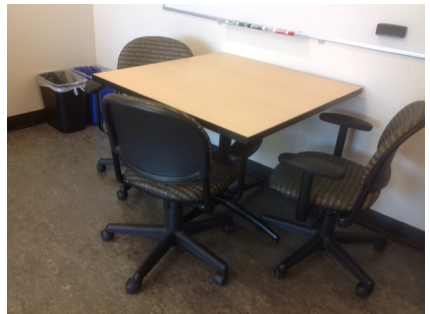
Item no., Rm no. and Name	Existing Architectural Barrier and Proposed Solution	Codes / Mitigation Info	Qty	Unit	Cost	Total
208	<ul style="list-style-type: none"> As-Built Description: Accessible non-fixed table or desk (top 28" to 34" high; knee space at least 27" high x 19" deep x 30" wide) not provided. Proposed Solution: Provide table or desk with accessible dimensions when purchasing new furniture. Notes: 3 tables, no accessible 	PCODE IN02A ADAAG 91 4.32.3 & .4 ADA 2010 306.1 CBC 2007 1122B.3 & 4 CBC 2016 11B-306.1 & 11B-902.3	1	JOB	\$4,800	\$4,800
Mitigated: <input type="radio"/> YES <input checked="" type="radio"/> NO

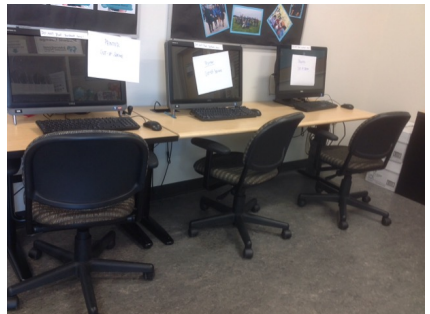
<input type="checkbox"/> Staff Only			
			Priority 2 Severity 2			
209	<ul style="list-style-type: none"> As-Built Description: Accessible non-fixed table or desk (top 28" to 34" high; knee space at least 27" high x 19" deep x 30" wide) not provided. Proposed Solution: Provide table or desk with accessible dimensions when purchasing new furniture. 	PCODE IN02A ADAAG 91 4.32.3 & .4 ADA 2010 306.1 CBC 2007 1122B.3 & 4 CBC 2016 11B-306.1 & 11B-902.3	1	JOB	\$4,800	\$4,800

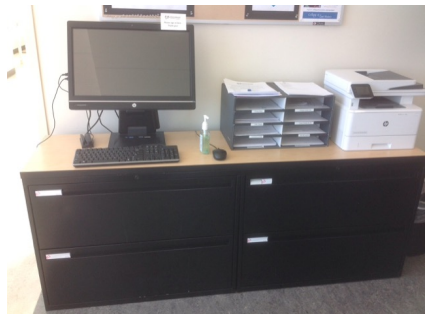
<input type="checkbox"/> Staff Only			
			Priority 2 Severity 2			
213	<ul style="list-style-type: none"> As-Built Description: Accessible non-fixed table or desk (top 28" to 34" high; knee space at least 27" high x 19" deep x 30" wide) not provided. As-Built: No knee space Proposed Solution: Provide table or desk with accessible dimensions when purchasing new furniture. 	PCODE IN02A ADAAG 91 4.32.3 & .4 ADA 2010 306.1 CBC 2007 1122B.3 & 4 CBC 2016 11B-306.1 & 11B-902.3	1	JOB	\$4,800	\$4,800
Mitigated: <input type="radio"/> YES <input checked="" type="radio"/> NO

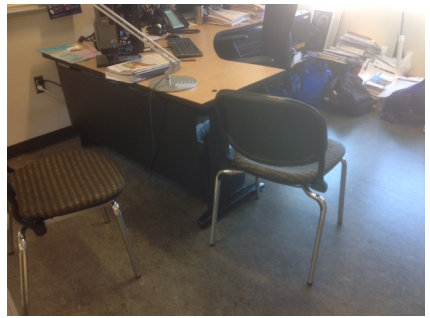
Item no., Rm no. and Name	Existing Architectural Barrier and Proposed Solution	Codes / Mitigation Info	Qty	Unit	Cost	Total
218	<ul style="list-style-type: none"> • <i>As-Built Description:</i> Accessible non-fixed table or desk (top 28" to 34" high; knee space at least 27" high x 19" deep x 30" wide) not provided. • <i>As-Built:</i> No knee clearance if used as work surface. • <i>Proposed Solution:</i> Provide table or desk with accessible dimensions when purchasing new furniture. 	PCODE IN02A ADAAG 91 4.32.3 & .4 ADA 2010 306.1 CBC 2007 1122B.3 & 4 CBC 2016 11B-306.1 & 11B-902.3 Mitigated: <input type="radio"/> YES <input checked="" type="radio"/> NO	22	JOB	\$4,800	\$105,600

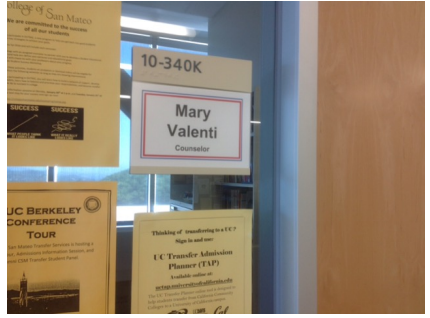
215	<ul style="list-style-type: none"> • <i>As-Built Description:</i> Sign not located on latch side of door and/or not located at 48" min. above to baseline of the lowest Braille cells and 60" max. to baseline of the highest line of raised characters. • <i>As-Built:</i> 63" high • <i>Proposed Solution:</i> Provide compliant signage including tactile characters and Grade II Braille on latch side of door located at compliant height. 	PCODE SA07 ADAAG 91 4.30.6 ADA 2010 703.4.1 CBC 2007 1117B.5.7 Mitigated: <input type="radio"/> YES <input checked="" type="radio"/> NO	25	JOB	\$150	\$3,750

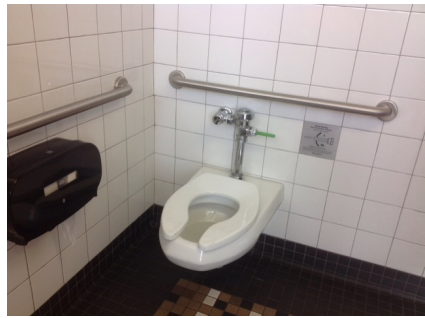
Item no., Rm no. and Name	Existing Architectural Barrier and Proposed Solution	Codes / Mitigation Info	Qty	Unit	Cost	Total
909	<ul style="list-style-type: none"> • <i>As-Built Description:</i> The rear wall grab is less than 36" min. or does not extend from the centerline of the water closet 12" min. on one side and 24" min. on the other side. • <i>As-Built:</i> 22" offset on the wide side • <i>Proposed Solution:</i> Provide or relocate accessible rear grab bar. 	PCODE WB07B ADAAG 91 4.17.6 ADA 2010 604.5.2 CBC 2007 1115B.4.1.3.2 CBC 2016 11B-604.5.2 Mitigated: <input type="radio"/> YES <input checked="" type="radio"/> NO	1	JOB	\$1,020	\$1,020

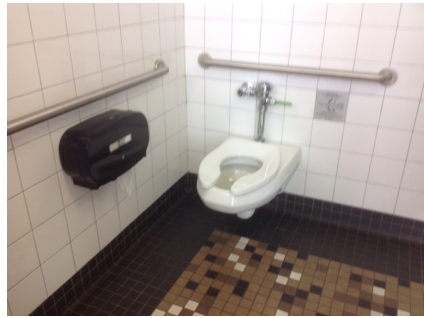
Water Closet

908	<ul style="list-style-type: none"> • <i>As-Built Description:</i> Water closet not 16"-18" (CA: 17"-18") from near side wall to center line of water closet (2010 ADAAG: 16"-18"). • <i>As-Built:</i> 19" o.c. • <i>Proposed Solution:</i> Relocate existing water closet and plumbing, remount with offset closet flange to provide 18" max. from side wall. 	PCODE WB02C ADAAG 91 Fig. 28 ADA 2010 604.2 CBC 2007 1115B.4.1.1 CBC 2016 11B-604.2 Mitigated: <input type="radio"/> YES <input checked="" type="radio"/> NO	1	JOB	\$1,500	\$1,500

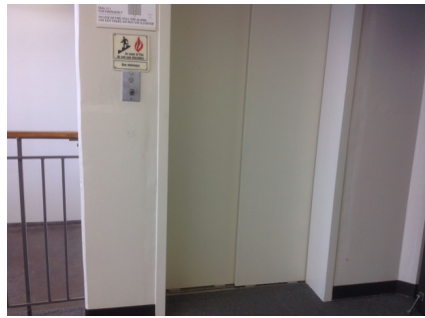
Item no., Rm no. and Name	Existing Architectural Barrier and Proposed Solution	Codes / Mitigation Info	Qty	Unit	Cost	Total
2	<ul style="list-style-type: none"> As-Built Description: Visual hall lantern, minimum 2-1/2" x 2-1/2", not provided, or installed less than 72" above floor. Proposed Solution: Provide or raise proper visual hall lantern for elevator. 	PCODE IK10A ADAAG 91 4.10.4(1) ADA 2010 407.2.2.2 CBC 2007 1116B.1.13 CBC 2016 11B-407.2.2.2 Mitigated: <input type="radio"/> YES <input checked="" type="radio"/> NO	1	JOB	\$4,650	\$4,650

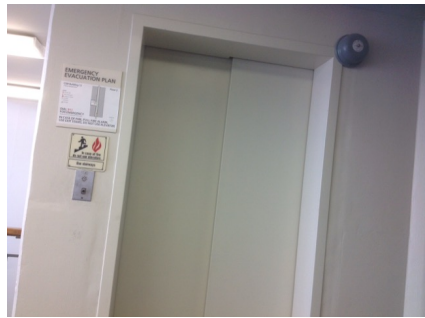
<input type="checkbox"/> Staff Only				
		Priority 2 Severity 3				
981	<ul style="list-style-type: none"> As-Built Description: Audible signal not provided (one for up, two for down). Proposed Solution: Provide proper audible hall signal for elevator. 	PCODE IK10B ADAAG 91 4.10.4 ADA 2010 407.2.2.3 CBC 2007 1116B.1.13 CBC 2016 11B-407.2.2.3 Mitigated: <input type="radio"/> YES <input checked="" type="radio"/> NO	1	JOB	\$4,650	\$4,650

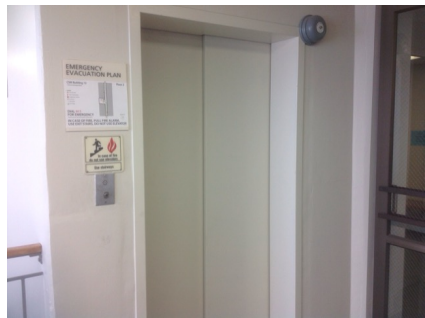
<input type="checkbox"/> Staff Only				
		Priority 2 Severity 3				
978	<ul style="list-style-type: none"> As-Built Description: Braille and raised floor numbers on entrance jambs located more or less than 5' above floor. Proposed Solution: Relocate Braille and raised floor numbers on entrance jambs to 5' above floor. 	PCODE IK11C ADAAG 91 4.10.5 ADA 2010 703.4.1 CBC 2007 1116B.1.14 CBC 2016 11B-703.4.1 Mitigated: <input type="radio"/> YES <input checked="" type="radio"/> NO	4	JOB	\$360	\$1,440

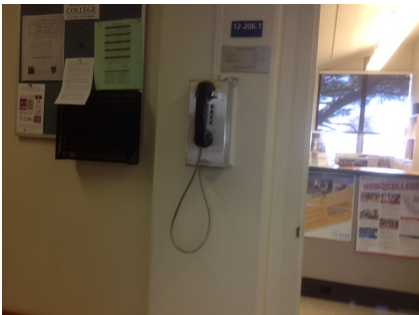
Item no., Rm no. and Name	Existing Architectural Barrier and Proposed Solution	Codes / Mitigation Info	Qty	Unit	Cost	Total
Telephone						
937	<ul style="list-style-type: none">As-Built Description: Telephone mounting height more than 48" to highest operable part of phone if side reach approach is available.As-Built: 55" AFFProposed Solution: Lower telephone enclosure and phone.	PCODE IB02 ADAAG 91 4.2.6 ADA 2010 704.2.2 CBC 2007 1118B.6 CBC 2016 11B-704.2.2 Mitigated: <div><input type="radio"/> YES <input checked="" type="radio"/> NO</div>	1	JOB	\$750	\$750

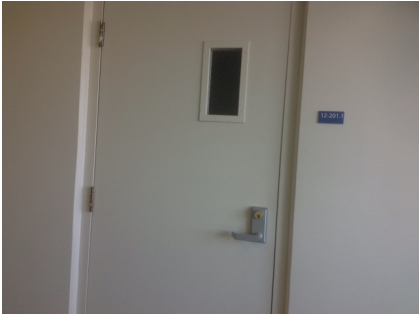
<input type="checkbox"/> Staff Only			
			Priority		Severity	
			2		3	
Door						
933	<ul style="list-style-type: none">As-Built Description: Vision Light at door that permits viewing, does not have bottom of at least one glazed panel located 43 inches maximum above the finish floor. (Exception: More than 66" above finished floor.)As-Built: 60" AFFProposed Solution: Provide new door with vision panel at 43" max.	PCODE ID06C ADA 2010 404.2.11 CBC 2016 11B-404.2.11 Mitigated: <div><input type="radio"/> YES <input checked="" type="radio"/> NO</div>	12	JOB	\$7,500	\$90,000

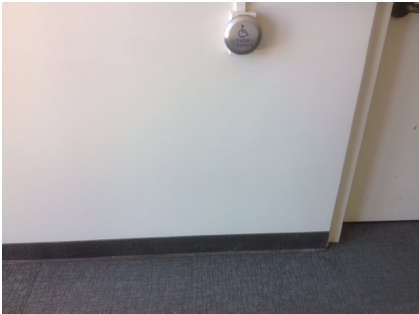
<input type="checkbox"/> Staff Only			
			Priority		Severity	
			2		1	
930	<ul style="list-style-type: none">As-Built Description: Lower push plate located at 7" minimum and 8" maximum above the floor or ground surface not provided.Proposed Solution: Provide lower push plate.Notes: Entrance from courtyard	PCODE ID13B CBC 2007 1133B.2.3.2 CBC 2016 11B-404.2.9 2.C Mitigated: <div><input type="radio"/> YES <input checked="" type="radio"/> NO</div>	1	JOB	\$1,500	\$1,500

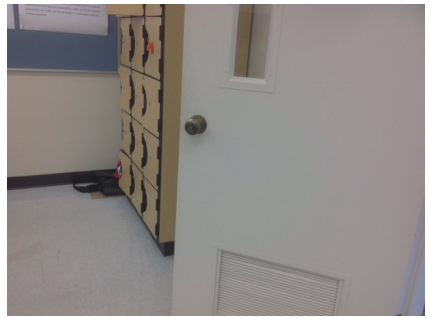
Item no., Rm no. and Name	Existing Architectural Barrier and Proposed Solution	Codes / Mitigation Info	Qty	Unit	Cost	Total
967	<ul style="list-style-type: none"> As-Built Description: Non-common use areas within this facility, such as offices, do not have accessible door hardware. Proposed Solution: Provide lever handle or other accessible hardware when a specific need is identified in the future or when altering area. 	PCODE ID07C ADAAG 91 4.13.9 ADA 2010 404.2.7 CBC 2007 1133B.2.5.2 CBC 2016 11B-404.2.7 Mitigated: <input type="radio"/> YES <input checked="" type="radio"/> NO	1	JOB	\$750	\$750

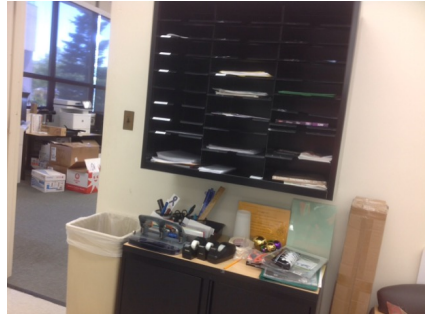
Reach Range

966	<ul style="list-style-type: none"> As-Built Description: Reach height to control or access point, exceeds 48" or is less than 15". As-Built: 56" AFF Proposed Solution: Modify equipment or mounting. 	PCODE IE01 ADAAG 91 4.2.5 ADA 2010 308.2.1 CBC 2007 1118B.5 CBC 2016 11B-308.2.1 Mitigated: <input type="radio"/> YES <input checked="" type="radio"/> NO	1	JOB	\$300	\$300

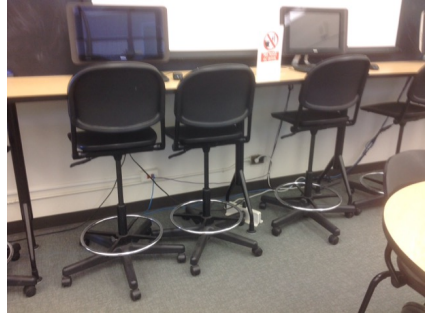
Non-Fixed Desk

961	<ul style="list-style-type: none"> As-Built Description: Accessible non-fixed table or desk (top 28" to 34" high; knee space at least 27" high x 19" deep x 30" wide) not provided. As-Built: 40" AFF Proposed Solution: Provide table or desk with accessible dimensions when purchasing new furniture. 	PCODE IN02A ADAAG 91 4.32.3 & .4 ADA 2010 306.1 CBC 2007 1122B.3 & 4 CBC 2016 11B-306.1 & 11B-902.3 Mitigated: <input type="radio"/> YES <input checked="" type="radio"/> NO	1	JOB	\$4,800	\$4,800

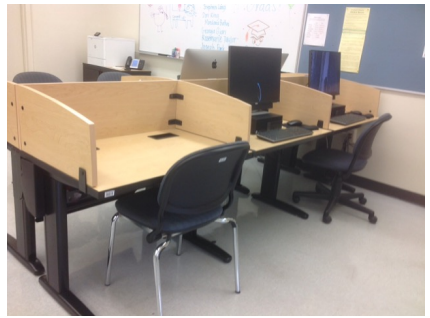
Item no., Rm no. and Name	Existing Architectural Barrier and Proposed Solution	Codes / Mitigation Info	Qty	Unit	Cost	Total
965	<ul style="list-style-type: none"> As-Built Description: Accessible non-fixed table or desk (top 28" to 34" high; knee space at least 27" high x 19" deep x 30" wide) not provided. As-Built: 26" high knee clearance Proposed Solution: Provide table or desk with accessible dimensions when purchasing new furniture. 	PCODE IN02A ADAAG 91 4.32.3 & .4 ADA 2010 306.1 CBC 2007 1122B.3 & 4 CBC 2016 11B-306.1 & 11B-902.3 Mitigated: <input type="radio"/> YES <input checked="" type="radio"/> NO	1	JOB	\$4,800	\$4,800

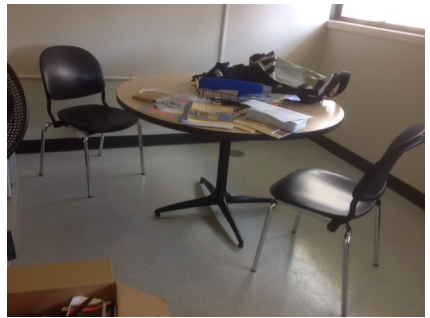
<input type="checkbox"/> Staff Only Priority 2 Severity 2			
971	<ul style="list-style-type: none"> As-Built Description: Accessible non-fixed table or desk (top 28" to 34" high; knee space at least 27" high x 19" deep x 30" wide) not provided. Proposed Solution: Provide table or desk with accessible dimensions when purchasing new furniture. 	PCODE IN02A ADAAG 91 4.32.3 & .4 ADA 2010 306.1 CBC 2007 1122B.3 & 4 CBC 2016 11B-306.1 & 11B-902.3 Mitigated: <input type="radio"/> YES <input checked="" type="radio"/> NO	1	JOB	\$4,800	\$4,800

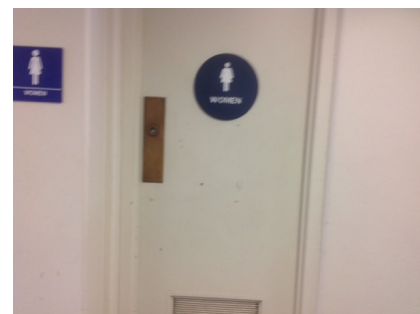
Multiple accommodation restroom not accessible; multiple compliance violations.

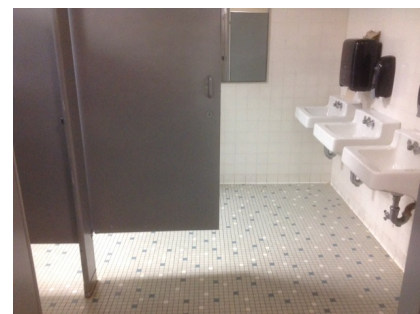
Multiple accommodation restroom not accessible;
multiple compliance violations.

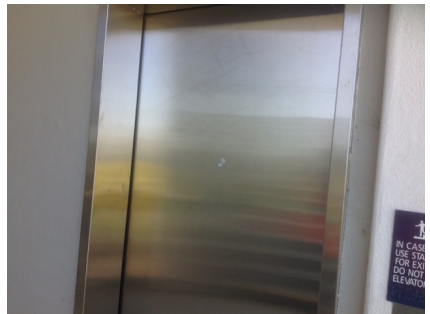
Item no., Rm no. and Name	Existing Architectural Barrier and Proposed Solution	Codes / Mitigation Info	Qty	Unit	Cost	Total
445	<ul style="list-style-type: none">• <i>As-Built Description:</i> Braille and raised floor numbers on entrance jambs located more or less than 5' above floor.• <i>Proposed Solution:</i> Relocate Braille and raised floor numbers on entrance jambs to 5' above floor.	<i>PCODE</i> IK11C <i>ADAAG 91</i> 4.10.5 <i>ADA 2010</i> 703.4.1 <i>CBC 2007</i> 1116B.1.14 <i>CBC 2016</i> 11B-703.4.1 Mitigated: <input type="radio"/> YES <input checked="" type="radio"/> NO	4	JOB	\$360	\$1,440

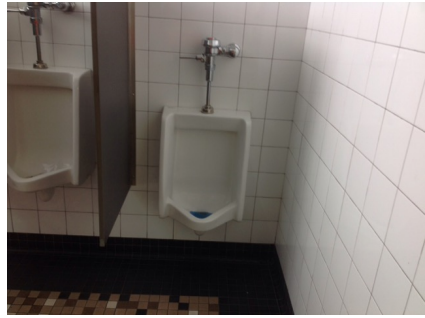
514	<ul style="list-style-type: none"> As-Built Description: Fixture mounted with rim more than 17" above floor. As-Built: 18" AFF Proposed Solution: Provide accessible urinal. Remodel restroom as needed. 	PCODE WE02 ADAAG 91 4.18.2 ADA 2010 605.2 CBC 2007 1115B.4.2.1 CBC 2016 11B-605.2 Mitigated: <input type="radio"/> YES <input checked="" type="radio"/> NO	1	JOB	\$7,200	\$7,200

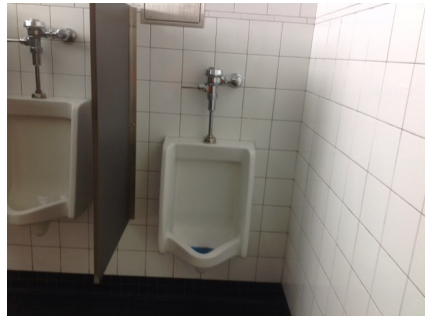
<input type="checkbox"/> Staff Only Priority 3 Severity 4						
515	<ul style="list-style-type: none"> As-Built Description: Urinal flush control lever more than 48" above floor. (CA Only: 44" max.) As-Built: 46" AFF Proposed Solution: Provide accessible urinal flush control. 	PCODE WE03 ADAAG 91 4.18.4 ADA 2010 605.4 CBC 2007 1115B.4.2.2 CBC 2016 11B-605.4 Mitigated: <input type="radio"/> YES <input checked="" type="radio"/> NO	1	JOB	\$1,500	\$1,500

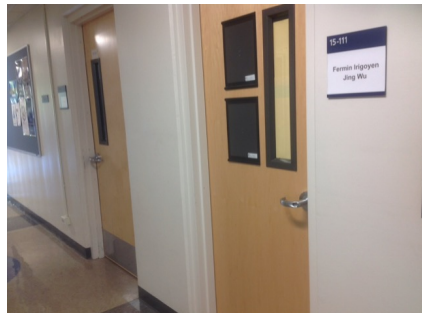
Item no., Rm no. and Name	Existing Architectural Barrier and Proposed Solution	Codes / Mitigation Info	Qty	Unit	Cost	Total
Door						
403	<ul style="list-style-type: none">As-Built Description: Vision Light at door that permits viewing, does not have bottom of at least one glazed panel located 43 inches maximum above the finish floor. (Exception: More than 66" above finished floor.)As-Built: 48" high AFFProposed Solution: Provide new door with vision panel at 43" max.	PCODE ID06C ADA 2010 404.2.11 CBC 2016 11B-404.2.11 Mitigated: <div><input type="radio"/> YES</div> <div><input checked="" type="radio"/> NO</div>	8	JOB	\$7,500	\$60,000

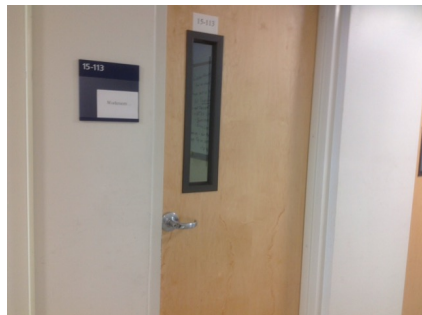
<div><input type="checkbox"/> Staff Only</div> <div><div>Priority</div><div>2</div><div>Severity</div><div>4</div></div>			
Signage						
402	<ul style="list-style-type: none">As-Built Description: Signs containing tactile characters is not located so that a clear floor space of 18" min x 18" min., centered on the tactile characters, is provided beyond the arc of any door swing between the closed position and 45 degree open position.As-Built: 63" AFFProposed Solution: Relocate compliant signage on latch side of door located at compliant height with a clear floor space.	PCODE SA07B ADA 2010 703.4.2 CBC 2016 11B-703.4.2 Mitigated: <div><input type="radio"/> YES</div> <div><input checked="" type="radio"/> NO</div>	7	JOB	\$150	\$1,050

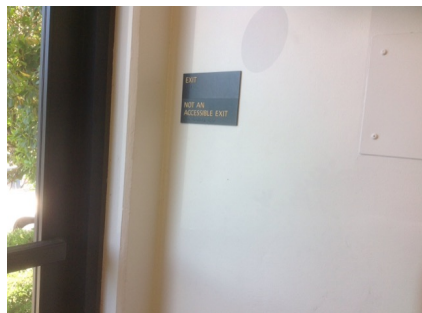
<div><input type="checkbox"/> Staff Only</div> <div><div>Priority</div><div>2</div><div>Severity</div><div>4</div></div>			
400	<ul style="list-style-type: none">As-Built Description: Braille symbols: dots are not 1/10" on centers in each cell with 2/10" space between cells.Proposed Solution: CA only - Provide new compliant signage including Contracted Grade 2 Braille with Title 24 spacing requirements - 1/10" on center dots with 2/10" space between cells.	PCODE SA07C CBC 2007 1117B.5.6 CBC 2016 11B-703.3 Mitigated: <div><input type="radio"/> YES</div> <div><input checked="" type="radio"/> NO</div>	1	JOB	\$450	\$450

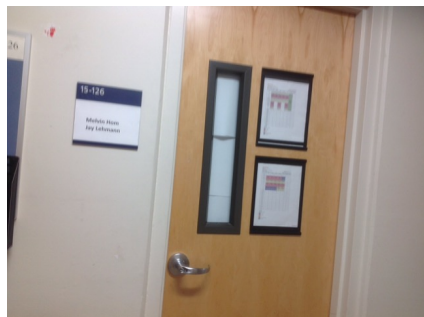
418	<ul style="list-style-type: none"> • <i>As-Built Description:</i> Signs containing tactile characters is not located so that a clear floor space of 18" min x 18" min., centered on the tactile characters, is provided beyond the arc of any door swing between the closed position and 45 degree open position. • <i>As-Built:</i> 63" AFF • <i>Proposed Solution:</i> Relocate compliant signage on latch side of door located at compliant height with a clear floor space. 	PCODE SA07B ADA 2010 703.4.2 CBC 2016 11B-703.4.2 Mitigated: <input type="radio"/> YES <input checked="" type="radio"/> NO	16	JOB	\$150	\$2,400

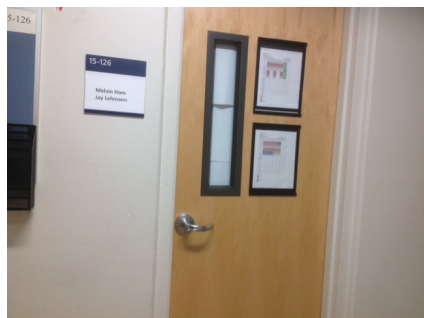
<input type="checkbox"/> Staff Only Priority 2 Severity 4						
419	<ul style="list-style-type: none"> • <i>As-Built Description:</i> Braille symbols: dots are not 1/10" on centers in each cell with 2/10" space between cells. • <i>As-Built:</i> AFF • <i>Proposed Solution:</i> CA only - Provide new compliant signage including Contracted Grade 2 Braille with Title 24 spacing requirements - 1/10" on center dots with 2/10" space between cells. 	PCODE SA07C CBC 2007 1117B.5.6 CBC 2016 11B-703.3 Mitigated: <input type="radio"/> YES <input checked="" type="radio"/> NO	16	JOB	\$450	\$7,200

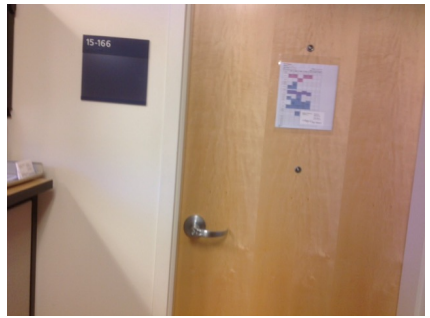
Item no., Rm no. and Name	Existing Architectural Barrier and Proposed Solution	Codes / Mitigation Info	Qty	Unit	Cost	Total
432	<ul style="list-style-type: none">• <i>As-Built Description:</i> Braille symbols: dots are not 1/10" on centers in each cell with 2/10" space between cells.• <i>Proposed Solution:</i> CA only - Provide new compliant signage including Contracted Grade 2 Braille with Title 24 spacing requirements - 1/10" on center dots with 2/10" space between cells.	<p>PCODE SA07C</p> <p>CBC 2007 1117B.5.6</p> <p>CBC 2016 11B-703.3</p> <p>Mitigated:</p> <p><input type="radio"/> YES</p> <p><input checked="" type="radio"/> NO</p>	1	JOB	\$450	\$450

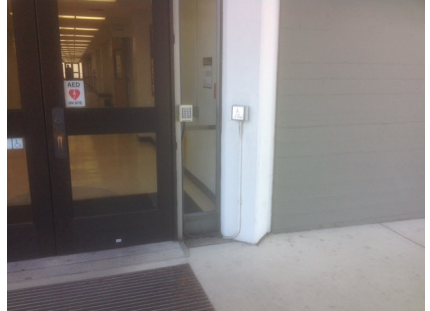
Item no., Rm no. and Name	Existing Architectural Barrier and Proposed Solution	Codes / Mitigation Info	Qty	Unit	Cost	Total
Door						
322	<ul style="list-style-type: none"> <i>As-Built Description:</i> Lower push plate located at 7" minimum and 8" maximum above the floor or ground surface not provided. <i>Proposed Solution:</i> Provide lower push plate. 	PCODE ID13B CBC 2007 1133B.2.3.2 CBC 2016 11B-404.2.9 2.C Mitigated: <input type="radio"/> YES <input checked="" type="radio"/> NO	2	JOB	\$1,500	\$3,000

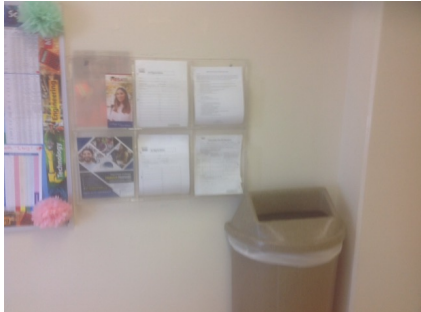
Item no., Rm no. and Name	Existing Architectural Barrier and Proposed Solution	Codes / Mitigation Info	Qty	Unit	Cost	Total
Brochure Bins						
323	<ul style="list-style-type: none">As-Built Description: Information brochure bins mounted above accessible height of 48".As-Built: 55" AFFProposed Solution: Relocate/remount bins at accessible height.	PCODE IN08 ADAAG 91 4.2.5 & 6 ADA 2010 308.2.1 CBC 2007 1118B.5 CBC 2016 11B-308.2.1	1	JOB	\$300	\$300

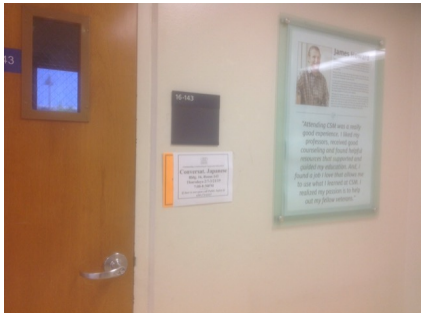
<input type="checkbox"/> Staff Only			
			Priority 2 Severity 3			
Signage						
329	<ul style="list-style-type: none">As-Built Description: Signs containing tactile characters is not located so that a clear floor space of 18" min x 18" min., centered on the tactile characters, is provided beyond the arc of any door swing between the closed position and 45 degree open position.As-Built: 61" AFFProposed Solution: Relocate compliant signage on latch side of door located at compliant height with a clear floor space.	PCODE SA07B ADA 2010 703.4.2 CBC 2016 11B-703.4.2	15	JOB	\$150	\$2,250

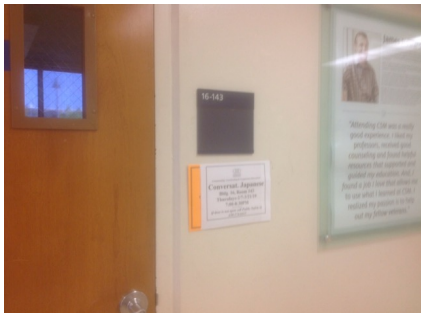
<input type="checkbox"/> Staff Only			
			Priority 2 Severity 4			
330	<ul style="list-style-type: none">As-Built Description: Braille symbols: dots are not 1/10" on centers in each cell with 2/10" space between cells.Proposed Solution: CA only - Provide new compliant signage including Contracted Grade 2 Braille with Title 24 spacing requirements - 1/10" on center dots with 2/10" space between cells.	PCODE SA07C CBC 2007 1117B.5.6 CBC 2016 11B-703.3	16	JOB	\$450	\$7,200

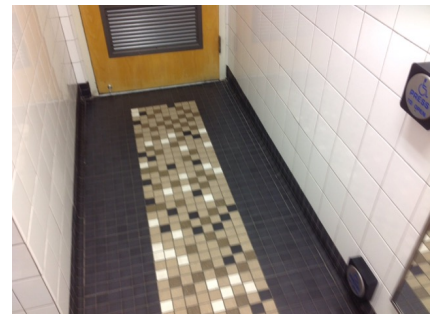
- *As-Built Description:*
Clear passage width (except doorways) from rest room entry to accessible water closet compartment less than 36" (CA only: 44" wide).
- *As-Built:* **43" wide**
- *Proposed Solution:*
Modify facility passage to be min. 44" wide.
Demolish existing partition and replace.

PCODE WC02A
 ADAAG 91 4.3.3
 ADA 2010 403.5.1
 CBC 2007 1115B.3.2.4
 CBC 2016 11B-403.5.1

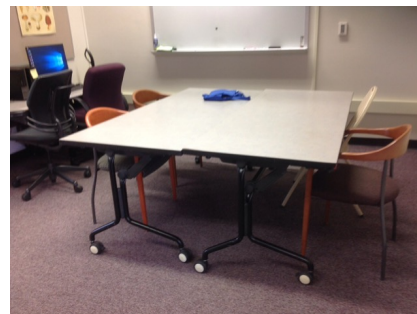
Item no., Rm no. and Name	Existing Architectural Barrier and Proposed Solution	Codes / Mitigation Info	Qty	Unit	Cost	Total
354	<ul style="list-style-type: none"> As-Built Description: Accessible non-fixed table or desk (top 28" to 34" high; knee space at least 27" high x 19" deep x 30" wide) not provided. As-Built: 26" high knee clearance Proposed Solution: Provide table or desk with accessible dimensions when purchasing new furniture. 	PCODE IN02A ADAAG 91 4.32.3 & .4 ADA 2010 306.1 CBC 2007 112B.3 & 4 CBC 2016 11B-306.1 & 11B-902.3 Mitigated: <input type="radio"/> YES <input checked="" type="radio"/> NO	1	JOB	\$4,800	\$4,800

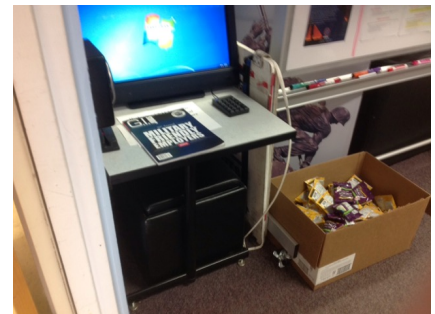
Item no., Rm no. and Name	Existing Architectural Barrier and Proposed Solution	Codes / Mitigation Info	Qty	Unit	Cost	Total
359	<ul style="list-style-type: none"> • <i>As-Built Description:</i> Accessible non-fixed table or desk (top 28" to 34" high; knee space at least 27" high x 19" deep x 30" wide) not provided. • <i>As-Built:</i> 12" knee depth • <i>Proposed Solution:</i> Provide table or desk with accessible dimensions when purchasing new furniture. 	PCODE IN02A ADAAG 91 4.32.3 & .4 ADA 2010 306.1 CBC 2007 112B.3 & 4 CBC 2016 11B-306.1 & 11B-902.3 Mitigated: <input type="radio"/> YES <input checked="" type="radio"/> NO	1	JOB	\$4,800	\$4,800

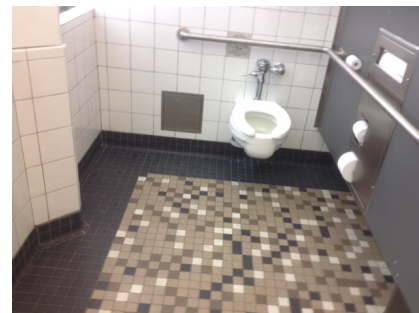
382

- *As-Built Description:*
Clear passage width (except doorways) from rest room entry to accessible water closet compartment less than 36" (CA only: 44" wide).
- *As-Built:* **41" - 43" wide**
- *Proposed Solution:*
Modify facility passage to be min. 44" wide.
Demolish existing partition and replace.

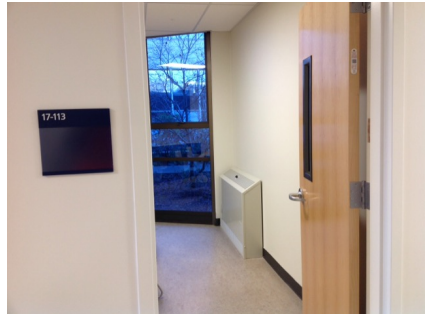
17	<ul style="list-style-type: none"> As-Built Description: Vision Light at door that permits viewing, does not have bottom of at least one glazed panel located 43 inches maximum above the finish floor. (Exception: More than 66" above finished floor.) As-Built: 44.5" high Proposed Solution: Provide new door with vision panel at 43" max. Notes: Located where vision panels in wall are not provided. When glass panels are provided adjacent to the door, we believe it is equivalent as a vision panel. 	PCODE ID06C ADA 2010 404.2.11 CBC 2016 11B-404.2.11	5	JOB	\$7,500	\$37,500
		Mitigated: <input type="radio"/> YES <input checked="" type="radio"/> NO

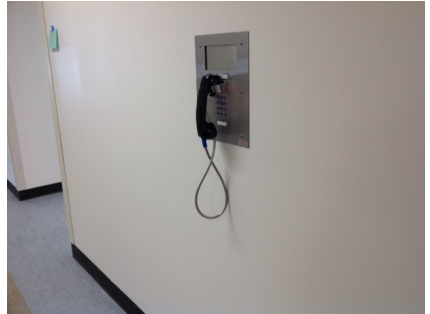
18	<ul style="list-style-type: none"> As-Built Description: Reach height to control or access point, exceeds 48" or is less than 15". As-Built: 49" high to top buttons Proposed Solution: Modify equipment or mounting. 	PCODE IE01 ADAAG 91 4.2.5 ADA 2010 308.2.1 CBC 2007 1118B.5 CBC 2016 11B-308.2.1	1	JOB	\$300	\$300
		Mitigated: <input type="radio"/> YES <input checked="" type="radio"/> NO

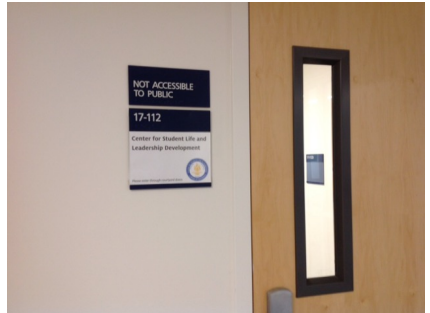
47	<ul style="list-style-type: none"> As-Built Description: Signs containing tactile characters is not located so that a clear floor space of 18" min x 18" min., centered on the tactile characters, is provided beyond the arc of any door swing between the closed position and 45 degree open position. As-Built: 64" high Proposed Solution: Relocate compliant signage on latch side of door located at compliant height with a clear floor space. 	PCODE SA07B ADA 2010 703.4.2 CBC 2016 11B-703.4.2	1	JOB	\$150	\$150
		Mitigated: <input type="radio"/> YES <input checked="" type="radio"/> NO

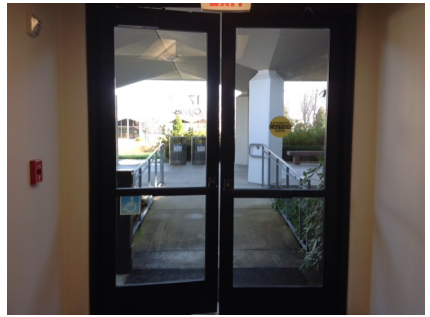
Item no., Rm no. and Name	Existing Architectural Barrier and Proposed Solution	Codes / Mitigation Info	Qty	Unit	Cost	Total
14	<ul style="list-style-type: none"> As-Built Description: At final exit door to exterior: Where required exit signs are installed, signs to provide exiting information for people with vision impairment are not provided. Proposed Solution: Provide raised letter/Braille "EXIT" sign at door. 	PCODE SA10A ADAAG 91 4.1.3(16) ADA 2010 216.4.1 CBC 2007 1011.3 CBC 2016 11B-216.4.1 Mitigated: <input type="radio"/> YES <input checked="" type="radio"/> NO	4	JOB	\$270	\$1,080

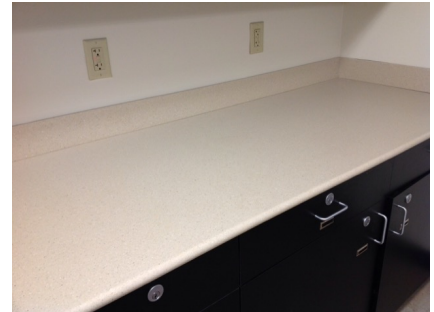
- 22 • *As-Built Description:*
Reach height to control or access point, where side approach is available, exceeds 48" or is less than 15" in height, or exceeds 10" in depth.
- *As-Built:* **27" deep to outlet.**
- *Proposed Solution:*
Modify equipment or mounting.

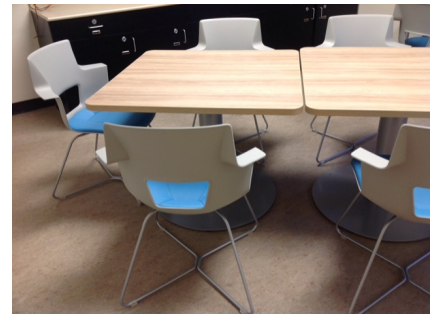
- 19 • *As-Built Description:*
Accessible non-fixed table or desk (top 28" to 34" high; knee space at least 27" high x 19" deep x 30" wide) not provided.
- *Proposed Solution:*
Provide table or desk with accessible dimensions when purchasing new furniture.

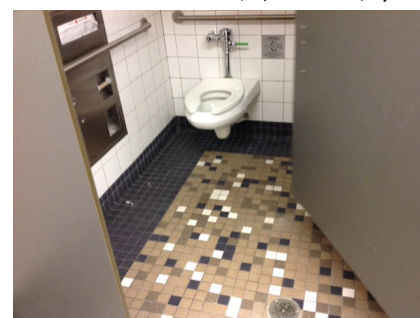
- 29
- **As-Built Description:**
Less than 59" from back wall to front wall or door swing of toilet stall, or less than 56" if water closet is wall-hung.
 - **As-Built:** **49" in front of toilet.**
 - **Proposed Solution:**
Reverse swing of stall door to mitigate the issue.

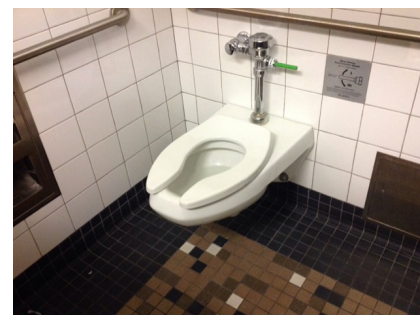
- 30
- **As-Built Description:**
Water closet not 16"-18" (CA: 17"-18") from near side wall to center line of water closet (2010 ADAAG: 16"-18").
 - **As-Built:** **18.5" o.c.**
 - **Proposed Solution:**
Relocate existing water closet and plumbing, remount with offset closet flange to provide 18" max. from side wall.

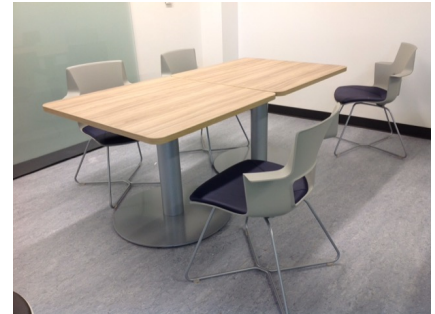
Item no., Rm no. and Name	Existing Architectural Barrier and Proposed Solution	Codes / Mitigation Info	Qty	Unit	Cost	Total
37	<ul style="list-style-type: none"> As-Built Description: Accessible non-fixed table or desk (top 28" to 34" high; knee space at least 27" high x 19" deep x 30" wide) not provided. Proposed Solution: Provide table or desk with accessible dimensions when purchasing new furniture. 	PCODE IN02A ADAAG 91 4.32.3 & .4 ADA 2010 306.1 CBC 2007 1122B.3 & 4 CBC 2016 11B-306.1 & 11B-902.3 Mitigated: <input type="radio"/> YES <input checked="" type="radio"/> NO	1	JOB	\$4,800	\$4,800

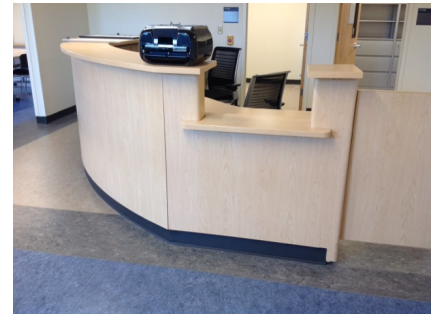
33	<ul style="list-style-type: none"> As-Built Description: Service counter (stand-up): Accessible section min. 36" length and 36" max. height (in CA: 28" to 34" high) not provided. As-Built: 33" total width, 24" opening Proposed Solution: Retrofit existing counter to provide accessible section. Interim solution: Provide auxiliary counter, table, or clipboard. 	PCODE IN03 ADAAG 91 7.2(2) ADA 2010 904.4 CBC 2007 1122B.4 CBC 2016 11B-904.4 Mitigated: <input type="radio"/> YES <input checked="" type="radio"/> NO	1	JOB	\$6,000	\$6,000
----	--	--	---	-----	---------	---------

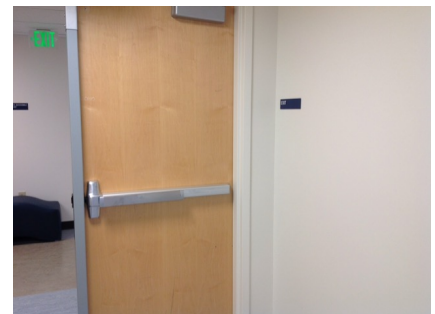
48	<ul style="list-style-type: none"> As-Built Description: At door leading into exit corridor: Where required exit signs are installed, signs to provide exiting information for people with vision impairment are not provided. Proposed Solution: Provide raised letter/Braille "EXIT ROUTE" sign at door. Notes: Signage depicts "EXIT". It should say "EXIT ROUTE". 	PCODE SA10D ADAAG 91 4.1.3(16) ADA 2010 216.4.1 CBC 2007 1011.3 CBC 2016 11B-216.4.1 Mitigated: <input type="radio"/> YES <input checked="" type="radio"/> NO	1	JOB	\$270	\$270
----	--	---	---	-----	-------	-------

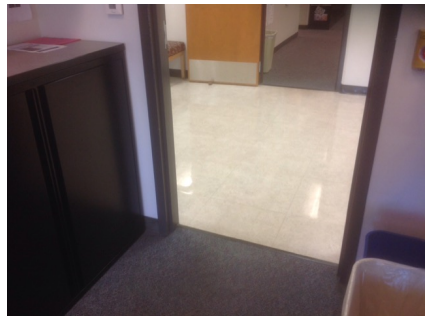
Item no., Rm no. and Name	Existing Architectural Barrier and Proposed Solution	Codes / Mitigation Info	Qty	Unit	Cost	Total
260	<ul style="list-style-type: none"> • As-Built Description: Front approach: At push side, door does not have clear and level maneuvering space measuring door width x 48" (door width plus 12" if door has both, latch and closer). • As-Built: 4" strike side clearance • Proposed Solution: Remove or relocate furniture or storage items. 	PCODE ID24A ADAAG 91 Fig. 25(a) ADA 2010 404.2.4 CBC 2007 11B-26A(a) CBC 2016 11B-404.2.4 Mitigated: <input type="radio"/> YES <input checked="" type="radio"/> NO	1	JOB	\$150	\$150

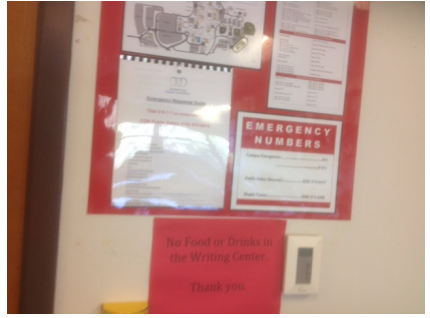
265	<ul style="list-style-type: none"> • As-Built Description: Reach height to control or access point, exceeds 48" or is less than 15". • As-Built: 56" AFF • Proposed Solution: Modify equipment or mounting. 	PCODE IE01 ADAAG 91 4.2.5 ADA 2010 308.2.1 CBC 2007 1118B.5 CBC 2016 11B-308.2.1 Mitigated: <input type="radio"/> YES <input checked="" type="radio"/> NO	1	JOB	\$300	\$300

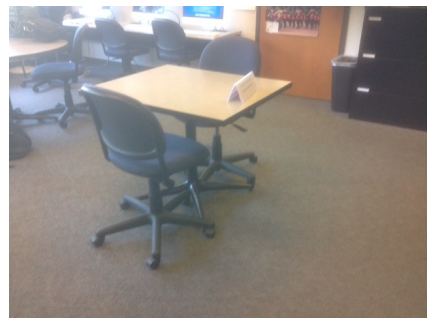
Item no., Rm no. and Name	Existing Architectural Barrier and Proposed Solution	Codes / Mitigation Info	Qty	Unit	Cost	Total
262	<ul style="list-style-type: none">• As-Built Description: Accessible non-fixed table or desk (top 28" to 34" high; knee space at least 27" high x 19" deep x 30" wide) not provided.• Proposed Solution: Provide table or desk with accessible dimensions when purchasing new furniture.• Notes: 6 tables, no accessible table provided	<p>PCODE IN02A</p> <p>ADAAG 91 4.32.3 & .4</p> <p>ADA 2010 306.1</p> <p>CBC 2007 1122B.3 & 4</p> <p>CBC 2016 11B-306.1 & 11B-902.3</p> <p>Mitigated:</p> <p><input type="radio"/> YES</p> <p><input checked="" type="radio"/> NO</p>	1	JOB	\$4,800	\$4,800

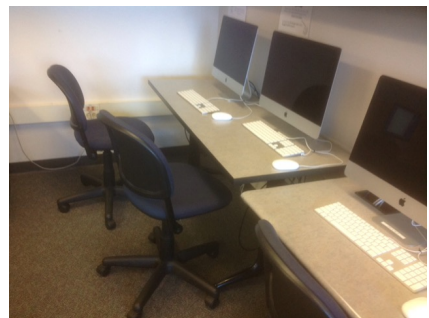
<input type="checkbox"/> Staff Only			
			Priority		Severity	
			2		2	
267	<ul style="list-style-type: none">• As-Built Description: Accessible non-fixed table or desk (top 28" to 34" high; knee space at least 27" high x 19" deep x 30" wide) not provided.• Proposed Solution: Provide table or desk with accessible dimensions when purchasing new furniture.• Notes: Quiet Room. 28 stations total, 1 accessible table provided. One additional is required.	<p>PCODE IN02A</p> <p>ADAAG 91 4.32.3 & .4</p> <p>ADA 2010 306.1</p> <p>CBC 2007 1122B.3 & 4</p> <p>CBC 2016 11B-306.1 & 11B-902.3</p> <p>Mitigated:</p> <p><input type="radio"/> YES</p> <p><input checked="" type="radio"/> NO</p>	1	JOB	\$4,800	\$4,800

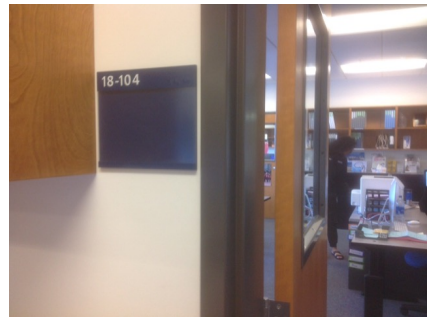
<input type="checkbox"/> Staff Only			
			Priority		Severity	
			2		2	
Signage						
263	<ul style="list-style-type: none">• As-Built Description: Signs containing tactile characters is not located so that a clear floor space of 18" min x 18" min., centered on the tactile characters, is provided beyond the arc of any door swing between the closed position and 45 degree open position.• As-Built: 63" AFF• Proposed Solution: Relocate compliant signage on latch side of door located at compliant height with a clear floor space.	<p>PCODE SA07B</p> <p>ADA 2010 703.4.2</p> <p>CBC 2016 11B-703.4.2</p> <p>Mitigated:</p> <p><input type="radio"/> YES</p> <p><input checked="" type="radio"/> NO</p>	2	JOB	\$150	\$300

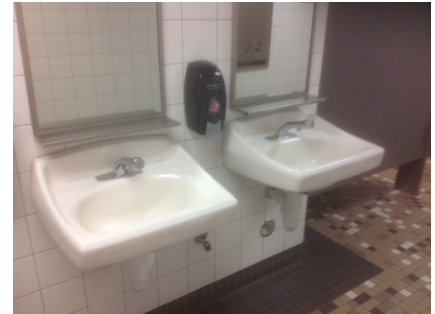
Item no., Rm no. and Name	Existing Architectural Barrier and Proposed Solution	Codes / Mitigation Info	Qty	Unit	Cost	Total
276	<ul style="list-style-type: none"> As-Built Description: Bottom of mirror located above lavatories or countertops more than 40" above floor. As-Built: 41" AFF Proposed Solution: Relocate or provide new accessible mirror. 	PCODE WG03 ADAAG 91 4.19.6 ADA 2010 603.3 CBC 2007 1115B.8.1 CBC 2016 11B-603.3 Mitigated: <input type="radio"/> YES <input checked="" type="radio"/> NO	1	JOB	\$450	\$450

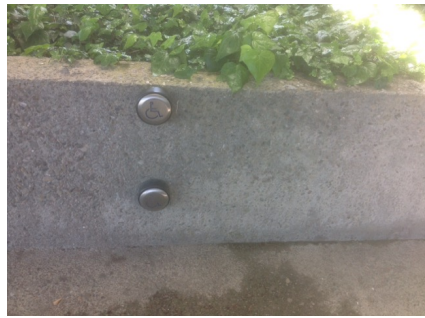
Item no., Rm no. and Name	Existing Architectural Barrier and Proposed Solution	Codes / Mitigation Info	Qty	Unit	Cost	Total
472	<ul style="list-style-type: none"> As-Built Description: High push plate located at 30" minimum and 44" maximum above the floor or ground surface not provided. As-Built: 28" high o.c. Proposed Solution: Provide higher push plate. 	PCODE ID13E CBC 2007 1133B.2.3.2 CBC 2016 11B-404.2.9 2.C Mitigated: <input type="radio"/> YES <input checked="" type="radio"/> NO	1	JOB	\$1,500	\$1,500

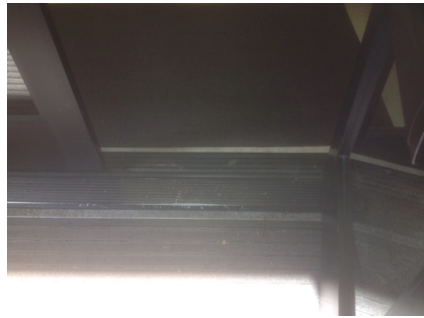
278	<ul style="list-style-type: none"> As-Built Description: Door inaccessible due to threshold or step at door exceeding 1/2". As-Built: 0.75" high Proposed Solution: Modify threshold to be no more than 1/2" by removing existing paving at door and providing landing with edge ramping (slope 1:20 max). 	PCODE ID02A ADAAG 91 4.13.8 ADA 2010 404.2.5 CBC 2007 1133B.2.4.1 CBC 2016 11B-404.2.5 Mitigated: <input type="radio"/> YES <input checked="" type="radio"/> NO	1	JOB	\$1,200	\$1,200

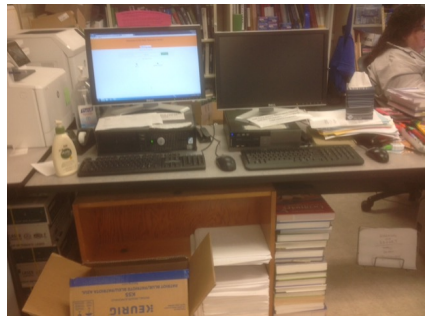
Item no., Rm no. and Name	Existing Architectural Barrier and Proposed Solution	Codes / Mitigation Info	Qty	Unit	Cost	Total
290	<ul style="list-style-type: none"> As-Built Description: Accessible non-fixed table or desk (top 28" to 34" high; knee space at least 27" high x 19" deep x 30" wide) not provided. As-Built: No knee clearance provided Proposed Solution: Provide table or desk with accessible dimensions when purchasing new furniture. 	PCODE IN02A ADAAG 91 4.32.3 & .4 ADA 2010 306.1 CBC 2007 1122B.3 & 4 CBC 2016 11B-306.1 & 11B-902.3 Mitigated: <input type="radio"/> YES <input checked="" type="radio"/> NO	1	JOB	\$4,800	\$4,800
