SMCCCD - College of San Mateo

Appendix L: Facilities

Access Compliance Survey Report

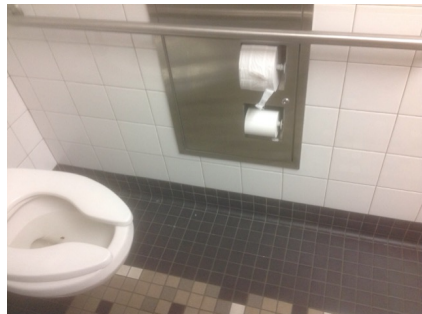
Item no., Rm no. and Name	Existing Architectural Barrier and Proposed Solution	Codes / Mitigation Info	Qty	Unit	Cost	Total
296	<ul style="list-style-type: none"> As-Built Description: Toilet paper dispenser less than 15" (CA: 19") or more than 48" above floor or not within 7" to 9" from front of water closet (Note: CA pre-2010 is allowed within 12" from front of water closet). As-Built: 12" o.c. Proposed Solution: Relocate or provide new toilet paper dispenser. 	PCODE WG02 ADAAG 91 4.16.6 ADA 2010 604.7 CBC 2007 1115B.8.4 CBC 2016 11B-604.7 Mitigated: <input type="radio"/> YES <input checked="" type="radio"/> NO	1	JOB	\$225	\$225

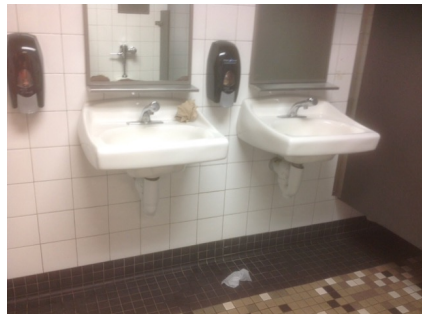
<input type="checkbox"/> Staff Only Priority Severity <div>3 3</div>			
294	<ul style="list-style-type: none"> As-Built Description: Bottom of mirror located above lavatories or countertops more than 40" above floor. As-Built: 41" AFF Proposed Solution: Relocate or provide new accessible mirror. 	PCODE WG03 ADAAG 91 4.19.6 ADA 2010 603.3 CBC 2007 1115B.8.1 CBC 2016 11B-603.3 Mitigated: <input type="radio"/> YES <input checked="" type="radio"/> NO	1	JOB	\$450	\$450

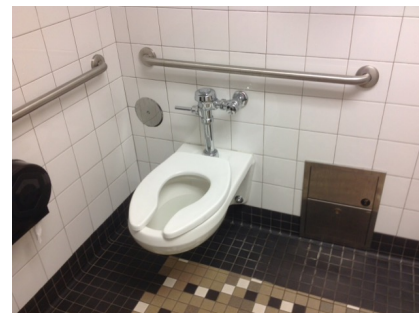
CBC 2016 11B-604.6

Replace flush control with properly mounted accessible type, or install sensor flush.

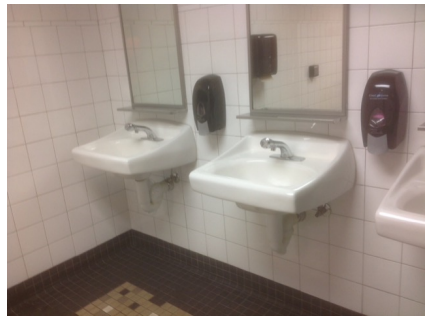
Item no., Rm no. and Name	Existing Architectural Barrier and Proposed Solution	Codes / Mitigation Info	Qty	Unit	Cost	Total
310	<ul style="list-style-type: none"> As-Built Description: Bottom of mirror located above lavatories or countertops more than 40" above floor. As-Built: 41" AFF Proposed Solution: Relocate or provide new accessible mirror. 	PCODE WG03 ADAAG 91 4.19.6 ADA 2010 603.3 CBC 2007 1115B.8.1 CBC 2016 11B-603.3 Mitigated: <input type="radio"/> YES <input checked="" type="radio"/> NO	1	JOB	\$450	\$450

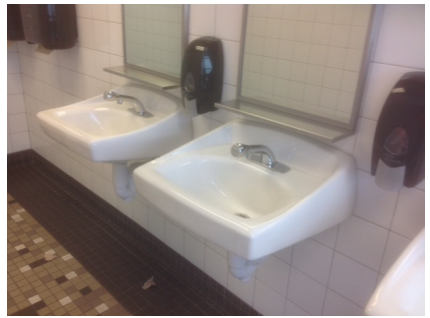
Item no., Rm no. and Name	Existing Architectural Barrier and Proposed Solution	Codes / Mitigation Info	Qty	Unit	Cost	Total
314	<ul style="list-style-type: none"> As-Built Description: Bottom of mirror located above lavatories or countertops more than 40" above floor. As-Built: 41" AFF Proposed Solution: Relocate or provide new accessible mirror. 	PCODE WG03 ADAAG 91 4.19.6 ADA 2010 603.3 CBC 2007 1115B.8.1 CBC 2016 11B-603.3	1	JOB	\$450	\$450
<div>

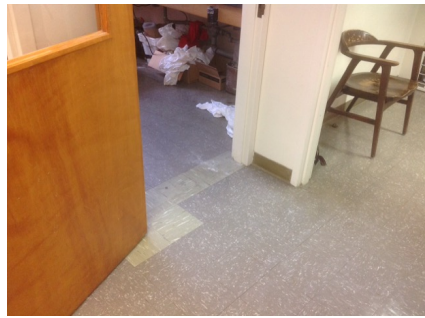
Item no., Rm no. and Name	Existing Architectural Barrier and Proposed Solution	Codes / Mitigation Info	Qty	Unit	Cost	Total
313	<ul style="list-style-type: none"> As-Built Description: Front approach: At pull side, door does not have clear and level maneuvering space measuring door width plus 18" x 60". (24" x 60" at exterior doors). As-Built: 13" deep Proposed Solution: Provide power door operator. 	PCODE ID23C ADAAG 91 Fig. 25(a) ADA 2010 404.2.4 CBC 2007 11B-26A(a) CBC 2016 11B-404.2.4 Mitigated: <input type="radio"/> YES <input checked="" type="radio"/> NO	1	JOB	\$15,000	\$15,000

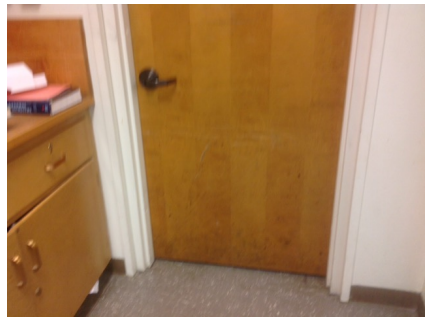
<input type="checkbox"/> Staff Only Priority 2 Severity 4						
319	<ul style="list-style-type: none"> As-Built Description: Front approach: At push side, door does not have clear and level maneuvering space measuring door width x 48" (door width plus 12" if door has both, latch and closer). As-Built: 4" strike side clearance Proposed Solution: Remove or relocate furniture or storage items. 	PCODE ID24A ADAAG 91 Fig. 25(a) ADA 2010 404.2.4 CBC 2007 11B-26A(a) Mitigated: <input type="radio"/> YES <input checked="" type="radio"/> NO	1	JOB	\$150	\$150

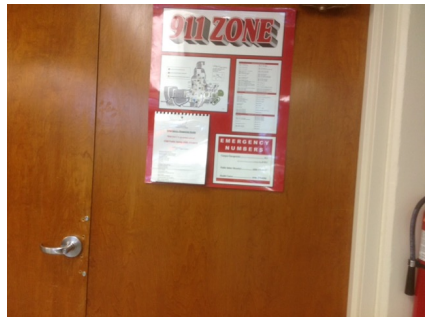
<input type="checkbox"/> Staff Only Priority 4 Severity 2						
Reach Range						
306	<ul style="list-style-type: none"> As-Built Description: Reach height to control or access point, exceeds 48" or is less than 15". As-Built: 54" high Proposed Solution: Modify equipment or mounting. 	PCODE IE01 ADAAG 91 4.2.5 ADA 2010 308.2.1 CBC 2007 1118B.5 CBC 2016 11B-308.2.1 Mitigated: <input type="radio"/> YES <input checked="" type="radio"/> NO	1	JOB	\$300	\$300

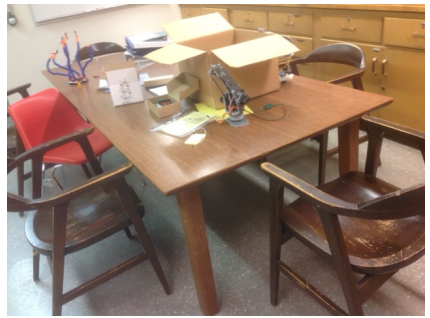
Item no., Rm no. and Name	Existing Architectural Barrier and Proposed Solution	Codes / Mitigation Info	Qty	Unit	Cost	Total
318	<ul style="list-style-type: none"> As-Built Description: Accessible non-fixed table or desk (top 28" to 34" high; knee space at least 27" high x 19" deep x 30" wide) not provided. As-Built: 25" AFF knee height Proposed Solution: Provide table or desk with accessible dimensions when purchasing new furniture. 	PCODE IN02A ADAAG 91 4.32.3 & .4 ADA 2010 306.1 CBC 2007 1122B.3 & 4 CBC 2016 11B-306.1 & 11B-902.3	1	JOB	\$4,800	\$4,800

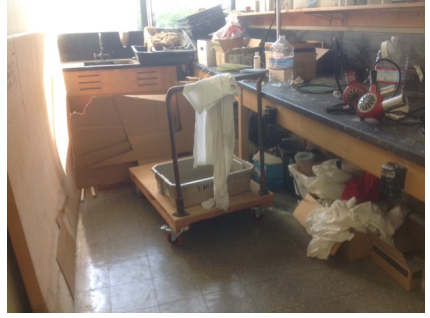
312	<ul style="list-style-type: none"> As-Built Description: Service counter (stand-up): Accessible section min. 36" length and 36" max. height (in CA: 28" to 34" high) not provided. As-Built: 36" AFF Proposed Solution: Retrofit existing counter to provide accessible section. Interim solution: Provide auxiliary counter, table, or clipboard. 	PCODE IN03 ADAAG 91 7.2(2) ADA 2010 904.4 CBC 2007 1122B.4 CBC 2016 11B-904.4	1	JOB	\$6,000	\$6,000

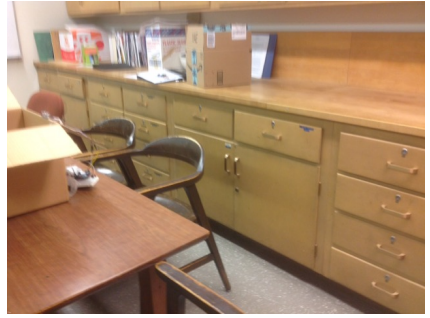
Mitigated: <input type="radio"/> YES <input checked="" type="radio"/> NO						
<input type="checkbox"/> Staff Only						
Priority 2 Severity 4						
317	<ul style="list-style-type: none"> As-Built Description: Service counter (stand-up): Accessible section min. 36" length and 36" max. height (in CA: 28" to 34" high) not provided. As-Built: 36" AFF Proposed Solution: Retrofit existing counter to provide accessible section. Interim solution: Provide auxiliary counter, table, or clipboard. 	PCODE IN03 ADAAG 91 7.2(2) ADA 2010 904.4 CBC 2007 1122B.4 CBC 2016 11B-904.4	1	JOB	\$6,000	\$6,000

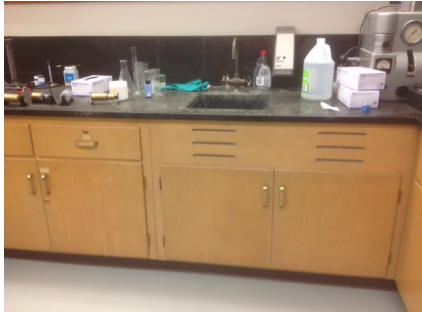
Item no., Rm no. and Name	Existing Architectural Barrier and Proposed Solution	Codes / Mitigation Info	Qty	Unit	Cost	Total
Sink						
307	<ul style="list-style-type: none"> As-Built Description: Sink rim higher than 34" above floor. As-Built: 36.5" high Proposed Solution: Remodel sink cabinet to lower sink. 	PCODE IN06 ADAAG 91 4.24.2 ADA 2010 606.3 CBC 2007 1115B.4.7.1 CBC 2016 11B-606.3 Mitigated: <input type="radio"/> YES <input checked="" type="radio"/> NO	1	JOB	\$5,250	\$5,250

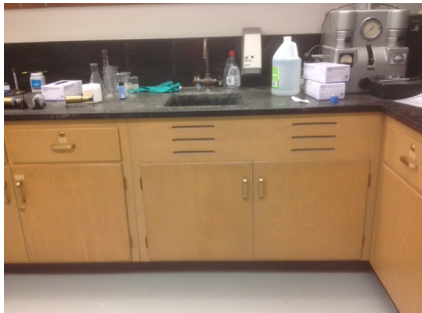
<input type="checkbox"/> Staff Only Priority 2 Severity 4			
308	<ul style="list-style-type: none"> As-Built Description: Sink does not have knee space min. 27" high x 19" deep x 30" wide. Proposed Solution: Remodel sink cabinet. 	PCODE IN06A ADAAG 91 4.24.3 ADA 2010 606.2 CBC 2007 1115B.4.7.1 CBC 2016 11B-606.2 Mitigated: <input type="radio"/> YES <input checked="" type="radio"/> NO	1	JOB	\$5,250	\$5,250

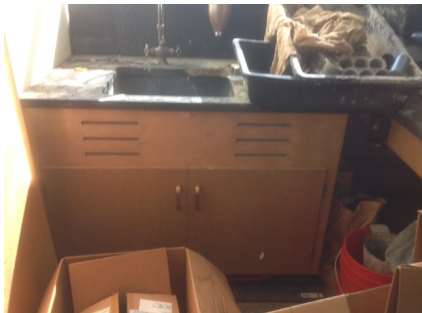
<input type="checkbox"/> Staff Only Priority 2 Severity 2			
314	<ul style="list-style-type: none"> As-Built Description: Sink does not have knee space min. 27" high x 19" deep x 30" wide. Proposed Solution: Remodel sink cabinet. 	PCODE IN06A ADAAG 91 4.24.3 ADA 2010 606.2 CBC 2007 1115B.4.7.1 CBC 2016 11B-606.2 Mitigated: <input type="radio"/> YES <input checked="" type="radio"/> NO	1	JOB	\$5,250	\$5,250

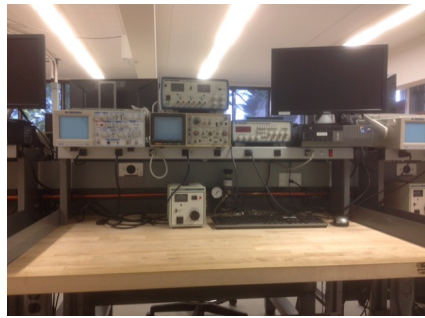
Item no., Rm no. and Name	Existing Architectural Barrier and Proposed Solution	Codes / Mitigation Info	Qty	Unit	Cost	Total
334	<ul style="list-style-type: none"> As-Built Description: Reach height to control or access point, exceeds 48" or is less than 15". As-Built: Equipment at station greater than 48" high. Proposed Solution: Modify equipment or mounting. Notes: 29 seats, no accessible provided. 	PCODE IE01 ADAAG 91 4.2.5 ADA 2010 308.2.1 CBC 2007 1118B.5 CBC 2016 11B-308.2.1 Mitigated: <input type="radio"/> YES <input checked="" type="radio"/> NO	1	JOB	\$300	\$300

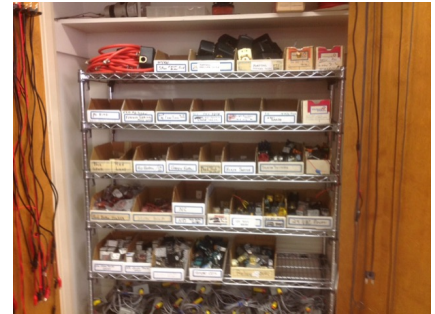
Item no., Rm no. and Name	Existing Architectural Barrier and Proposed Solution	Codes / Mitigation Info	Qty	Unit	Cost	Total
342	<ul style="list-style-type: none"> • <i>As-Built Description:</i> Reach height to control or access point, exceeds 48" or is less than 15". • <i>As-Built:</i> 65" AFF • <i>Proposed Solution:</i> Modify equipment or mounting. • <i>Notes:</i> Provide duplicate items within reach ranges if used independently by students. 	PCODE IE01 ADAAG 91 4.2.5 ADA 2010 308.2.1 CBC 2007 1118B.5 CBC 2016 11B-308.2.1 Mitigated: <input type="radio"/> YES <input checked="" type="radio"/> NO	1	JOB	\$300	\$300

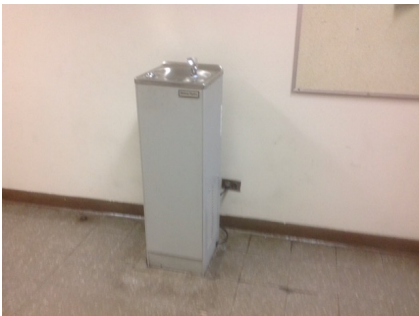
Item no., Rm no. and Name	Existing Architectural Barrier and Proposed Solution	Codes / Mitigation Info	Qty	Unit	Cost	Total
429	<ul style="list-style-type: none">As-Built Description: Wall- and post-mounted cantilevered units: Knee space not provided at drinking fountain (27" high, 8" deep, 30" wide from front of drinking fountain).Proposed Solution: Provide new, accessible fountain.	PCODE IA02 ADAAG 91 4.15.5(1) ADA 2010 602.2 CBC 2007 1115B.4.6.2 CBC 2016 11B-602.2 Mitigated: <div><input type="radio"/> YES</div> <div><input checked="" type="radio"/> NO</div>	1	JOB	\$9,600	\$9,600

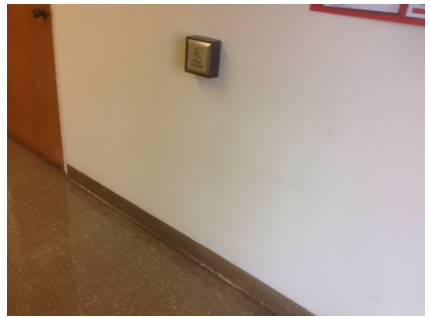
Item no., Rm no. and Name	Existing Architectural Barrier and Proposed Solution	Codes / Mitigation Info	Qty	Unit	Cost	Total
424	<ul style="list-style-type: none"> As-Built Description: Lower push plate located at 7" minimum and 8" maximum above the floor or ground surface not provided. Proposed Solution: Provide lower push plate. 	PCODE ID13B CBC 2007 1133B.2.3.2 CBC 2016 11B-404.2.9 2.C Mitigated: <input type="radio"/> YES <input checked="" type="radio"/> NO	2	JOB	\$1,500	\$3,000

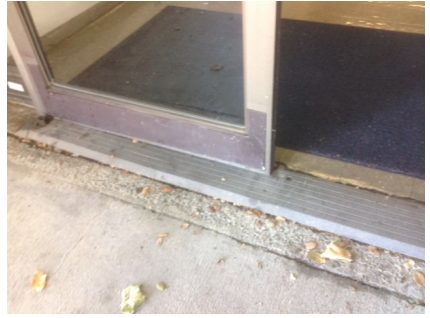
Door Threshold

425	<ul style="list-style-type: none"> As-Built Description: Door inaccessible due to threshold or step at door exceeding 1/2". As-Built: 1.25" AFF Proposed Solution: Modify threshold to be no more than 1/2" by removing existing paving at door and providing landing with edge ramping (slope 1:20 max). 	PCODE ID02A ADAAG 91 4.13.8 ADA 2010 404.2.5 CBC 2007 1133B.2.4.1 CBC 2016 11B-404.2.5 Mitigated: <input type="radio"/> YES <input checked="" type="radio"/> NO	1	JOB	\$1,200	\$1,200

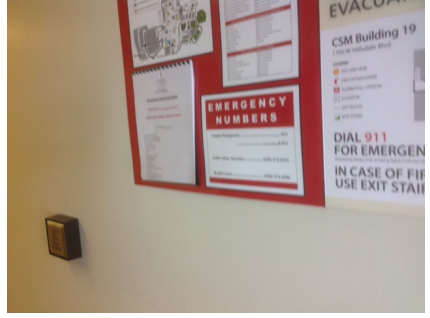
Reach Range

427	<ul style="list-style-type: none"> As-Built Description: Reach height to control or access point, exceeds 48" or is less than 15". As-Built: 50" AFF Proposed Solution: Modify equipment or mounting. 	PCODE IE01 ADAAG 91 4.2.5 ADA 2010 308.2.1 CBC 2007 1118B.5 CBC 2016 11B-308.2.1 Mitigated: <input type="radio"/> YES <input checked="" type="radio"/> NO	1	JOB	\$300	\$300

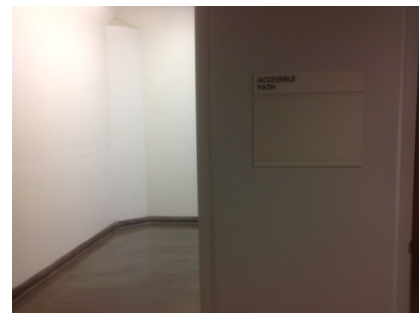
Exterior signage at inaccessible entrances to provide direction to accessible entrances is missing or noncompliant.

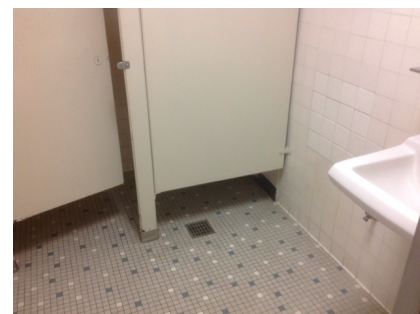
Single accommodation restroom not accessible; multiple compliance violations.

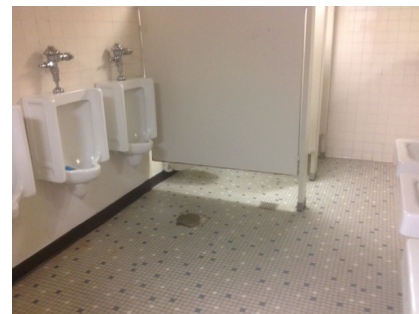
Multiple accommodation restroom not accessible;
multiple compliance violations.

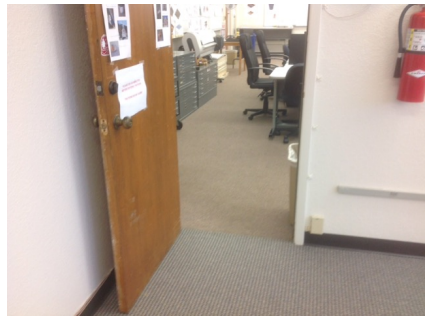
Item no., Rm no. and Name	Existing Architectural Barrier and Proposed Solution	Codes / Mitigation Info	Qty	Unit	Cost	Total
356	<ul style="list-style-type: none"> • <i>As-Built Description:</i> Door on accessible route has less than 32" clear and 80" (78" min. to closer if provided) opening width when 90° open. • <i>As-Built:</i> 28" wide • <i>Proposed Solution:</i> Provide new, larger door and frame with new accessible hardware. • <i>Notes:</i> Path of travel to adjacent classroom 	PCODE ID01 ADAAG 91 4.13.5 ADA 2010 404.2.3 CBC 2007 1133B.1.1.1.1 CBC 2016 11B-404.2.3 Mitigated: <input type="radio"/> YES <input checked="" type="radio"/> NO	1	JOB	\$7,800	\$7,800

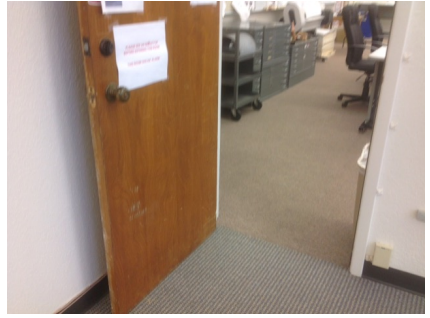
Door Hardware

357	<ul style="list-style-type: none"> • <i>As-Built Description:</i> Door does not have accessible operating hardware. • <i>Proposed Solution:</i> Provide lever handle or other accessible hardware. • <i>Notes:</i> Path of travel to adjacent classroom 	PCODE ID07 ADAAG 91 4.13.9 ADA 2010 404.2.7 CBC 2007 1133B.2.5.2 CBC 2016 11B-404.2.7 Mitigated: <input type="radio"/> YES <input checked="" type="radio"/> NO	1	JOB	\$750	\$750

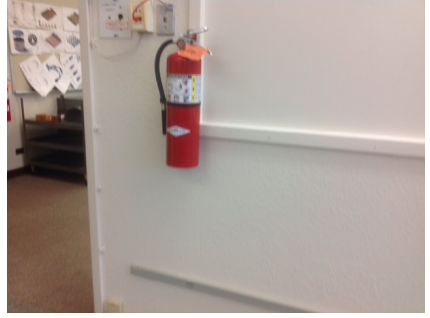
Reach Range

353	<ul style="list-style-type: none"> • <i>As-Built Description:</i> Reach height to control or access point, exceeds 48" or is less than 15". • <i>As-Built:</i> 57" AFF • <i>Proposed Solution:</i> Modify equipment or mounting. 	PCODE IE01 ADAAG 91 4.2.5 ADA 2010 308.2.1 CBC 2007 1118B.5 CBC 2016 11B-308.2.1 Mitigated: <input type="radio"/> YES <input checked="" type="radio"/> NO	1	JOB	\$300	\$300

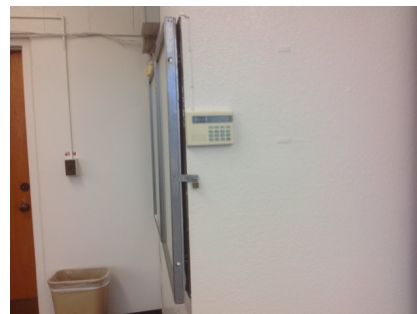
Item no., Rm no. and Name	Existing Architectural Barrier and Proposed Solution	Codes / Mitigation Info	Qty	Unit	Cost	Total
359	<ul style="list-style-type: none"> As-Built Description: Reach height to control or access point, exceeds 48" or is less than 15". As-Built: 56" AFF to alarm Proposed Solution: Modify equipment or mounting. 	PCODE IE01 ADAAG 91 4.2.5 ADA 2010 308.2.1 CBC 2007 1118B.5 CBC 2016 11B-308.2.1	1	JOB	\$300	\$300
<div>Mitigated:</div> <div> <input type="radio"/> YES <input checked="" type="radio"/> NO </div> <div> <input type="checkbox"/> Staff Only </div> <div> Priority 2 Severity 3 </div>

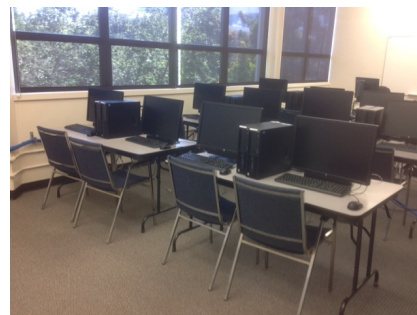
**Non-Fixed Desk**

354	<ul style="list-style-type: none"> As-Built Description: Accessible non-fixed table or desk (top 28" to 34" high; knee space at least 27" high x 19" deep x 30" wide) not provided. As-Built: 25" knee Proposed Solution: Provide table or desk with accessible dimensions when purchasing new furniture. Notes: 20 seats, no accessible seat provided 	PCODE IN02A ADAAG 91 4.32.3 & .4 ADA 2010 306.1 CBC 2007 1122B.3 & 4 CBC 2016 11B-306.1 & 11B-902.3	1	JOB	\$4,800	\$4,800
<div>Mitigated:</div> <div> <input type="radio"/> YES <input checked="" type="radio"/> NO </div> <div> <input type="checkbox"/> Staff Only </div> <div> Priority 2 Severity 2 </div>

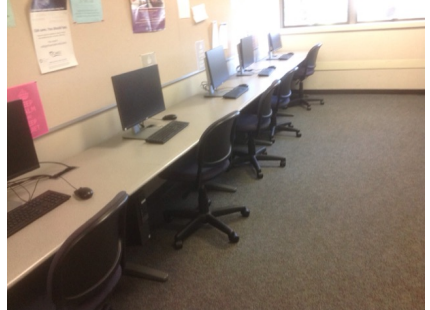
Item no., Rm no. and Name	Existing Architectural Barrier and Proposed Solution	Codes / Mitigation Info	Qty	Unit	Cost	Total
Non-Fixed Desk						
364	<ul style="list-style-type: none"> As-Built Description: Accessible non-fixed table or desk (top 28" to 34" high; knee space at least 27" high x 19" deep x 30" wide) not provided. As-Built: 26" AFF knee clearance Proposed Solution: Provide table or desk with accessible dimensions when purchasing new furniture. Notes: 14 seats, no accessible seat provided 	PCODE IN02A ADAAG 91 4.32.3 & .4 ADA 2010 306.1 CBC 2007 1122B.3 & 4 CBC 2016 11B-306.1 & 11B-902.3 Mitigated: <input type="radio"/> YES <input checked="" type="radio"/> NO	1	JOB	\$4,800	\$4,800

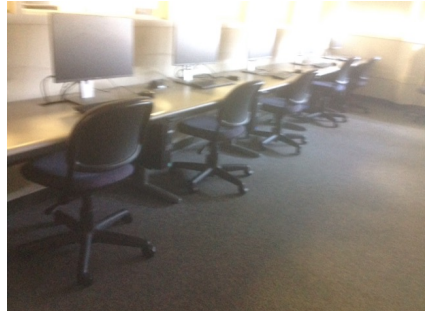
<input type="checkbox"/> Staff Only Priority 2 Severity 2			
368	<ul style="list-style-type: none"> As-Built Description: Accessible non-fixed table or desk (top 28" to 34" high; knee space at least 27" high x 19" deep x 30" wide) not provided. As-Built: 26" AFF knee height Proposed Solution: Provide table or desk with accessible dimensions when purchasing new furniture. Notes: 26 seats, no accessible seat provided 	PCODE IN02A ADAAG 91 4.32.3 & .4 ADA 2010 306.1 CBC 2007 1122B.3 & 4 CBC 2016 11B-306.1 & 11B-902.3 Mitigated: <input type="radio"/> YES <input checked="" type="radio"/> NO	1	JOB	\$4,800	\$4,800

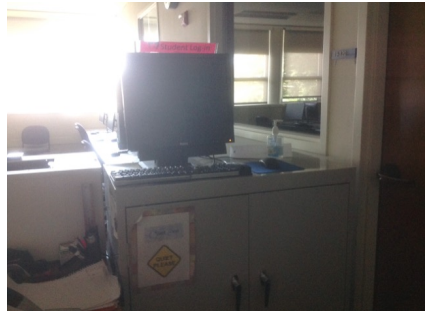
<input type="checkbox"/> Staff Only Priority 2 Severity 2			
369	<ul style="list-style-type: none"> As-Built Description: Accessible non-fixed table or desk (top 28" to 34" high; knee space at least 27" high x 19" deep x 30" wide) not provided. Proposed Solution: Provide table or desk with accessible dimensions when purchasing new furniture. Notes: Log in desk does not provide knee clearance. 	PCODE IN02A ADAAG 91 4.32.3 & .4 ADA 2010 306.1 CBC 2007 1122B.3 & 4 CBC 2016 11B-306.1 & 11B-902.3 Mitigated: <input type="radio"/> YES <input checked="" type="radio"/> NO	1	JOB	\$4,800	\$4,800

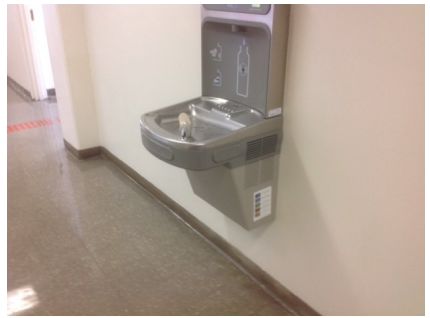
Item no., Rm no. and Name	Existing Architectural Barrier and Proposed Solution	Codes / Mitigation Info	Qty	Unit	Cost	Total
381	<ul style="list-style-type: none"> As-Built Description: Drinking fountain lacks protection for visually impaired persons. Proposed Solution: Provide cane-detectable rails. 	PCODE IA05C ADAAG 91 4.4.1 ADA 2010 307.2 CBC 2007 1115B.4.6.3 CBC 2016 11B-307.2 Mitigated: <input type="radio"/> YES <input checked="" type="radio"/> NO	1	JOB	\$1,500	\$1,500

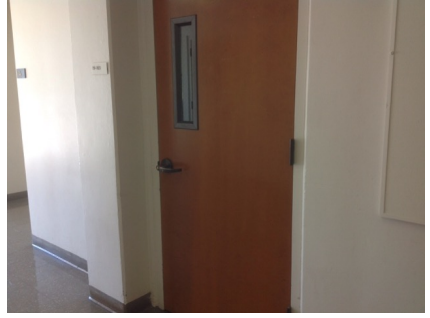
377	<ul style="list-style-type: none"> As-Built Description: Vision Light at door that permits viewing, does not have bottom of at least one glazed panel located 43 inches maximum above the finish floor. (Exception: More than 66" above finished floor.) As-Built: 48" AFF Proposed Solution: Provide new door with vision panel at 43" max. 	PCODE ID06C ADA 2010 404.2.11 CBC 2016 11B-404.2.11 Mitigated: <input type="radio"/> YES <input checked="" type="radio"/> NO	8	JOB	\$7,500	\$60,000

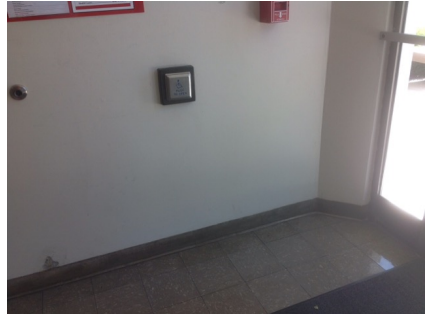
<input type="checkbox"/> Staff Only Priority 2 Severity 4			
382	<ul style="list-style-type: none"> As-Built Description: Lower push plate located at 7" minimum and 8" maximum above the floor or ground surface not provided. Proposed Solution: Provide lower push plate. 	PCODE ID13B CBC 2007 1133B.2.3.2 CBC 2016 11B-404.2.9 2.C Mitigated: <input type="radio"/> YES <input checked="" type="radio"/> NO	2	JOB	\$1,500	\$3,000

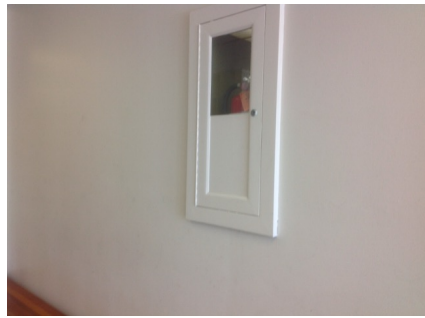
Item no., Rm no. and Name	Existing Architectural Barrier and Proposed Solution	Codes / Mitigation Info	Qty	Unit	Cost	Total
379	<ul style="list-style-type: none"> As-Built Description: Reach height to control or access point, exceeds 48" or is less than 15". As-Built: 55" AFF Proposed Solution: Modify equipment or mounting. 	PCODE IE01 ADAAG 91 4.2.5 ADA 2010 308.2.1 CBC 2007 1118B.5 CBC 2016 11B-308.2.1	2	JOB	\$300	\$600
<div>

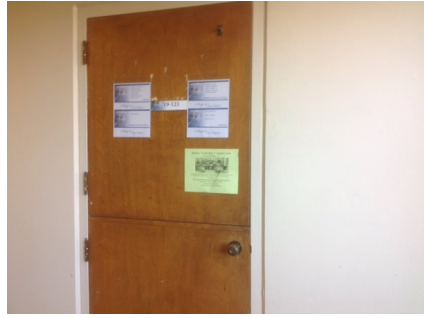
376	<ul style="list-style-type: none"> As-Built Description: Sign designating a permanent room or space does not include Grade 2 Braille. Proposed Solution: Provide new compliant signage including California Grade 2 Braille (1/10" on center dots with 2/10" space between cells). 	PCODE SA07A ADAAG 91 4.30.4 ADA 2010 703.2 CBC 2007 1117B.5.6 CBC 2016 11B-703.3	6	JOB	\$270	\$1,620
<div>

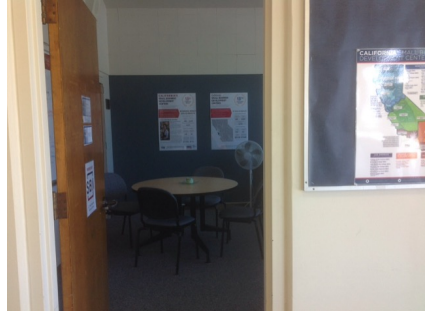
Item no., Rm no. and Name	Existing Architectural Barrier and Proposed Solution	Codes / Mitigation Info	Qty	Unit	Cost	Total
Signage						
397	<ul style="list-style-type: none"> • <i>As-Built Description:</i> Sign designating a permanent room or space does not include Grade 2 Braille. • <i>Proposed Solution:</i> Provide new compliant signage including California Grade 2 Braille (1/10" on center dots with 2/10" space between cells). 	PCODE SA07A ADAAG 91 4.30.4 ADA 2010 703.2 CBC 2007 1117B.5.6 CBC 2016 11B-703.3	1	JOB	\$270	\$270
Mitigated: <input type="radio"/> YES <input checked="" type="radio"/> NO

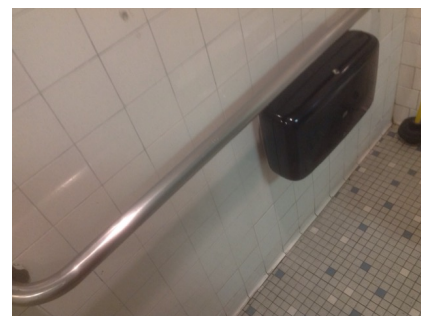
Item no., Rm no. and Name	Existing Architectural Barrier and Proposed Solution	Codes / Mitigation Info	Qty	Unit	Cost	Total
409	<ul style="list-style-type: none"> As-Built Description: Grab bar clearance not 1-1/2" from wall. As-Built: 2.5" between grab bar and wall Proposed Solution: Provide accessible grab bars. 	PCODE WB07E ADAAG 91 4.26.2 ADA 2010 609.3 CBC 2007 1115B.7.1 CBC 2016 11B-609.3	1	JOB	\$1,500	\$1,500

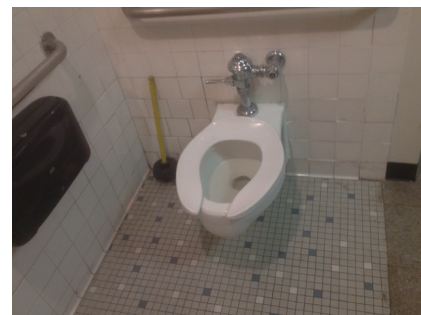
406	<ul style="list-style-type: none"> As-Built Description: Water closet not 16"-18" (CA: 17"-18") from near side wall to center line of water closet (2010 ADAAG: 16"-18"). As-Built: 22" o.c. Proposed Solution: Relocate existing water closet and plumbing, remount with offset closet flange to provide 18" max. from side wall. 	PCODE WB02C ADAAG 91 Fig. 28 ADA 2010 604.2 CBC 2007 1115B.4.1.1 CBC 2016 11B-604.2	1	JOB	\$1,500	\$1,500
-----	--	---	---	-----	---------	---------

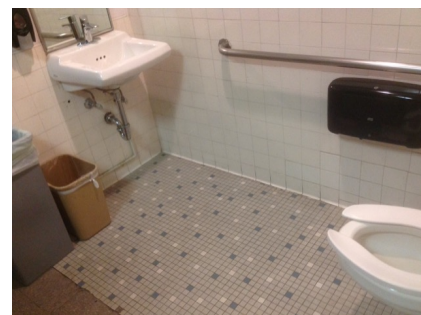
404	<ul style="list-style-type: none"> As-Built Description: CA only: In single-accommodation restroom less than 48" in front of water closet provided. As-Built: 46" to lavatory Proposed Solution: Remodel restroom to provide at least 48" in front of water closet. 	PCODE WB03A CBC 2007 1115B.3.2.1 CBC 2016 11B-604.3.1	1	JOB	\$15,000	\$15,000
-----	---	---	---	-----	----------	----------

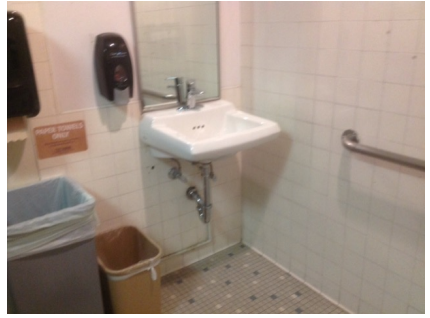
402	<ul style="list-style-type: none"> As-Built Description: Clear floor space, 30" x 48" in front of fixture, extending 19" max. under the lavatory, not provided (CA only: Less than 18" from side wall to centerline of lavatory). As-Built: 15" o.c. Proposed Solution: Relocate existing lavatory. 	PCODE WD01A ADAAG 91 4.19.3 ADA 2010 606.2 CBC 2007 1115B.4.3 CBC 2016 11B-606.2, 11B-606.6	1	JOB	\$2,700	\$2,700

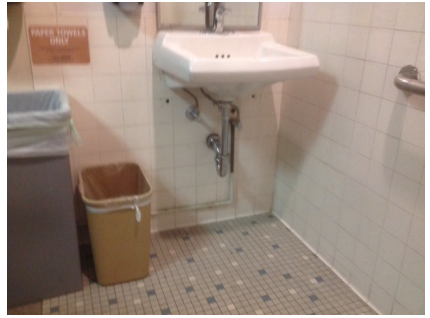
403	<ul style="list-style-type: none"> As-Built Description: Hot or sharp-surfaced water/drain pipe not insulated or covered. Proposed Solution: Insulate or cover water/drain pipe. 	PCODE WD05 ADAAG 91 4.19.4 ADA 2010 606.5 CBC 2007 1115B.4.3.4 CBC 2016 11B-606.5	1	JOB	\$360	\$360

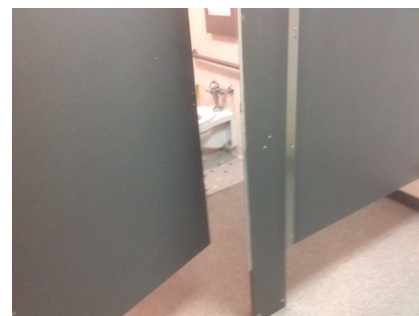
Stall partition obstructs restroom clearances. We recommend removing completely.

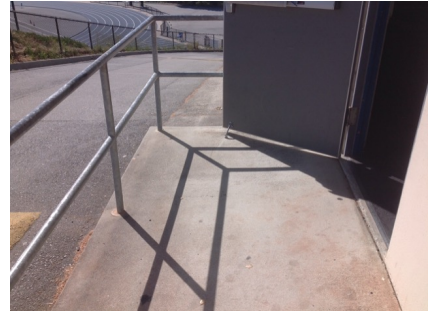
Item no., Rm no. and Name	Existing Architectural Barrier and Proposed Solution	Codes / Mitigation Info	Qty	Unit	Cost	Total
Door Swing						
340	<ul style="list-style-type: none">As-Built Description: Front approach: At pull side, door does not have clear and level maneuvering space measuring door width plus 18" x 60". (24" x 60" at exterior doors).As-Built: 57"Proposed Solution: Enlarge ramp landing.	<p>PCODE ID23A</p> <p>ADAAG 91 Fig. 25(a)</p> <p>ADA 2010 404.2.4</p> <p>CBC 2007 11B-26A(a)</p> <p>CBC 2016 11B-404.2.4</p> <p>Mitigated:</p> <p><input type="radio"/> YES</p> <p><input checked="" type="radio"/> NO</p>	1	JOB	\$150	\$150

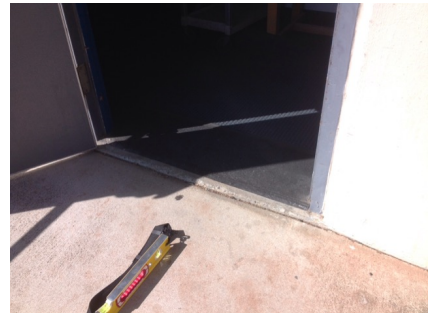
<input type="checkbox"/> Staff Only			
			<div><div>Priority</div><div>1</div><div>Severity</div><div>4</div></div>			
Door Threshold						
338	<ul style="list-style-type: none">As-Built Description: Door inaccessible due to threshold or step at door exceeding 1/2".As-Built: 1"Proposed Solution: Modify threshold to be no more than 1/2" by removing existing paving at door and providing landing with edge ramping (slope 1:20 max).	<p>PCODE ID02A</p> <p>ADAAG 91 4.13.8</p> <p>ADA 2010 404.2.5</p> <p>CBC 2007 1133B.2.4.1</p> <p>CBC 2016 11B-404.2.5</p> <p>Mitigated:</p> <p><input type="radio"/> YES</p> <p><input checked="" type="radio"/> NO</p>	1	JOB	\$1,200	\$1,200

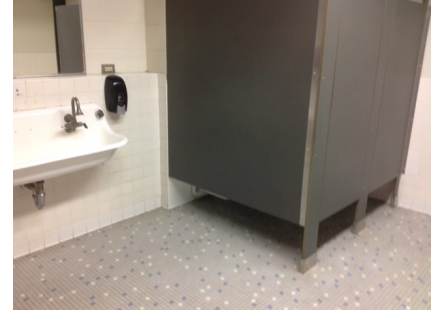
• *As-Built Description:*Multiple accommodation restroom not accessible;
multiple compliance violations.• *Proposed Solution:*Remodel area to provide accessible restroom with
one accessible stall, lavatory (and one urinal at
Mens).

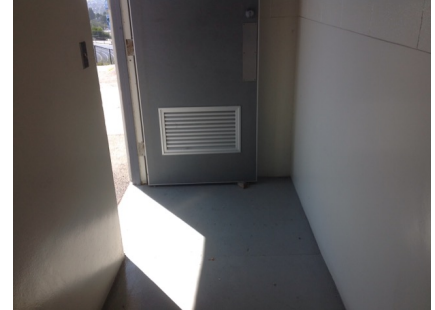
356

☐ **Staff Only****Priority****3****Severity****3****Door Threshold**

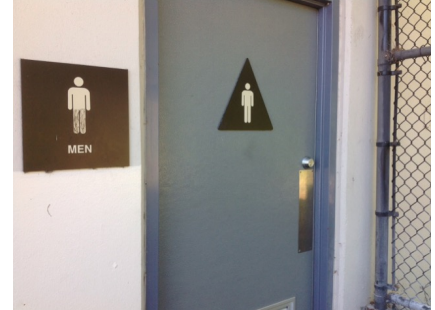
363

Multiple accommodation restroom not accessible; multiple compliance violations.

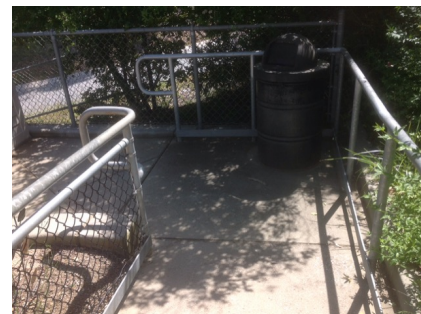
Item no., Rm no. and Name	Existing Architectural Barrier and Proposed Solution	Codes / Mitigation Info	Qty	Unit	Cost	Total
Slope						
109	<ul style="list-style-type: none"> As-Built Description: Slope greater than 1:12 (8.3%). As-Built: 8.4 - 9.3% Proposed Solution: Demolish existing and provide new ramp with handrails. Notes: Third ramp run 	PCODE EB02 ADAAG 91 4.8.2 ADA 2010 405.2 CBC 2007 1133B.5.3 CBC 2016 11B-405.2	240	SF	\$300	\$72,000
Mitigated: <input type="radio"/> YES <input checked="" type="radio"/> NO

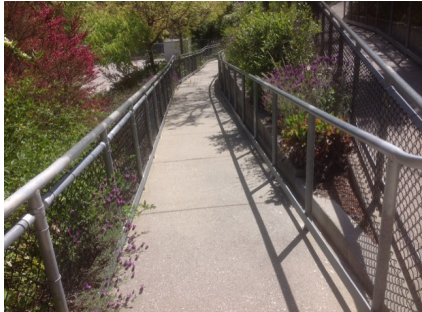
<input type="checkbox"/> Staff Only Priority 1 Severity 4			
104	<ul style="list-style-type: none"> As-Built Description: Level 2% max. landing for ramp not provided. As-Built: 3.0% Proposed Solution: Rebuild ramp to provide landings for each ramp run with slopes no greater than 2% Notes: Top landing 	PCODE EB05A ADAAG 91 4.8.4 ADA 2010 405.7.1 CBC 2007 1133B.5.4.1 CBC 2016 11B-405.7.1	36	SF	\$300	\$10,800

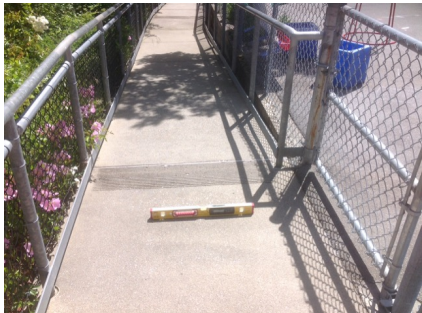
<input type="checkbox"/> Staff Only Priority 1 Severity 4			
107	<ul style="list-style-type: none"> As-Built Description: Level 2% max. landing for ramp not provided. As-Built: Intermediate landing 3.2% Proposed Solution: Rebuild ramp to provide landings for each ramp run with slopes no greater than 2% Notes: 68" deep 	PCODE EB05A ADAAG 91 4.8.4 ADA 2010 405.7.1 CBC 2007 1133B.5.4.1 CBC 2016 11B-405.7.1	36	SF	\$300	\$10,800
Mitigated: <input type="radio"/> YES <input checked="" type="radio"/> NO

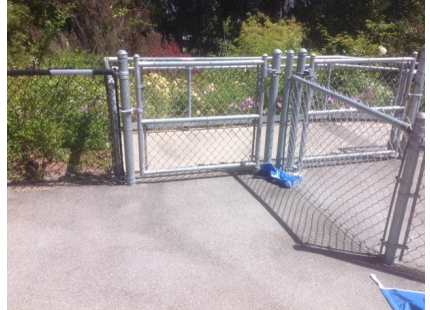
<input type="checkbox"/> Staff Only Priority 1 Severity 3			
99	<ul style="list-style-type: none"> • <i>As-Built Description:</i> Surface of required maneuvering clearance at door slopes more than 1/4":12" (2.0%). • <i>As-Built:</i> 5% • <i>Proposed Solution:</i> Modify surface slope at door. 	PCODE ID11 ADAAG 91 4.13.6 ADA 2010 404.2.4.4 CBC 2007 1133B.2.4 CBC 2016 11B-404.2.4 Mitigated: <input type="radio"/> YES <input checked="" type="radio"/> NO	25	SF	\$120	\$3,000

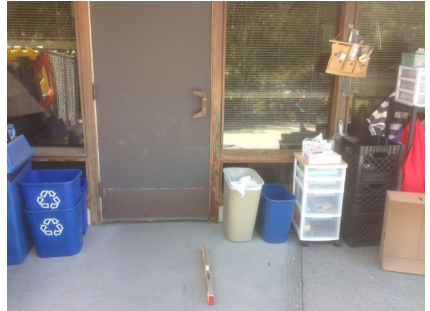
<input type="checkbox"/> Staff Only Priority 1 Severity 3			
101	<ul style="list-style-type: none"> • <i>As-Built Description:</i> Surface of required maneuvering clearance at door slopes more than 1/4":12" (2.0%). • <i>As-Built:</i> 4.6% • <i>Proposed Solution:</i> Modify surface slope at door. • Notes: 2 doors 	PCODE ID11 ADAAG 91 4.13.6 ADA 2010 404.2.4.4 CBC 2007 1133B.2.4 CBC 2016 11B-404.2.4 Mitigated: <input type="radio"/> YES <input checked="" type="radio"/> NO	50	SF	\$120	\$6,000

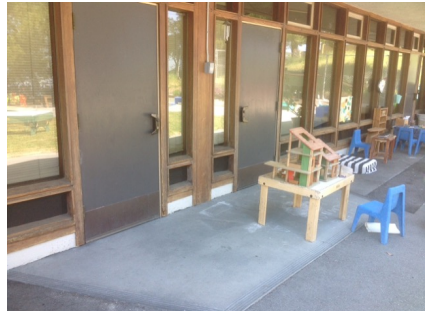
Item no., Rm no. and Name	Existing Architectural Barrier and Proposed Solution	Codes / Mitigation Info	Qty	Unit	Cost	Total
102	<ul style="list-style-type: none"> As-Built Description: Surface of required maneuvering clearance at door slopes more than 1/4":12" (2.0%). As-Built: 6% Proposed Solution: Modify surface slope at door. 	PCODE ID11 ADAAG 91 4.13.6 ADA 2010 404.2.4.4 CBC 2007 1133B.2.4 CBC 2016 11B-404.2.4 Mitigated: <input type="radio"/> YES <input checked="" type="radio"/> NO	25	SF	\$120	\$3,000

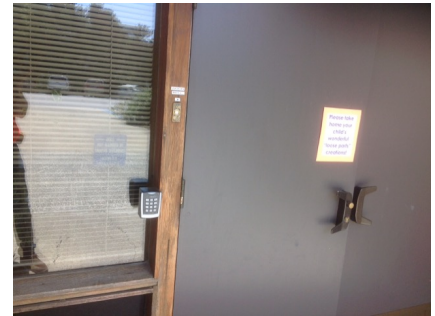
- 116
- *As-Built Description:*
Reach height to control or access point, exceeds 48" or is less than 15".
 - *As-Built:* **55"**
 - *Proposed Solution:*
Modify equipment or mounting.

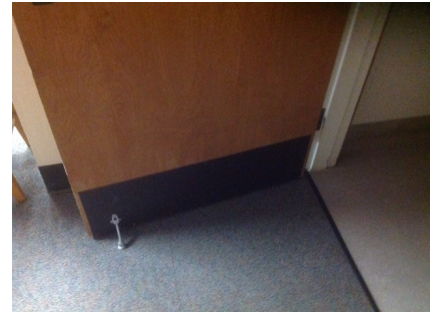
- 72
- *As-Built Description:*
Entrance to toilet or bathing facility not identified with ADAAG compliant signage.
 - *Proposed Solution:*
Provide ADA compliant sign mounted at 48" min. above to baseline of the lowest Braille cells and 60" max. to baseline of the highest line of raised characters on nearest adjacent wall, on latch side of a single door (located not to cause a Braille reader to stand within the door swing).

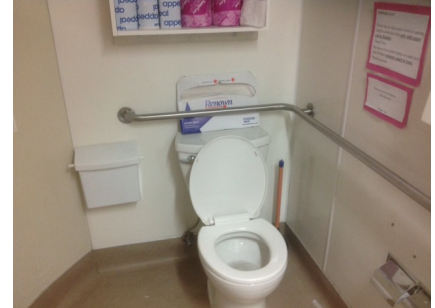
- 75
- *As-Built Description:*
Toilet stall less than 60" wide.
 - *As-Built:* **55"**
 - *Proposed Solution:*
Provide new accessible stall.

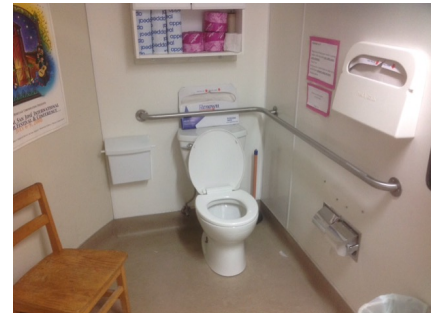
- 77
- *As-Built Description:*
Water closet not 16"-18" (CA: 17"-18") from near side wall to center line of water closet (2010 ADAAG: 16"-18").
 - *As-Built:* **16" o.c.**
 - *Proposed Solution:*
Relocate existing water closet and plumbing, remount with offset closet flange to provide 18" max. from side wall.

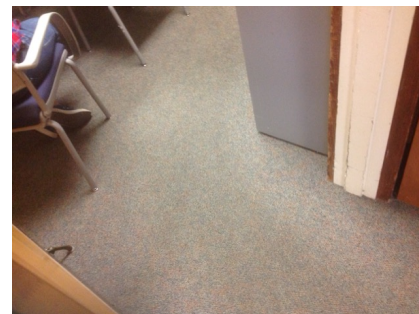
Item no., Rm no. and Name	Existing Architectural Barrier and Proposed Solution	Codes / Mitigation Info	Qty	Unit	Cost	Total
83	<ul style="list-style-type: none"> As-Built Description: Front approach: At pull side, door does not have clear and level maneuvering space measuring door width plus 18" x 60". (24" x 60" at exterior doors). As-Built: 5" Proposed Solution: Remove or relocate furniture or storage items. 	PCODE ID23A ADAAG 91 Fig. 25(a) ADA 2010 404.2.4 CBC 2007 11B-26A(a) CBC 2016 11B-404.2.4 Mitigated: <input type="radio"/> YES <input checked="" type="radio"/> NO	1	JOB	\$150	\$150

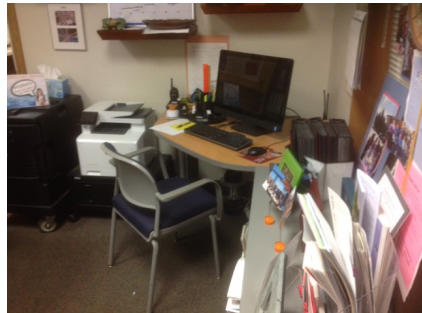
84	<ul style="list-style-type: none"> As-Built Description: Service counter (stand-up): Accessible section min. 36" length and 36" max. height (in CA: 28" to 34" high) not provided. As-Built: 36" high Proposed Solution: Retrofit existing counter to provide accessible section. Interim solution: Provide auxiliary counter, table, or clipboard. 	PCODE IN03 ADAAG 91 7.2(2) ADA 2010 904.4 CBC 2007 1122B.4 CBC 2016 11B-904.4 Mitigated: <input type="radio"/> YES <input checked="" type="radio"/> NO	1	JOB	\$6,000	\$6,000

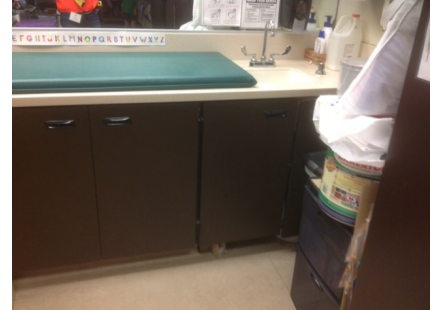
- 94
- *As-Built Description:*
Sink rim higher than 34" above floor.
 - *As-Built:* **36.5" high and no knee clearance**
 - *Proposed Solution:*
Remodel sink cabinet to lower sink.

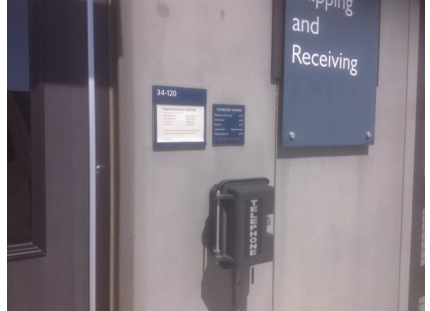
Item no., Rm no. and Name	Existing Architectural Barrier and Proposed Solution	Codes / Mitigation Info	Qty	Unit	Cost	Total
Signage						
227	<ul style="list-style-type: none"> As-Built Description: Signs containing tactile characters is not located so that a clear floor space of 18" min x 18" min., centered on the tactile characters, is provided beyond the arc of any door swing between the closed position and 45 degree open position. As-Built: 62" AFF Proposed Solution: Relocate compliant signage on latch side of door located at compliant height with a clear floor space. 	PCODE SA07B ADA 2010 703.4.2 CBC 2016 11B-703.4.2 Mitigated: <input type="radio"/> YES <input checked="" type="radio"/> NO	1	JOB	\$150	\$150

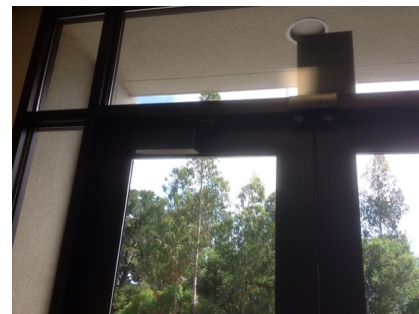
- 10
- *As-Built Description:*
Excessive force required to open door.

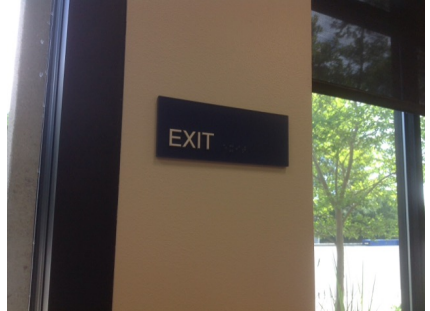
Item no., Rm no. and Name	Existing Architectural Barrier and Proposed Solution	Codes / Mitigation Info	Qty	Unit	Cost	Total
Signage						
11	<ul style="list-style-type: none"> • <i>As-Built Description:</i> Sign designating a permanent room or space does not include Grade 2 Braille. • <i>Proposed Solution:</i> Provide new compliant signage including California Grade 2 Braille (1/10" on center dots with 2/10" space between cells). • <i>Notes:</i> Wrong Braille location 	PCODE SA07A ADAAG 91 4.30.4 ADA 2010 703.2 CBC 2007 1117B.5.6 CBC 2016 11B-703.3	1	JOB	\$270	\$270
Mitigated: <input type="radio"/> YES <input checked="" type="radio"/> NO

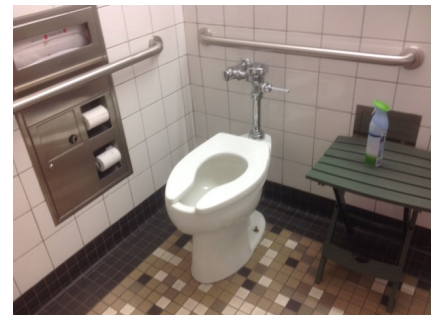
- 17 • *As-Built Description:*
Water closet not 16"-18" (CA: 17"-18") from near side wall to center line of water closet (2010 ADAAG: 16"-18").

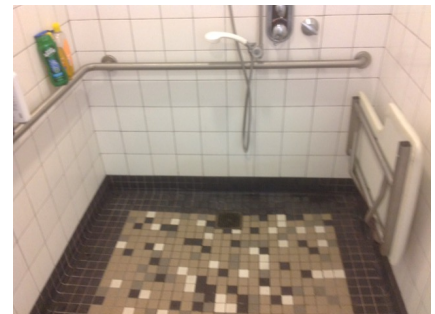
- 22 • *As-Built Description:*
Floor surface sloped greater than 2.0% (1:48) due to drain.

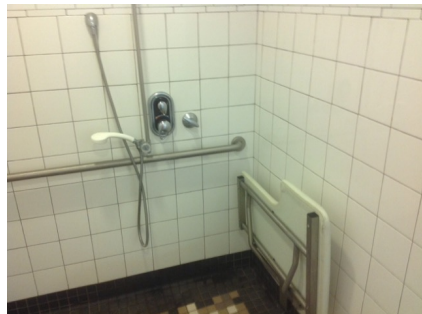
Item no., Rm no. and Name	Existing Architectural Barrier and Proposed Solution	Codes / Mitigation Info	Qty	Unit	Cost	Total
20	<ul style="list-style-type: none"> As-Built Description: Controls not located at 40" max. height or not within a range of no less than 19" and no more than 27" from the seat wall. As-Built: Diverter 14" o.c. from seat wall Proposed Solution: Provide new, or relocate, shower controls. 	PCODE WF12 ADAAG 91 4.27.3 ADA 2010 608.5 CBC 2007 1115B.4.4.4.1 CBC 2016 11B-608.5 Mitigated: <input type="radio"/> YES <input checked="" type="radio"/> NO	1	JOB	\$2,400	\$2,400

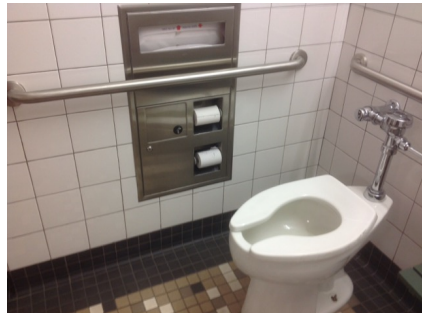
19	<ul style="list-style-type: none"> As-Built Description: Toilet paper dispenser less than 15" (CA: 19") or more than 48" above floor or not within 7" to 9" from front of water closet (Note: CA pre-2010 is allowed within 12" from front of water closet). As-Built: Behind front of toilet Proposed Solution: Relocate or provide new toilet paper dispenser. 	PCODE WG02 ADAAG 91 4.16.6 ADA 2010 604.7 CBC 2007 1115B.8.4 CBC 2016 11B-604.7 Mitigated: <input type="radio"/> YES <input checked="" type="radio"/> NO	1	JOB	\$225	\$225

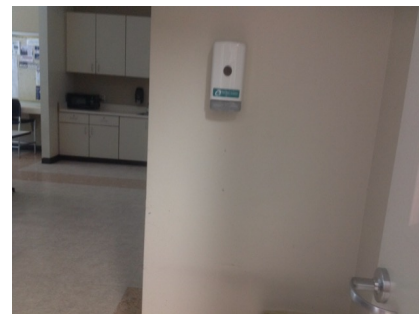
- 29
- *As-Built Description:*
Reach height to control or access point, exceeds 48" or is less than 15".
 - *As-Built:* **53" AFF**
 - *Proposed Solution:*
Modify equipment or mounting.

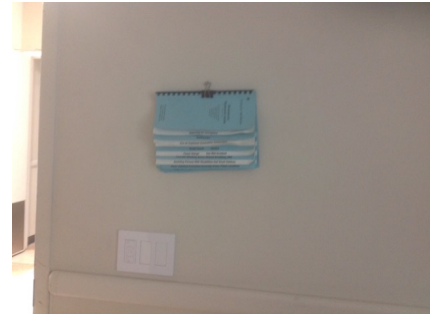
Item no., Rm no. and Name	Existing Architectural Barrier and Proposed Solution	Codes / Mitigation Info	Qty	Unit	Cost	Total
30	<ul style="list-style-type: none"> As-Built Description: Reach height to control or access point, exceeds 48" or is less than 15". As-Built: 62" AFF Proposed Solution: Modify equipment or mounting. 	PCODE IE01 ADAAG 91 4.2.5 ADA 2010 308.2.1 CBC 2007 1118B.5 CBC 2016 11B-308.2.1	1	JOB	\$300	\$300
<div> <div>Mitigated:</div> <div> <input type="radio"/> YES <input checked="" type="radio"/> NO </div> </div> <div> <input type="checkbox"/> Staff Only </div> <div> <div>Priority</div> <div>2</div> </div> <div> <div>Severity</div> <div>2</div> </div>

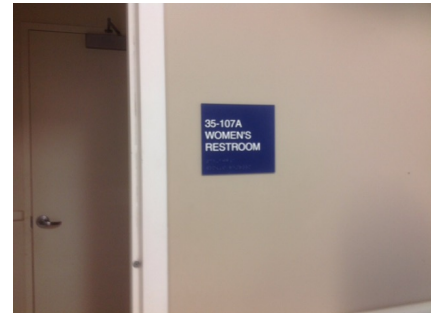
- 31
- *As-Built Description:*
Signs containing tactile characters is not located so that a clear floor space of 18" min x 18" min., centered on the tactile characters, is provided beyond the arc of any door swing between the closed position and 45 degree open position.
 - *As-Built:* **62" to bottom of highest tactile**
 - *Proposed Solution:*
Relocate compliant signage on latch side of door located at compliant height with a clear floor space.

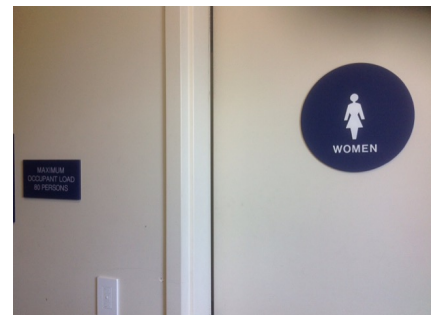
- 38
- *As-Built Description:*
Entrance to toilet or bathing facility not identified with ADAAG compliant signage.
 - *Proposed Solution:*
Provide ADA compliant sign mounted at 48" min. above to baseline of the lowest Braille cells and 60" max. to baseline of the highest line of raised characters on nearest adjacent wall, on latch side of a single door (located not to cause a Braille reader to stand within the door swing).

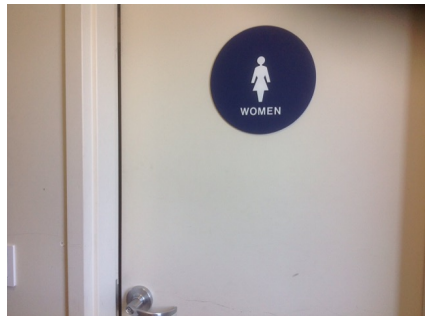
Item no., Rm no. and Name	Existing Architectural Barrier and Proposed Solution	Codes / Mitigation Info	Qty	Unit	Cost	Total
39	<ul style="list-style-type: none"> As-Built Description: Required in CA only: identification symbol centered 58" to 60" high on sanitary facility door that contrasts with the door not provided (women: 12" ø circle, men: 12" triangle, unisex: combined symbol). As-Built: 64" o.c. Proposed Solution: Provide properly mounted sanitary facility symbol when altering area. If wheelchair accessible, include International Symbol of Accessibility on sign. Notes: Door from classroom 	PCODE SA15 CBC 2007 1115B.6 CBC 2016 11B-703.7.2.6 Mitigated: <input type="radio"/> YES <input checked="" type="radio"/> NO	1	JOB	\$270	\$270

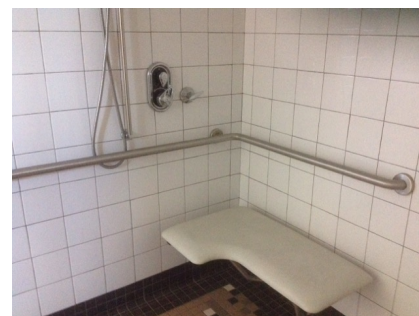
- 469
- *As-Built Description:*
In a standard roll-in type shower, grab bars are not provided on the back wall and side wall opposite the seat. Grab bars shall not be provided above the seat.

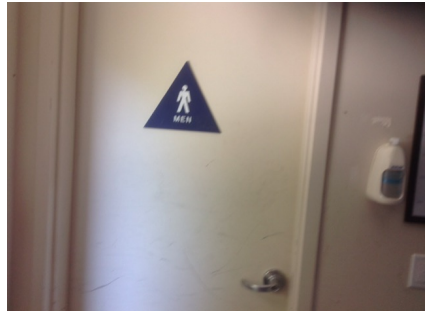
<input type="checkbox"/> Staff Only Priority 3 Severity 3			
50	<ul style="list-style-type: none"> As-Built Description: Required in CA only: identification symbol centered 58" to 60" high on sanitary facility door that contrasts with the door not provided (women: 12" ø circle, men: 12" triangle, unisex: combined symbol). As-Built: 65" Proposed Solution: Provide properly mounted sanitary facility symbol when altering area. If wheelchair accessible, include International Symbol of Accessibility on sign. 	PCODE SA15 CBC 2007 1115B.6 CBC 2016 11B-703.7.2.6 Mitigated: <input type="radio"/> YES <input checked="" type="radio"/> NO	1	JOB	\$270	\$270

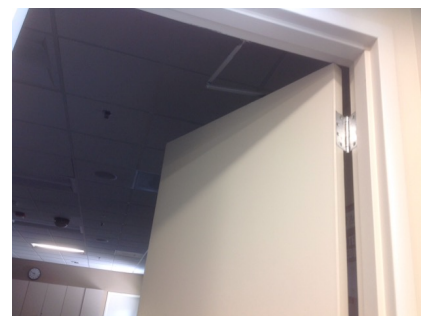
- 54
- *As-Built Description:*
At push side of door on accessible route, bottom 10" does not have a smooth, uninterrupted surface.
 - *Proposed Solution:*
Remove door stopper when altering area. Provide rubber wedge.

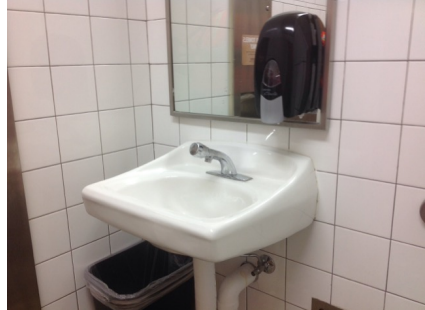
Item no., Rm no. and Name	Existing Architectural Barrier and Proposed Solution	Codes / Mitigation Info	Qty	Unit	Cost	Total
Accessories						
568	<ul style="list-style-type: none"> As-Built Description: Dispensers in sanitary facilities, such as for towels, soap, sanitary napkins, seat covers, etc., and waste receptacles more than 48" (CA only: 40") from floor to highest operating slot or control. As-Built: Soap dispenser 41" high Proposed Solution: Relocate existing restroom accessories. 	PCODE WG01A ADAAG 91 4.23.7 ADA 2010 308.2.1 CBC 2007 1115B.8.3 CBC 2016 11B-603.5 Mitigated: <input type="radio"/> YES <input checked="" type="radio"/> NO	1	JOB	\$300	\$300

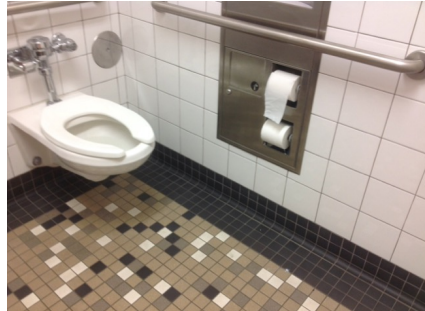
<input type="checkbox"/> Staff Only Priority 3 Severity 4			
570	<ul style="list-style-type: none"> As-Built Description: Toilet paper dispenser less than 15" (CA: 19") or more than 48" above floor or not within 7" to 9" from front of water closet (Note: CA pre-2010 is allowed within 12" from front of water closet). As-Built: 12" o.c. Proposed Solution: Relocate or provide new toilet paper dispenser. 	PCODE WG02 ADAAG 91 4.16.6 ADA 2010 604.7 CBC 2007 1115B.8.4 CBC 2016 11B-604.7 Mitigated: <input type="radio"/> YES <input checked="" type="radio"/> NO	1	JOB	\$225	\$225

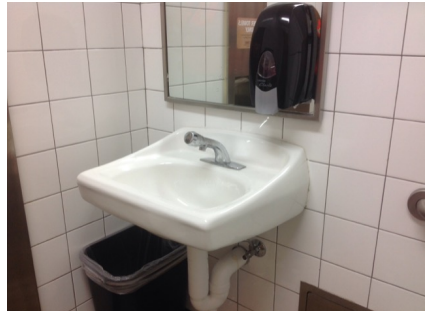
<input type="checkbox"/> Staff Only Priority 3 Severity 3			
567	<ul style="list-style-type: none"> As-Built Description: Bottom of mirror located above lavatories or countertops more than 40" above floor. As-Built: 41" high Proposed Solution: Relocate or provide new accessible mirror. 	PCODE WG03 ADAAG 91 4.19.6 ADA 2010 603.3 CBC 2007 1115B.8.1 CBC 2016 11B-603.3 Mitigated: <input type="radio"/> YES <input checked="" type="radio"/> NO	1	JOB	\$450	\$450

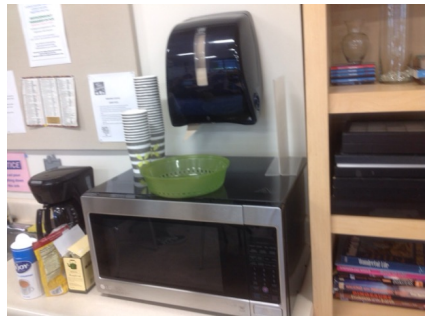
Item no., Rm no. and Name	Existing Architectural Barrier and Proposed Solution	Codes / Mitigation Info	Qty	Unit	Cost	Total
598	<ul style="list-style-type: none"> As-Built Description: Reach height to control or access point, exceeds 48" or is less than 15". As-Built: 59" high Proposed Solution: Modify equipment or mounting. 	PCODE IE01 ADAAG 91 4.2.5 ADA 2010 308.2.1 CBC 2007 1118B.5 CBC 2016 11B-308.2.1	1	JOB	\$300	\$300

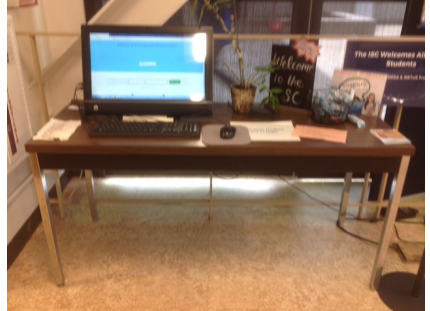
596	<ul style="list-style-type: none"> As-Built Description: Accessible non-fixed table or desk (top 28" to 34" high; knee space at least 27" high x 19" deep x 30" wide) not provided. As-Built: 25" knee height Proposed Solution: Provide table or desk with accessible dimensions when purchasing new furniture. 	PCODE IN02A ADAAG 91 4.32.3 & .4 ADA 2010 306.1 CBC 2007 1122B.3 & 4 CBC 2016 11B-306.1 & 11B-902.3	1	JOB	\$4,800	\$4,800

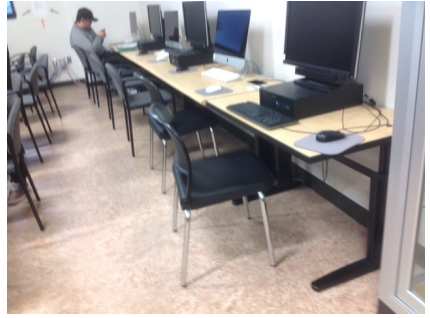
600	<ul style="list-style-type: none"> As-Built Description: Accessible non-fixed table or desk (top 28" to 34" high; knee space at least 27" high x 19" deep x 30" wide) not provided. As-Built: 25" high Proposed Solution: Provide table or desk with accessible dimensions when purchasing new furniture. Notes: 20 total, 0 accessible 	PCODE IN02A ADAAG 91 4.32.3 & .4 ADA 2010 306.1 CBC 2007 1122B.3 & 4 CBC 2016 11B-306.1 & 11B-902.3	1	JOB	\$4,800	\$4,800

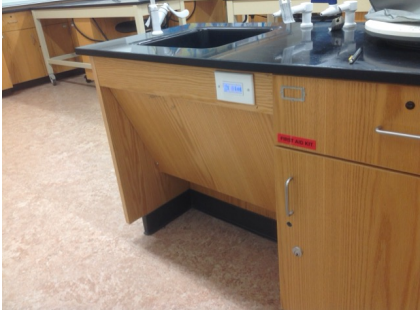
Item no., Rm no. and Name	Existing Architectural Barrier and Proposed Solution	Codes / Mitigation Info	Qty	Unit	Cost	Total
Sink						
608	<ul style="list-style-type: none"> As-Built Description: Sink does not have knee space min. 27" high x 19" deep x 30" wide. Proposed Solution: Remodel sink cabinet. Notes: Teacher/display sink 	PCODE IN06A ADAAG 91 4.24.3 ADA 2010 606.2 CBC 2007 1115B.4.7.1 CBC 2016 11B-606.2	1	JOB	\$5,250	\$5,250

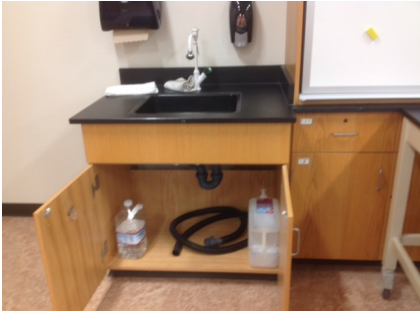
<input type="radio"/> YES <input checked="" type="radio"/> NO			
			<input type="checkbox"/> Staff Only			
			Priority 2 Severity 2			
609	<ul style="list-style-type: none"> As-Built Description: Sink does not have knee space min. 27" high x 19" deep x 30" wide. Proposed Solution: Remodel sink cabinet. 	PCODE IN06A ADAAG 91 4.24.3 ADA 2010 606.2 CBC 2007 1115B.4.7.1 CBC 2016 11B-606.2	1	JOB	\$5,250	\$5,250

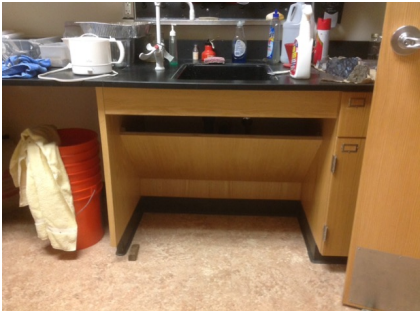
<input type="checkbox"/> Staff Only			
			Priority 2 Severity 2			
612	<ul style="list-style-type: none"> As-Built Description: Sink does not have knee space min. 27" high x 19" deep x 30" wide. Proposed Solution: Remodel sink cabinet. 	PCODE IN06A ADAAG 91 4.24.3 ADA 2010 606.2 CBC 2007 1115B.4.7.1 CBC 2016 11B-606.2	1	JOB	\$5,250	\$5,250

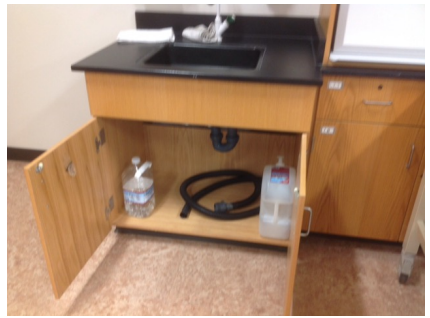
Item no., Rm no. and Name	Existing Architectural Barrier and Proposed Solution	Codes / Mitigation Info	Qty	Unit	Cost	Total
610	<ul style="list-style-type: none"> As-Built Description: Sink rim higher than 34" above floor. As-Built: 36" high Proposed Solution: Remodel sink cabinet to lower sink. 	PCODE IN06REF ADAAG 91 4.24.2 ADA 2010 606.3 CBC 2007 1115B.4.7.1 CBC 2016 11B-606.3 Mitigated: <input type="radio"/> YES <input checked="" type="radio"/> NO				
			REF
