SMCCCD - College of San Mateo

Appendix L: Facilities

Access Compliance Survey Report

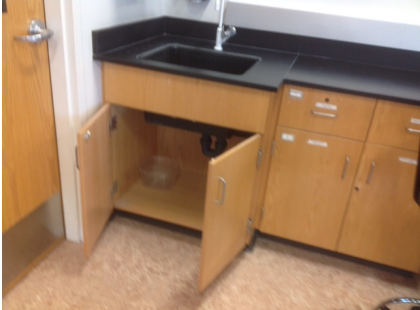
Item no., Rm no. and Name	Existing Architectural Barrier and Proposed Solution	Codes / Mitigation Info	Qty	Unit	Cost	Total
Sink						
617	<ul style="list-style-type: none"> As-Built Description: Sink rim higher than 34" above floor. As-Built: 36" high Proposed Solution: Remodel sink cabinet to lower sink. 	PCODE IN06 ADAAG 91 4.24.2 ADA 2010 606.3 CBC 2007 1115B.4.7.1 CBC 2016 11B-606.3 Mitigated: <input type="radio"/> YES <input checked="" type="radio"/> NO	1	JOB	\$5,250	\$5,250

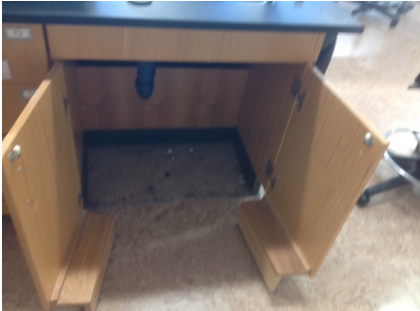
<input type="checkbox"/> Staff Only Priority 2 Severity 4			
616	<ul style="list-style-type: none"> As-Built Description: Sink does not have knee space min. 27" high x 19" deep x 30" wide. As-Built: 28" wide Proposed Solution: Remodel sink cabinet. Notes: Teachers/display sink 	PCODE IN06A ADAAG 91 4.24.3 ADA 2010 606.2 CBC 2007 1115B.4.7.1 CBC 2016 11B-606.2 Mitigated: <input type="radio"/> YES <input checked="" type="radio"/> NO	1	JOB	\$5,250	\$5,250

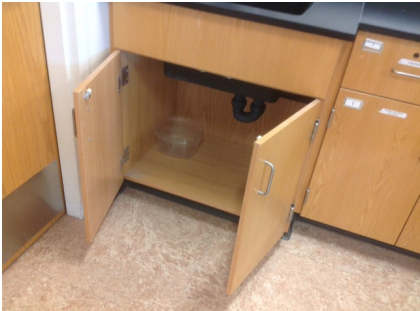
<input type="checkbox"/> Staff Only Priority 2 Severity 2			
618	<ul style="list-style-type: none"> As-Built Description: Sink does not have knee space min. 27" high x 19" deep x 30" wide. Proposed Solution: Remodel sink cabinet. 	PCODE IN06A ADAAG 91 4.24.3 ADA 2010 606.2 CBC 2007 1115B.4.7.1 CBC 2016 11B-606.2 Mitigated: <input type="radio"/> YES <input checked="" type="radio"/> NO	1	JOB	\$5,250	\$5,250

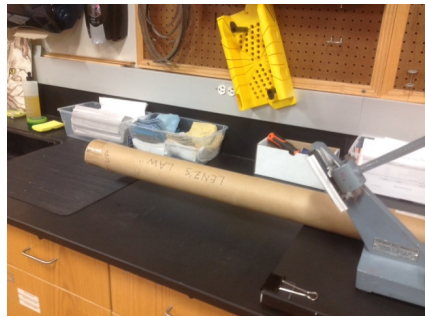
Item no., Rm no. and Name	Existing Architectural Barrier and Proposed Solution	Codes / Mitigation Info	Qty	Unit	Cost	Total
620	<ul style="list-style-type: none"> As-Built Description: Reach height for side approach to control or access point over an obstruction that is 34" max. high and 24" max. deep exceeds 46". As-Built: 26" reach depth Proposed Solution: Modify equipment or mounting. 	PCODE IE02A ADAAG 91 Fig. 6(c) ADA 2010 308.3.2 CBC 2007 Fig. 11B-5D(c) CBC 2016 11B-308.3.2 Mitigated: <input type="radio"/> YES <input checked="" type="radio"/> NO	1	JOB	\$300	\$300

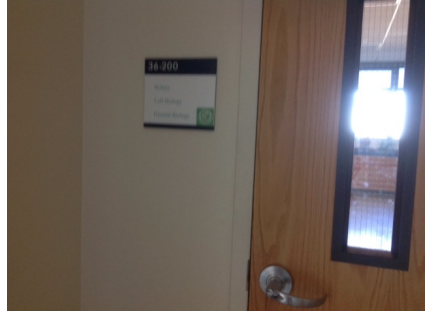
Item no., Rm no. and Name	Existing Architectural Barrier and Proposed Solution	Codes / Mitigation Info	Qty	Unit	Cost	Total
Signage						
640	<ul style="list-style-type: none"> As-Built Description: Sign not located on latch side of door and/or not located at 48" min. above to baseline of the lowest Braille cells and 60" max. to baseline of the highest line of raised characters. As-Built: 62" high Proposed Solution: Provide compliant signage including tactile characters and Grade II Braille on latch side of door located at compliant height. 	PCODE SA07 ADAAG 91 4.30.6 ADA 2010 703.4.1 CBC 2007 1117B.5.7 CBC 2016 11B-703.4.1 Mitigated: <input type="radio"/> YES <input checked="" type="radio"/> NO	15	JOB	\$150	\$2,250

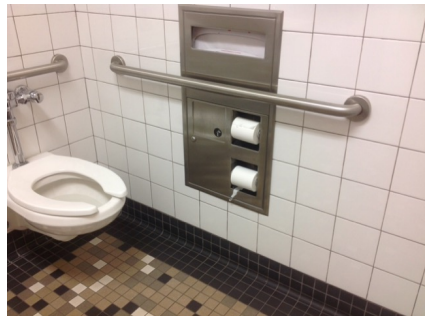
Item no., Rm no. and Name	Existing Architectural Barrier and Proposed Solution	Codes / Mitigation Info	Qty	Unit	Cost	Total
655	<ul style="list-style-type: none"> As-Built Description: Toilet paper dispenser less than 15" (CA: 19") or more than 48" above floor or not within 7" to 9" from front of water closet (Note: CA pre-2010 is allowed within 12" from front of water closet). As-Built: 12" o.c. Proposed Solution: Relocate or provide new toilet paper dispenser. 	PCODE WG02 ADAAG 91 4.16.6 ADA 2010 604.7 CBC 2007 1115B.8.4 CBC 2016 11B-604.7 Mitigated: <input type="radio"/> YES <input checked="" type="radio"/> NO	1	JOB	\$225	\$225

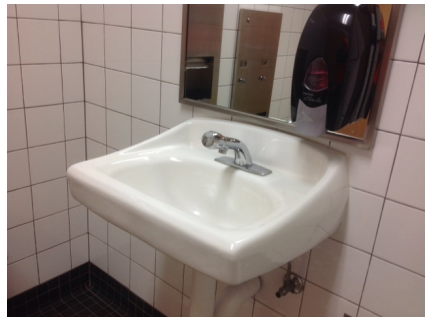
<input type="checkbox"/> Staff Only Priority 3 Severity 3			
650	<ul style="list-style-type: none"> As-Built Description: Bottom of mirror located above lavatories or countertops more than 40" above floor. As-Built: 40.5" high Proposed Solution: Relocate or provide new accessible mirror. 	PCODE WG03 ADAAG 91 4.19.6 ADA 2010 603.3 CBC 2007 1115B.8.1 CBC 2016 11B-603.3 Mitigated: <input type="radio"/> YES <input checked="" type="radio"/> NO	1	JOB	\$450	\$450

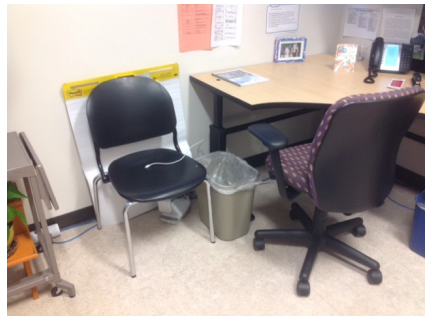
Item no., Rm no. and Name	Existing Architectural Barrier and Proposed Solution	Codes / Mitigation Info	Qty	Unit	Cost	Total
663	<ul style="list-style-type: none"> As-Built Description: Accessible non-fixed table or desk (top 28" to 34" high; knee space at least 27" high x 19" deep x 30" wide) not provided. As-Built: No knee space if used by students as writing surface. Proposed Solution: Provide table or desk with accessible dimensions when purchasing new furniture. 	PCODE IN02A ADAAG 91 4.32.3 & .4 ADA 2010 306.1 CBC 2007 112B.3 & 4 CBC 2016 11B-306.1 & 11B-902.3 Mitigated: <input type="radio"/> YES <input checked="" type="radio"/> NO	1	JOB	\$4,800	\$4,800

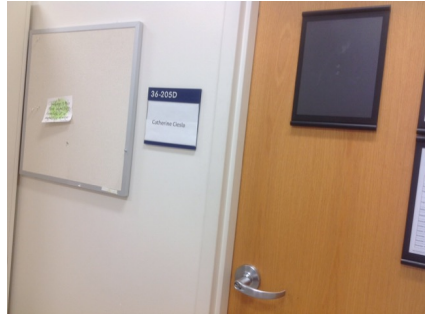
658	<ul style="list-style-type: none"> As-Built Description: Sign not located on latch side of door and/or not located at 48" min. above to baseline of the lowest Braille cells and 60" max. to baseline of the highest line of raised characters. As-Built: 62" high Proposed Solution: Provide compliant signage including tactile characters and Grade II Braille on latch side of door located at compliant height. 	PCODE SA07 ADAAG 91 4.30.6 ADA 2010 703.4.1 CBC 2007 1117B.5.7 CBC 2016 11B-703.4.1 Mitigated: <input type="radio"/> YES <input checked="" type="radio"/> NO	1	JOB	\$150	\$150

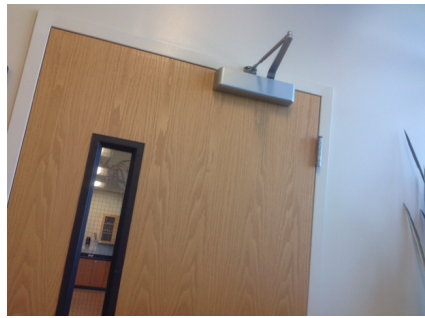
Item no., Rm no. and Name	Existing Architectural Barrier and Proposed Solution	Codes / Mitigation Info	Qty	Unit	Cost	Total
677	<ul style="list-style-type: none"> As-Built Description: Excessive force required to open door and/or door closing time of less than 5 seconds. As-Built: 2 seconds Proposed Solution: Provide new door closer adjusted to accessible standards. 	PCODE ID03A ADAAG 91 4.13.10 & 11 ADA 2010 404.2.8 & 404.2.9 CBC 2007 1133B.2.5.1 CBC 2016 11B-404.2.9 Mitigated: <input type="radio"/> YES <input checked="" type="radio"/> NO	1	JOB	\$1,125	\$1,125

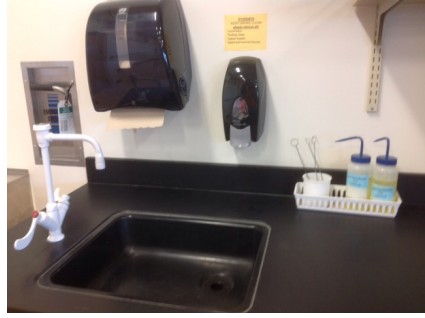
669	<ul style="list-style-type: none"> As-Built Description: Reach height to control or access point, exceeds 48" or is less than 15". As-Built: 26" deep Proposed Solution: Modify equipment or mounting. 	PCODE IE01 ADAAG 91 4.2.5 ADA 2010 308.2.1 CBC 2007 1118B.5 CBC 2016 11B-308.2.1 Mitigated: <input type="radio"/> YES <input checked="" type="radio"/> NO	1	JOB	\$300	\$300

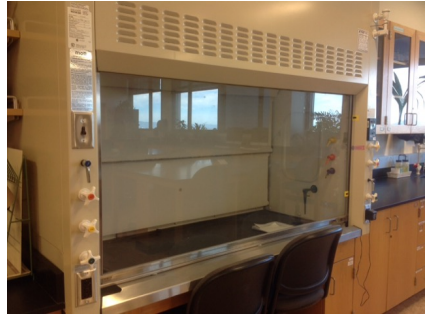
<input type="checkbox"/> Staff Only Priority 2 Severity 4						
670	<ul style="list-style-type: none"> As-Built Description: Reach height to control or access point, exceeds 48" or is less than 15". As-Built: 56" high Proposed Solution: Modify equipment or mounting. 	PCODE IE01 ADAAG 91 4.2.5 ADA 2010 308.2.1 CBC 2007 1118B.5 CBC 2016 11B-308.2.1 Mitigated: <input type="radio"/> YES <input checked="" type="radio"/> NO	1	JOB	\$300	\$300

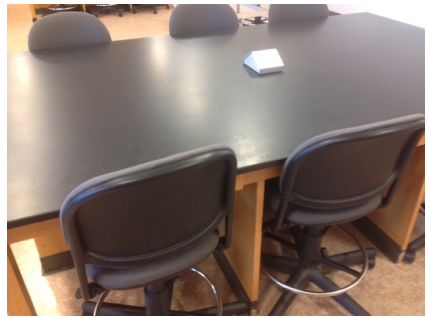
Item no., Rm no. and Name	Existing Architectural Barrier and Proposed Solution	Codes / Mitigation Info	Qty	Unit	Cost	Total
671	<ul style="list-style-type: none"> As-Built Description: Reach height to control or access point, exceeds 48" or is less than 15". As-Built: 26" reach to outlet Proposed Solution: Modify equipment or mounting. 	PCODE IE01 ADAAG 91 4.2.5 ADA 2010 308.2.1 CBC 2007 1118B.5 CBC 2016 11B-308.2.1	1	JOB	\$300	\$300

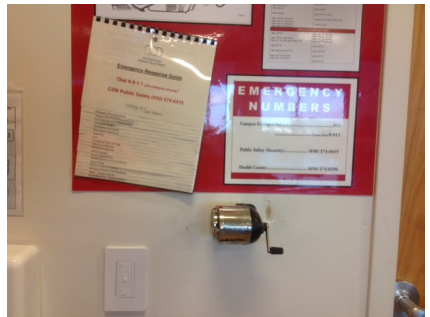
678	<ul style="list-style-type: none"> As-Built Description: Reach height to control or access point, exceeds 48" or is less than 15". As-Built: 54" high Proposed Solution: Modify equipment or mounting. 	PCODE IE01 ADAAG 91 4.2.5 ADA 2010 308.2.1 CBC 2007 1118B.5 CBC 2016 11B-308.2.1	1	JOB	\$300	\$300

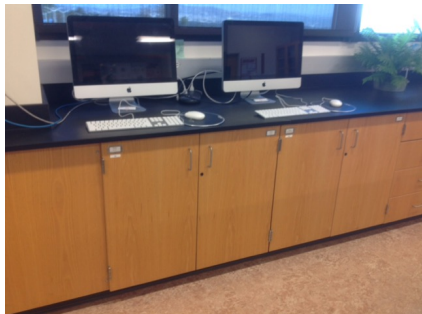
Item no., Rm no. and Name	Existing Architectural Barrier and Proposed Solution	Codes / Mitigation Info	Qty	Unit	Cost	Total
674	<ul style="list-style-type: none">• <i>As-Built Description:</i> Accessible non-fixed table or desk (top 28" to 34" high; knee space at least 27" high x 19" deep x 30" wide) not provided.• <i>Proposed Solution:</i> Provide table or desk with accessible dimensions when purchasing new furniture.• <i>Notes:</i> No knee space for work station.	<p>PCODE IN02A</p> <p>ADAAG 91 4.32.3 & .4</p> <p>ADA 2010 306.1</p> <p>CBC 2007 1122B.3 & 4</p> <p>CBC 2016 11B-306.1 & 11B-902.3</p> <p>Mitigated:</p> <p><input type="radio"/> YES</p> <p><input checked="" type="radio"/> NO</p>	1	JOB	\$4,800	\$4,800

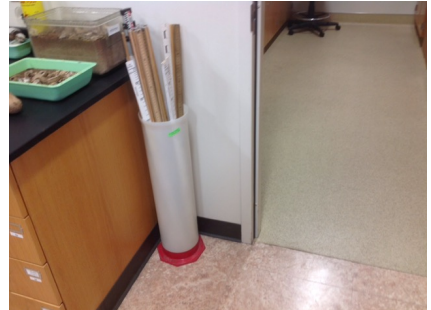
Item no., Rm no. and Name	Existing Architectural Barrier and Proposed Solution	Codes / Mitigation Info	Qty	Unit	Cost	Total
<div>Door Swing</div>						
696	<div><div>As-Built Description:</div><div>Front approach: At pull side, door does not have clear and level maneuvering space measuring door width plus 18" x 60". (24" x 60" at exterior doors).</div><div>As-Built: 17"</div><div>Proposed Solution:</div><div>Provide power door operator.</div><div>Notes:</div><div>Class Lab Service 206B</div></div>	<div>PCODE ID23C</div> <div>ADAAG 91 Fig. 25(a)</div> <div>ADA 2010 404.2.4</div> <div>CBC 2007 11B-26A(a)</div> <div>CBC 2016 11B-404.2.4</div> <div>Mitigated:</div> <div><div><input type="radio"/> YES</div><div><input checked="" type="radio"/> NO</div></div>	1	JOB	\$15,000	\$15,000
			<div>

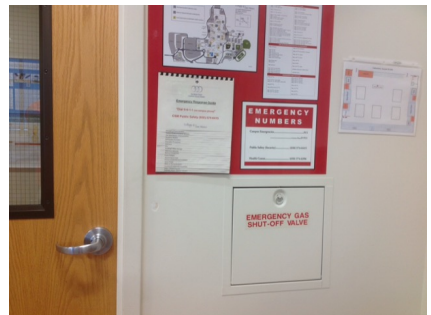
<div>Reach Range</div>						
679	<div><div>As-Built Description:</div><div>Reach height to control or access point, exceeds 48" or is less than 15".</div><div>As-Built: 54" high</div><div>Proposed Solution:</div><div>Modify equipment or mounting.</div></div>	<div>PCODE IE01</div> <div>ADAAG 91 4.2.5</div> <div>ADA 2010 308.2.1</div> <div>CBC 2007 1118B.5</div> <div>CBC 2016 11B-308.2.1</div> <div>Mitigated:</div> <div><div><input type="radio"/> YES</div><div><input checked="" type="radio"/> NO</div></div>	1	JOB	\$300	\$300
			<div>

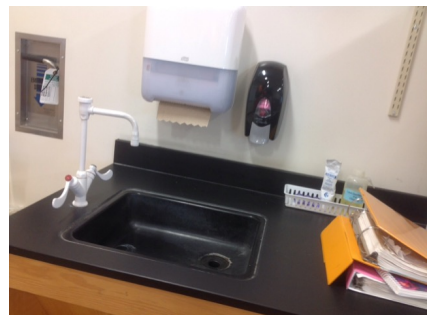
</div>			
			<div><div><input type="checkbox"/> Staff Only</div><div><div>Priority</div><div>2</div><div>Severity</div><div>3</div></div></div>			
<div>Reach Range</div>						
681	<div><div>As-Built Description:</div><div>Reach height to control or access point, exceeds 48" or is less than 15".</div><div>As-Built: 26" reach</div><div>Proposed Solution:</div><div>Modify equipment or mounting.</div></div>	<div>PCODE IE01</div> <div>ADAAG 91 4.2.5</div> <div>ADA 2010 308.2.1</div> <div>CBC 2007 1118B.5</div> <div>CBC 2016 11B-308.2.1</div> <div>Mitigated:</div> <div><div><input type="radio"/> YES</div><div><input checked="" type="radio"/> NO</div></div>	1	JOB	\$300	\$300

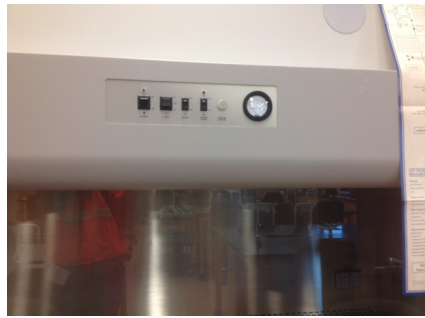
Item no., Rm no. and Name	Existing Architectural Barrier and Proposed Solution	Codes / Mitigation Info	Qty	Unit	Cost	Total
682	<ul style="list-style-type: none"> As-Built Description: Reach height to control or access point, exceeds 48" or is less than 15". As-Built: 65" high Proposed Solution: Modify equipment or mounting. 	PCODE IE01 ADAAG 91 4.2.5 ADA 2010 308.2.1 CBC 2007 1118B.5 CBC 2016 11B-308.2.1 Mitigated: <input type="radio"/> YES <input checked="" type="radio"/> NO	1	JOB	\$300	\$300

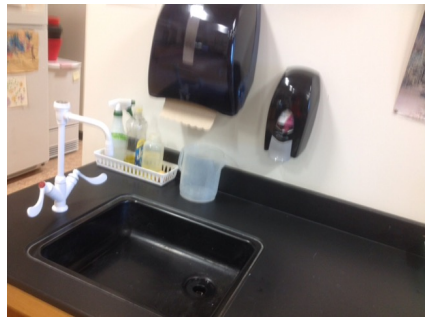
<input type="checkbox"/> Staff Only Priority 2 Severity 2			
692	<ul style="list-style-type: none"> As-Built Description: Reach height to control or access point, exceeds 48" or is less than 15". As-Built: 26" reach depth Proposed Solution: Modify equipment or mounting. Notes: Class Lab Service 206B 	PCODE IE01 ADAAG 91 4.2.5 ADA 2010 308.2.1 CBC 2007 1118B.5 CBC 2016 11B-308.2.1 Mitigated: <input type="radio"/> YES <input checked="" type="radio"/> NO	1	JOB	\$300	\$300

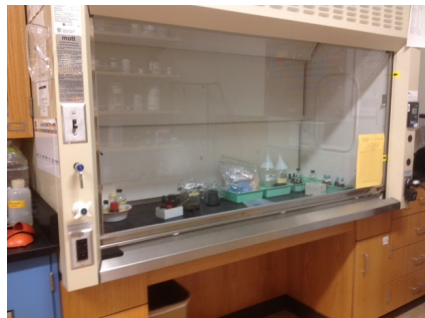
<input type="checkbox"/> Staff Only Priority 2 Severity 4			
693	<ul style="list-style-type: none"> As-Built Description: Reach height to control or access point, exceeds 48" or is less than 15". As-Built: 52" high Proposed Solution: Modify equipment or mounting. Notes: Class Lab Service 206B 	PCODE IE01 ADAAG 91 4.2.5 ADA 2010 308.2.1 CBC 2007 1118B.5 CBC 2016 11B-308.2.1 Mitigated: <input type="radio"/> YES <input checked="" type="radio"/> NO	1	JOB	\$300	\$300

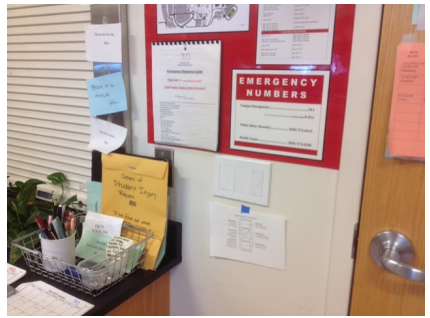
Item no., Rm no. and Name	Existing Architectural Barrier and Proposed Solution	Codes / Mitigation Info	Qty	Unit	Cost	Total
694	<ul style="list-style-type: none"> As-Built Description: Reach height to control or access point, exceeds 48" or is less than 15". As-Built: 54" high Proposed Solution: Modify equipment or mounting. Notes: Class Lab Service 206B 	PCODE IE01 ADAAG 91 4.2.5 ADA 2010 308.2.1 CBC 2007 1118B.5 CBC 2016 11B-308.2.1 Mitigated: <input type="radio"/> YES <input checked="" type="radio"/> NO	1	JOB	\$300	\$300

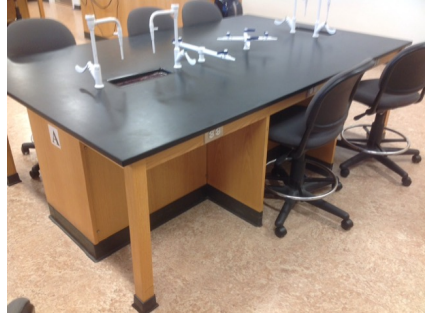
683	<ul style="list-style-type: none"> As-Built Description: Accessible non-fixed table or desk (top 28" to 34" high; knee space at least 27" high x 19" deep x 30" wide) not provided. As-Built: 28.5" wide Proposed Solution: Provide table or desk with accessible dimensions when purchasing new furniture. 	PCODE IN02A ADAAG 91 4.32.3 & .4 ADA 2010 306.1 CBC 2007 1122B.3 & 4 CBC 2016 11B-306.1 & 11B-902.3 Mitigated: <input type="radio"/> YES <input checked="" type="radio"/> NO	1	JOB	\$4,800	\$4,800

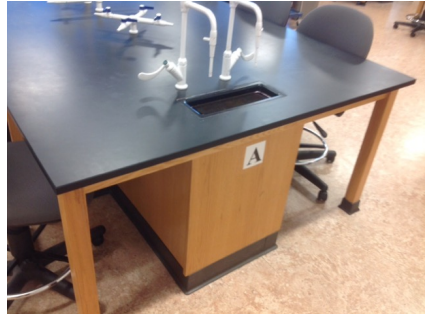
<input type="checkbox"/> Staff Only Priority 2 Severity 2						
686	<ul style="list-style-type: none"> As-Built Description: Accessible non-fixed table or desk (top 28" to 34" high; knee space at least 27" high x 19" deep x 30" wide) not provided. Proposed Solution: Provide table or desk with accessible dimensions when purchasing new furniture. 	PCODE IN02A ADAAG 91 4.32.3 & .4 ADA 2010 306.1 CBC 2007 1122B.3 & 4 CBC 2016 11B-306.1 & 11B-902.3 Mitigated: <input type="radio"/> YES <input checked="" type="radio"/> NO	1	JOB	\$4,800	\$4,800

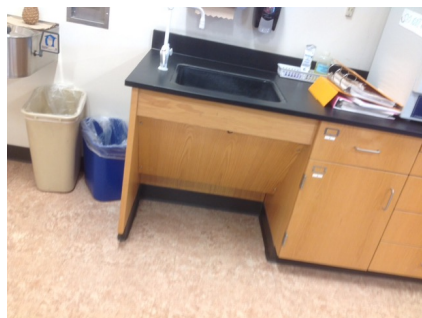
Item no., Rm no. and Name	Existing Architectural Barrier and Proposed Solution	Codes / Mitigation Info	Qty	Unit	Cost	Total
Sink						
680	<ul style="list-style-type: none"> As-Built Description: Sink does not have knee space min. 27" high x 19" deep x 30" wide. Proposed Solution: Remodel sink cabinet. 	PCODE IN06A ADAAG 91 4.24.3 ADA 2010 606.2 CBC 2007 1115B.4.7.1 CBC 2016 11B-606.2 Mitigated: <input type="radio"/> YES <input checked="" type="radio"/> NO	1	JOB	\$5,250	\$5,250

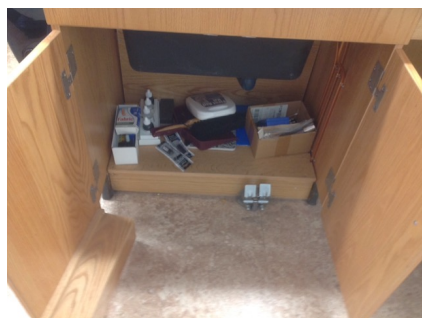
<input type="checkbox"/> Staff Only Priority 2 Severity 2			
687	<ul style="list-style-type: none"> As-Built Description: Sink does not have knee space min. 27" high x 19" deep x 30" wide. Proposed Solution: Remodel sink cabinet. Notes: Sink not finished under. 	PCODE IN06A ADAAG 91 4.24.3 ADA 2010 606.2 CBC 2007 1115B.4.7.1 CBC 2016 11B-606.2 Mitigated: <input type="radio"/> YES <input checked="" type="radio"/> NO	1	JOB	\$5,250	\$5,250

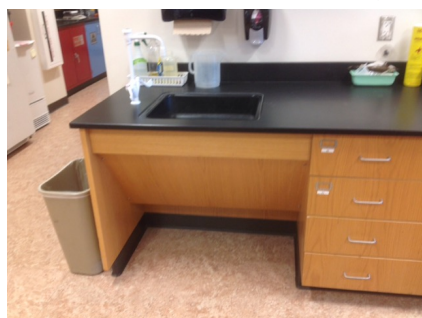
<input type="checkbox"/> Staff Only Priority 2 Severity 2			
691	<ul style="list-style-type: none"> As-Built Description: Sink does not have knee space min. 27" high x 19" deep x 30" wide. Proposed Solution: Remodel sink cabinet. Notes: Class Lab Service 206B 	PCODE IN06A ADAAG 91 4.24.3 ADA 2010 606.2 CBC 2007 1115B.4.7.1 CBC 2016 11B-606.2 Mitigated: <input type="radio"/> YES <input checked="" type="radio"/> NO	1	JOB	\$5,250	\$5,250

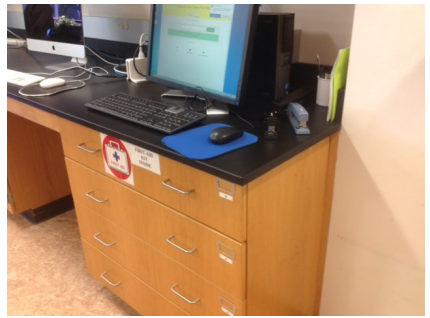
Item no., Rm no. and Name	Existing Architectural Barrier and Proposed Solution	Codes / Mitigation Info	Qty	Unit	Cost	Total
711	<ul style="list-style-type: none"> As-Built Description: Accessible fixed table or desk (top 28" to 34" high; knee space at least 27" high x 19" deep x 30" wide) not provided. Proposed Solution: Provide new fixed accessible table or desk. Notes: Check-in station 	PCODE IN02 ADAAG 91 4.32.3 & .4 ADA 2010 306.1 & 902.3 CBC 2007 1122B.3 & 4 CBC 2016 11B-306.1 & 11B-902.3	1	JOB	\$7,500	\$7,500
<div>

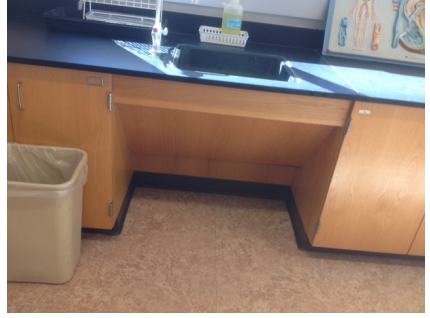
705	<ul style="list-style-type: none"> As-Built Description: Sink does not have knee space min. 27" high x 19" deep x 30" wide. Proposed Solution: Remodel sink cabinet. 	PCODE IN06A ADAAG 91 4.24.3 ADA 2010 606.2 CBC 2007 1115B.4.7.1 CBC 2016 11B-606.2	1	JOB	\$5,250	\$5,250
<div>

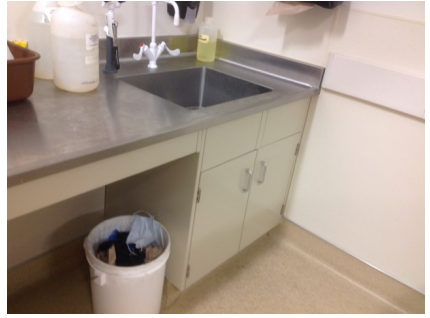
</div> <div> <input type="radio"/> YES <input checked="" type="radio"/> NO </div> <div> <input type="checkbox"/> Staff Only </div> <div> Priority 2 Severity 2 </div>						
709	<ul style="list-style-type: none"> As-Built Description: Sink does not have knee space min. 27" high x 19" deep x 30" wide. Proposed Solution: Remodel sink cabinet. 	PCODE IN06A ADAAG 91 4.24.3 ADA 2010 606.2 CBC 2007 1115B.4.7.1 CBC 2016 11B-606.2	1	JOB	\$5,250	\$5,250
<div>

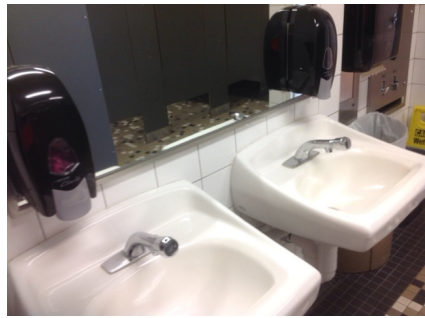
Item no., Rm no. and Name	Existing Architectural Barrier and Proposed Solution	Codes / Mitigation Info	Qty	Unit	Cost	Total
727	<ul style="list-style-type: none"> As-Built Description: Bottom of mirror located above lavatories or countertops more than 40" above floor. As-Built: 41" high Proposed Solution: Relocate or provide new accessible mirror. 	PCODE WG03 ADAAG 91 4.19.6 ADA 2010 603.3 CBC 2007 1115B.8.1 CBC 2016 11B-603.3 Mitigated: <input type="radio"/> YES <input checked="" type="radio"/> NO	1	JOB	\$450	\$450

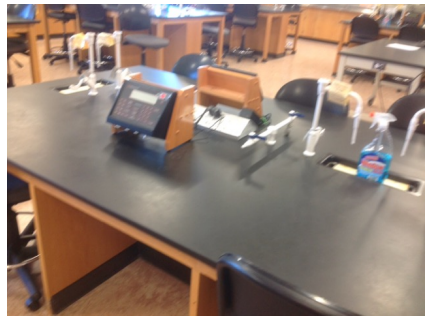
Item no., Rm no. and Name	Existing Architectural Barrier and Proposed Solution	Codes / Mitigation Info	Qty	Unit	Cost	Total
765	<ul style="list-style-type: none"> As-Built Description: Reach height for side approach to control or access point over an obstruction that is 34" max. high and 24" max. deep exceeds 46". As-Built: Greater than 24" reach to accessories mounted on desk Proposed Solution: Modify equipment or mounting. 	PCODE IE02A ADAAG 91 Fig. 6(c) ADA 2010 308.3.2 CBC 2007 Fig. 11B-5D(c) CBC 2016 11B-308.3.2 Mitigated: <input type="radio"/> YES <input checked="" type="radio"/> NO	1	JOB	\$300	\$300

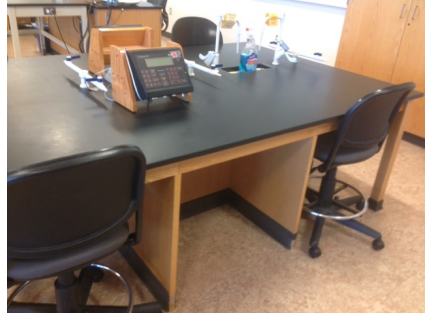
Non-Fixed Desk

764	<ul style="list-style-type: none"> As-Built Description: Accessible non-fixed table or desk (top 28" to 34" high; knee space at least 27" high x 19" deep x 30" wide) not provided. As-Built: 28" wide Proposed Solution: Provide table or desk with accessible dimensions when purchasing new furniture. Notes: 32 total, no accessible 	PCODE IN02A ADAAG 91 4.32.3 & .4 ADA 2010 306.1 CBC 2007 1122B.3 & 4 CBC 2016 11B-306.1 & 11B-902.3 Mitigated: <input type="radio"/> YES <input checked="" type="radio"/> NO	1	JOB	\$4,800	\$4,800

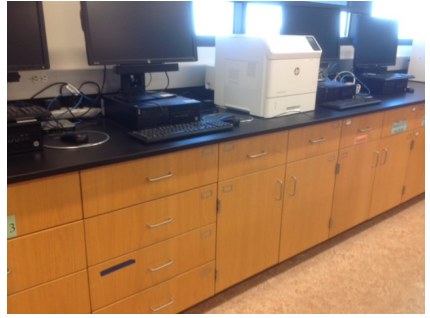
<input type="checkbox"/> Staff Only Priority 2 Severity 2						
767	<ul style="list-style-type: none"> As-Built Description: Accessible non-fixed table or desk (top 28" to 34" high; knee space at least 27" high x 19" deep x 30" wide) not provided. As-Built: No knee clearance Proposed Solution: Provide table or desk with accessible dimensions when purchasing new furniture. 	PCODE IN02A ADAAG 91 4.32.3 & .4 ADA 2010 306.1 CBC 2007 1122B.3 & 4 CBC 2016 11B-306.1 & 11B-902.3 Mitigated: <input type="radio"/> YES <input checked="" type="radio"/> NO	1	JOB	\$4,800	\$4,800

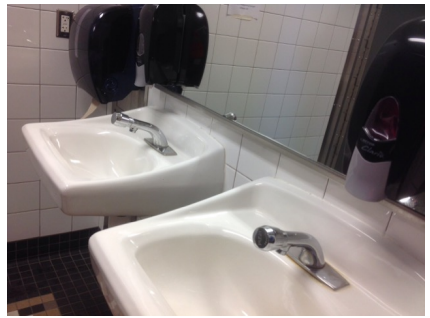
Item no., Rm no. and Name	Existing Architectural Barrier and Proposed Solution	Codes / Mitigation Info	Qty	Unit	Cost	Total
786	<ul style="list-style-type: none"> As-Built Description: Bottom of mirror located above lavatories or countertops more than 40" above floor. As-Built: 41" high Proposed Solution: Relocate or provide new accessible mirror. 	PCODE WG03 ADAAG 91 4.19.6 ADA 2010 603.3 CBC 2007 1115B.8.1 CBC 2016 11B-603.3 Mitigated: <input type="radio"/> YES <input checked="" type="radio"/> NO	1	JOB	\$450	\$450

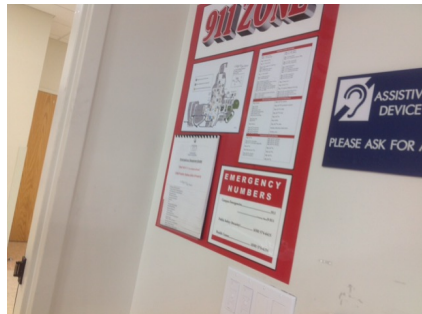
Item no., Rm no. and Name	Existing Architectural Barrier and Proposed Solution	Codes / Mitigation Info	Qty	Unit	Cost	Total
795	<ul style="list-style-type: none"> As-Built Description: Reach height to control or access point, exceeds 48" or is less than 15". As-Built: 54" high Proposed Solution: Modify equipment or mounting. 	PCODE IE01 ADAAG 91 4.2.5 ADA 2010 308.2.1 CBC 2007 1118B.5 CBC 2016 11B-308.2.1 Mitigated: <input type="radio"/> YES <input checked="" type="radio"/> NO	1	JOB	\$300	\$300

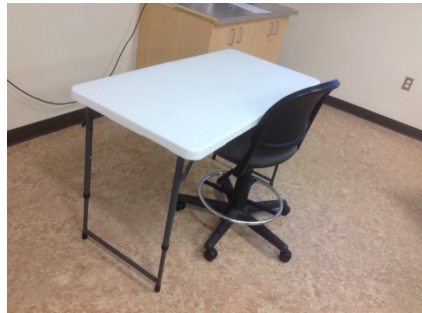
Non-Fixed Desk

794	<ul style="list-style-type: none"> As-Built Description: Accessible non-fixed table or desk (top 28" to 34" high; knee space at least 27" high x 19" deep x 30" wide) not provided. Proposed Solution: Provide table or desk with accessible dimensions when purchasing new furniture. Notes: 60 seats, 2 accessible. Ensure at least 5% are accessible. 	PCODE IN02A ADAAG 91 4.32.3 & .4 ADA 2010 306.1 CBC 2007 1122B.3 & 4 CBC 2016 11B-306.1 & 11B-902.3 Mitigated: <input type="radio"/> YES <input checked="" type="radio"/> NO	1	JOB	\$4,800	\$4,800

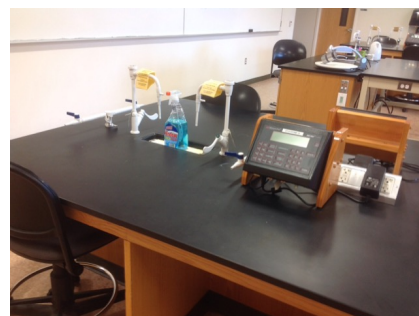
Item no., Rm no. and Name	Existing Architectural Barrier and Proposed Solution	Codes / Mitigation Info	Qty	Unit	Cost	Total
804	<ul style="list-style-type: none"> As-Built Description: Reach height to control or access point, exceeds 48" or is less than 15". As-Built: 28" to mounted items Proposed Solution: Modify equipment or mounting. 	PCODE IE01 ADAAG 91 4.2.5 ADA 2010 308.2.1 CBC 2007 1118B.5 CBC 2016 11B-308.2.1	1	JOB	\$300	\$300
<div>Mitigated:</div> <div> <input type="radio"/> YES <input checked="" type="radio"/> NO </div> <div> <input type="checkbox"/> Staff Only </div> <div> Priority 2 Severity 4 </div>

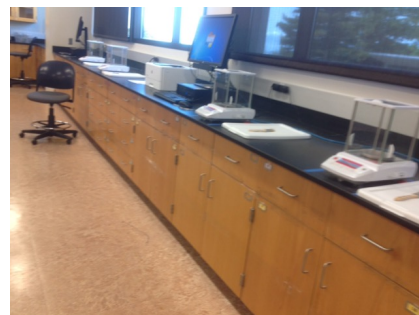
**Desk**

802	<ul style="list-style-type: none"> As-Built Description: Accessible fixed table or desk (top 28" to 34" high; knee space at least 27" high x 19" deep x 30" wide) not provided. As-Built: 36" high, no knee space Proposed Solution: Provide new fixed accessible table or desk. 	PCODE IN02 ADAAG 91 4.32.3 & .4 ADA 2010 306.1 & 902.3 CBC 2007 1122B.3 & 4 CBC 2016 11B-306.1 & 11B-902.3	1	JOB	\$7,500	\$7,500
<div>Mitigated:</div> <div> <input type="radio"/> YES <input checked="" type="radio"/> NO </div> <div> <input type="checkbox"/> Staff Only </div> <div> Priority 2 Severity 4 </div>

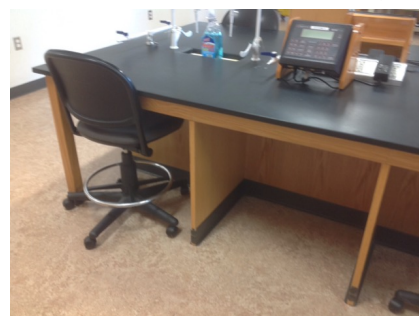
**Non-Fixed Desk**

801	<ul style="list-style-type: none"> As-Built Description: Accessible non-fixed table or desk (top 28" to 34" high; knee space at least 27" high x 19" deep x 30" wide) not provided. As-Built: 28" wide Proposed Solution: Provide table or desk with accessible dimensions when purchasing new furniture. Notes: 32 seats, no accessible 	PCODE IN02A ADAAG 91 4.32.3 & .4 ADA 2010 306.1 CBC 2007 1122B.3 & 4 CBC 2016 11B-306.1 & 11B-902.3	1	JOB	\$4,800	\$4,800
<div>Mitigated:</div> <div> <input type="radio"/> YES <input checked="" type="radio"/> NO </div> <div> <input type="checkbox"/> Staff Only </div> <div> Priority 2 Severity 2 </div>

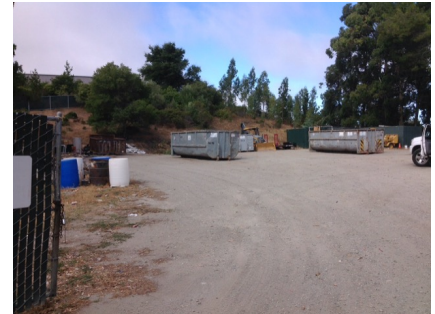
- 2
- *As-Built Description:*
Refer to notes for observation and recommendation.
 - *Proposed Solution:*
 - *Notes:*
Dirt lot used for storage of building material.

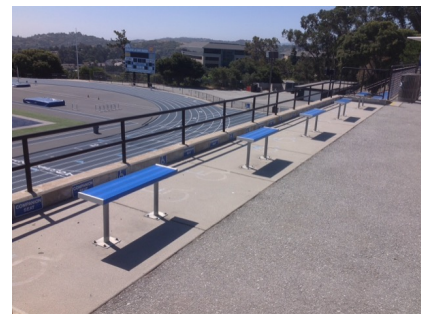
Item no., Rm no. and Name	Existing Architectural Barrier and Proposed Solution	Codes / Mitigation Info	Qty	Unit	Cost	Total
371	<ul style="list-style-type: none"> As-Built Description: Proper amount of seating for disabled persons at public seating is not provided (4 to 25=1; 26 to 50=2; 51 to 150=4; 151 to 300=5; 301 to 500=6; 501 to 5000=6+1 for each hundred; >5001=46+1 for each 200. Proposed Solution: Modify seating to provide clear and level wheelchair space 33" x 48" or 33" x 60", including companion seat, as required. Notes: 20 lower seats, 20 upper seats. Ensure total number of accessible seats are provided. 	PCODE GE01 ADAAG 91 4.1.2(19)a ADA 2010 221.2.1 CBC 2007 1104B.3.4 CBC 2016 11B-221.2.1 Mitigated: <input type="radio"/> YES <input checked="" type="radio"/> NO	1	EA	\$1,800	\$1,800

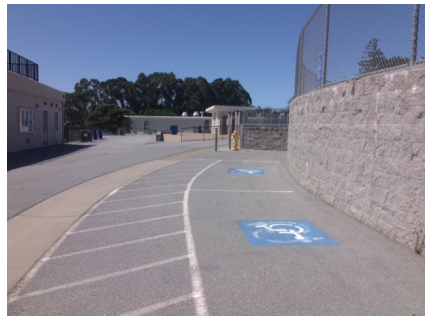
Item no., Rm no. and Name	Existing Architectural Barrier and Proposed Solution	Codes / Mitigation Info	Qty	Unit	Cost	Total
378	<ul style="list-style-type: none"> As-Built Description: No van parking provided (one in every 6 or fraction of 6 accessible spaces, but not less than one). Proposed Solution: Provide van parking space(s) by restriping; provide van sign. 	PCODE EA07 ADAAG 91 4.1.2(5)(b) ADA 2010 208.2; 502.1 CBC 2007 1129B.3.2 CBC 2016 11B-208.2.4 Mitigated: <input type="radio"/> YES <input checked="" type="radio"/> NO	1	JOB	\$1,050	\$1,050

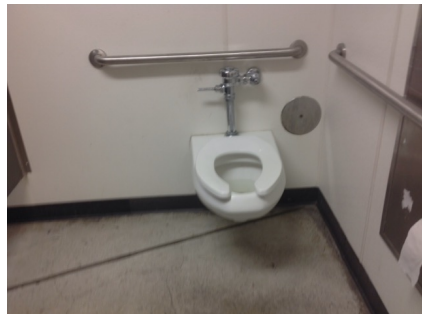
Item no., Rm no. and Name	Existing Architectural Barrier and Proposed Solution	Codes / Mitigation Info	Qty	Unit	Cost	Total
384	<ul style="list-style-type: none"> As-Built Description: Water closet not 16"-18" (CA: 17"-18") from near side wall to center line of water closet (2010 ADAAG: 16"-18"). As-Built: 18.5" o.c. Proposed Solution: Relocate existing water closet and plumbing, remount with offset closet flange to provide 18" max. from side wall. 	PCODE WB02C ADAAG 91 Fig. 28 ADA 2010 604.2 CBC 2007 1115B.4.1.1 CBC 2016 11B-604.2 Mitigated: <input type="radio"/> YES <input checked="" type="radio"/> NO	1	JOB	\$1,500	\$1,500

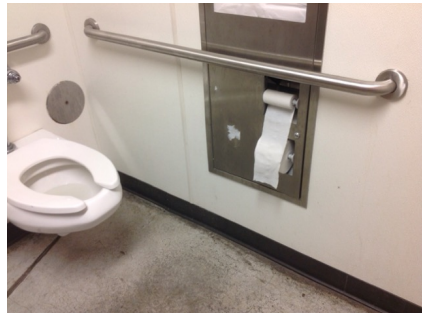
385	<ul style="list-style-type: none"> As-Built Description: Toilet paper dispenser less than 15" (CA: 19") or more than 48" above floor or not within 7" to 9" from front of water closet (Note: CA pre-2010 is allowed within 12" from front of water closet). As-Built: 13" o.c. Proposed Solution: Relocate or provide new toilet paper dispenser. 	PCODE WG02 ADAAG 91 4.16.6 ADA 2010 604.7 CBC 2007 1115B.8.4 Mitigated: <input type="radio"/> YES <input checked="" type="radio"/> NO	1	JOB	\$225	\$225

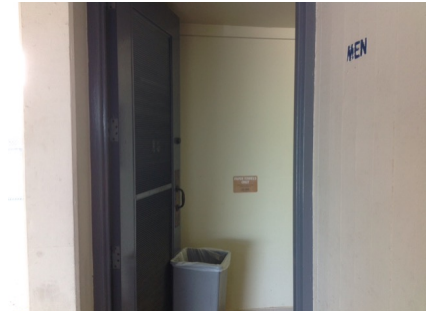
<input type="checkbox"/> Staff Only Priority 3 Severity 3			
286	<ul style="list-style-type: none"> As-Built Description: Required in CA only: identification symbol centered 58" to 60" high on sanitary facility door that contrasts with the door not provided (women: 12" ø circle, men: 12" triangle, unisex: combined symbol). Proposed Solution: Provide properly mounted sanitary facility symbol when altering area. If wheelchair accessible, include International Symbol of Accessibility on sign. 	PCODE SA15 CBC 2007 1115B.6 CBC 2016 11B-703.7.2.6 Mitigated: <input type="radio"/> YES <input checked="" type="radio"/> NO	1	JOB	\$270	\$270

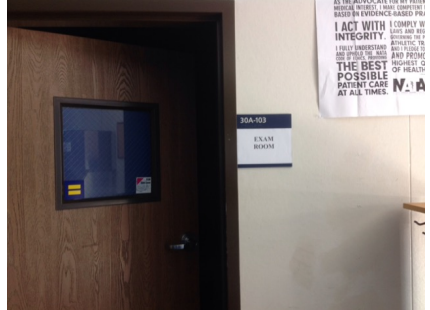
Item no., Rm no. and Name	Existing Architectural Barrier and Proposed Solution	Codes / Mitigation Info	Qty	Unit	Cost	Total
Signage						
307	<ul style="list-style-type: none"> As-Built Description: Sign not located on latch side of door and/or not located at 48" min. above to baseline of the lowest Braille cells and 60" max. to baseline of the highest line of raised characters. As-Built: 62" high Proposed Solution: Provide compliant signage including tactile characters and Grade II Braille on latch side of door located at compliant height. 	PCODE SA07 ADAAG 91 4.30.6 ADA 2010 703.4.1 CBC 2007 1117B.5.7 CBC 2016 11B-703.4.1	2	JOB	\$150	\$300
Mitigated: <input type="radio"/> YES <input checked="" type="radio"/> NO

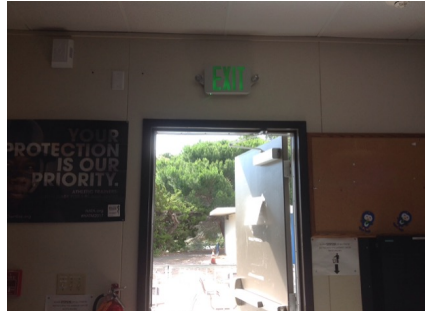
<input type="checkbox"/> Staff Only Priority 2 Severity 3			
305	<ul style="list-style-type: none"> As-Built Description: At final exit door to exterior: Where required exit signs are installed, signs to provide exiting information for people with vision impairment are not provided. Proposed Solution: Provide raised letter/Braille "EXIT" sign at door. 	PCODE SA10A ADAAG 91 4.1.3(16) ADA 2010 216.4.1 CBC 2007 1011.3 CBC 2016 11B-216.4.1	1	JOB	\$270	\$270

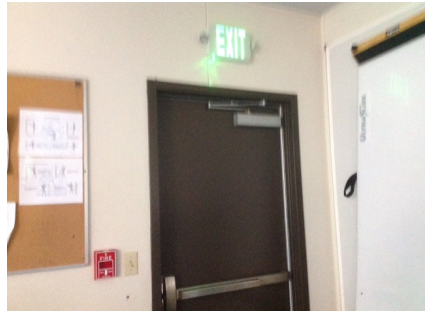
<input type="checkbox"/> Staff Only Priority 2 Severity 3			
306	<ul style="list-style-type: none"> As-Built Description: At door leading into exit stairway: Where required exit signs are installed, signs to provide exiting information for people with vision impairment are not provided. Proposed Solution: Provide raised letter/Braille "EXIT STAIR UP/DOWN" sign at door. 	PCODE SA10B ADAAG 91 4.1.3(16) ADA 2010 216.4.1 CBC 2007 1011.3 CBC 2016 11B-216.4.1	1	JOB	\$270	\$270
Mitigated: <input type="radio"/> YES <input checked="" type="radio"/> NO

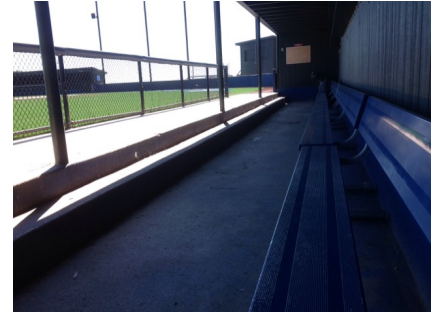
Refer to notes for observation and recommendation.

• **Notes:****Two steps to dugout, no accessible route provided****Mitigated:**☐ YES☒ NO

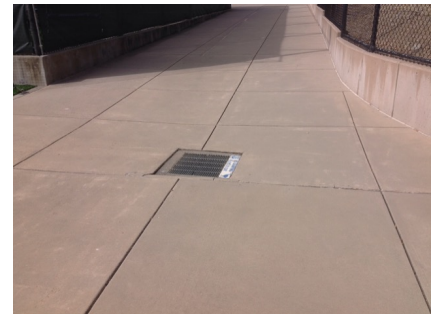
- 7
- *As-Built Description:*
Walk: Pavement dislocation creates abrupt change in level exceeding 1/2" in accessible route.
 - *Proposed Solution:*
Remove, replace or repair area of pavement sufficient to correct abrupt change in level.

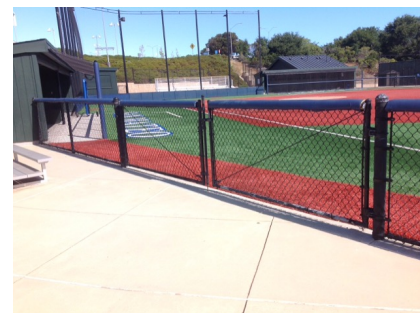
- *Notes:*

No accessible gate onto field.**Mitigated:**☐ YES☒ NO

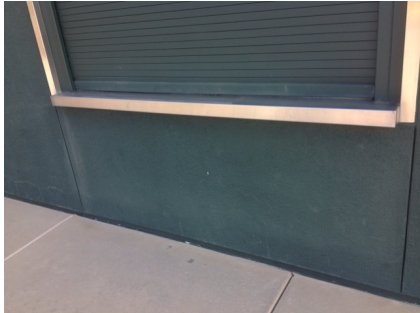
Item no., Rm no. and Name	Existing Architectural Barrier and Proposed Solution	Codes / Mitigation Info	Qty	Unit	Cost	Total
Public Counter						
27	<ul style="list-style-type: none">As-Built Description: Service counter (stand-up): Accessible section min. 36" length and 36" max. height (in CA: 28" to 34" high) not provided.As-Built: 32.25" highProposed Solution: Retrofit existing counter to provide accessible section. Interim solution: Provide auxiliary counter, table, or clipboard.	<p>PCODE IN03</p> <p>ADAAG 91 7.2(2)</p> <p>ADA 2010 904.4</p> <p>CBC 2007 1122B.4</p> <p>CBC 2016 11B-904.4</p> <p>Mitigated:</p> <p><input type="radio"/> YES</p> <p><input checked="" type="radio"/> NO</p>	1	JOB	\$6,000	\$6,000

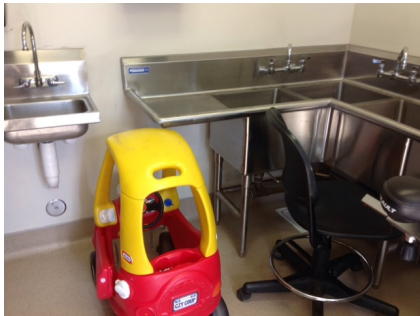
<input type="checkbox"/> Staff Only			
			<div>Priority 2Severity 4</div>			
Sink						
24	<ul style="list-style-type: none">As-Built Description: Sink does not have knee space min. 27" high x 19" deep x 30" wide.Proposed Solution: Remodel sink cabinet.Notes: Staff area	<p>PCODE IN06A</p> <p>ADAAG 91 4.24.3</p> <p>ADA 2010 606.2</p> <p>CBC 2007 1115B.4.7.1</p> <p>CBC 2016 11B-606.2</p> <p>Mitigated:</p> <p><input type="radio"/> YES</p> <p><input checked="" type="radio"/> NO</p>	1	JOB	\$5,250	\$5,250

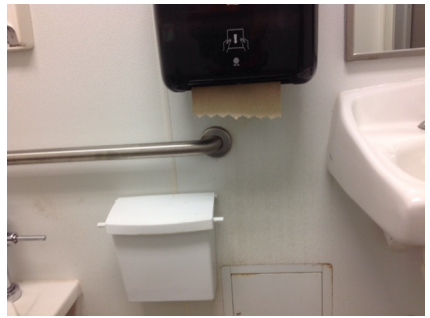
Item no., Rm no. and Name	Existing Architectural Barrier and Proposed Solution	Codes / Mitigation Info	Qty	Unit	Cost	Total
12	<ul style="list-style-type: none"> As-Built Description: Accessories/dispensers in accessible stall located closer than 1-1/2" below or 12" above grab bar impedes its use. Proposed Solution: Relocate accessories/dispensers to be no closer than 1-1/2" below and 12" above grab bars (except if accessories are recessed, flush with wall, and have no sharp edges). 	PCODE WB071 ADAAG 91 4.26.2 ADA 2010 609.3 CBC 2007 1133B.4.2.5 CBC 2016 11B-609.3 Mitigated: <input type="radio"/> YES <input checked="" type="radio"/> NO	1	JOB	\$225	\$225

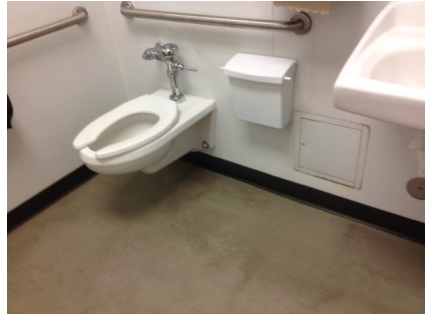
11	<ul style="list-style-type: none"> As-Built Description: Toilet stall less than 60" wide. As-Built: 54" Proposed Solution: Provide new accessible stall. Notes: 28" between WC and lavatory 	PCODE WB06 ADAAG 91 4.17.3 ADA 2010 604.8.1.1 CBC 2007 1115B.3.1.4.1 CBC 2016 11B-604.8.1.1 Mitigated: <input type="radio"/> YES <input checked="" type="radio"/> NO	1	JOB	\$4,500	\$4,500

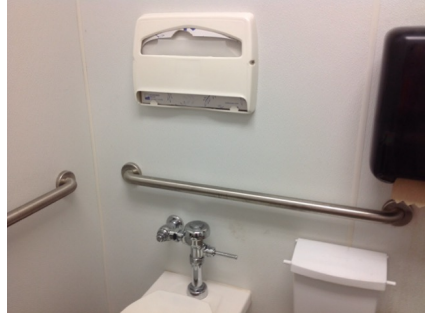
13	<ul style="list-style-type: none"> As-Built Description: Dispensers in sanitary facilities, such as for towels, soap, sanitary napkins, seat covers, etc., and waste receptacles more than 48" (CA only: 40") from floor to highest operating slot or control. As-Built: 50" high Proposed Solution: Relocate existing restroom accessories. 	PCODE WG01A ADAAG 91 4.23.7 ADA 2010 308.2.1 CBC 2007 1115B.8.3 CBC 2016 11B-603.5 Mitigated: <input type="radio"/> YES <input checked="" type="radio"/> NO	1	JOB	\$300	\$300

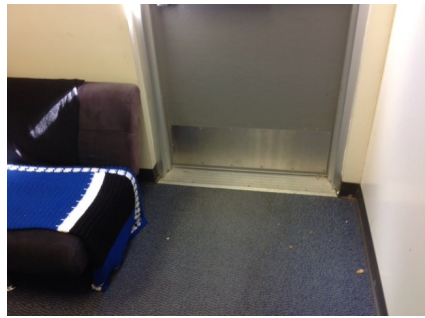
Item no., Rm no. and Name	Existing Architectural Barrier and Proposed Solution	Codes / Mitigation Info	Qty	Unit	Cost	Total
20	<ul style="list-style-type: none"> As-Built Description: Front approach: At push side, door does not have clear and level maneuvering space measuring door width x 48" (door width plus 12" if door has both, latch and closer). Proposed Solution: Remove or relocate furniture or storage items. 	PCODE ID24A ADAAG 91 Fig. 25(a) ADA 2010 404.2.4 CBC 2007 11B-26A(a) CBC 2016 11B-404.2.4 Mitigated: <input type="radio"/> YES <input checked="" type="radio"/> NO	1	JOB	\$150	\$150

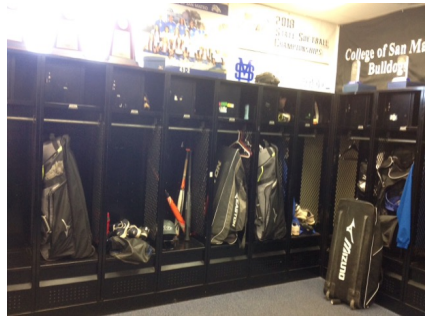
23	<ul style="list-style-type: none"> As-Built Description: Reach height to control or access point, exceeds 48" or is less than 15". Proposed Solution: Modify equipment or mounting. Notes: Locker reach 	PCODE IE01 ADAAG 91 4.2.5 ADA 2010 308.2.1 CBC 2007 1118B.5 CBC 2016 11B-308.2.1 Mitigated: <input type="radio"/> YES <input checked="" type="radio"/> NO	1	JOB	\$300	\$300

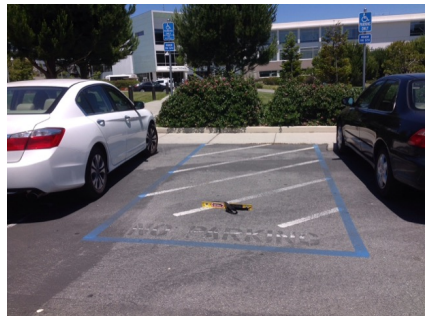
Item no., Rm no. and Name	Existing Architectural Barrier and Proposed Solution	Codes / Mitigation Info	Qty	Unit	Cost	Total
243	<ul style="list-style-type: none"> As-Built Description: Access aisle at accessible parking space has slope greater than 1/4":12" (2%). As-Built: 3.3% Proposed Solution: Modify slope at accessible parking space aisle. 	PCODE EA05B ADAAG 91 4.6.3 ADA 2010 502.4 CBC 2007 1129B.3.3 CBC 2016 11B-502.4 Mitigated: <input type="radio"/> YES <input checked="" type="radio"/> NO	100	SF	\$36	\$3,600

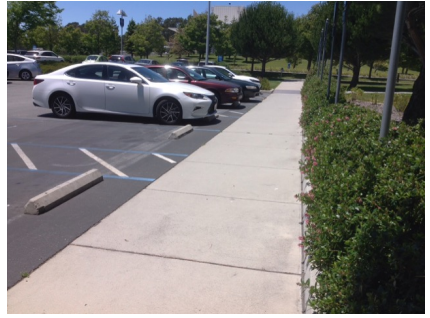
20	<ul style="list-style-type: none"> As-Built Description: At parking lot with 301-400 spaces, the number of accessible spaces is less than required by code; 8 spaces required. Proposed Solution: Provide required accessible parking spaces with signs including a minimum of one van space. Notes: There are 316 total parking spaces with 7 accessible provided. 	PCODE EA01H ADAAG 91 4.1.2(5)* ADA 2010 208.2 CBC 2007 Tbl. 11B-6 CBC 2016 11B-208.2 Tbl. 11B-208.2 Mitigated: <input type="radio"/> YES <input checked="" type="radio"/> NO	1	JOB	\$900	\$900

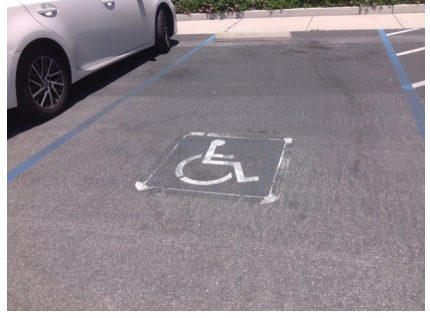
244	<ul style="list-style-type: none"> As-Built Description: International Symbol of Accessibility (36" square, in white on blue) is not painted on the pavement near the rear end of the parking space (required in CA only). Proposed Solution: Apply symbol on parking space pavement when altering area. 	PCODE EA04A CBC 2007 1129B.4 CBC 2016 11B-502.6.4.1 Mitigated: <input type="radio"/> YES <input checked="" type="radio"/> NO	8	JOB	\$360	\$2,880

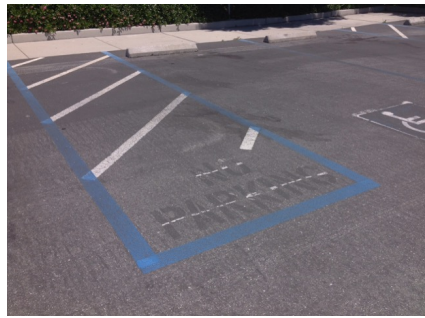
Item no., Rm no. and Name	Existing Architectural Barrier and Proposed Solution	Codes / Mitigation Info	Qty	Unit	Cost	Total
245	<ul style="list-style-type: none"> As-Built Description: The words "NO PARKING" not painted on the ground within loading and unloading access aisle (12" min high white letters), located so that it is visible to traffic enforcement officials (required in CA only). Proposed Solution: Provide the words "NO PARKING" in each access aisle, painted in 12" high letters, when altering area. 	PCODE EA04D CBC 2007 1129B.3.1 CBC 2016 11B-502.3.3 Mitigated: <input type="radio"/> YES <input checked="" type="radio"/> NO	4	JOB	\$300	\$1,200

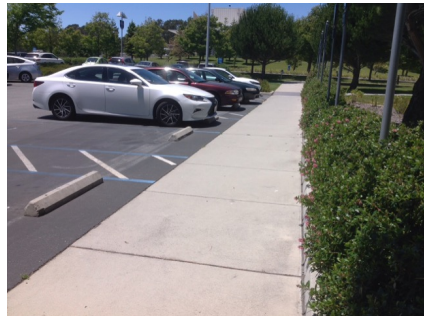
246	<ul style="list-style-type: none"> As-Built Description: Detectable warning not provided where pedestrian crosses vehicular area. Proposed Solution: Provide detectable warning surface (i.e. in-line truncated domes) at regular curb ramp. 	PCODE EH07A ADAAG 91 4.7.7 ADA 2010 705.1 CBC 2007 1127B.5.7 CBC 2016 11B-705.1.2.2 Mitigated: <input type="radio"/> YES <input checked="" type="radio"/> NO	4	JOB	\$750	\$3,000

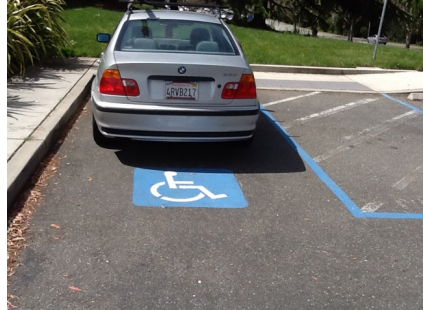
Item no., Rm no. and Name	Existing Architectural Barrier and Proposed Solution	Codes / Mitigation Info	Qty	Unit	Cost	Total
Parking						
422	<ul style="list-style-type: none"> • <i>As-Built Description:</i> Accessible parking space smaller than 8' wide (CA only: 9' x 18'). • <i>As-Built:</i> 8'10" • <i>Proposed Solution:</i> Modify parking space(s) to create accessible space. • <i>Notes:</i> Left space 	PCODE EA02A ADAAG 91 4.6.3 ADA 2010 502.2 CBC 2007 1129B.3.1 CBC 2016 11B-502.2	1	JOB	\$600	\$600

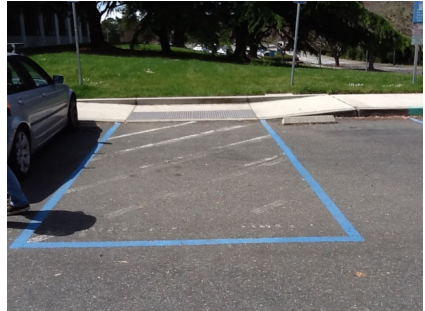
<input type="checkbox"/> Staff Only			
			Priority 1 Severity 4			
420	<ul style="list-style-type: none"> • <i>As-Built Description:</i> The words "NO PARKING" not painted on the ground within loading and unloading access aisle (12" min high white letters), located so that it is visible to traffic enforcement officials (required in CA only). • <i>Proposed Solution:</i> Provide the words "NO PARKING" in each access aisle, painted in 12" high letters, when altering area. 	PCODE EA04D CBC 2007 1129B.3.1 CBC 2016 11B-502.3.3	1	JOB	\$300	\$300

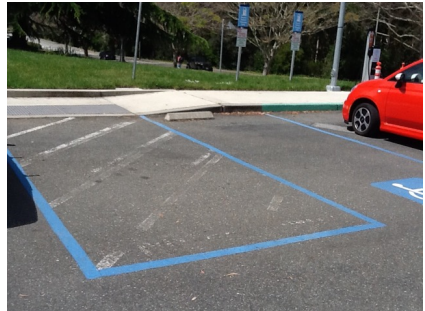
<input type="checkbox"/> Staff Only			
			Priority 1 Severity 4			
421	<ul style="list-style-type: none"> • <i>As-Built Description:</i> CA only: The area within the blue borderlines not marked with hatched lines a maximum of 36" on center. • <i>Proposed Solution:</i> Restripe to provide hatched lines at 36" on center within access aisle. • <i>Notes:</i> Contrast and "NO PARKING" faded 	PCODE EA04I CBC 2007 1129B.3.1 CBC 2016 11B-502.3.3	1	JOB	\$300	\$300

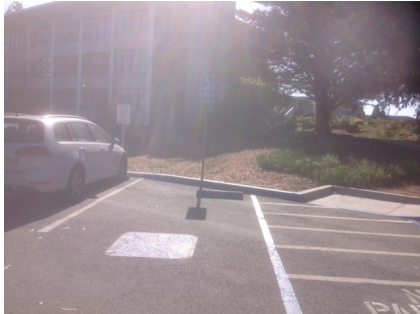
Item no., Rm no. and Name	Existing Architectural Barrier and Proposed Solution	Codes / Mitigation Info	Qty	Unit	Cost	Total
<u>Parking</u>						
235	<ul style="list-style-type: none">• <i>As-Built Description:</i> No van parking provided (one in every 6 or fraction of 6 accessible spaces, but not less than one).• <i>Proposed Solution:</i> Provide van parking space(s) by restriping; provide van sign.	<p>PCODE EA07</p> <p>ADAAG 91 4.1.2(5)(b)</p> <p>ADA 2010 208.2; 502.1</p> <p>CBC 2007 1129B.3.2</p> <p>CBC 2016 11B-208.2.4</p> <p>Mitigated:</p> <p><input type="radio"/> YES</p> <p><input checked="" type="radio"/> NO</p>	1	JOB	\$1,050	\$1,050

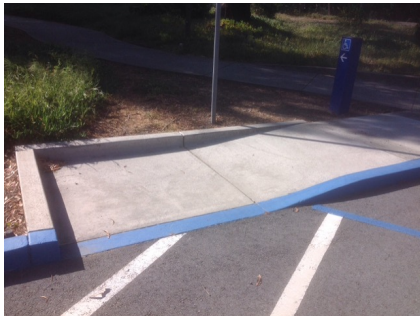
<input type="checkbox"/> Staff Only			
			Priority	Severity		
			1	2		
<u>Cross Slope</u>						
238	<ul style="list-style-type: none">• <i>As-Built Description:</i> Cross slope more than 1":48" (2.083%).• <i>As-Built:</i> Bottom landing 2.7%• <i>Proposed Solution:</i> Modify cross slope.	<p>PCODE EF07</p> <p>ADAAG 91 4.3.7</p> <p>ADA 2010 403.3</p> <p>CBC 2007 1133B.7.1.3</p> <p>CBC 2016 11B-403.3</p> <p>Mitigated:</p> <p><input type="radio"/> YES</p> <p><input checked="" type="radio"/> NO</p>	16	SF	\$75	\$1,200

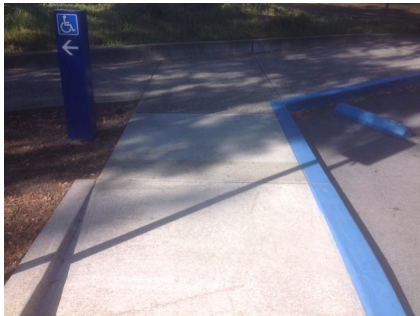
<input type="checkbox"/> Staff Only			
			Priority	Severity		
			1	4		
<u>Curb Ramp</u>						
239	<ul style="list-style-type: none">• <i>As-Built Description:</i> Less than 48" level space at top and 1:12 flared sides not provided.• <i>As-Built:</i> Top landing 3.2% direction of travel• <i>Proposed Solution:</i> Demolish existing and provide new curb ramp.	<p>PCODE EH05B</p> <p>ADAAG 91 4.7.5; Fig.12(a)</p> <p>ADA 2010 406.4</p> <p>CBC 2007 1127B.5.4</p> <p>CBC 2016 11B-406.5.3</p> <p>Mitigated:</p> <p><input type="radio"/> YES</p> <p><input checked="" type="radio"/> NO</p>	1	JOB	\$7,500	\$7,500

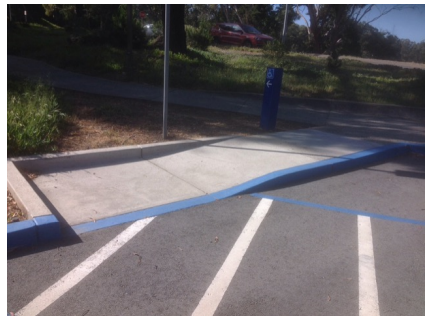
Item no., Rm no. and Name	Existing Architectural Barrier and Proposed Solution	Codes / Mitigation Info	Qty	Unit	Cost	Total
236	<ul style="list-style-type: none"> As-Built Description: Detectable warning not provided where pedestrian crosses vehicular area. Proposed Solution: Provide detectable warning surface (i.e. in-line truncated domes) at regular curb ramp. 	PCODE EH07A ADAAG 91 4.7.7 ADA 2010 705.1 CBC 2007 1127B.5.7 CBC 2016 11B-705.1.2.2 Mitigated: <input type="radio"/> YES <input checked="" type="radio"/> NO	1	JOB	\$750	\$750

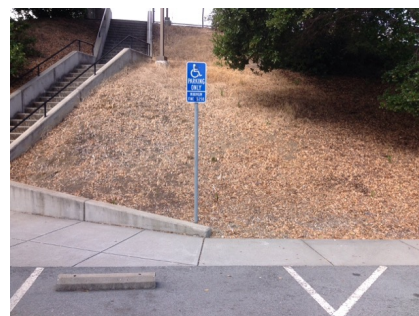
- 5 • *As-Built Description:*
Sign for accessible parking space is missing or non-compliant.

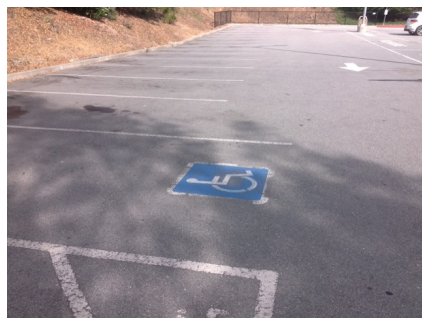
Item no., Rm no. and Name	Existing Architectural Barrier and Proposed Solution	Codes / Mitigation Info	Qty	Unit	Cost	Total
Parking						
6	<ul style="list-style-type: none"> As-Built Description: International Symbol of Accessibility (36" square, in white on blue) is not painted on the pavement near the rear end of the parking space (required in CA only). As-Built: Faded 32 x 32 Proposed Solution: Apply symbol on parking space pavement when altering area. 	PCODE EA04A CBC 2007 1129B.4 CBC 2016 11B-502.6.4.1 Mitigated: <input type="radio"/> YES <input checked="" type="radio"/> NO	1	JOB	\$360	\$360

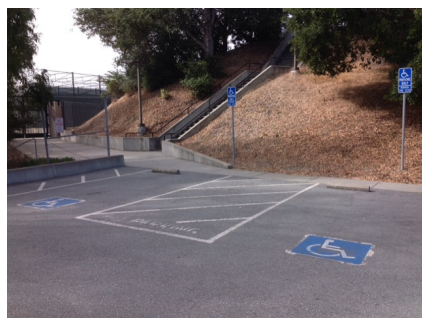
<input type="checkbox"/> Staff Only Priority 1 Severity 4			
4	<ul style="list-style-type: none"> As-Built Description: An accessible parking space shall be outlined or painted blue (required in CA only). As-Built: No blue contrast Proposed Solution: Identify accessible parking space using blue markings. 	PCODE EA04K CBC 2016 11B-502.6 Mitigated: <input type="radio"/> YES <input checked="" type="radio"/> NO	1	JOB	\$360	\$360

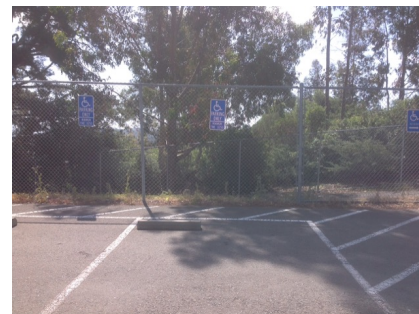
Sign for accessible parking space is missing or non-compliant.

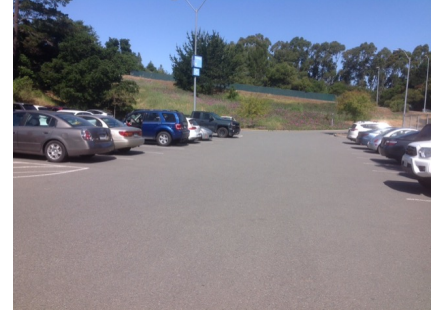
- 5 • *As-Built Description:*
International Symbol of Accessibility (36" square, in white on blue) is not painted on the pavement near the rear end of the parking space (required in CA only).

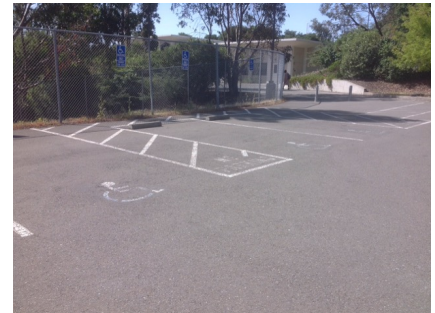
- 4 • *As-Built Description:*
The words "NO PARKING" not painted on the ground within loading and unloading access aisle (12" min high white letters), located so that it is visible to traffic enforcement officials (required in CA only).

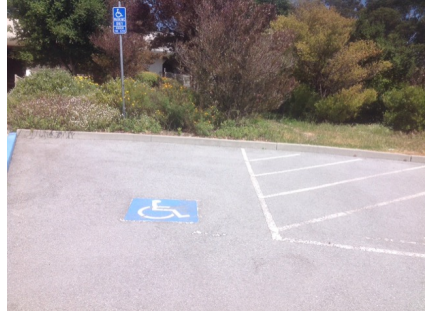
Item no., Rm no. and Name	Existing Architectural Barrier and Proposed Solution	Codes / Mitigation Info	Qty	Unit	Cost	Total
Parking						
62	<ul style="list-style-type: none"> As-Built Description: International Symbol of Accessibility (36" square, in white on blue) is not painted on the pavement near the rear end of the parking space (required in CA only). As-Built: 30 x 30 Proposed Solution: Apply symbol on parking space pavement when altering area. 	PCODE EA04A CBC 2007 1129B.4 CBC 2016 11B-502.6.4.1 Mitigated: <input type="radio"/> YES <input checked="" type="radio"/> NO	1	JOB	\$360	\$360

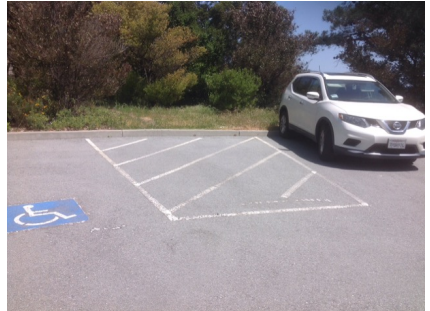
<input type="checkbox"/> Staff Only Priority 1 Severity 4			
63	<ul style="list-style-type: none"> As-Built Description: An accessible parking space shall be outlined or painted blue (required in CA only). Proposed Solution: Identify accessible parking space using blue markings. 	PCODE EA04K CBC 2016 11B-502.6 Mitigated: <input type="radio"/> YES <input checked="" type="radio"/> NO	1	JOB	\$360	\$360

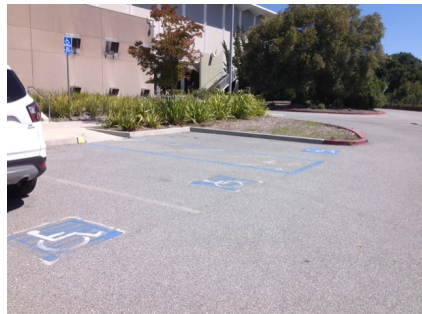
<input type="checkbox"/> Staff Only Priority 1 Severity 4			
772	<ul style="list-style-type: none"> As-Built Description: CA only: The area within the blue borderlines not marked with hatched lines a maximum of 36" on center. As-Built: Contrast faded Proposed Solution: Restripe to provide hatched lines at 36" on center within access aisle. 	PCODE EA04I CBC 2007 1129B.3.1 CBC 2016 11B-502.3.3 Mitigated: <input type="radio"/> YES <input checked="" type="radio"/> NO	1	JOB	\$300	\$300
